Liquefaction during the 1977 San Juan Province, Argentina earthquake ($M_s = 7.4$)

T. Leslie Youd ^a, David K. Keefer ^b

Abstract

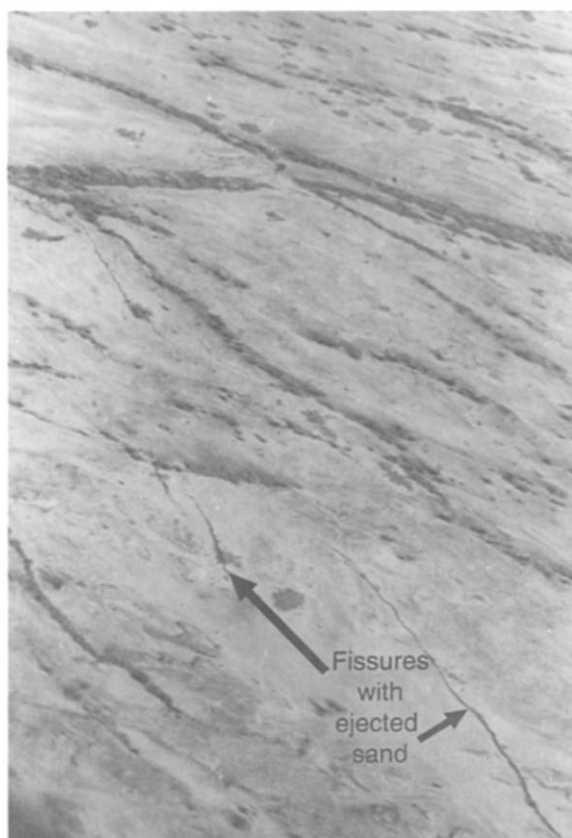
From an aerial reconnaissance of the Valle del Bermejo, the general distribution of ground fissures and sand boils on the valley floor are surveyed. The longest and widest fissures, and the largest sand boils were concentrated in a 60-km long northwest-trending segment of the Valle de Bermejo extending to distances of up to 40 km north of the foreshock epicenter (Fig. 1). Fissures in that area ranged up to several hundred meters long and up to several meters wide. Many large sand boils, with deposits up to tens of meters in extent, erupted through these fissures and also at several isolated locations. Most of the fissures were within one kilometer of and generally parallel to one of the many river channels that traverse the valley floor. The fissures and sand boils shown in

Fig. 2. Typical large fissures and sand boil deposits observed on the floor of the Valle del Bermejo. Fissures are several hundred meters long and several meters wide.

Liquefaction in the Valle del Bermejo occurred primarily beneath active floodplains and other low-lying areas characterized by relatively recent deposition (presumably late Holocene) and shallow groundwater levels. Very few fissures or sand boils were observed on terraces, where groundwater levels are lower and deposits are older.

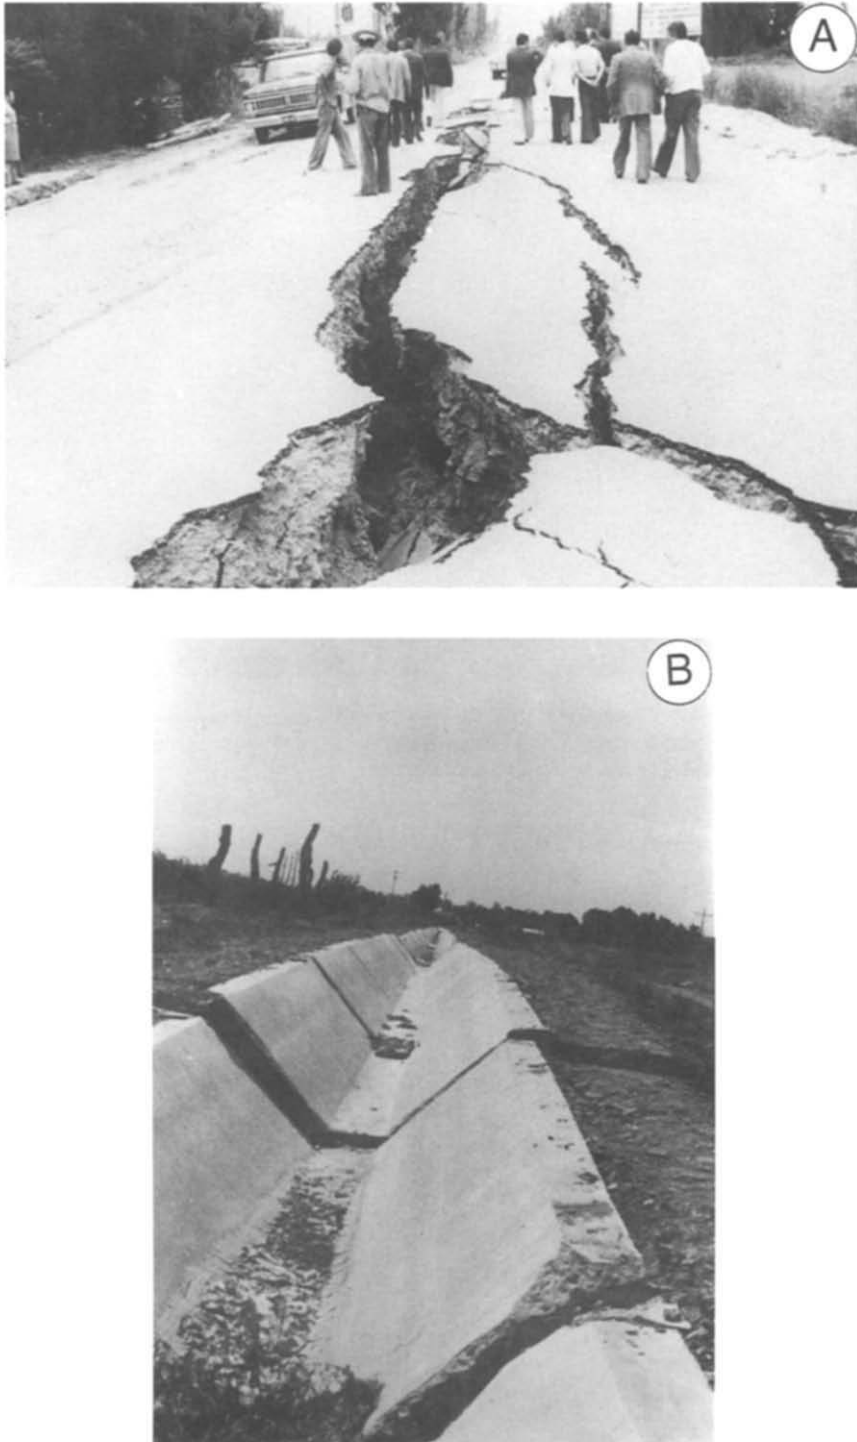
Damage caused by liquefaction in the Valle del Tulum included disrupted highways, railroads and canals (Fig. 3); fractured and differentially settled buildings; tilted tanks and water towers; and differentially settled fields. Examples of these types of damage are described and illustrated in the following sections on specific site studies.

Fig. 3(A). Highway embankment settled and split due to liquefaction of subsurface soils (courtesy of INPRES). (B) Canal lining pulled apart by liquefaction-induced lateral spread (courtesy of K.L. Logani, Harza Engineering).

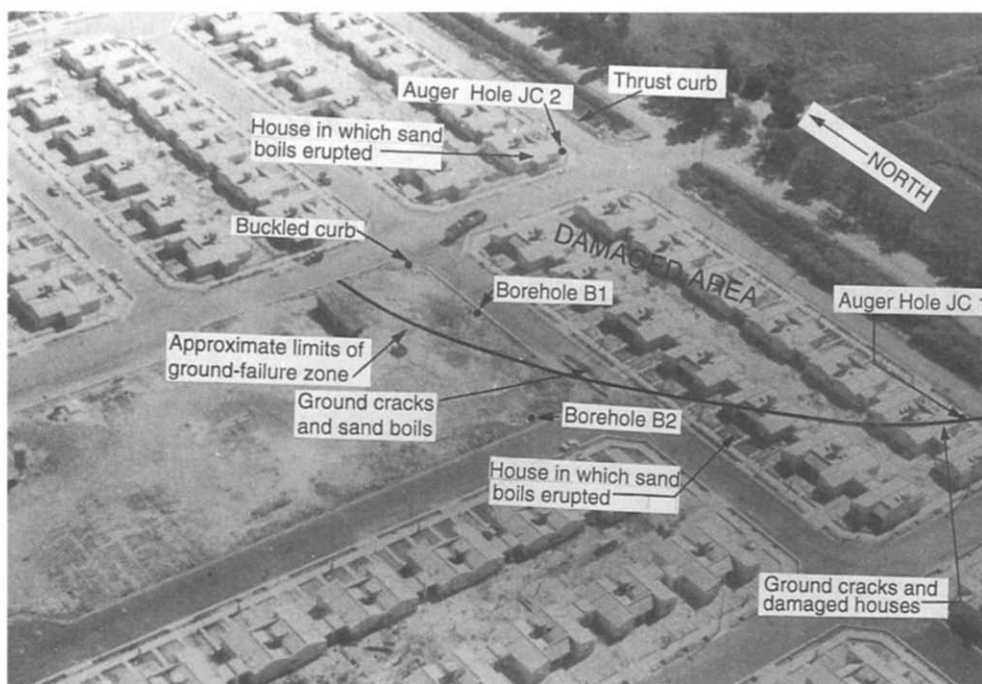
The Barrio Justo P. Castro is a subdivision of single-story duplex houses with unreinforced-concrete slab floors, lightly-reinforced masonry block walls and tile roofs. The houses were newly built and many were unoccupied at the time of the earthquake. The houses withstood the earthquake shaking very well except for a few that were severely damaged by differential ground displacements or eruption of sand boils. Ground displacements and sand boils were restricted to the southeastern part of the barrio, the only area beneath which liquefaction occurred (Fig. 4). The affected part of the Barrio was bounded on the southwest by an arcuate belt of open fissures (extensional features) accompanied by buckled concrete curbs and drainage channel linings (compressional features). The house shown in Fig. 5, for example, straddled the belt of open fissures and was pulled apart and fractured by fissures as wide as 220 mm with scarps as high as 200 mm. Just south of these open fissures, however, curbs and canal linings were buckled in compression.

Sand boils erupted at several localities along the margins of the ground failure zone, including eruptions within two houses as noted on Fig. 4. The sand boils within houses provided an opportunity to estimate the quantities of sand and water that were erupted. Fig. 7 shows deposited sand along with high-water marks on the walls of one of the houses (the house near Hole JC 2). That house was unoccupied and the doors were closed at the time of the earthquake. The marks on the wall show that water ponded as high as 230 mm above the floor level during the eruption and sand deposits were as thick as 150 mm.

Fig. 4. Aerial photograph of Barrio J.P. Castro in Cauce showing the area where liquefaction and ground oscillation occurred and drill hole locations and houses within which sand boils erupted. The arcuate southern bound of the ground-failure zone is characterized by open fissures and buckled concrete curbs and walls.

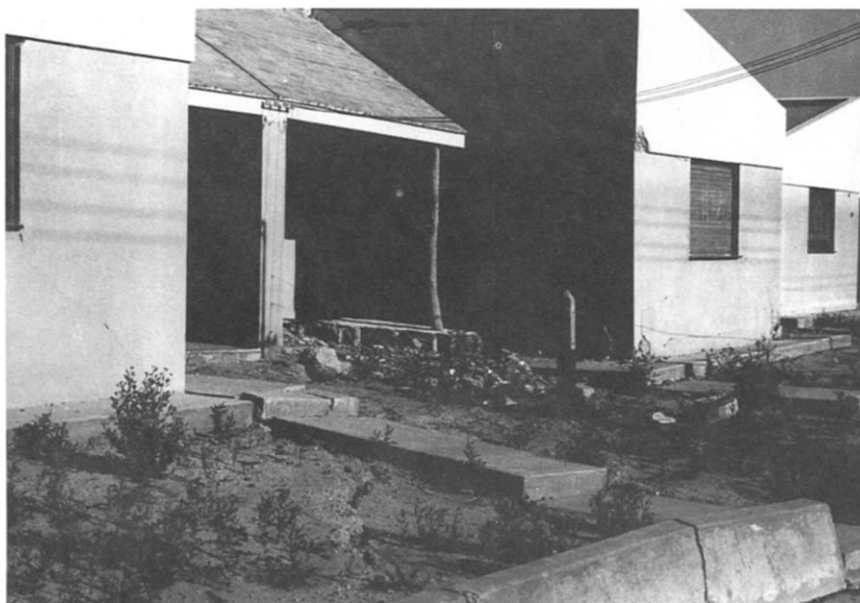
Fig. 5. House in Barrio J.C. Castro intersected by a ground fissure that pulled apart and vertically offset the slab foundation and cracked or collapsed exterior and interior walls. Note the cracked and tilted walks and curbs in the foreground and the collapsed wall of the house in the background.

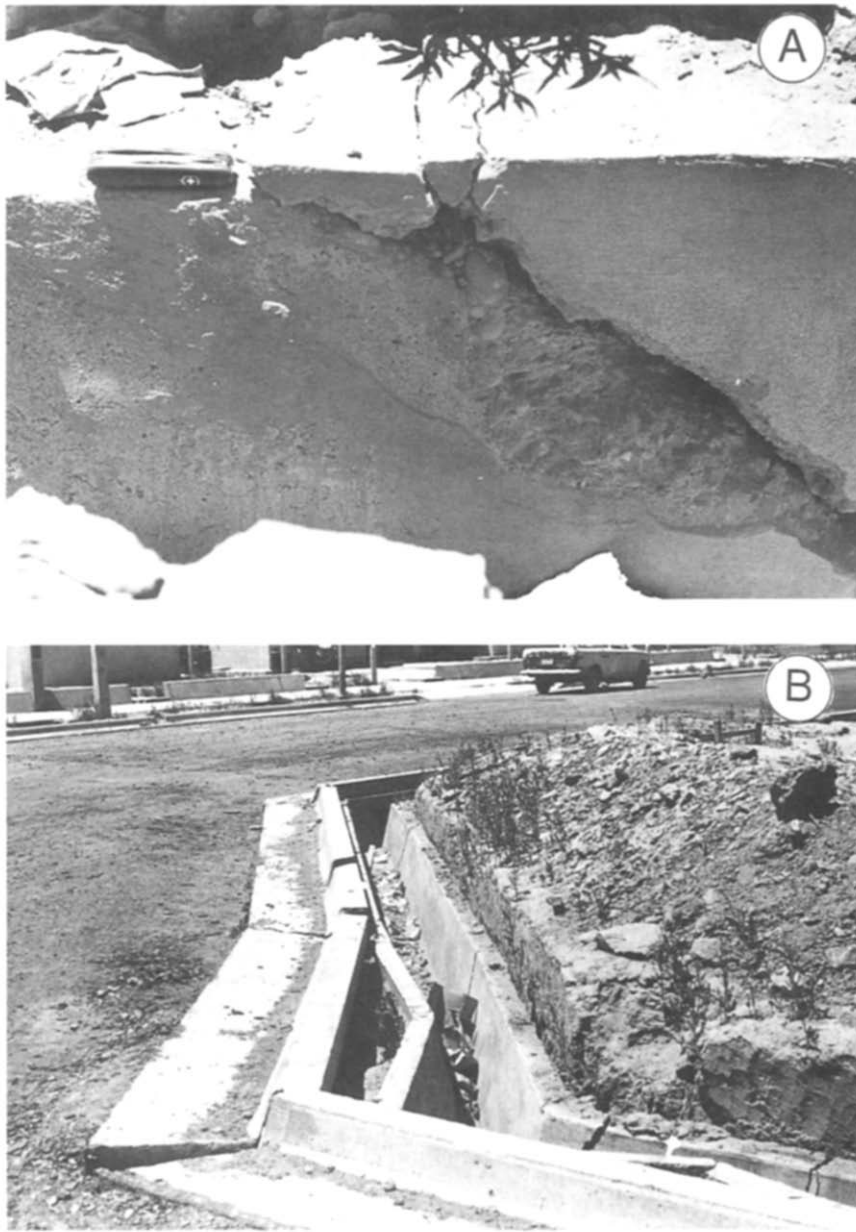
The northern margin of the ground failure zone was bounded by a diffuse band of compressional effects including buckled, sheared and thrust curbs and crinkled channel linings. Fig. 6 shows buckled channel linings and a sheared curb. These disruptions are typical of compressional features that marked both margins of the disturbed zone. The maximum compression displacement measured across a single thrust feature was about 60 mm.

Fig. 6(A). Curb that was sheared and (B) canal linings that buckled due to compressional forces generated by liquefaction-induced ground oscillation and consequent impacts between mobile and immobile soil segments.

Liquefaction of subsurface sediment was the cause of ground failure in the Barrio Justo P. Castro. Here, the liquefied layer decoupled the overlying stiff sediments from the underlying deposits which allowed the upper non-liquefied sediment layers to transiently shift back and forth in a form of ground failure called "ground oscillation" (Youd, 1984; NRC, 1985). These upper layers broke into large blocks that oscillated independently of surrounding and underlying soils, alternately impacting one margin of the failure zone and then the other. The impacts produced compressional effects, such as the buckled curbs along both margins of the zone (Fig. 6). The final

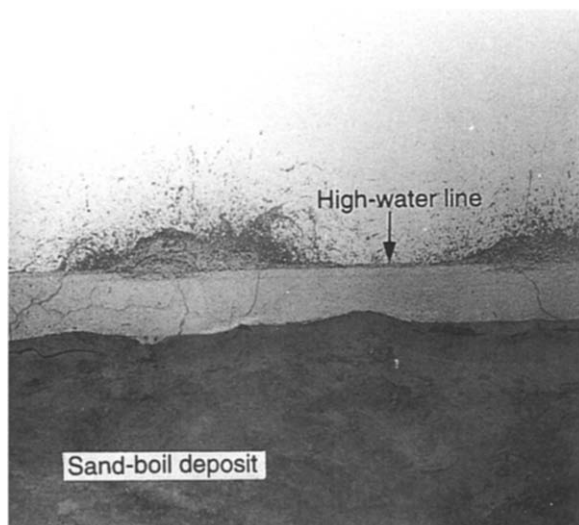
Calculations from these measurements indicate that 11.99 m³ of sand and water erupted into the house. The bulk volume of the sand on the floor

Fig. 7. Sand boil which erupted in a house in the Barrio J.P. Castro and deposited 12 m^3 of water and sediment on the floor. Stains on the walls show the height to which water rose during the sand boil eruption.

was 5.14 m^3 . Assuming a specific gravity of 2.65 for the sand grains and an average bulk dry density of 1.43 g/cm^3 (the average of the two tube samples), the volumes of the granular solids and water were 2.77 m^3 and 9.22 m^3 , respectively. These values yield a ratio of 3.33 parts water to 1 part solids, by volume, for this sand boil. The core samples of sediment contained 70% by weight sand, 27% silt and 3% clay with a mean grain size of 0.12 mm.

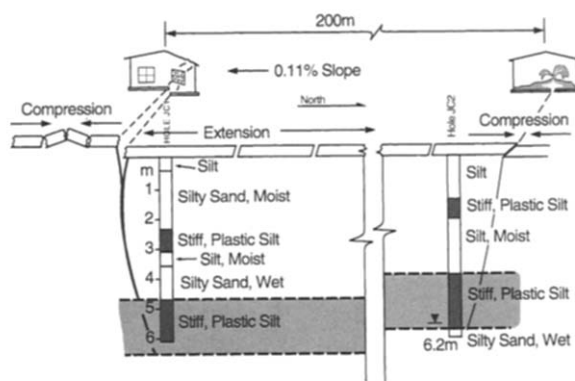
To investigate the shallow subsurface stratigraphy beneath the ground failure zone, two holes, JC1 and JC2, were hand augured to a depth of 6.1 m. The locations of these holes are noted on Fig. 4. Samples of the penetrated sediments were visually classified in the field, and bag samples were taken to the laboratory for further testing and classification. Logs of the two holes and an inferred cross-section of the sediment layers beneath the site are shown on Fig. 8. Also noted on the cross-section are the ground slope of 0.11%, downward to the south, and the relative locations of extensional and compressional surface features at the margins of the ground failure zone. The sediment section consists of a 4.0 to 4.7-m thick surficial sequence of silts and silty sands with

Fig. 8. Diagrammatic cross-section depicting sediment layers beneath that part of Barrio J.P. Castro where liquefaction-induced ground oscillation and consequent damage occurred.

minor amounts of clay. Beneath this sequence is a 1.9-m thick layer of very stiff plastic silt, which was difficult to penetrate with a hand auger. That silt contained intermittent zones of mottling and roots indicative of deposition in a marshy environment. The water table, at a depth of 5.7 m, lay near the base of the stiff plastic silt layer. With the available auger rod, we only were able to penetrate 0.3 m into a wet silty sand layer that lies beneath the stiff clay. The silty sand appears to be the upper part of the sediment unit that liquefied, as noted below.

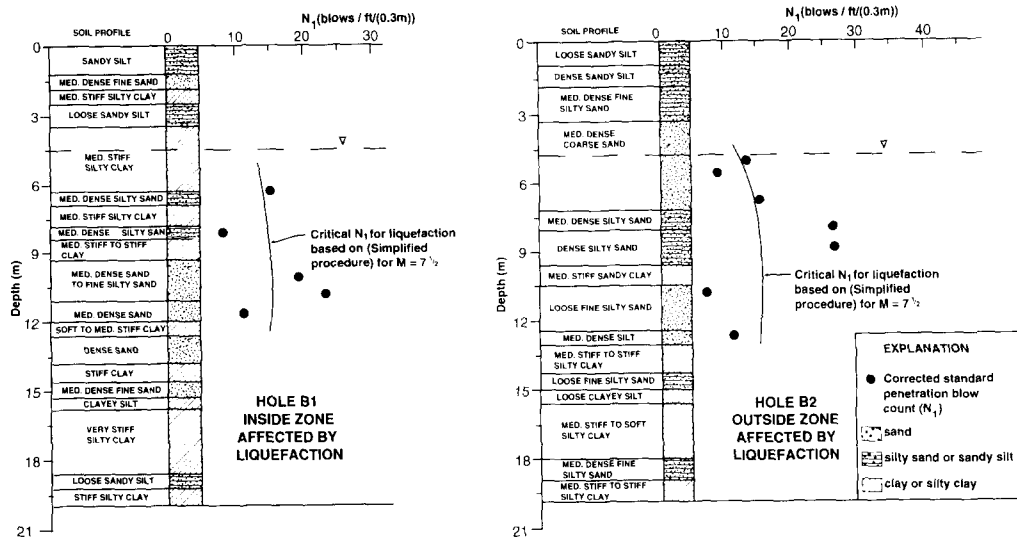
A second subsurface investigation was performed at the site by Idriss et al. (1979). In January 1979, they drilled two holes, B1 and B2 (locations marked on Fig. 4) to explore the subsurface stratigraphy and conduct standard penetration tests. The logs of those two holes are reproduced in Fig. 9. The upper 6 m of the profile for hole B1, which was located within the ground failure zone, is similar to that of the auger holes with a 3.7-m thick layer of sandy silt underlain by a 2.7-m thick layer of medium stiff plastic silt, overlying a 0.6-m thick layer of silty sand. The top of the silty sand layer is at a depth of 6.4 m in hole B1 compared to 5.9 m in hole JC2. (Hole JC1, which was augured to a depth of 6.1 m, did not reach this silty sand layer.) The 0.6-m thick layer of silty sand and the two underlying similar layers of loose to medium dense sand are apparently the materials that liquefied during the earthquake.

Fig. 9. Borehole logs showing subsurface sediment units where liquefaction effects were observed (Hole B1) and where they were not (Hole B2). Liquefaction occurred in an 0.6-m thick medium dense silty sand layer at a depth between 6 and 8 m (and perhaps in some underlying granular layers as well). Where the silty sand is capped by an impermeable clay layer, surface liquefaction effects were observed; where the silty sand is capped by a coarse sand layer (allowing upward drainage) liquefaction effects were not observed. (Borehole data from Idriss et al., 1979).

The principal difference between the soil profiles developed from holes B1, JC1, JC2 (within the ground failure zone) and B2 (outside the ground failure zone) is the absence of the 2.7-m thick clay layer above the 0.6-m thick silty sand layer. Hole B2 shows that that specific layer is replaced by a similarly thick layer of medium dense coarse sand. Idriss et al. (1979) suggest that excess pore pressures generated in the silty sand at the latter location may have readily dissipated upward into the partly saturated coarse sand, preventing liquefaction in that area.

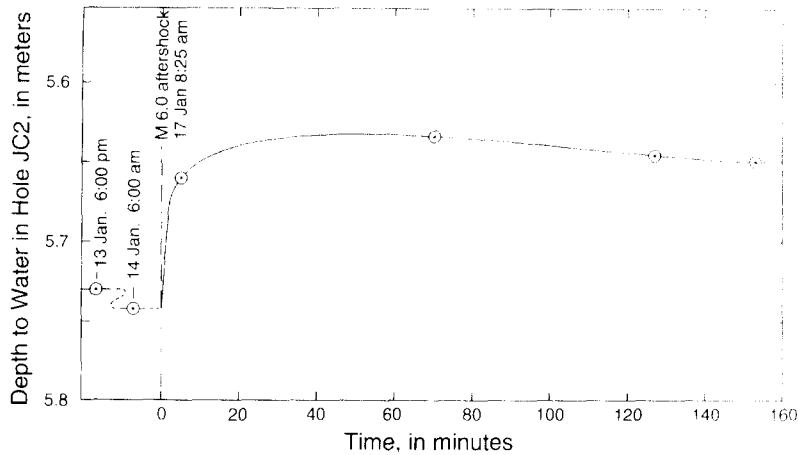
between this and subsequent measurements indicates that the water level rose to a maximum level of 5.64 m about 10 min after the aftershock, and then slowly declined over the next two hours. The rise of water level in Hole JC2 confirms the generation of excess pore pressures in the silty sand during the aftershock; those pressures gradually dissipated, in part by drainage into the open auger hole. Greater pore pressures leading to liquefaction apparently developed during the much stronger mainshock.

Fig. 10. Water depth in hole JC2 before and after the January 17, 1978 aftershock ($M=6.0$).

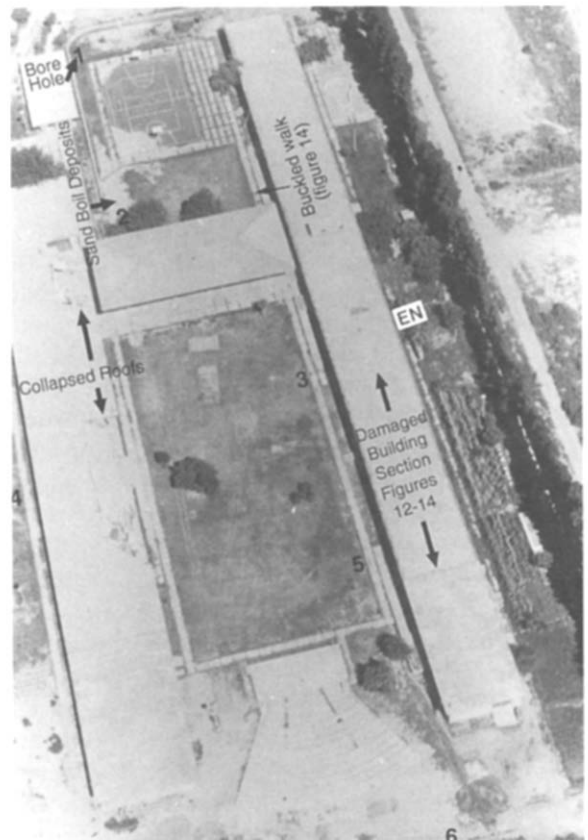
Fig. 11. Aerial view of Escuela Normal, Cauete, showing damaged building section, bore hole locations and other pertinent features. View looking west.

Both long buildings suffered severe damage. Ground shaking caused collapse of the heavy roof section at two localities in the 130-m long southern building (locations marked on Fig. 11). A 30-m long segment of the northern building suffered damage, with the roof of the building being shifted westward relative to the foundation. That displacement caused fracture of the columns at the top and bottom of the window level and column tilt between those two points.

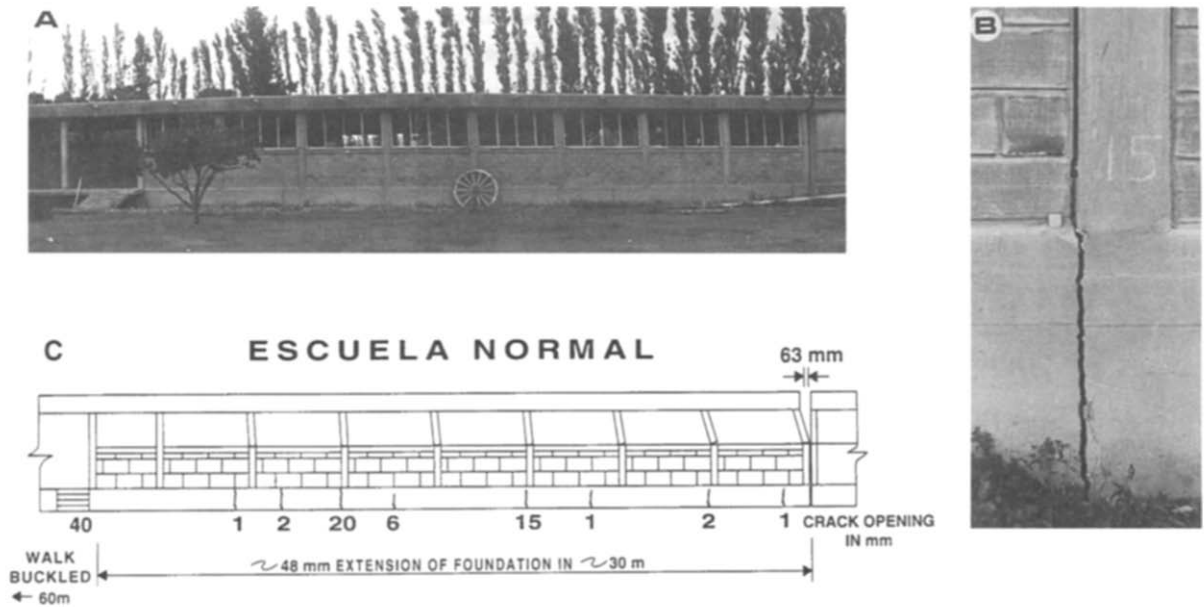
Fig. 12(A). Section of building damaged by extensional ground displacement at Escuela Normal. (B) Extensional crack in foundation with 20-mm opening. (C) Diagram of damaged section of building showing observed offset columns and foundation cracks. (After Youd, 1989.)

The column with the largest tilt was located at the eastern end of the damaged section (Fig. 13). A 63-mm offset was measured in that column between the top of the block wall (bottom of the window) and the roof. The columns west of that locality were cracked and similarly offset, but the amount of offset decreased with each column until the eighth column, which was undamaged (Fig. 12).

Upon examination of the foundation of the building, several recent fractures were found in the perimeter wall, most of which were left open from a few to as much as 20 mm. The localities and widths of these cracks are noted on Fig. 12C. In the 30-m long section of the foundation wall beneath the fractured and tilted columns, the cumulative width of the cracks was 48 mm, which is roughly comparable to the 63 mm of maximum offset between the roof and foundation at the eastern end of the structure. (Additional separation may have occurred at foundation joints or in fractures beyond the 30-m section.) These measurements indicate that the ground and foundation beneath the damaged building extended (or spread) laterally by at least 48 mm, opening the cracks in the foundation wall. This action pulled the eastern end of the foundation and infilled walls relatively eastward while the roof remained attached to the western end of the building. This action caused fractions and tilting of the columns as illustrated in Fig. 12 (Youd, 1989).

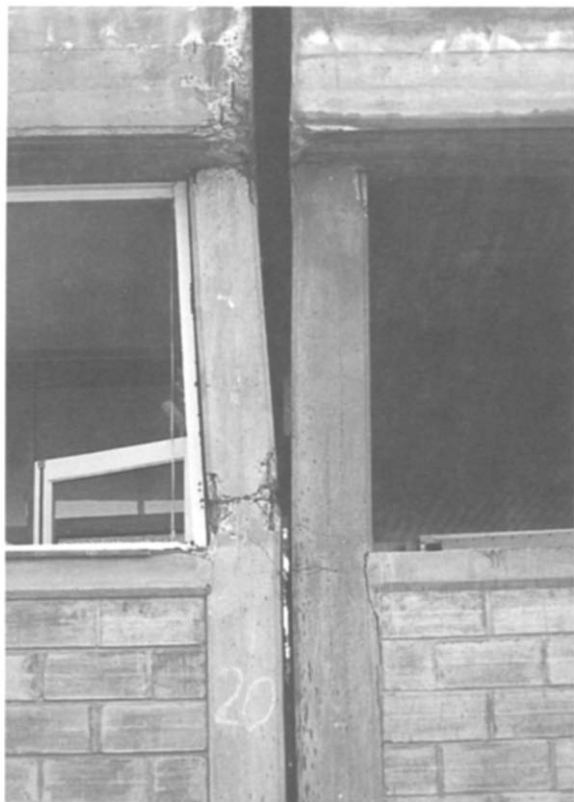
Fig. 13. Fractured and tilted column at the end of the damaged section of Escuela Normal building.

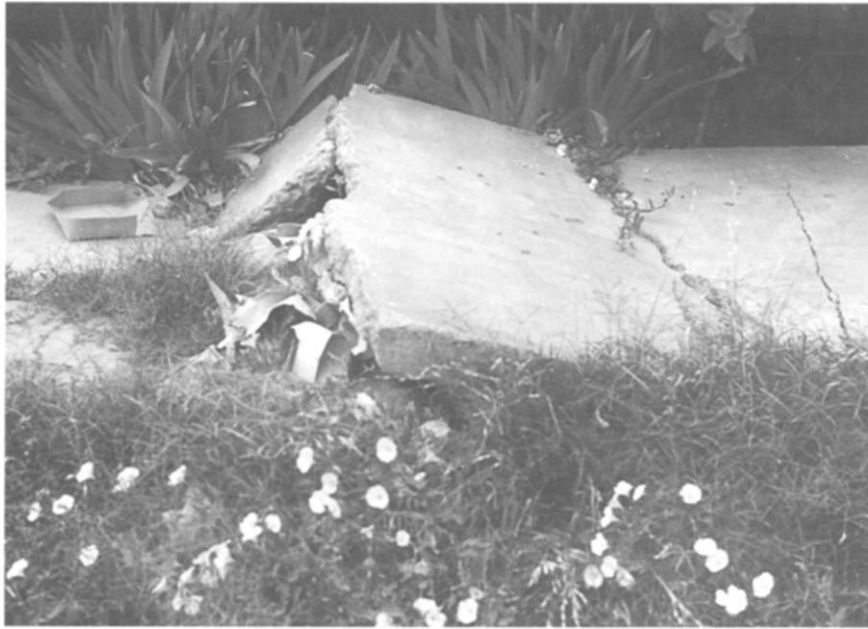
parts of the site. Evidence of such compression included a buckled sidewalk 30 m west of the damaged section of building (Fig. 14). The buckling shortened the sidewalk by about 130 mm.

Fig. 14. Concrete side-walk buckled and shortened by about 130 mm due to compressional ground displacement on the Escuela Normal campus. (Location noted on Fig. 11.)

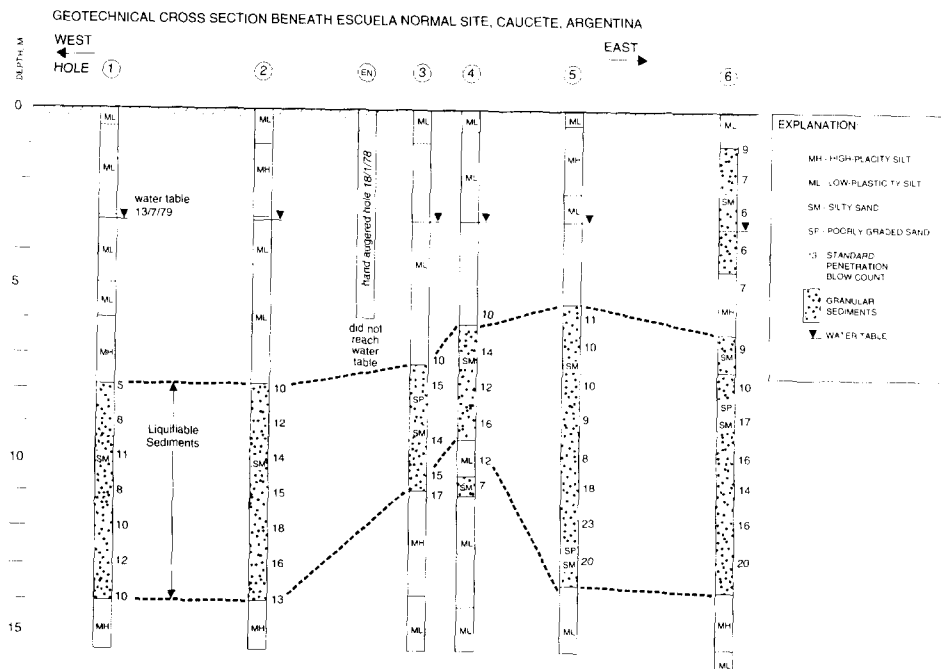
Using a groundwater depth of 6 m and the borehole data reported by Ing. Suarez, the liquefaction susceptibility is analyzed at the site using the "simplified procedure" of Seed et al. (1985). For this analysis, a peak acceleration, a_{max} , of 0.56 g is used, as reported by INPRES (1977) for Caucete. The results of the analysis indicate that the silty sand layer should have liquefied during the earthquake a result that is corroborated by the eruption of sand boils and the development of differential ground displacements that occurred at the site.

Fig. 15. Cross-section showing sediment layers beneath Escuela Normal campus. Borehole data from Ing. Raul Suarez, Universidad Nacional de San Juan, Argentina (written communication).

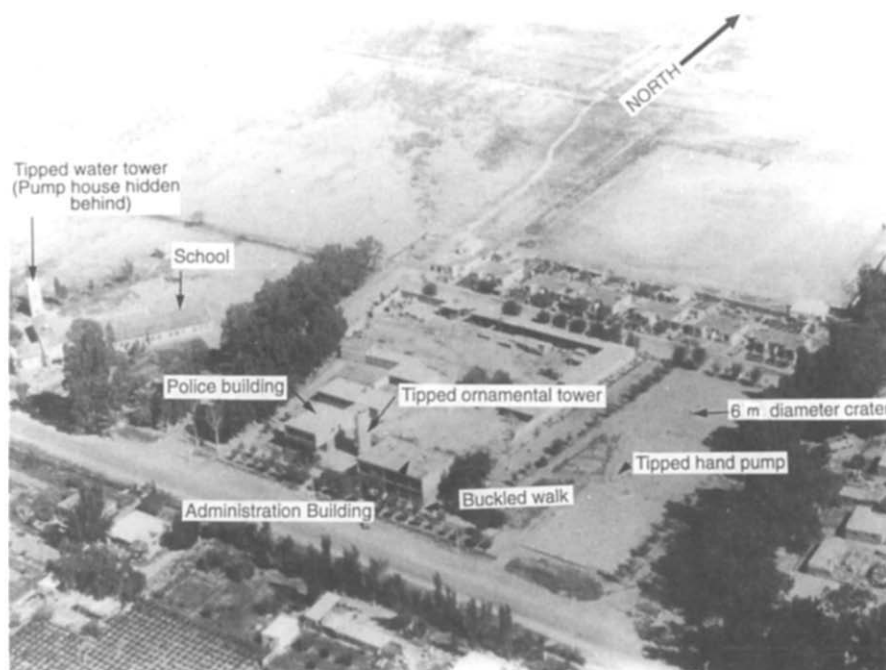
police station, a school, two towers, a pump house, several other small structures and several open areas (Fig. 16). Two modern, two-story reinforced-concrete buildings, an administration facility and a police station, suffered differential settlement of a few centimeters, but the only resultant damage we observed were a few very minor cracks in the exterior building walls. Also, an ornamental tower, about 10 m high, between the police station and the administration building, tilted about one degree to the east; the sidewalk between the buildings suffered minor differential settlement and buckling.

Fig. 16. Aerial view of municipal center at San Martin showing major buildings and localities of damage caused by liquefaction. View looking north.

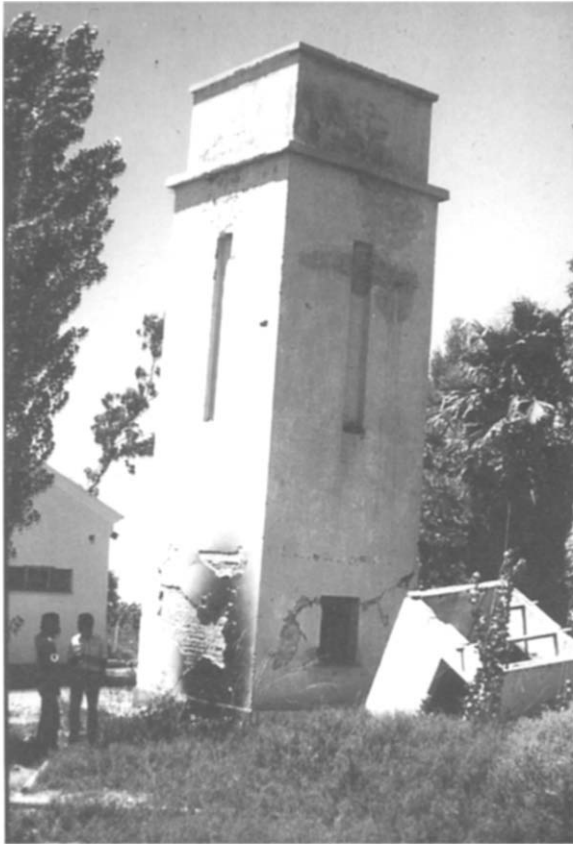
The most spectacular damage to structures at San Martin was the tilting of a 6-m high water tower and the toppling of a nearby pump house into a 1-m deep crater (Fig. 17). Similarly, a smaller crater developed beneath a small hand-pump structure in one of the open areas, and a large crater, 6 m in diameter and 1 m deep, formed in an open area about 100 m north of the small pump (Figs. 18A,B). Several residents reported that the area was flooded with water shortly after

Fig. 17. Photograph of the water-storage tower that tilted due to loss of bearing strength and nearby pump house that toppled into an eroded crater.

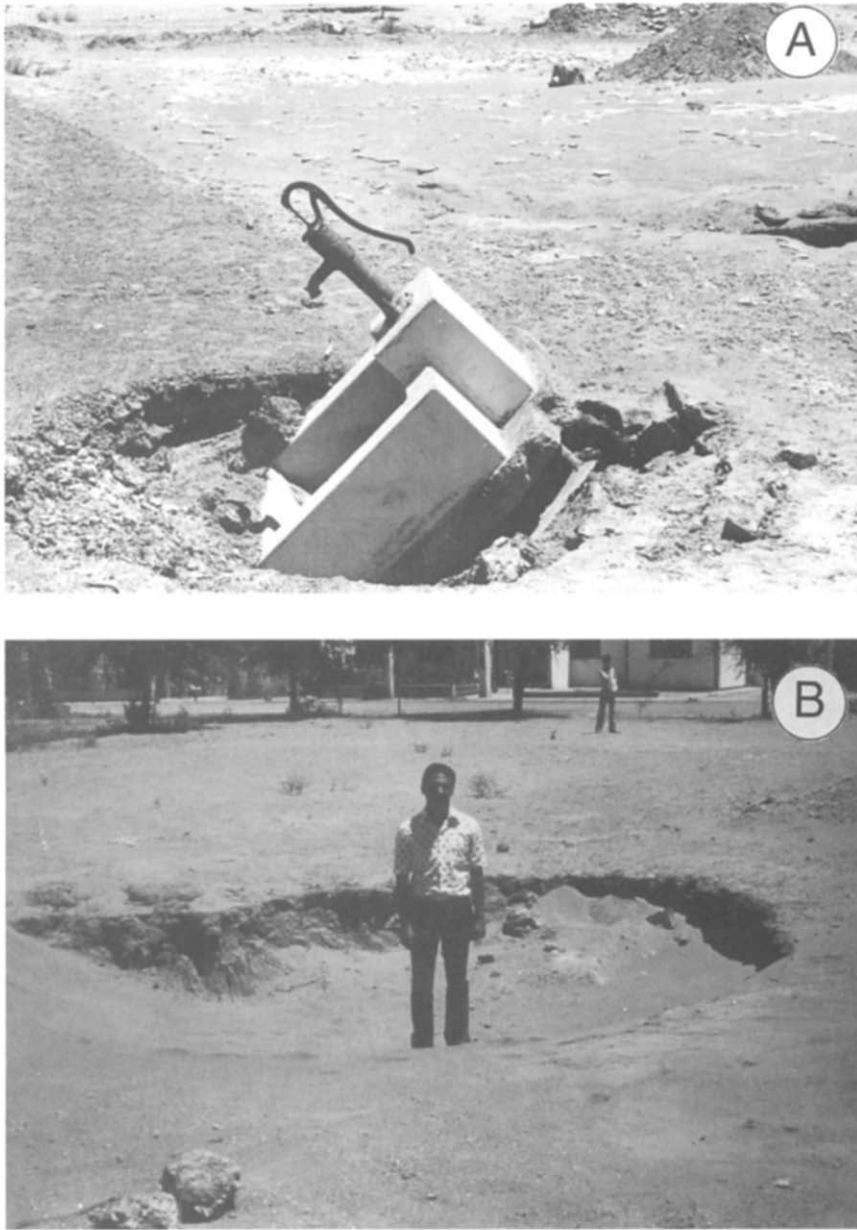
those casings eroded cavities beneath the overlying structures. The structures then toppled into the cavities. Similarly, a hole or crack must have developed beneath the 6-m diameter crater (Fig. 18B) which led to the erosion of that feature.

Fig. 18(A). Small crater that developed beneath a hand pump and (B) large (6-m diameter) crater that developed in a nearby open area.

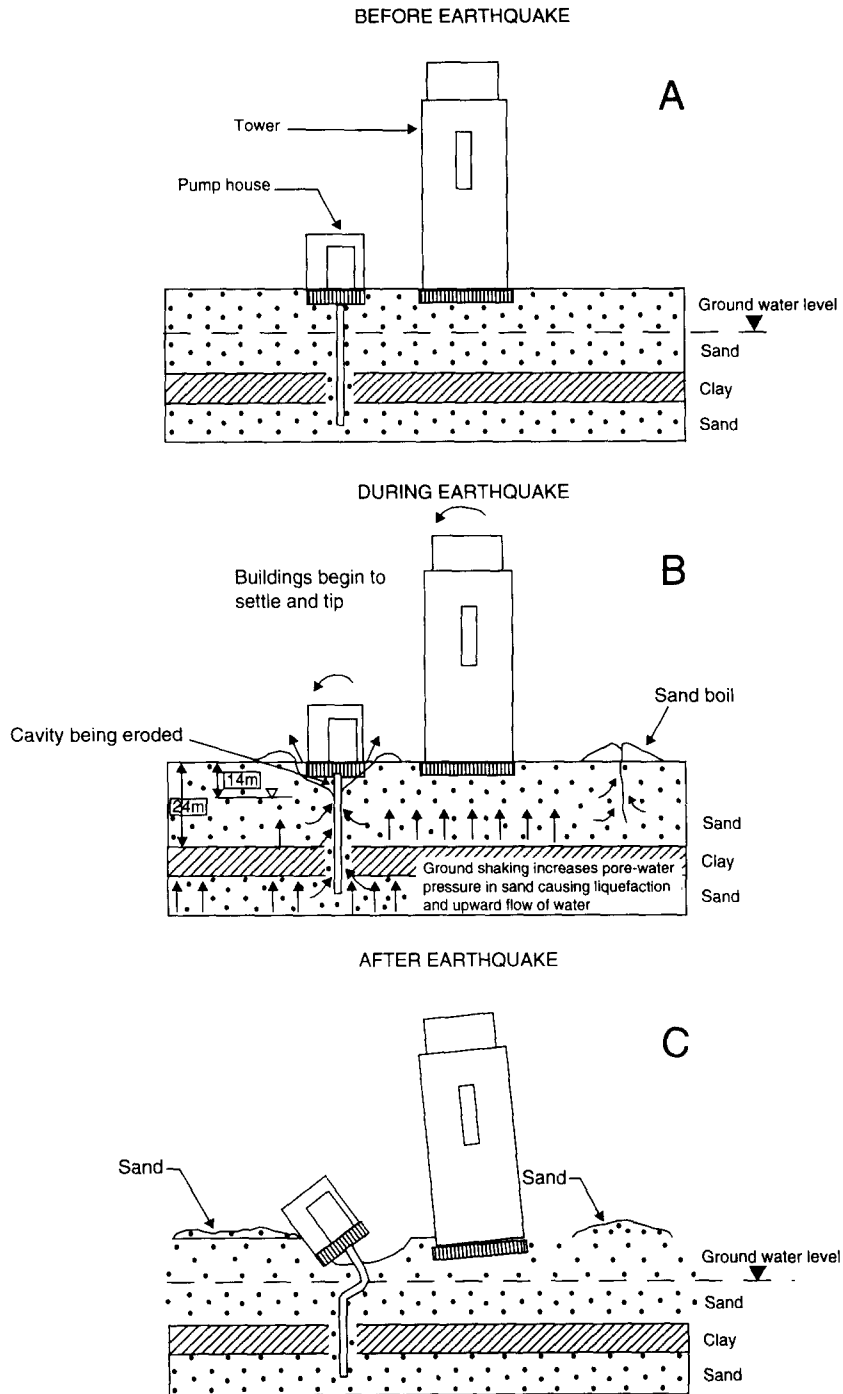
and toppling of the pump house are diagrammed in Fig. 19. During the earthquake, ground shaking caused compaction of sand, which disrupted grain-to-grain contacts. These disruptions led to a transfer of loads from granular contacts to the pore water, generating excess pore-water pressures. The excess pressures caused upward flow of pore water, but free drainage was restricted by the plastic-silt layer. The excess pore water accumulated and probably formed a transient layer of free groundwater immediately beneath the plastic-silt layer. That water was under sufficient pressure to generate dynamic expulsions of a large volumes of water through holes and cracks in the impermeable strata. The well casings that perforated the clay layer provided two such conduits. The large quantities of water that vented to the surface around

Fig. 19. Diagrams showing the processes that led to tilting of the water-storage tower and toppling of the pump house (see Fig. 16). (A) Setting before earthquake; (B) liquefaction during earthquake causes upward flow of water which found a ready drainage path around the well casing; (C) Setting after the earthquake with leaning tower and toppled pump house. (Drawings not to scale.)

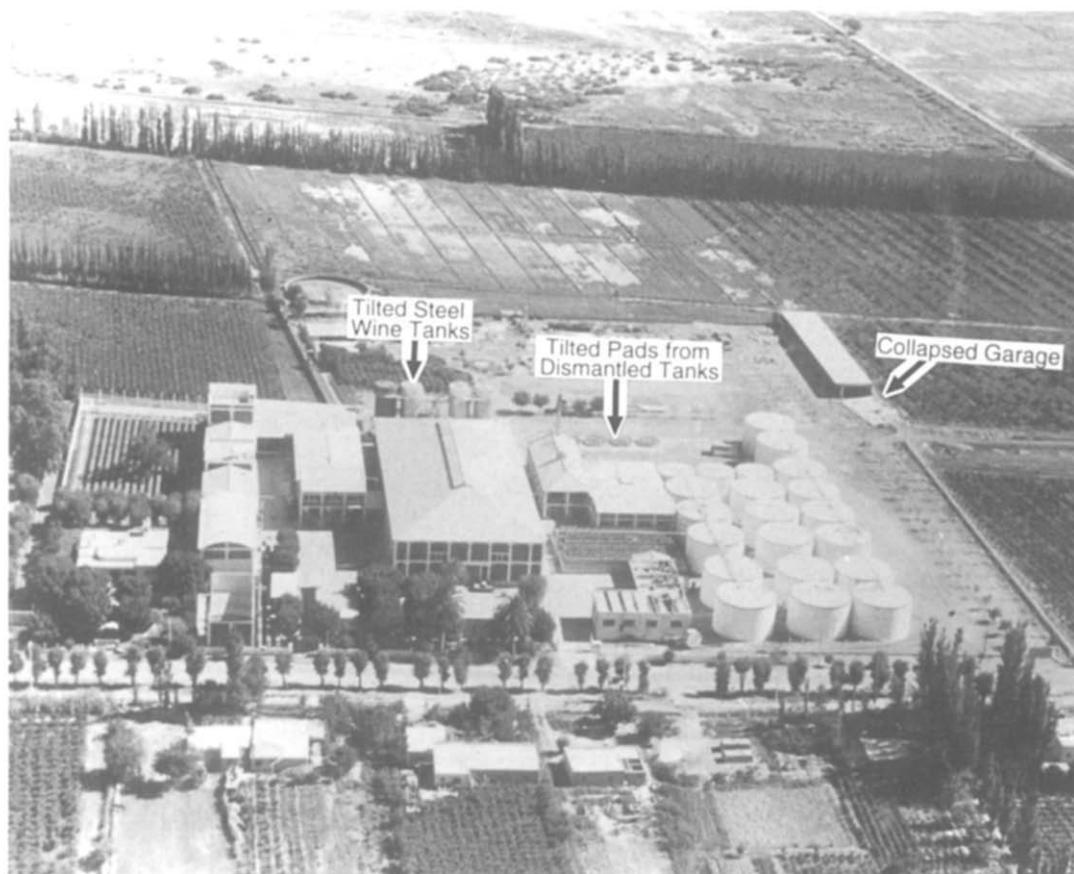
The San Isidro Winery, typical of the many wineries in the Valle del Tulum, consists of several single story buildings and a dozen or more large storage tanks founded on circular reinforced-concrete mat foundations (Fig. 20). The most important damage to the winery was tilting of nine tanks in a row behind the main processing facility (Fig. 21). Tilt of those tanks ranged from 2 to 5°. At the time of the visit of the authors, five of the tanks, those with the greatest rotation, had been dismantled, leaving only the tilted footings. These tanks were constructed of reinforced concrete. The four remaining tanks, all fabricated with steel, were repaired by constructing new perimeter-wall footings and then jacking the tanks back into an upright position.

Other damage to the winery included a slight differential settlement beneath some of the larger buildings and the collapse of a single-story garage structure (Fig. 20). A band of ground fissures passed beneath that garage; transient and permanent displacements associated with these fissures probably led to the collapse.

Fig. 20. Aerial photo of San Isidro Winery showing locations of tilted tanks and other damaged facilities. View looking north.

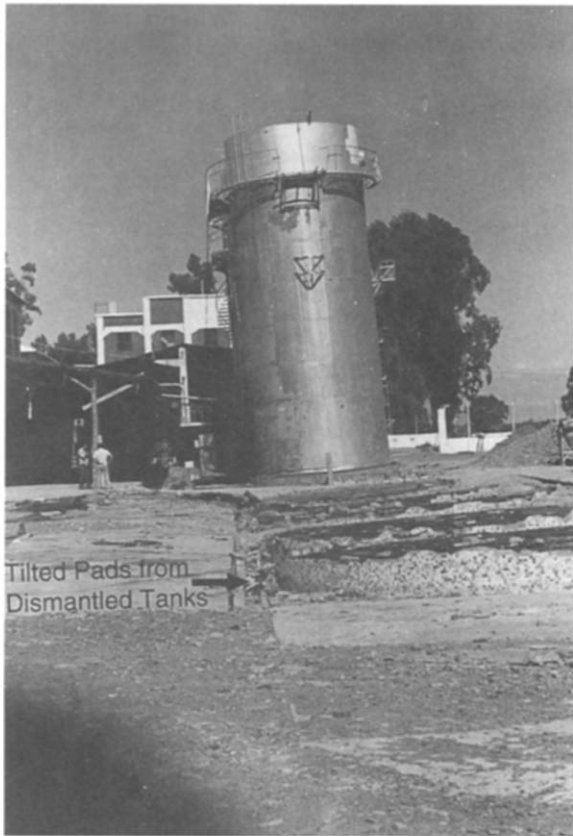
Liquefaction of subsurface sands and silts led to the damage at the winery site. Liquefaction-induced loss of bearing strength allowed the nine tanks to tilt. The amount of tilting appears to have been a function of load. For example, several

foundation slabs without tanks were unaffected while footings of filled tanks tilted substantially. Compaction of subsurface sediments and ground oscillation led to the other damage at the winery.

Fig. 21. Tilted steel tanks (4 units) and tilted foundation slabs (5 units) for concrete tanks that have been dismantled. Foundations and tanks tilted between 2 and 5°.

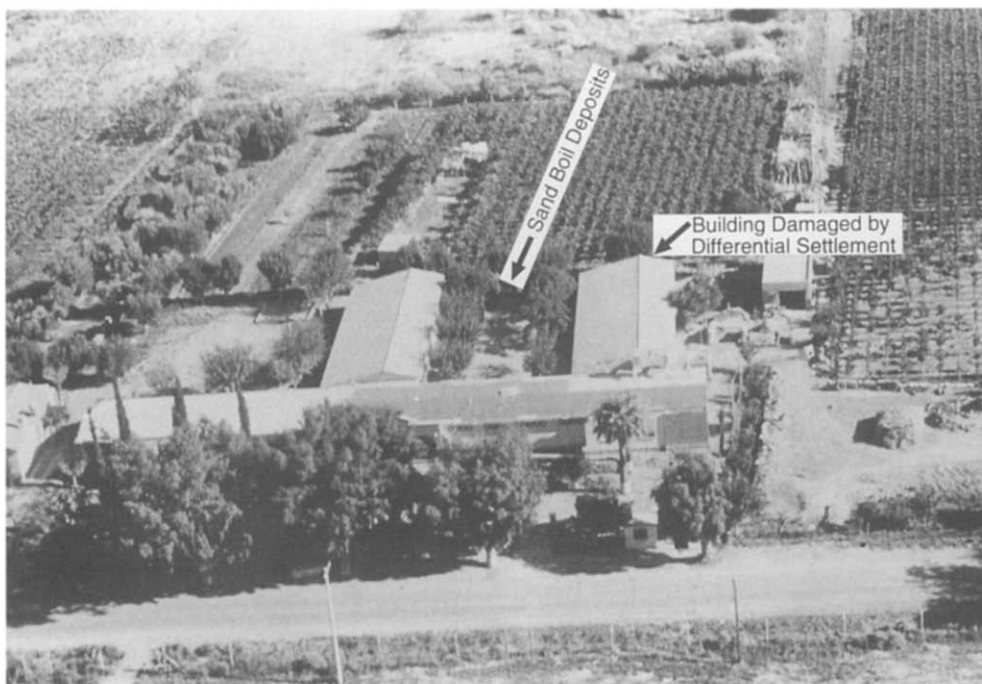
The Escuela Juan J. Pasos consists of several reinforced-concrete single-story classroom buildings founded on shallow spread and perimeter-wall footings. Wide verandas extend from the main structures to partially cover an interior courtyard (Fig. 22). The school was constructed in 1948.

During the earthquake, sand boils erupted in fields surrounding the school and several large boils erupted within the courtyard, venting large quantities of water and sand. The vented sand deposits covered much of the area and extended under the verandas. Differential ground settlement beneath the buildings caused numerous cracks in columns and walls (Fig. 23). The largest differential settlement was about 60 mm, and the maximum settlement of footings supporting col-

Fig. 22. Aerial view of Escuela J.J. Pasos showing buildings and areas where liquefaction effects were observed. View looking north.

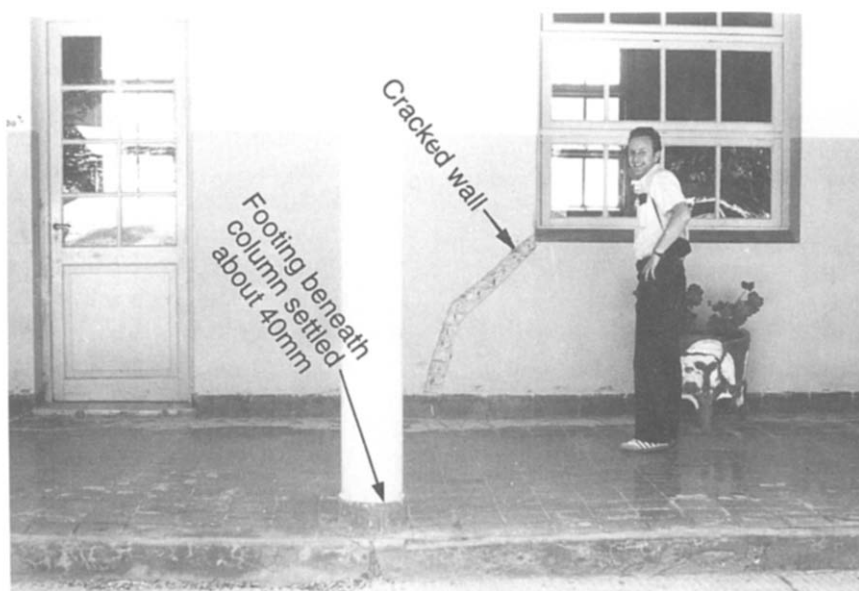
umns was about 40 mm. In spite of the differential settlements and the numerous cracks in walls and columns, the buildings were in no danger of collapse. At the time of the visit of the authors, the buildings were being repaired.

Liquefaction-induced soil compaction and loss of bearing strength, combined with soil-structure interaction generated the differential settlements that disrupted the school buildings. Evidences of liquefaction included large sand boils that erupted

Fig. 23. Building at Escuela J.J. Pasos with cracked wall and differentially settled columns due to ground settlement and loss of bearing strength caused by liquefaction of subsurface sediments.
