## Metallographic Failure Analysis on Bucket Elevator Conveyor Chain Links

### Abstract

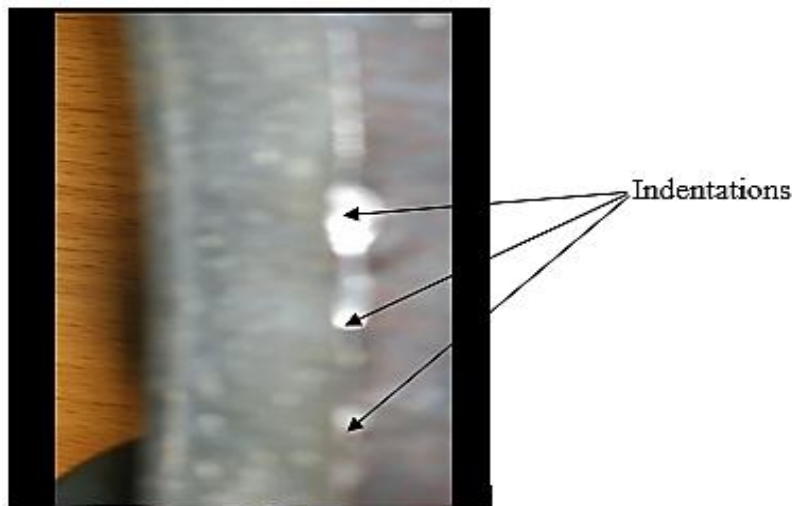
The preliminary examination done at the factory site revealed indentations on the chain links which is as a result of the sprocket impacting on the chain link as shown in Fig. 3. This is an indication that misalignment do exist in the bucket elevator system and must be eliminated. This impact force of the sprocket on the chain link aided in the progression of the cracks generated by the inclusions within the chain link. The impact force was one of the main sources of vibration and noise existing in the bucket elevator. It also resulted in the stretch and fatigue of the chain links.

The result of vibration is unsteady chain speeds which affect the engagement process as well as the impact levels. Accurately alignment of sprockets is very important to the life of both the chain links and sprockets as the life of a properly aligned sprocket can be maximized and in so doing also ensures that the bucket elevator operates at maximum efficiency. It was observed that the sprockets were not in alignment as there was an offset between the two shafts and the sprockets.

Due to this, the chain forces were not evenly distributed to each tooth of the sprockets, thereby increasing the tension in the chain. Accurate alignment of shafts and sprocket tooth faces provides a uniform distribution of load across the entire chain width and contributes substantially to maximum drive life and also reduces the wear and the damage of the sprockets and chain.

*Figure 3: Indentations on chain link.*

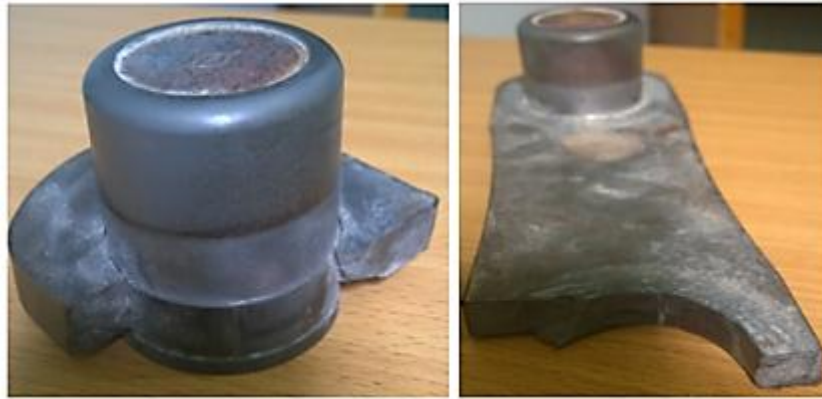
Observing the fractured surface using stereo microscope revealed that the type of fracture was brittle fracture as smooth grains appeared on the fractured surface. Brittle fracture also occurs as a result of induced inclusions at grain boundaries

[10]. Fig. 4 shows that the crack had initiated from an inclusion which points to the fact that the fracture is of brittle type. Another observation that emphasize that the fracture was of the brittle type was that the fractured surface for all the samples were without any necking.

**Figure 4:** Failed chain links.

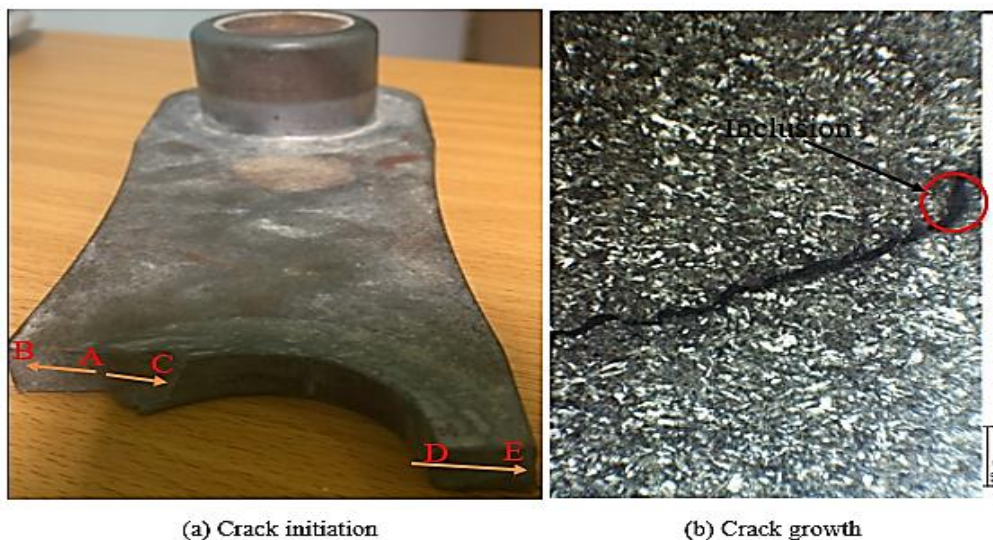
Fig. 5 shows that the crack had initiated from an inclusion which points to the fact that the fracture is of brittle type. Another observation that emphasize that the fracture was of the brittle type was that the fractured surface for all the samples were without any necking. Also, the mechanism

of failure was obtained by tracing the chevron mark on the fractured surface. The chevron mark showed that the fracture initiated from the core of the fractured surface of the chain link and progressed outward until it snapped i.e.,  $A \rightarrow B \rightarrow C \rightarrow D \rightarrow E$  as shown in the Plate 5.

**Figure 5:** Fracture mechanism initiating from the core.

Fig. 5 (a) shows that the crack began at point A and progressed gradually to the surface at point B. Since the chain link is under tensile loading and the crack had already been initiated at A and grown to B, it then progressed from C to D and finally fractured at E. The initiation and growth of the crack from A to B is as shown in Fig. 5 (b). The point of fracture initiation was dependent on where the inclusion which

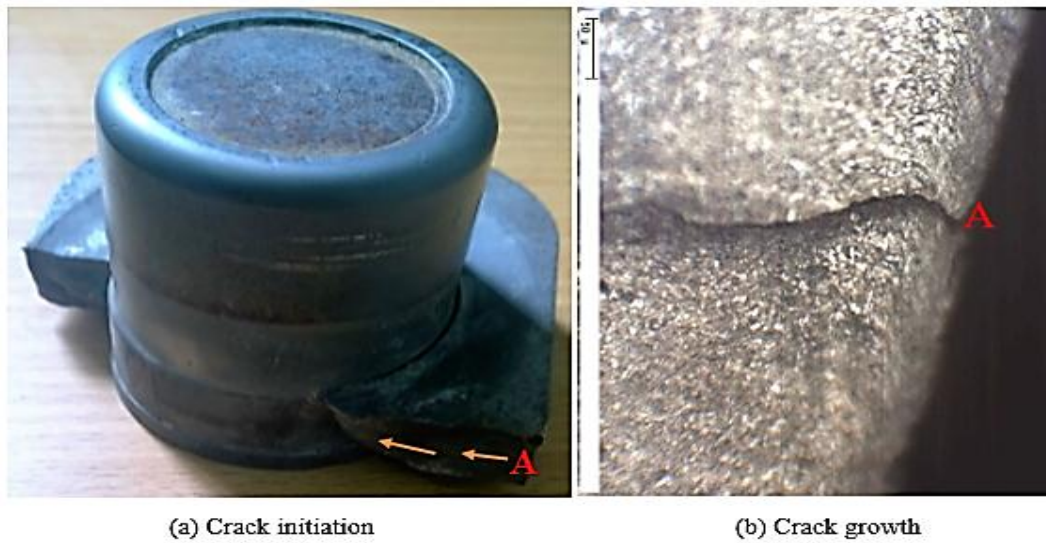
was the cause of failure was located; whether at the surface or the core. Fig. 6 shows a sample where the crack had initiated from near the surface and progressed until eventual fracture occurred. Fig. 6 (a) shows the crack initiation whereas, Fig. 6 (b) shows the crack growth. The point at which the crack initiated was therefore dependent on the location of the inclusion from which the crack had initiated from.

**Figure 7:** Mechanism of failure initiating from boundary.

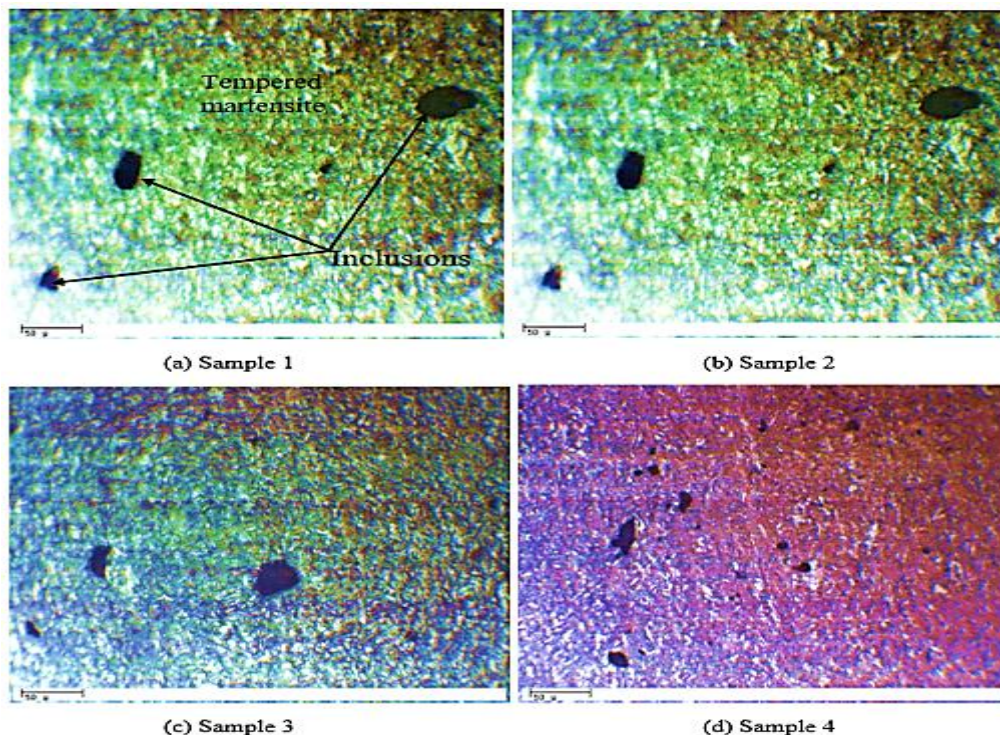
**Figure 8:** Micro-structure for Un-failed chain link sample showing inclusions for samples 1 to 4.

The micro structure of the un-failed chain links is that of a tempered martensite. Martensite in its quenched state is very hard and brittle and because of this brittleness, martensitic steels are usually tempered to restore some ductility and increase toughness [12]. The samples do share the same microstructure but the size and distribution of the inclusions differ as shown in Fig. 8 and 9. Inclusions are known to have low formability and during loading they produce cracks in the steel.

from an inclusion as shown in the Fig. 8, 9 and 11.

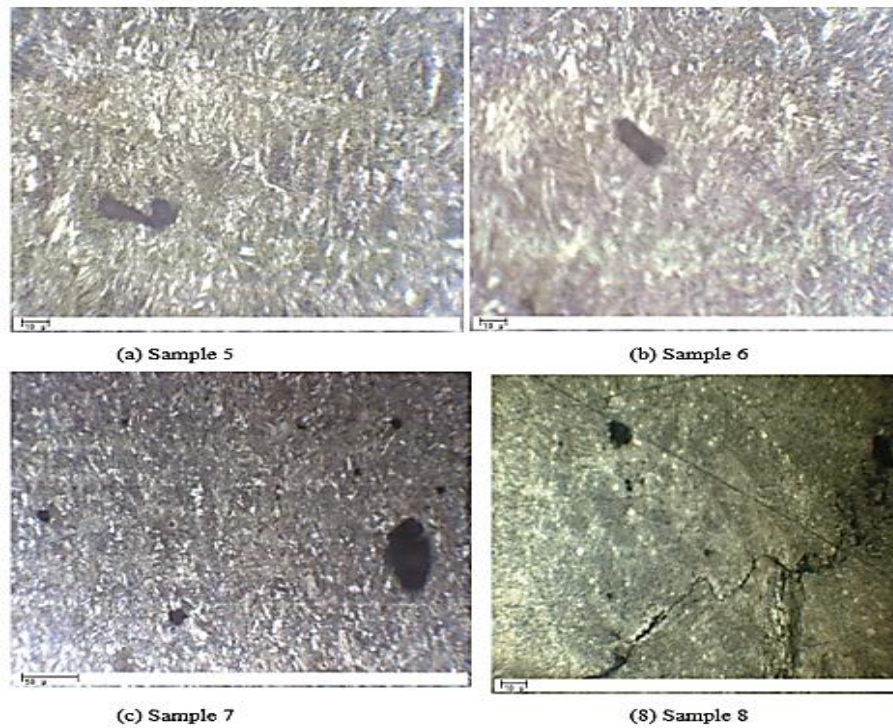
**Figure 9:** Microstructure for Un-failed chain link sample showing inclusions for samples 5 to 8.

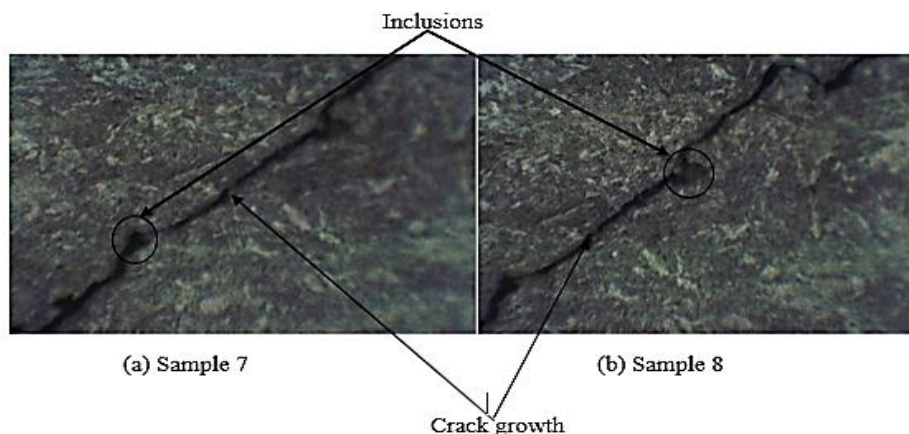
Also inclusions produce cracks during heating because of different co-efficient of thermal expansion between steel and inclusion which results in higher stress development and subsequent cracking. Although, the presence of inclusions can never be entirely avoided, the quantity, size, shape, distribution and composition can be modified to achieve better mechanical properties [13]. These cracks then propagated during loading leading to the eventual fracture of the material.

**Figure 10:** Cracks within material.

Brittle fracture was therefore the root cause of failure of the conveyor chain link induced by inclusions as shown in Fig. 9, 10 and 11. This is further emphasized by the fact that there was no necking as well as the grain on the fractured surface being smooth.

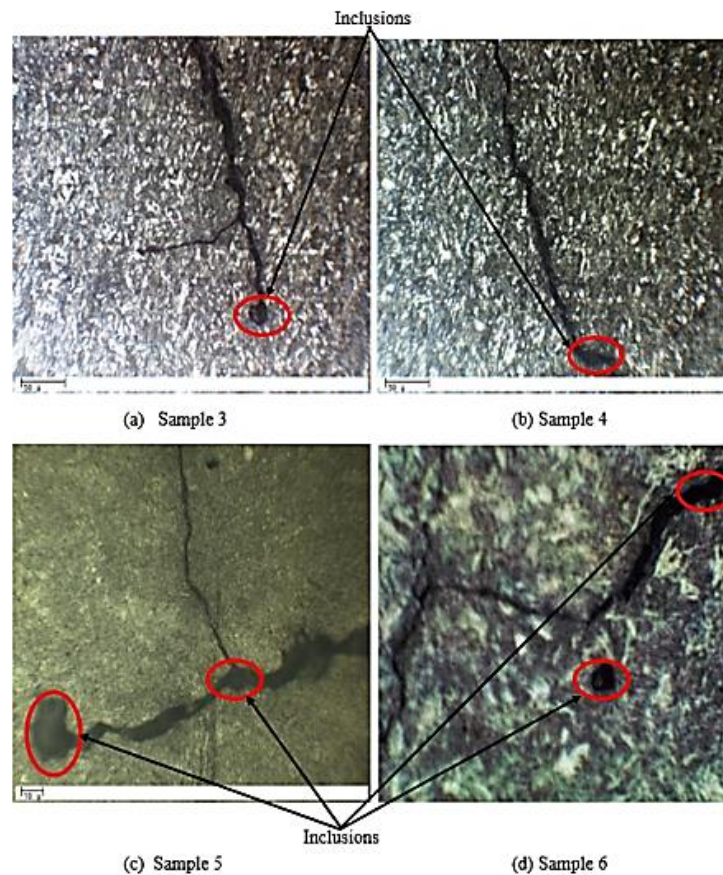
**Figure 11:** Cracks initiation from inclusions from failed samples.

From the design point of view, the problems of inclusions can be solved by introducing stress concentration factors for inclusions as these inclusions tend to raise the stresses in the region where these inclusions are located. The factors which are responsible for change in stress concentration are; change in modulus of elasticity of the inclusion and the steel matrix, changes in the type of bonding at the inclusion metallic interface, creep effect and dislocation processes near the inclusion.

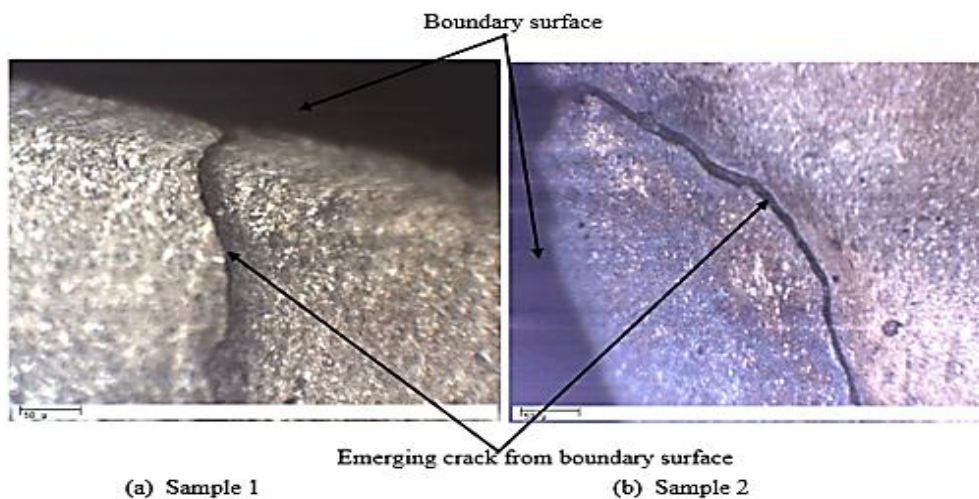
For other samples studied the failure was observed to have initiated from the boundary as shown in Fig. 12 as a result of the inclusion located at the boundary. The

point at which the crack initiated was therefore dependent on the location of the inclusion from which the crack is initiation from.

**Figure 12:** Cracks initiation from boundary.
