**ANNUAL ENVIRONMENTAL REPORT**

**RILTA ENVIRONMENTAL LTD.**

**BLOCK 402 GREENOGUE BUSINESS PARK**

**JANUARY 2018 – DECEMBER 2018**

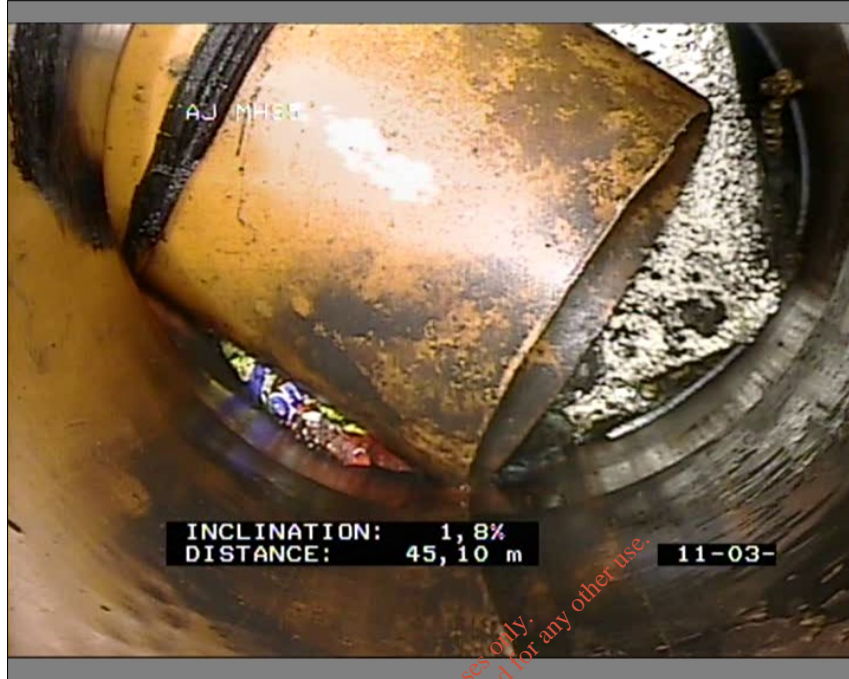
Photo: 8\_14A, MPEG #: 280217\_1, 00:13:29  
 45.49m, Connection other than junction, at 10 o'clock, diameter 100mm

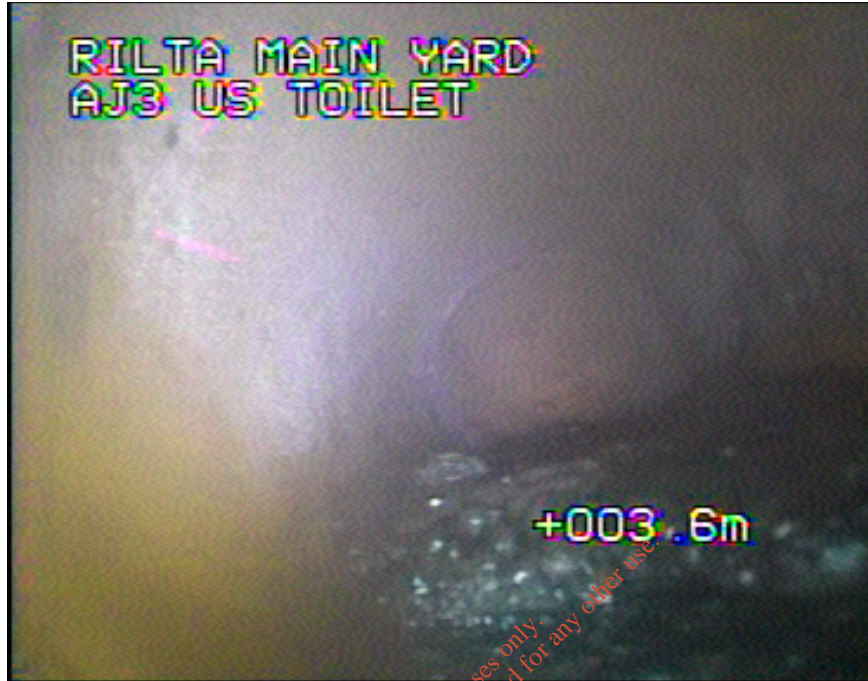
Photo: 10\_5A, MPEG #: 280217\_1, 00:00:35  
 3.6m, Settled deposits, fine, 15% cross-sectional area loss

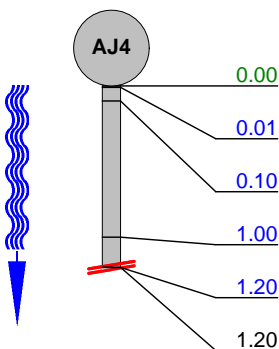
IC	Start node type, inspection chamber, reference number : AJ4	00:00:00		(Constr) 0
		WL	Water level, 0% of the vertical dimension	00:00:00		(Serv) 0
		LL	Line deviates left	00:00:01		(Serv) 0
		LR	Line deviates right	00:00:12		(Serv) 0
		WL	Water level, 0% of the vertical dimension	00:00:24		(Serv) 0
		SA	Survey abandoned Remarks: Survey could not be completed due to sharp bends on this pipe.	00:00:24		(Misc) 0

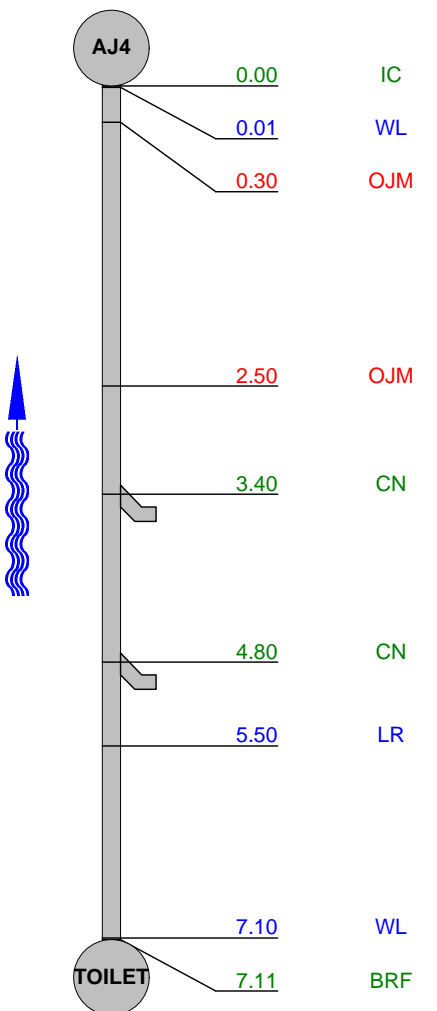
0.00	IC	Start node type, inspection chamber, reference number : AJ4	00:00:00		(Constr) 0
	0.01	WL	Water level, 0% of the vertical dimension	00:00:00		(Serv) 0
	0.30	OJM	Open joint, medium	00:00:03	13_3A	(Struct) 1
	2.50	OJM	Open joint, medium	00:00:36	13_4A	(Struct) 1
	3.40	CN	Connection other than junction, at 11 o'clock, diameter 100mm Remarks: From Urinals	00:00:57		(Constr) 0
	4.80	CN	Connection other than junction, at 11 o'clock, diameter 100mm Remarks: From Toilet	00:01:24		(Constr) 0
	5.50	LR	Line deviates right	00:01:05		(Serv) 0
	7.10	WL	Water level, 0% of the vertical dimension	00:01:26		(Serv) 0
	7.11	BRF	Finish node type, major connection without manhole reference number: SINK Remarks: Sink beside Lab door.	00:01:26		(Constr) 0

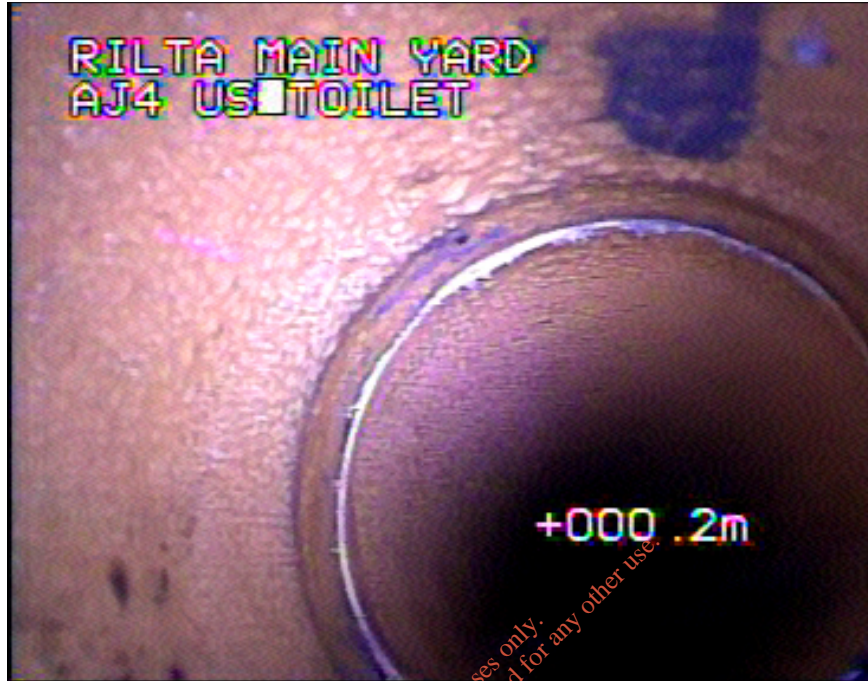
Photo: 13\_3A, MPEG #: 280217\_1, 00:00:03  
 0.3m, Open joint, medium

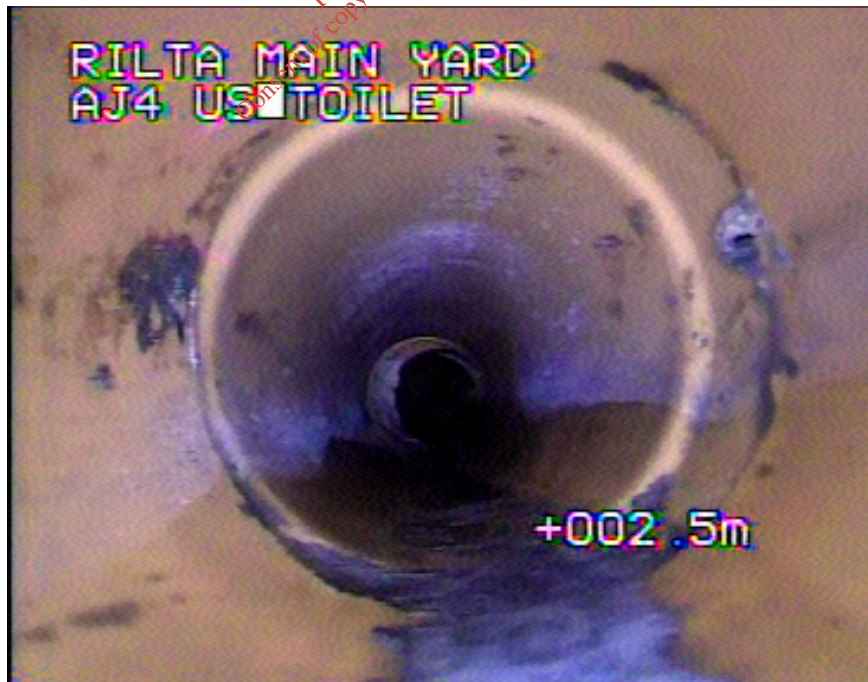
Photo: 13\_4A, MPEG #: 280217\_1, 00:00:36  
 2.5m, Open joint, medium

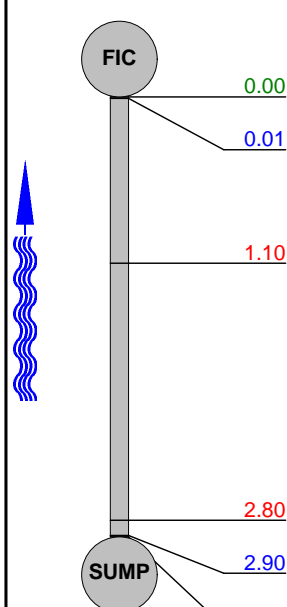
0.00	OS	Start node type, oil separator, reference number : FIC	00:00:01		(Constr) 0
	0.01	WLC	Clear water level, 0% of the vertical dimension	00:00:01		(Serv) 0
	1.10	OJM	Open joint, medium	00:00:27	19_3A	(Struct) 1
	2.80	FC	Fracture, circumferential, from 2 to 7 o'clock	00:00:51	19_4A	(Struct) 3
	2.90	WL	Water level, 0% of the vertical dimension	00:01:36		(Serv) 0
	2.91	CPF	Finish node type, catchpit reference number: SUMP	00:01:36		(Constr) 0

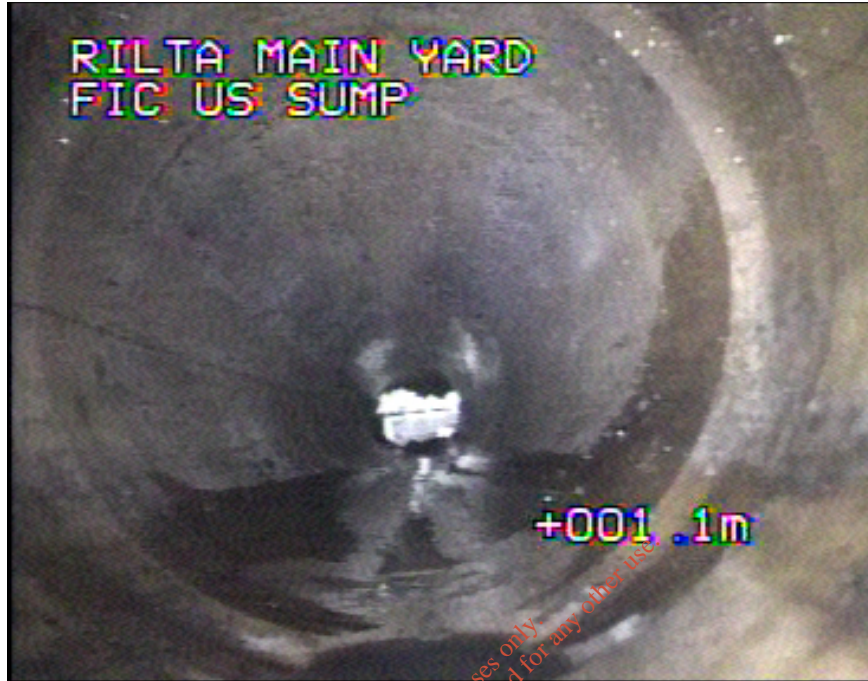
Photo: 19\_3A, MPEG #: 280217\_1, 00:00:27  
 1.1m, Open joint, medium

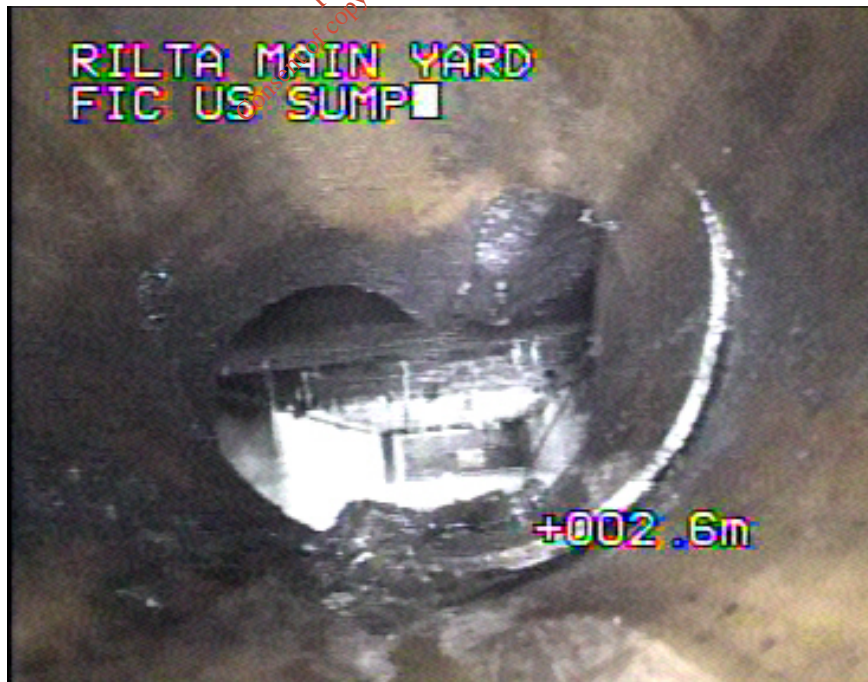
Photo: 19\_4A, MPEG #: 280217\_1, 00:00:51  
 2.8m, Fracture, circumferential, from 2 to 7 o'clock

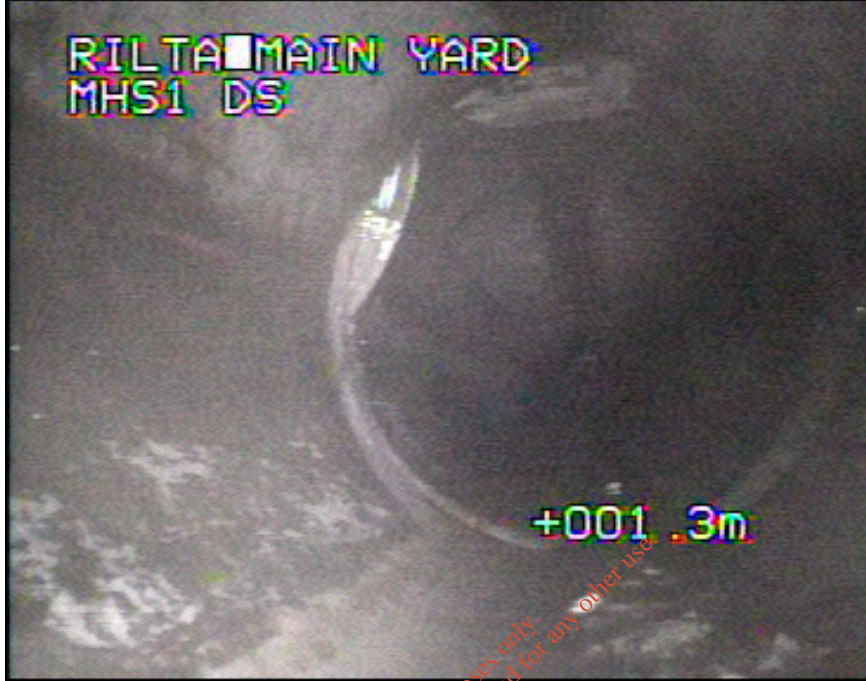
Photo: 27\_4A, MPEG #: 280217\_1, 00:00:47  
 1.5m, Sealing ring intruding, from 9 to 12 o'clock

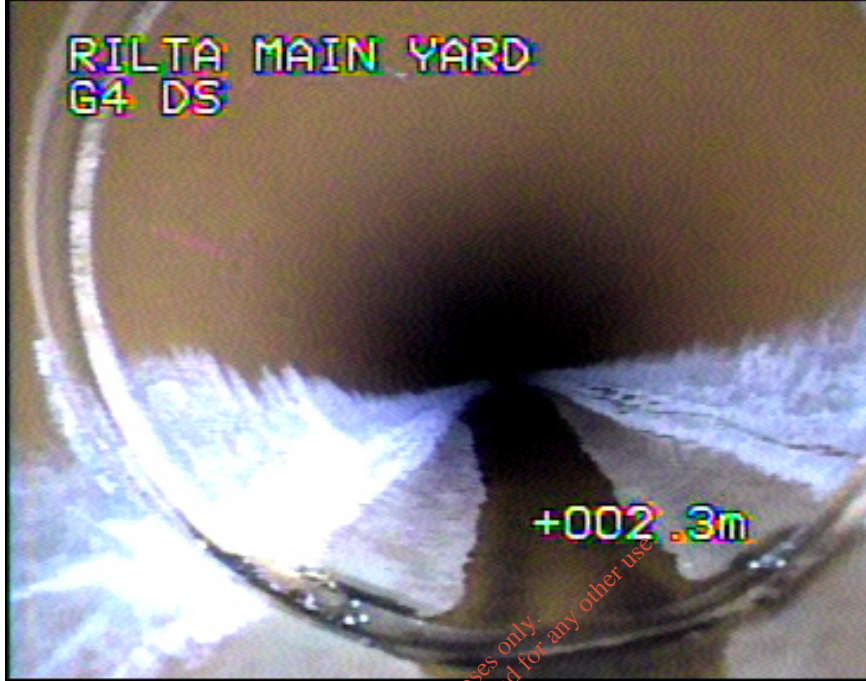
Photo: 38\_3A, MPEG #: 280217\_1, 00:00:12  
 2.2m, Open joint, medium

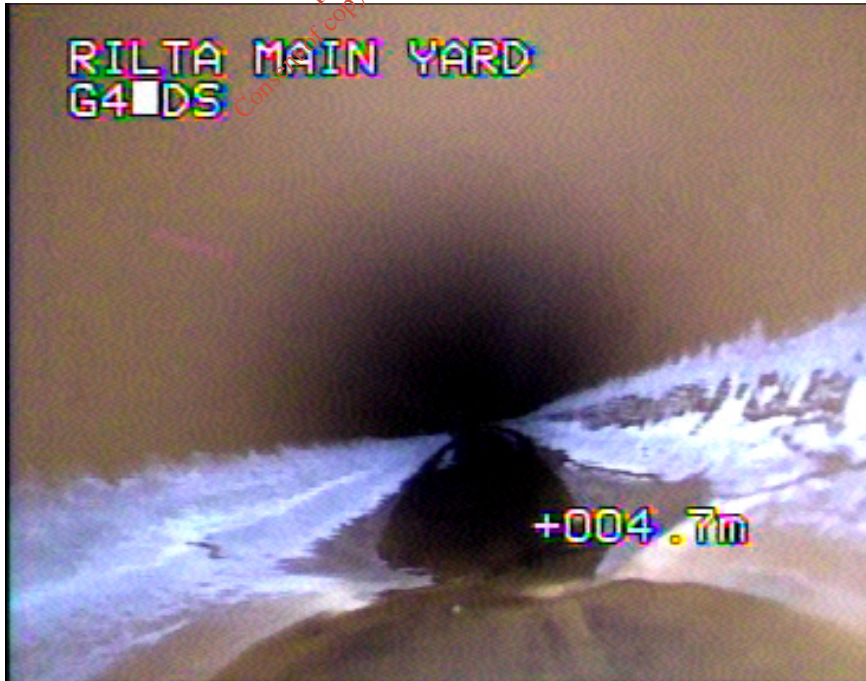
Photo: 38\_5A, MPEG #: 280217\_1, 00:00:33  
 4.7m, Surface damage, other, from 4 to 8 o'clock

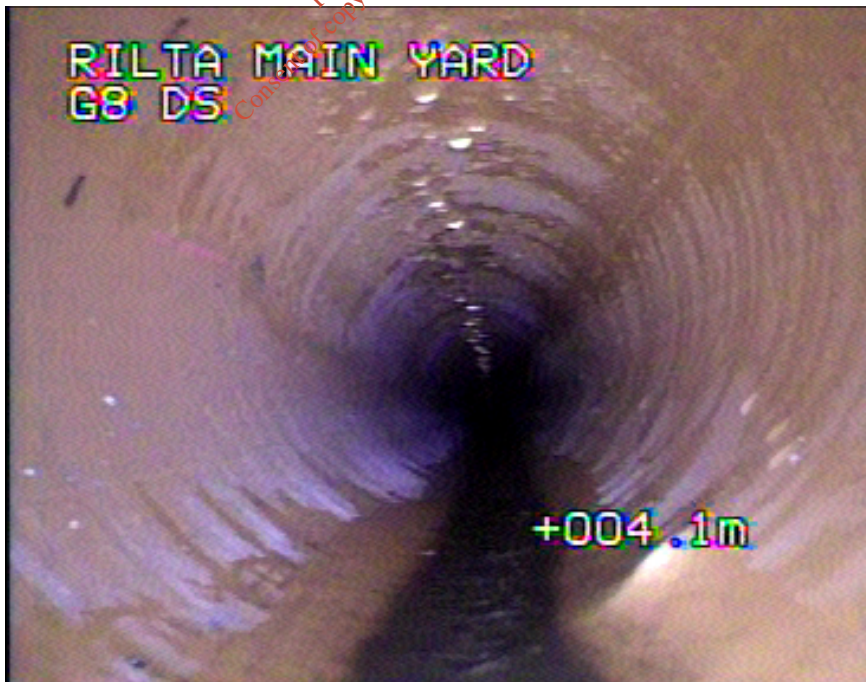
Photo: 42\_4A, MPEG #: 280217\_1, 00:00:36  
 4.1m, Surface damage, other, from 4 to 5 o'clock

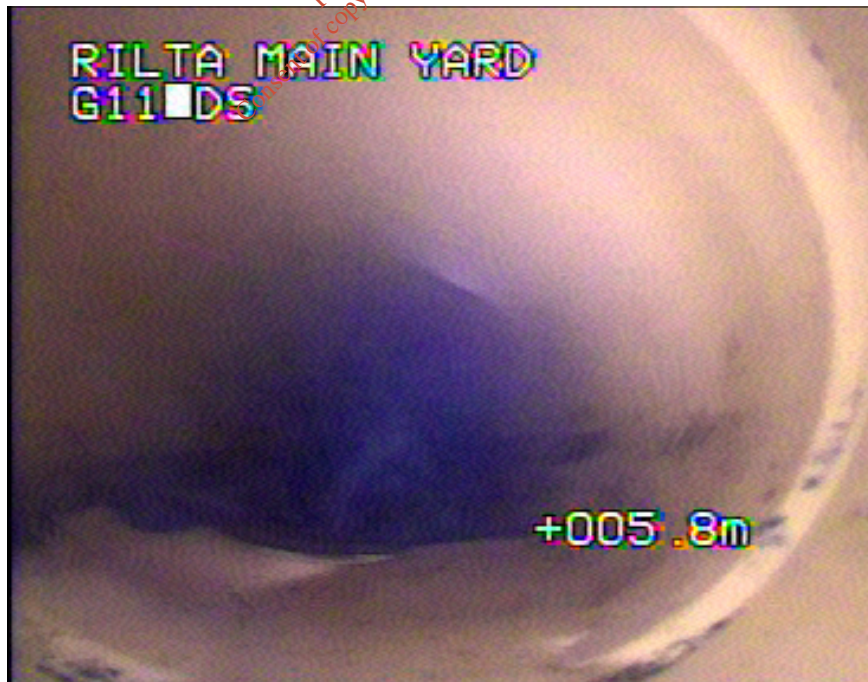
Photo: 47\_4A, MPEG #: 280217\_1, 00:01:48  
 5.8m, Deformed sewer/drain, 10%
