## **An Investigation of Recent Building Collapses around the World with Special References to Rana Plaza**

R. Islam<sup>1</sup>, M. A. K. Azad<sup>2</sup>, A. Sinha<sup>3</sup> and M. Lixon<sup>4</sup>

*Every year a large number of buildings collapse around the world. It is important to investigate the reasons for collapse because a large number of people are killed or injured. In this thesis the Rana Plaza Building (the largest disaster occurred on 24 April 2013 at Savar, Dhaka, Bangladesh) collapsed has been broadly discussed because it was one of the biggest non-terror-related structure failure where 1,135 people were killed and 2,515 were injured. Before the analysis of the Rana Plaza some of the recent building failures around the world have been analyzed. These include Ronan Point collapse, Hyatt Regency walkway collapse, World Trade Centre collapse and Sampoong department store collapse. In this thesis the causes of these four major failures have been identified and discussed. We have analyzed the Rana Plaza by Etabs using as-built condition and from the analysis we have shown that the structure was already in vulnerable position and the generator just triggered the failu

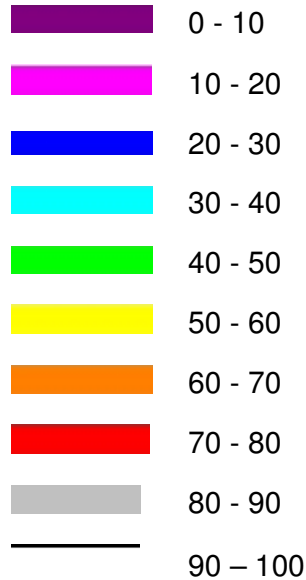
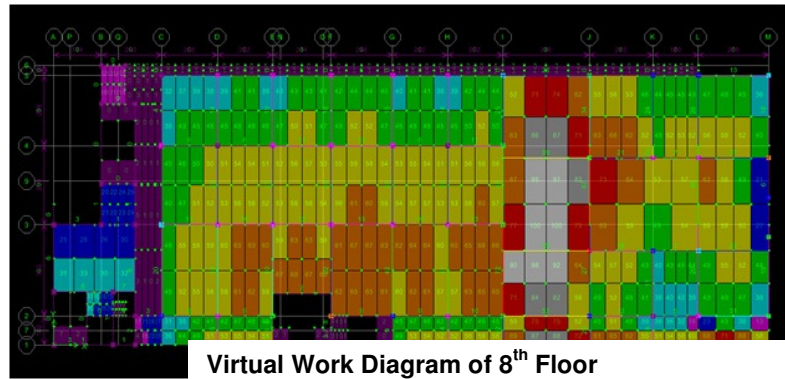
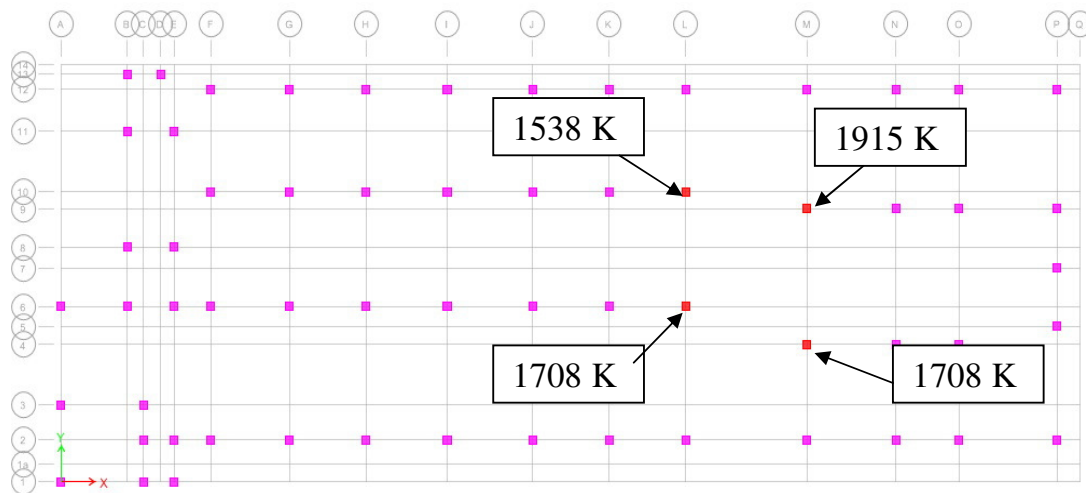
These colors represent which elements should be stiffened to control lateral displacements in structure.

Overstressed Column at Basement Floor
