Structural Assessment of the Barrô Romanesque Church

Built on the left bank of the Douro River, halfway of the slope, the Romanesque Church of Barrô was founded in the 12th century. This church underwent many changes during its service years, where the major concerns were the water infiltration and the belltower, which have led to many problems. Throughout the visual inspection, a major crack in the front façade and bulging of the lateral wall was observed, therefore doubts were raised on their causes. An effort has been made to perform photogrammetry on the structure, further enhanced with a detailed drawing survey to observe and localize the damages.

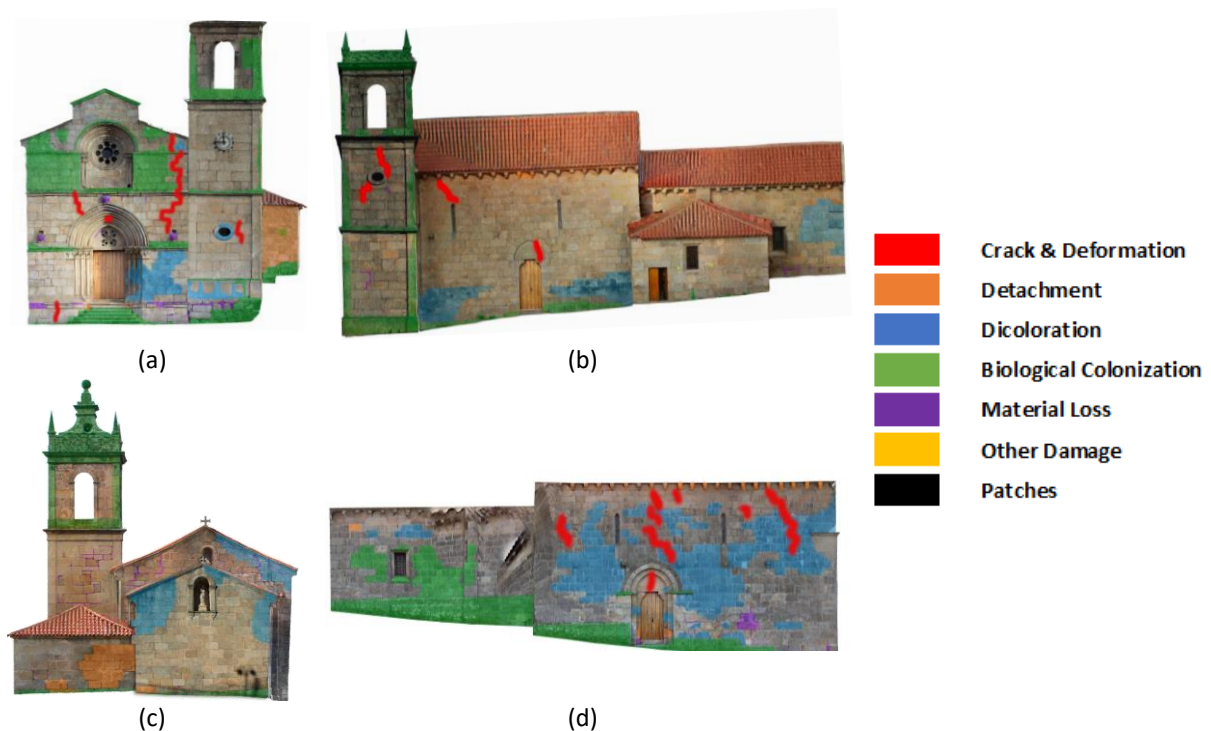
Figure 3. Damage Maps: (a) west façade; (b) south façade; (c) east façade; (d) north façade;

The exterior of the Church showed disintegration of the granite stone with signs of detachment of single grains or aggregates of grains. Scaling detachment was observed in localized parts. This is an effect of decay that can be related to the erosion of stones due to salt crystallization. The exterior of the Church shows other damages due to erosion, including loss of matrix and rounding of the edges close to the joints. There are also missing parts of the façade elements. The façades of Barrô Church have several cracks that can be classified as fractures. Especially in the West façade, significant cracks were observed in the wall above the choir. The West façade also shows a black crust. Around the Church, several types of biological colonization were observed, including plants, algae, and lichens. Biofilm was also observed, especially in the North Façade. Figure 3 shows the damage maps drawn on top of the Photoscan model mapped according to [2].

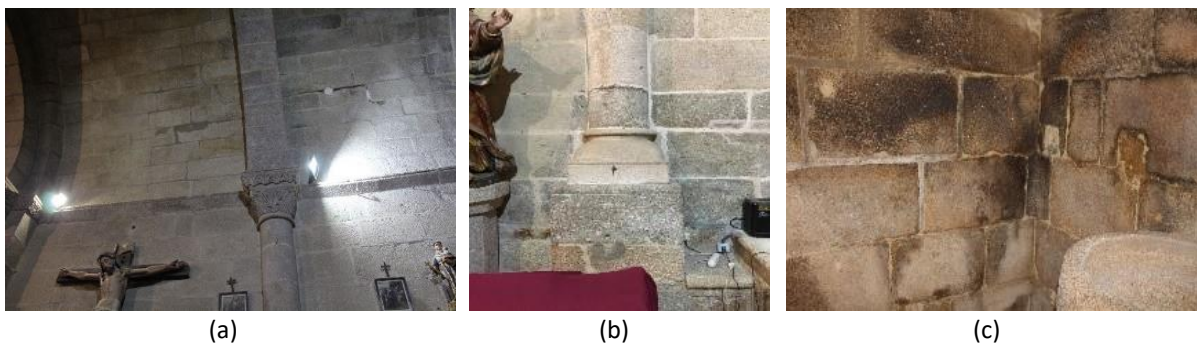
Figure 4. Interior damage: (a) crack in the vault; (b) deformation of the column; (c) patina;

The interior of the Church shows signs of cracking. The most significant crack is visible in the vault of the main chapel. The North façade wall of the Church has signs of deformation, which was observed clearly from the interior of the Church since the wall and one of the columns of the Main Chapel are exhibiting concave deformation. The interior of the Church shows signs of patina and staining due to moisture. Figure 4 shows the damages described, respectively from left to right.

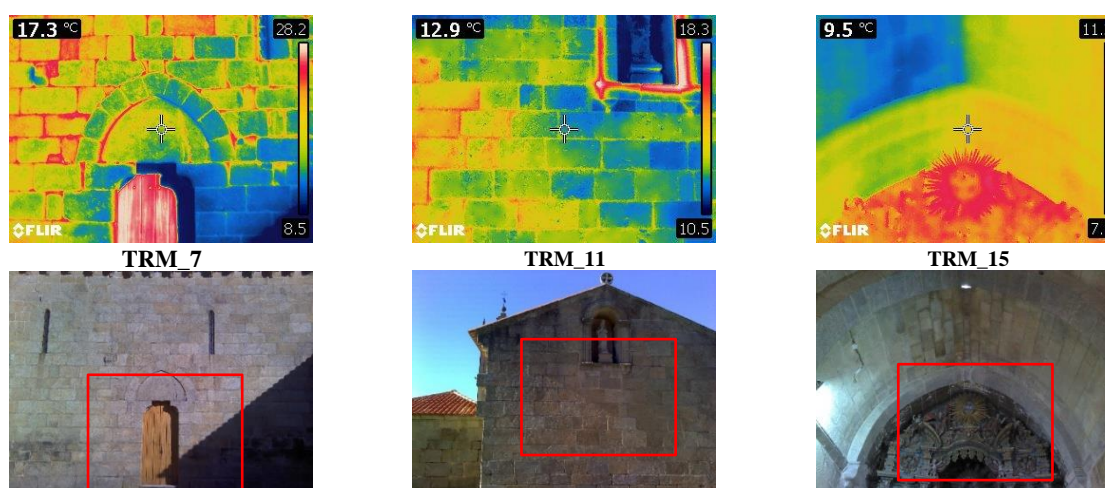
Figure 6. Thermal camera pictures (top) and the part they represent (bottom)

From TRM_7, it can be observed that on the left side there is a clear separation of the arch above the door to the stone filling underneath, not clearly visible to the naked eye. Additionally, from TRM_11 another distinct separation between the sculpture stand and the rest of the wall can be seen. TRM_15 shows material differences between the altar and the stone vault, which has a clear thermal separation line at the apex. This separation comes from the orientation of the church where the left side (of this picture) is the northern side whereas the right side is the southern side, which at the time of measurement was constantly in contact with the sun.

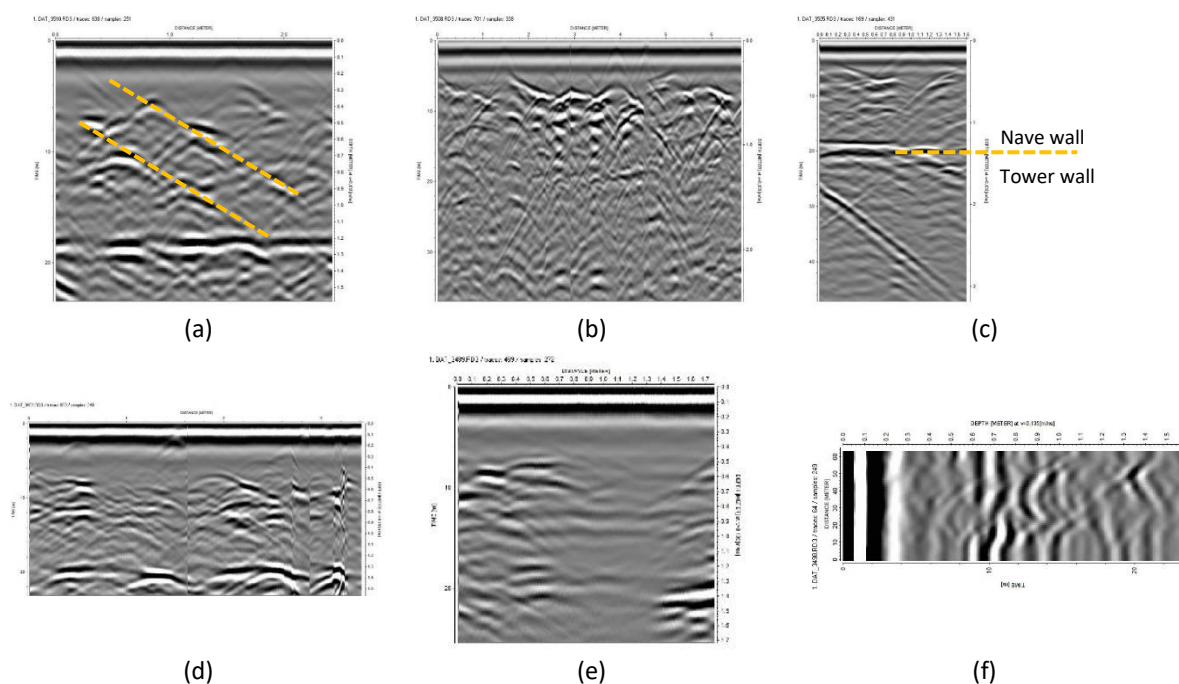
Figure 7. Radargrams at: (a) GPR_1 northern wall choir level; (b) GPR_2 western façade wall choir level; (c) GPR_3 southern nave-tower wall interface choir level; (d) GPR_4 southern wall; (e) GPR_5 northern wall; (f) GPR_5 beginning of the vault;

Ground penetrating radar was utilized in order to understand the inner constitution of the walls, identify any presence of damage and to measure the thickness of the walls and the vault. The measurements were carried out with an 800 MHz antenna and the locations are shown in Figure 5. The GPR_1 radargram (Figure 7a) shows an internal view of the crack in that part of the wall. Patterns of hyperbolas show a specific trend rather than being random as they would be on a normal wall and this explains the cracks as the consequence of detachment. From the GPR_2 radargram (Figure 7b) one can observe a difference in amplitude from the rest of the wall that is at the inner layer and the external interior masonry, which indicates a thicker separation between the layers and thus explaining the out-of-plane deformation perceived. On the southern wall in the choir level (GPR_3) a clear separation between the nave wall and the tower wall can be seen from the radargram in Figure 7c.

The radargrams for the walls (GPR_4 and GPR_5) show that the walls are composed of three-leaf walls, the inner layer is very regular and they contain a large number of interlocking stones (Figure 7d and Figure 7e). Lastly, from the measurement at the starting of the vault (GPR_5), it is found out that the thickness at its start is around 50 cm, which can be seen from Figure 7f.

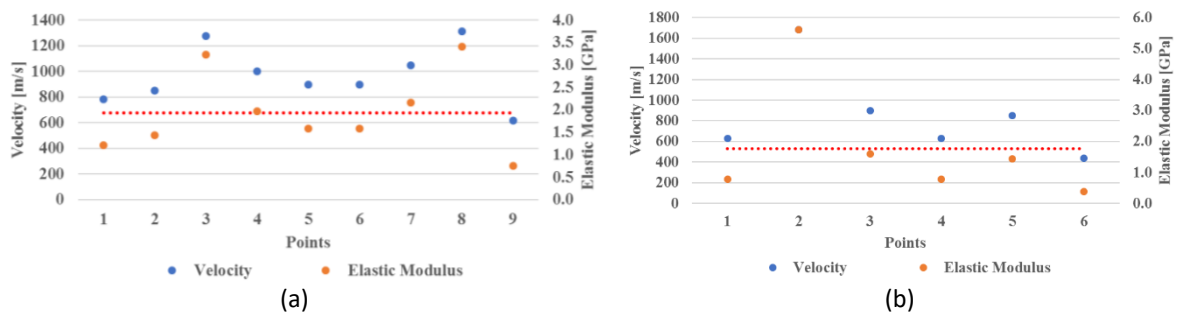
Figure 8. Correlation between velocity and the elastic modulus in: (a) northern wall IE_1; (b) southern wall IE_3;

The elastic wave method impact-echo was performed in 3 locations as shown above in Figure 5, where IE_1 and IE_3 with the direct method and IE_2 with the indirect method. IE_1 was carried out in 9 points with a layout of 3 by 3 points each separated 50 cm from each other. The elastic modulus is correlated with the velocities utilizing the formulations for P and R waves and a Poisson's ratio of 0.2 and a common density for stones of about 2.2 ton/m³. Similarly, for the test IE_3, 6 points with a layout of 2 by 3 each separated by 50 cm from each other were tested. The correlation between the velocities and elastic modulus for tests IE_1 and IE_3 is shown in Figure 8. A mean elastic modulus value comes up to be around 2.0 GPa with slight deviations in some points of IE_1 and only one point of deviation in IE_3, which may be due to the presence of interlocking stones.

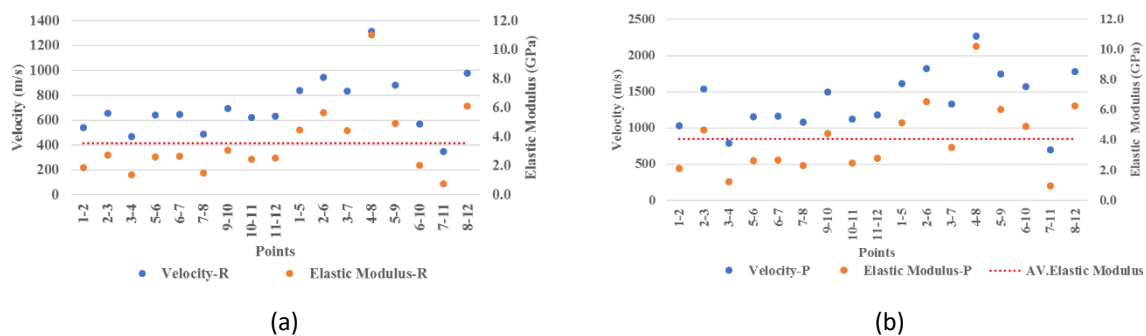
Figure 9. Correlation between velocity and the elastic modulus: (a) R-waves; (b) P-waves;

In contrast, 12 points were measured in IE_2 (choir level) with a layout of 4 by 3 separated by 50 cm in the vertical direction and 100 cm in the horizontal direction (shown in Figure 9). The mean elastic modulus from the P-wave and R-wave measurements is around 4.0 GPa with a deviation at point 4-8.

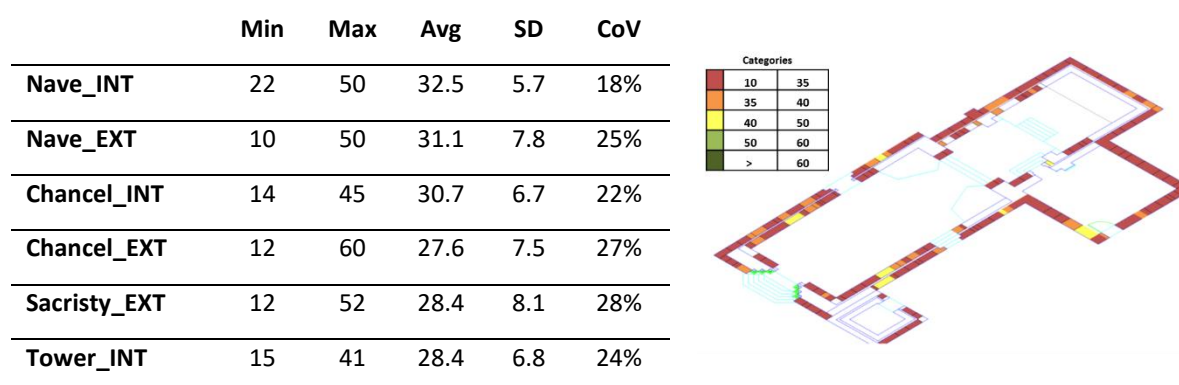
Figure 10. Results from the rebound hammer in the form of a table (left) and visual classification (right);

The rebound hammer test provides a superficial measurement of the hardness of materials. In the case of stone masonry with dry joints the rebound hammer gives only qualitative measurements of surface hardness as to be compared relatively between different locations in the church (outside “EXT” and inside “INT”). This comparison is done with the sole purpose of identifying the weaker spots of the masonry. The rebound values from this test are shown in the form of a table and visually classified represented by distinctive colors in Figure 10.

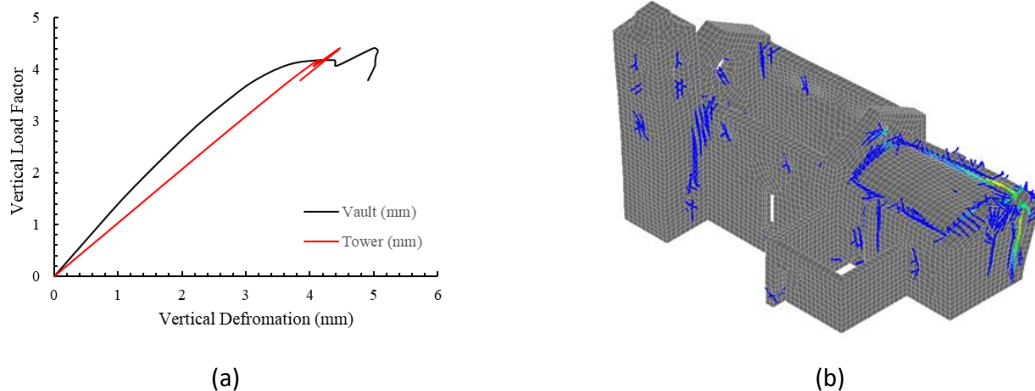
Figure 12. Results of pushdown analysis: (a) capacity curve; (b) crack distribution;

In order to observe the present vertical load-bearing capacity of the structure, and derive the vertical load safety factor, a nonlinear pushdown analysis was performed. In this analysis, gravity forces were applied in increasing steps and analysis was deemed to be completed when major damage at the junction of wall and vault was observed. The total weight of the structure for the gravity loading was calculated as 2224 tons. Figure 12a shows the vertical load factor normalized with respect to the total deadweight of the structure plotted against the vertical displacement at the center of the vault and tower top. Figure 12b shows the crack distribution observed for this analysis at peak load (load factor of 3.79).

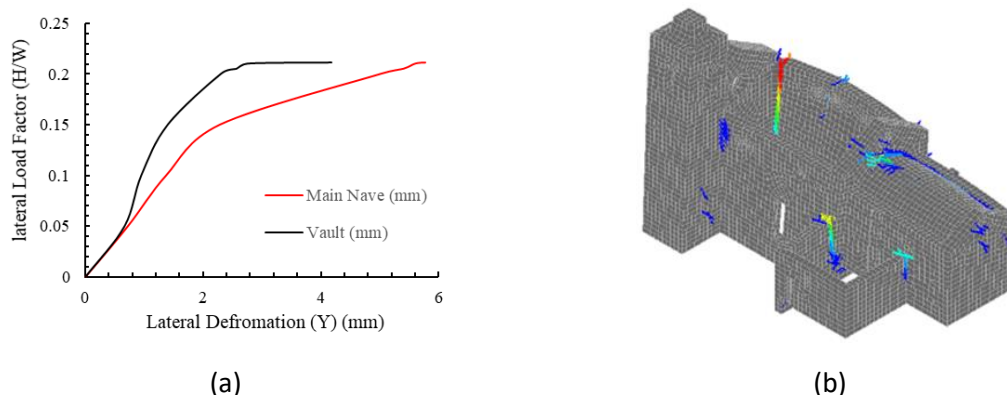
Figure 13. Pushover analysis (east-west direction): (a) capacity curve; (b) crack distribution;

The pushover analysis was performed applying an equivalent acceleration in the North-South and East-West directions, with forces proportional to the mass. For the pushover analysis, gravity forces were initially applied, and a horizontal acceleration was imposed with appropriate load steps. The analysis was performed with modified Newton-Raphson method. This was done to solve the non-linear equilibrium equations and find convergence based on energy balance. After performing the pushover analysis, displacement vs load factor was computed for the extreme points of the structure. From the lateral pushover in the east-west direction, the lateral capacity was found to be $0.15g$ (Figure 13a) and damage at the peak load ($0.21g$) in terms of crack distribution is shown in Figure 13b.

From the numerical nonlinear analysis, in the case of the lateral pushover in the east-west direction at $0.15g$ of equivalent acceleration, it was possible to observe the same bulging observed on the side with a considerable amount of magnitude. Furthermore, with lateral pushover in the east-west direction, it was possible to obtain the damage observed on the site on the vault and northern façade.

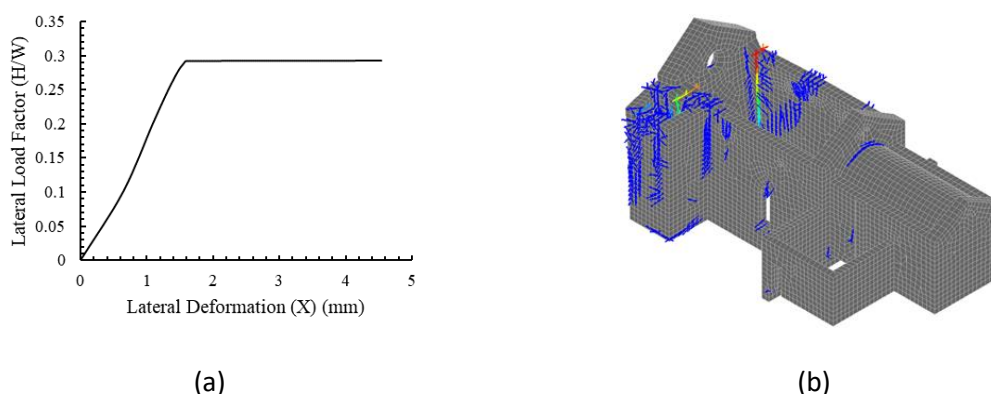
Figure 14. Pushover analysis (north-south direction): (a) capacity curve; (b) crack distribution;

For the pushover analysis in the north-south direction, several cases of the Church's geometry were considered: without the tower, with the full tower, and with the tower at the same height as the main wall of the Church. This was done due to the fact that the tower was not always have been a part of the main church and it was important to know the effect of the tower in different periods of its construction. The case with the tower at the same height as the main wall is presented for this particular case, a lateral capacity of $0.25g$ was defined (Figure 14a), and at that stage, the crack distribution at the main nave is shown in Figure 14b.

In the case of the mass-proportional pushover in the north-south direction, the model in which the tower height is the same as the church yields a considerable amount of damage like the one observed on site. Moreover, it was possible to observe the cracking pattern near to the junction of the west façade and adjoining north and south façade. Given the actual code-based seismic hazard level of the area (peak ground acceleration on rock equals $0.08g$ [10] and the actual conditions, the church seems to be safe.

From the pushover analyses at both the direction, it was observed that for the ground acceleration of $0.08g$, no major damage was observed except for minor cracking at the wall junctions. Moreover, these analyses were performed assuming conservative values of material properties that also contribute as a safety factor in these analyses. Apart from localized injection of the walls aiming its consolidation, no major structural repair works are suggested to a church standing for more than 800 years. Instead, a health monitoring system seems to be mandatory to follow the evolution of the major structural cracks.
