## The combined use of PSInSAR and UAV photogrammetry techniques for the analysis of the kinematics of a coastal landslide affecting an urban area (SE Spain)

**Abstract** In the present work, the case of the Cármenes del Mar resort (Granada, Spain) is shown. It can be considered one of the most extreme examples on the Mediterranean coast of severe pathologies associated with urban development on coastal landslides. The resort, with 416 dwellings, was partially built on a deep-seated landslide which affects a soft formation composed of dark graphite schists. In November 2015, the City Council officially declared a state of emergency in the resort and 24 dwellings have already been evacuated. We have used two remote sensing techniques to monitor the landslide with the aim of identifying and measuring a wide range of displacements rates (from mm/year to m/year): (1) PSInSAR, exploiting 25 ENVISAT SAR images acquired from May 2003 to December 2009, and (2) photogrammetry, considering the output from two Unmanned Aerial Vehicle (UAV) flights made in June 2015 and January 2016 and the outdated photos from a conventional flight in 2008. The relationship between the geology of the site, d

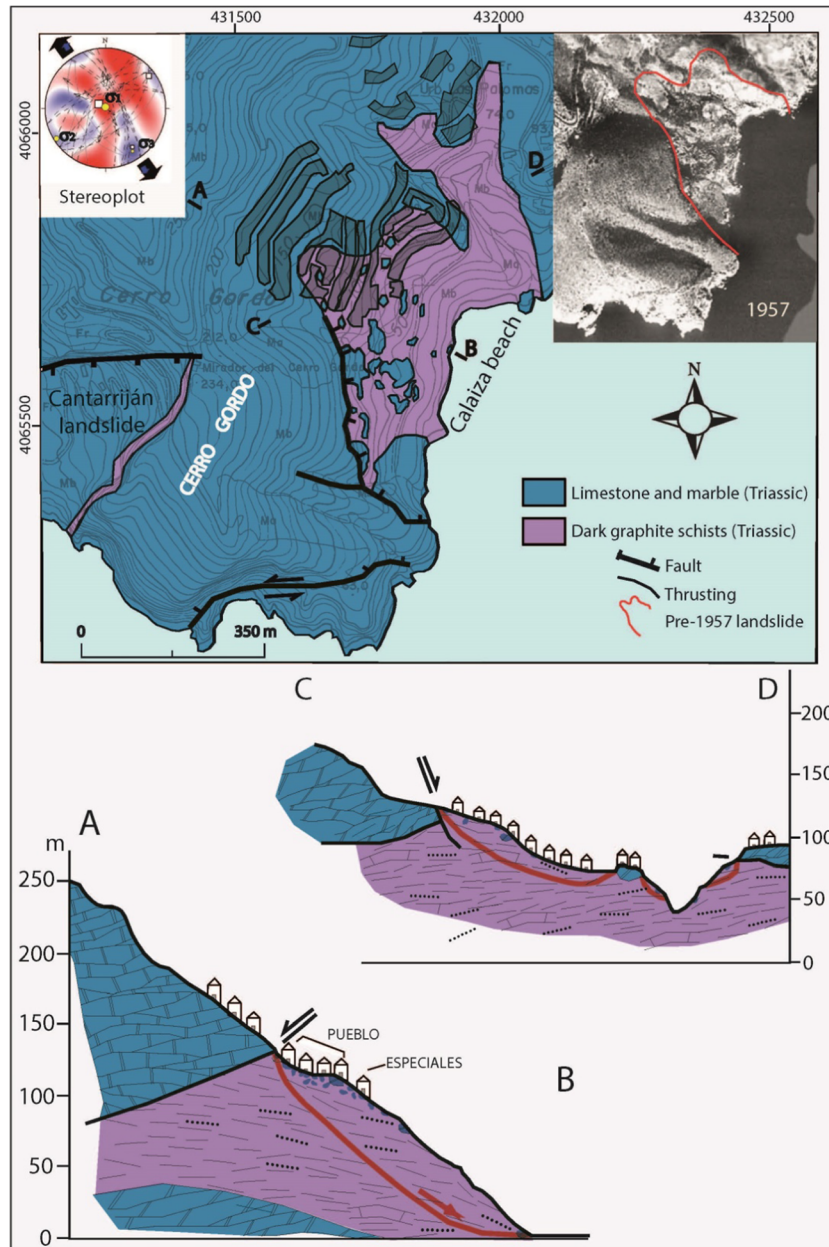
Figure 3 shows the geology of the setting. On the lower part of the slope, there are soft material outcrops, which are composed mainly of dark graphite schists and calc-schists (Paleozoic in age). This material is highly tectonized and altered, at least in the first 31.5 m (Vorsevi 1998), and the exfoliation tends to dip toward the slope. Because of their laminar structure, the materials are ductile and malleable and have a soil-like behaviour. Moisture variations materially alter their mechanical behaviour, the strength parameters decreasing the higher the water content. The main geotechnical parameters are as follows (Rodríguez-Ortiz 2011): density = 2.2 t/m<sup>3</sup>; cohesion = 2.5 t/m<sup>3</sup>; angle of friction = 23°. All the limits of the schist outcropping are mechanical contacts, and the rest of the slope is clearly dominated by the Triassic marbles from the Alpujarride Complex. They are predominately karstified marbles

**Fig. 3** Geological map of the area. The slope consists of dark graphite schist in the lower part and karstified marbles at the top. A normal fault oriented NNW-SSE delimits the schist formation on its western boundary, where lateral spreading processes have been identified. Stereoplot depicts the orientation of fractures in the area related to the most recent extensional stage. The 1957 aerial photo shows the existence of an old and large landslide in the area where the resort would later be constructed. Two geological cross sections (A-B and C-D) have been drawn to represent the disposition of the two main geo-formations and the location of the landslide failure surface based on boreholes from previous reports (Rodríguez-Ortiz 2011)

The interpretation of the aerial photographs taken in 1957 allows the identification of an original landslide in the landscape (Fig. 3). With an extension of around  $10^4 \text{ m}^2$ , the landslide can be mostly considered as a planar movement affecting the cataclastic and altered schist formation. The crown is located at a height of around 140 m (the geological contact between the schists and the marble formations), and the body extends until a few metres above sea level. The lateral landslide boundaries correspond to

the major streams in the area. The disposition of the different geological formations in the area can be seen in the cross sections represented in Fig. 3, where the landslide failure surface has been identified at a depth of up to 40 m, based on borehole data reported in Rodríguez-Ortiz (2011).

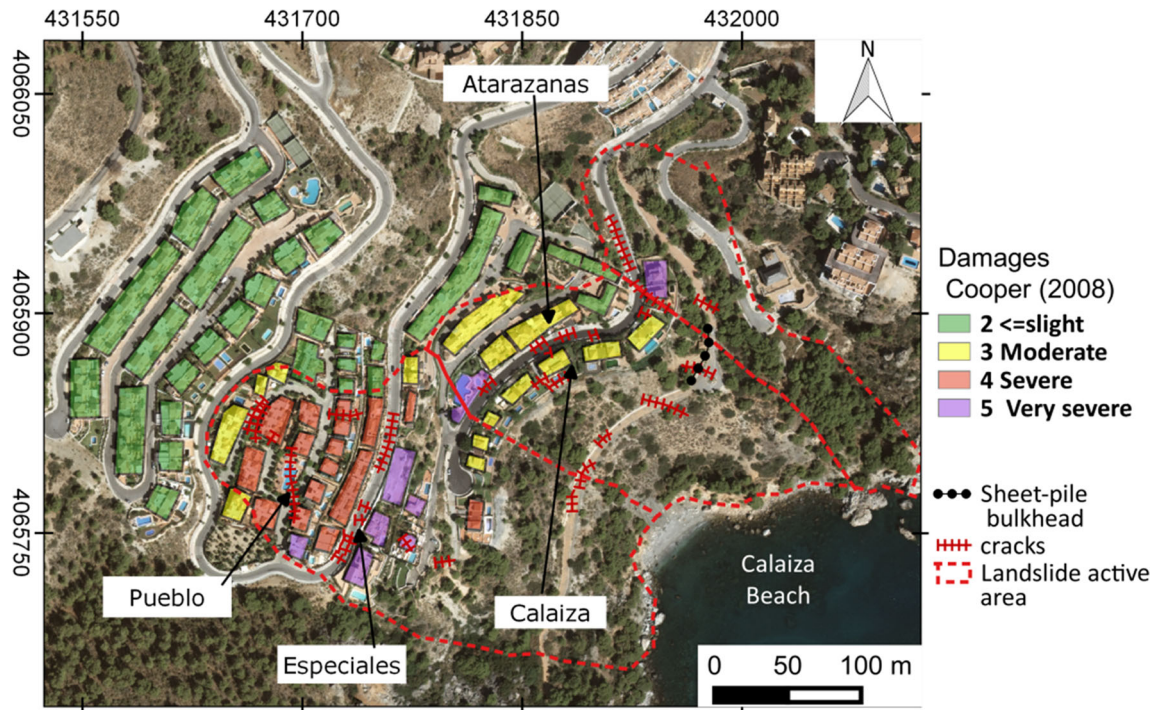
**Fig. 4** Map of damage based on Cooper (2008) classification. Updated in January 2016

An inventory of damage was carried out in January 2016 (Fig. 4). The buildings were categorised following the classification proposed by Cooper (2008) according to different degrees of damage. The author rates the damage from 0 (no damage) to 7 (total collapse). The most affected areas are located in the lower part of the resort (*Pueblo*, *Especiales*, *Atarazanas* and *Calaiza*) where numerous houses and places have been assessed as having a level 4 degree of damage (severe) and some of them a level 5 (very severe). Based on the distribution of damage, the boundaries of

the current active landslide area have been drawn, and three main bodies have been identified: the southwestern one, where the most severe damage has been detected (*Pueblo* and *Especiales*); the central body, with moderate damage to buildings (*Atarazanas*, *Calaiza*) but with open cracks on the lower part of the slope; and the north-eastern body, where very severe damage has been reported in two dwellings (already evacuated) and long cracks have been identified. There is a clear spatial correlation between the original landslide body identified in 1957 (Fig. 3) and the current active area.

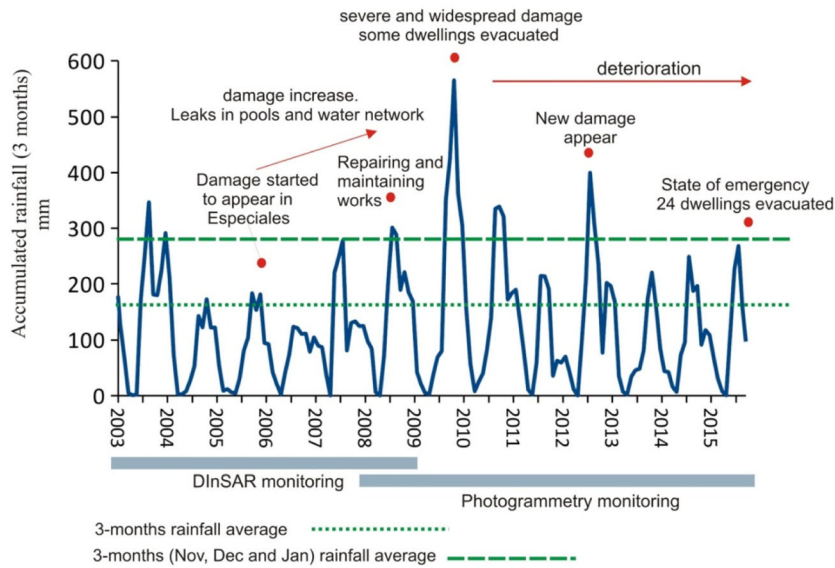
Damage history in the resort seems to show a clear relationship between the most damaging events and water recharge episodes (rainy events and leaks from swimming pools and the water supply network). To prove this temporal connection, monthly rainfall data has been recorded by the nearest weather station (Cuevas de NerjaES77, AEMET-Spanish Meteorological Agency) for the period spanning from January 2003 to January 2016. Figure 6 represents the accumulated rainfall (3 months) for this period and the history of damage. We have considered the 3-month accumulated rainfall period as the rainy months in the region are November, December and January, and thus, we can represent their influence better. Figure 6 shows that 2009–2010 winter was extremely rainy in the region, when accumulated rainfall was almost twice the average value. The most severe and spreading damage was reported at this time, as also happened in the Marina del Este resort (Notti et al. 2015). Later, during the rainy winter 2012–2013, new damage appeared which led to the progressive deterioration of the resort until the current state of emergency.

**Fig. 6** Three-month accumulated rainfall for the period January 2003–January 2016 and the temporal representation of the main damage events. Two rainy winters (2009–2010 and 2012–2013) occurred and severe and new damage appeared. The monitoring periods have also been indicated

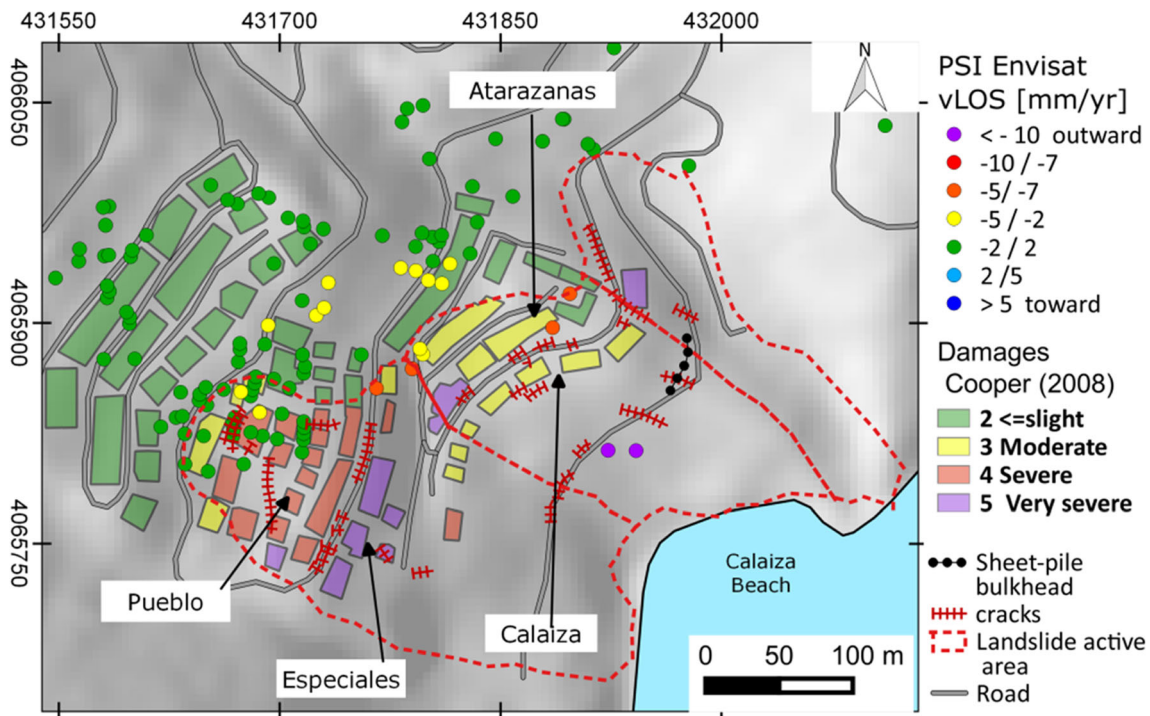
**Fig. 7** PS velocity map based on ENVISAT ascending data (2003–2009) superimposed to the damage map. The stable area of the resort, located uphill of the active landslide body, is well characterised. Insufficient PS from the active landslide area have been obtained to monitor movement

of PS with low velocities, between  $-2$  mm and  $-5$  mm/year, appear where no damage has been detected yet. Within the active landslide area, and specifically in Pueblo site, a concentration of stable PS can be seen despite the damage observed. That is because the

over 5 mm/year. The highest values of velocity ( $> -10$  mm/year) are located in the lower part of the landslide where large cracks have appeared. The lack of PS results may be due to not only the unfavourable orientation of the slope (NW-SE) but also to the presumable high velocity ratios of the movement (over 20 mm/year, the threshold estimated for ENVISAT), especially in the Especiales site, where severe damage had already been detected.

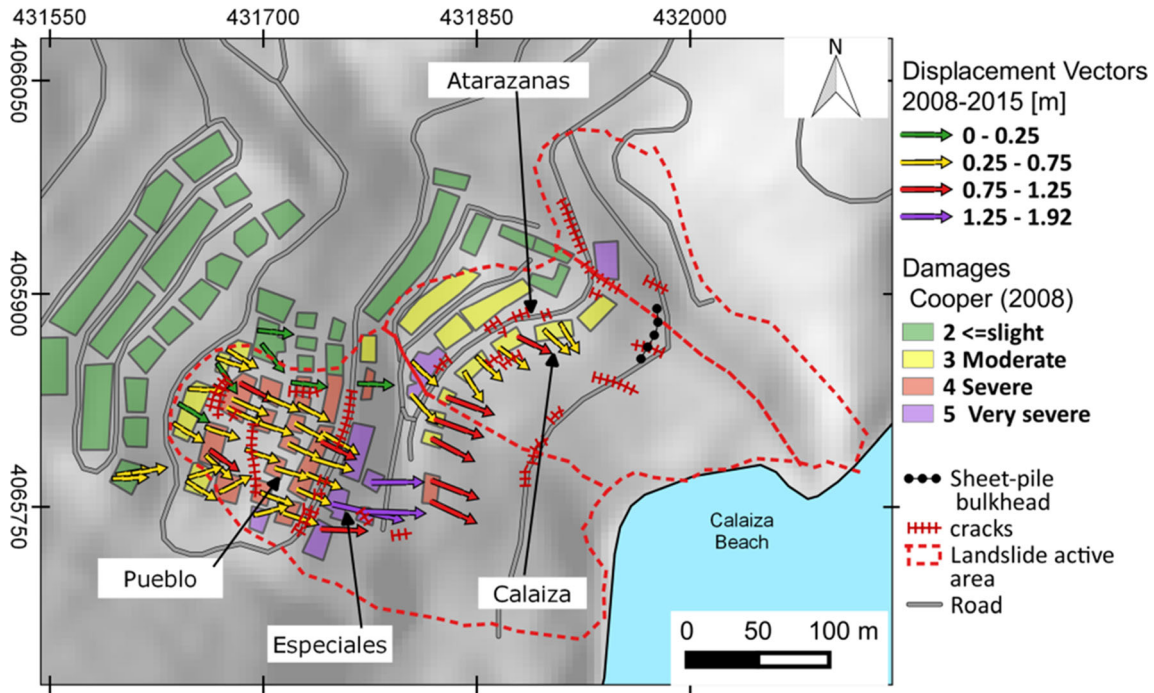
**Fig. 10** Displacement vectors of the buildings for the period spanning 2008–2015 superimposed onto the damage inventory map. A general NW-SE direction of the movement can be observed, each vector allows the landslide flanks as well as the previously defined lobes, to be defined with accuracy. The southwestern sector of the resort is the most active and is where major building displacements (up to 1.92 m in 8 years) and the most severe damage have been detected

In general, the flanks and toe areas of the original landslide are the most damaged, and are where higher displacement rates have been observed (Fig. 10). Ephemeral streams are located along the flanks of the landslide and fluvial erosion contributes to the instability of these areas. Additionally, marine erosion tends to steepen the front of the active toe, this area being one of the most rapidly evolving places in the landslide, where numerous cracks and shallow failures have appeared and where the highest values of  $V_{slope}$  have been detected. The push exerted by the material advancing from behind produces significant deformations and changes in the morphology of this sector and can explain the high displacement values (0.75–1.5 m) obtained in the southern sector of Calaiza (Fig. 10). Nevertheless, some of these houses located on the seafront, despite photogrammetry showing large displacements, only present moderate damage. They are terraced houses, not detached, and have probably moved as one unit. Conversely, a group of houses located in the central lobe, in the western extreme of Atarazanas, shows severe damage but the displacements obtained are in the mid-range (0.25–0.75 m). They are detached houses in a very steep area, and they seem to have been affected by spatially heterogeneous deformations. Additionally, some houses located at both sides of Pueblo site, and outside the current landslide boundaries, show displacements (up to 0.75 m in 8 years) which could indicate a future expansion of the landslide body and the consequent emergence of new damage.
