Space Shuttle debris and meteoroid impacts

E.L. Christiansen^{a,*}, J.L. Hyde^b, R.P. Bernhard^b

Abstract

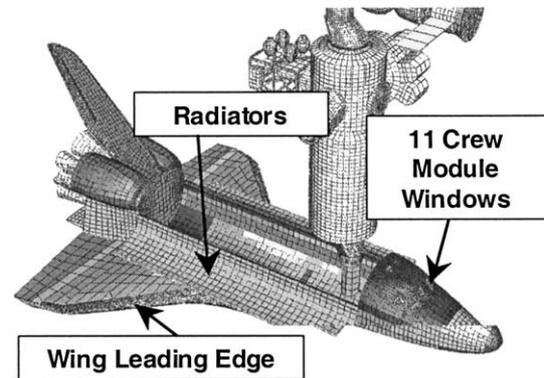
Another design modification resulted from post-flight M/OD impact damage surveys (Fig. 1). After STS-86 in September 1997, an impact was found on an exterior radiator manifold that connects separate radiator panels on the Orbiter. Subsequent interior inspection of the radiator line showed a region of detached spall under the impact site. The Shuttle Program responded to this near perforation of the interconnect lines by adding a

Fig. 1. Orbiter surfaces inspected for M/OD impact damage.

double-layer β -cloth sleeve to reduce the vulnerability of the interconnect lines. The National Research Council report (1997) and Jensen et al. (1999) provide additional information on operational changes and design modifications to the Shuttle to reduce M/OD impact damage risks.

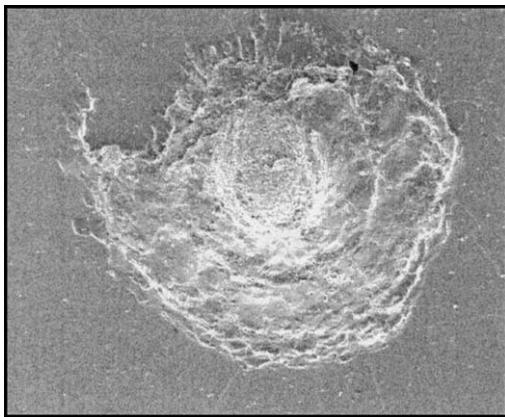
The largest impact to an Orbiter window occurred on STS-92, which was International Space Station (ISS) Flight 3A. A crater of 10-mm diameter and 1.9-mm deep was found on the port-middle (#2) debris pane (Fig. 2). SEM/EDX analysis indicated the cause of the damage was a piece of paint (orbital debris). The window was replaced. Based on average impact conditions for this mission (impact velocity of 9.3 km/s and impact angle of 45°), the crater geometry can be best explained by a 0.76-mm diameter by 0.3-mm thick paint chip that impacts the window in an edge-on orientation.

Fig. 2. STS-92 left-hand #2 window crater (10-mm diameter by 1.9-mm deep) caused by orbital debris (paint).

Generally there are many small impacts found on the Shuttle windows that do not cause any concern. In some cases, the impacts are large enough to require the window to be replaced, because of the potential for flaw growth during subsequent launch/landing cycles. The replacement criteria vary for each window on the Orbiter and location of the flaw, because of the different stresses experienced by the windows during launch. Although 1578 impacts were recorded on the windows, only 98 were large enough to cause the window to be replaced due to hypervelocity impact damage over the 50 missions sampled for meteoroid/debris damage from STS-50 to STS-110. Of the 98 impact replacements, SEM/EDX analysis revealed 41 were from orbital debris, 18 from meteoroids, 10 were unknown (no definitive SEM/EDX results), and 29 had no sample returned. Fig. 3 illustrates the composition of orbital debris for the 41 debris impacts that caused a window replacement. Aluminum and paint particles resulted in a majority of the window replacements, although steel and

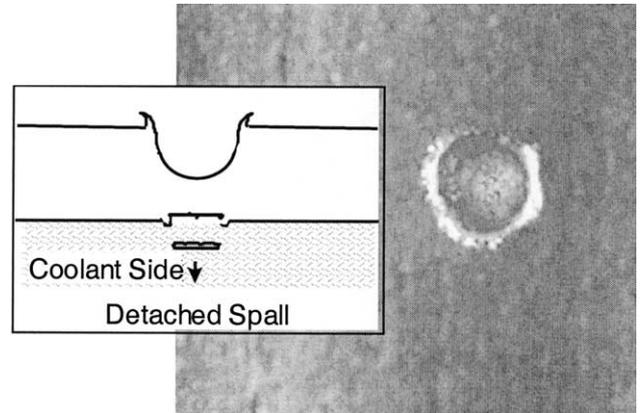
Probably the severest impact to the Shuttle fleet as it represents a “near miss” of a major problem is the impact found on a radiator line after STS-86 (Hyde et al., 2001). Post-flight inspection of OV-104 (*Atlantis*) radiator panels after mission STS-86 found a significant hypervelocity impact in the external manifold hard line that extends along the two forward radiator panels. The impact penetrated through a β cloth cover, crossed a 6.4-mm (0.25 inch) gap, and left a 0.8-mm diameter by

Fig. 6. Deep crater (0.8-mm diameter by 0.47 mm) in 0.9-mm thick aluminum interconnect line. Inset illustrates how detached spall occurred from under the crater. SEM/EDX indicated a steel debris impactor.

0.47-mm deep crater in the manifold hard line (Fig. 6). The aluminum external hard lines are 0.9-mm (0.035 in.) thick in the impacted region. From hypervelocity impact data, the crater depth-to-wall thickness ratio of 0.52 indicated that spall effects were likely on the inside of the line at the point of impact. A borescope inspection of the line interior was conducted to assess internal damage and a small area of detached spall was found on the inside of the tube under the impact site. This indicates that the impact very nearly put a hole in the external manifold that would have caused a leak of freon cool-

ant, potentially shortening the mission. Flight rules dictate that a leak in one of the Orbiter’s two radiator systems will result in early mission termination. The Orbiter Project Office determined that an upgrade to the meteoroid/debris protection of the radiator external lines was needed, and additional two-ply β -cloth sleeves were installed on all external radiator lines. Samples obtained for SEM/EDX analysis included the perforated β cloth thermal cover and tape pull samples from the external line. Analysis found iron (Fe), chromium (Cr), and nickel (Ni) on the β cloth (teflon–glass background) and in the external line samples, indicating the damage was caused by a stainless steel orbital debris particle (approximately 0.4-mm diameter as indicated in Table 1).

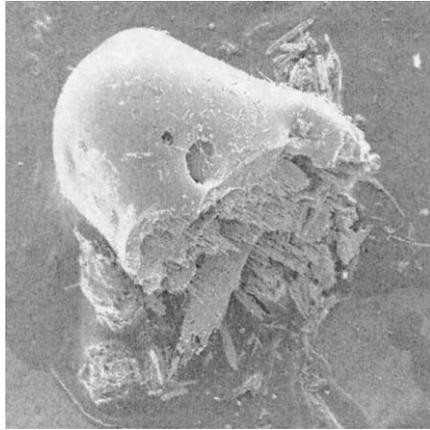
The largest confirmed orbital debris impact was from an estimated 1-mm diameter by 3-mm long piece of lead–tin solder which was recovered in a 17-mm diameter cavity in the fibrous insulation material (FRSI) used on the exterior of the port side payload bay door (Fig. 7). STS-73 was the mission that used a partially closed payload bay door as a “bumper” shield to protect the radiator, SpaceLab, and cryogenic oxygen/hydrogen tanks within the EDO pallet. The semi-closed payload door proved to be an effective shield. Post-flight analysis indicates the impacting particle had a trajectory that intersected the LO₂ and LH₂ tanks contained on the EDO pallet. Had the door not been positioned in the debris protect orientation, this particular impact (3 mm × 1 mm lead–tin solder particle) could have easily penetrated the lightweight thermal blanket surrounding the EDO pallet and damaged or ruptured a pressurized LO₂/LH₂ tank.

Fig. 7. SEM image of 1.5 mm × 1 mm × 1 mm lead/tin particle extracted from STS-73 FRSI impact crater. From its morphology and structure, this grain appears to be a piece of solder with small amounts of electric circuit board attached at an end. The fibers in the circuit board contain silicon and calcium with minor aluminum present.
