Analyzing and Solving Stability Problems during the Commissioning of the Steam Turbine

Klodian Gumeni

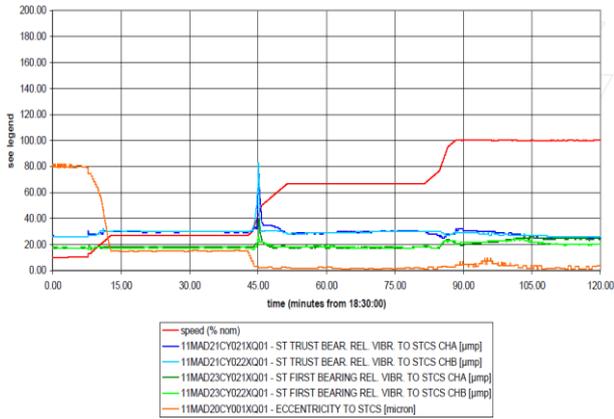
Figure 1. Cold start trends

- a) acceptable vibration behaviour during startups: the maximum vibration is recorded at bearing MAD21 at the 1st critical speed of the steam turbine and it is about 80-85 μm , 0-p (relative vibration of rotating parts: alarm set at 75 μm 0-p). Significantly lower vibration levels at bearing MAD 23.
- b) no differences during the cold or hot startup [4].
- c) good vibration behaviour during shut down, with a max vibration level of about 45 μm 0-p at bearing MAD 21.
- d) good vibration behaviour at load: about 31 μm 0-p at brg. MAD21, about 20 μm 0-p at brg. MAD23. Both values refer to rotating parts.
- e) low vibration levels, both during speed transients and at load, for both bearings on stationary parts.

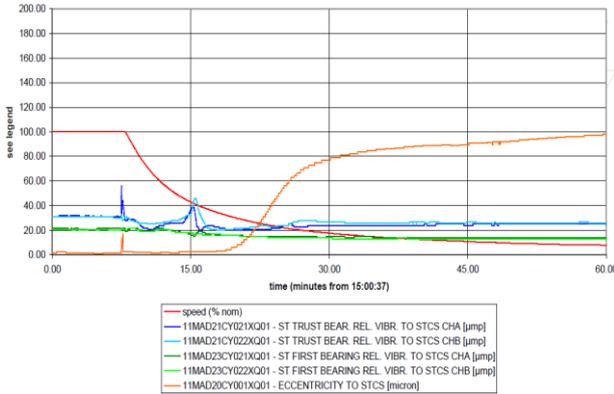
Figure 2. Shut down from base load

Usually the vibration behaviour is rougher during runs down than runs up, because speed gradients through critical speeds cannot be controlled during shutdown and therefore the speed gradient is lower, allowing vibrations to develop at critical speeds. A bearing reaching and passing alarm level during speed transient can be accepted if vibration levels at load are good. No accepted common vibration standard requires vibration below alarm level during speed transients.

As a matter of fact the vibration behaviour of the steam turbine after the correction activity was reasonably good. In particular during the rundowns, no vibration increase was observed at all or related to rubs as previously occurred.

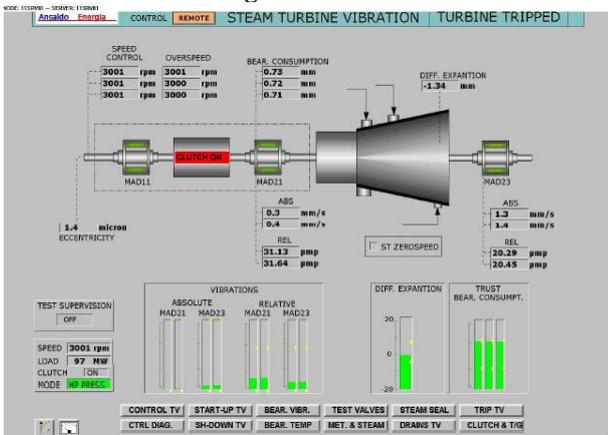
Figure 4. Print screen of operation at load (clutch engaged)

At load the vibration behaviour of the steam turbine can be classified as just within class A of ISO 7919-2 (A/B boundary 80 μm pp per ISO 7919-2) [5].

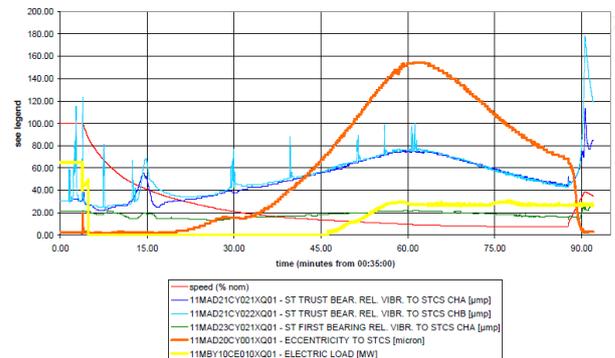
Figure 5. Trip and 1st restart

A steam turbine trip occurred due to high vibration of brg. MAD21 (MAD21CY22 sensor).

It was quite immediately clear that the high vibration was due to a spike occurred at sensor MAD21CY11 (relative vibration, rotating part) of brg MAD21. Analyses carried out on the data provided by site confirmed the initial findings:

- No vibration occurred at sensor A of brg. MAD21, neither to brg MAD23
- No vibration increases occurred on stationary parts

Other spikes were recorded before and after the trip at the same sensor. Checks carried out later on the signals and sensors indicated a probe converter faulty for the relative vibration measurement of brg. MAD21 sensor A.

A restart of the steam turbine, after about 1 ½ hour from the trip, was carried out but a trip occurred at about 1100 rpm, for high vibration at brg. MAD21.

Analysis of the data provided shows a quite uncommon behavior of bearing MAD21 vibration (at both sensors A and B) during run down, i.e a significant vibration level increase during run down with a maximum of 75 µm about one hour after the trip with the steam turbine at about 300 rpm. This is a very high and uncommon vibration level for such a low rotating speed [7]. Later the vibration behaviour trends tend to decrease, but at the moment of the 1st (aborted) restart still higher than the value that (looking at the data of other run down and start up) can be considered typical for the unit [3]. Also the eccentricity reading, compared with readings of other run downs and run ups, indicates an uncommon behaviour (increase up to 155 µm about one hour after the trip, against usual values of 80-100 µm) [4].

It is quite clear that the high vibration levels at the restarts are related to a temporary bowed rotor.

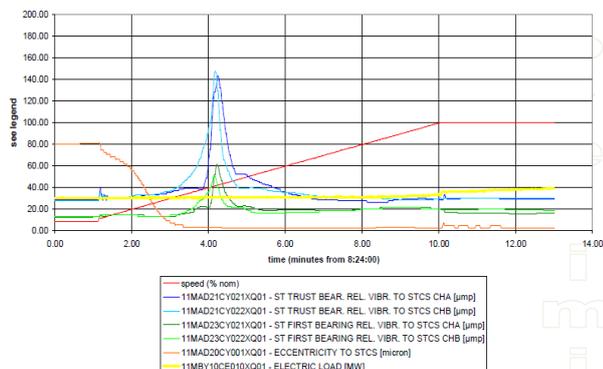
Figure 6. 3rd (hot) restart after two trips

Finally the unit was restarted about eight hours after the trip and full speed was reached, in spite of quite high vibration at brg. MAD21 (above 140 µm 0-p with a readjusted trip limit of 125 µm 0-p plus a delay of the trip of 1,5 seconds) [6].

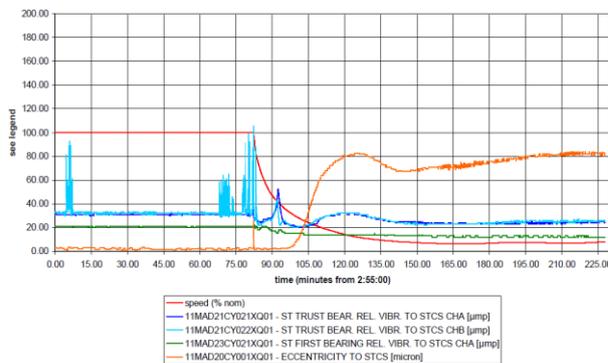
Figure 7. Trip of ST during shut down

A further trip due to brg. MAD21 relative vibration (probe CY22) spikes occurred during run down of the ST. Vibrations during run down were quite low, some increase of vibration level at brg. MAD21 as well as of the eccentricity occurred again but with levels significantly lower than the previous observed.

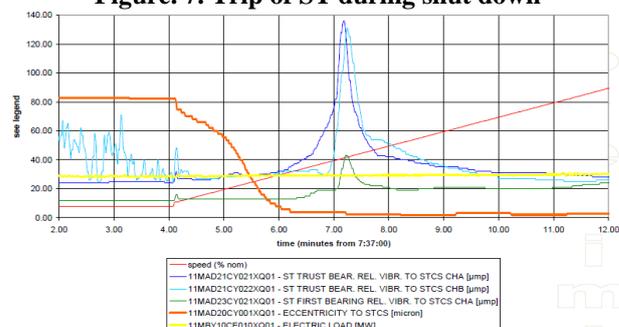
Figure 8. Hot restart of ST

The steam turbine was restarted about 3 ½ hours after the trip and full speed was reached with relatively high vibrations at brg. MAD21 at the critical speed (about 135 µm 0-p)

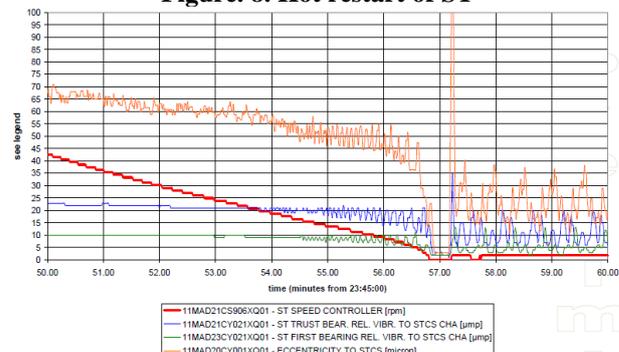
Figure 9. Trip of ST (eccentricity on turning gear)

Then a further trip occurred on the power Station (not related to steam turbine). Vibration behaviour was good during run down, 65 µm 0-p at brg. MAD21 passing through critical speed. No increase of vibration at low speed were observed and the eccentricity was “normal”.

The data of this trip, provide also a better understanding of the eccentricity reading, with the unit on turning gear. The p-p eccentricity (i.e. the so called TIR) is slightly less than 30 µm. Operation of the steam turbine during a few events was monitored too. In particular a startup, a shutdown and a trip were analyzed.

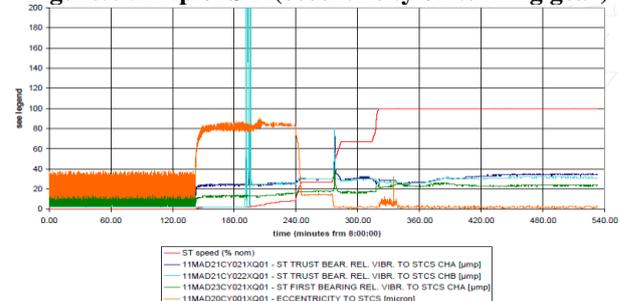
Figure 10. Startup of ST, cold condition

During the startup (a cold one), vibrations level were relatively low also at critical speed (< of 80 µm 0-p). Vibration levels at load were to acceptable values and the operation of the ST was stable.

It is also worth of note that the eccentricity before startup (with the steam turbine on turning gear) was about 30 µm pp and reached a reading of 80 – 90 µm with the steam turbine revolving at a couple of hundreds of rpm.

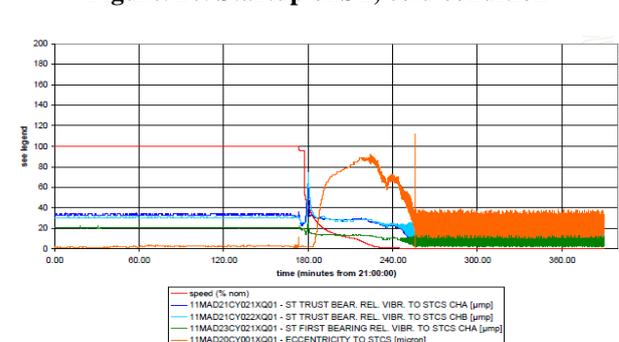
Figure 11. Emergency shutdown

During the shutdown, vibrations at critical speed were quite similar to them on start up. No significant increase of vibration at low speed, eccentricity behaviour “regular” with usual 30 µm on turning gear.

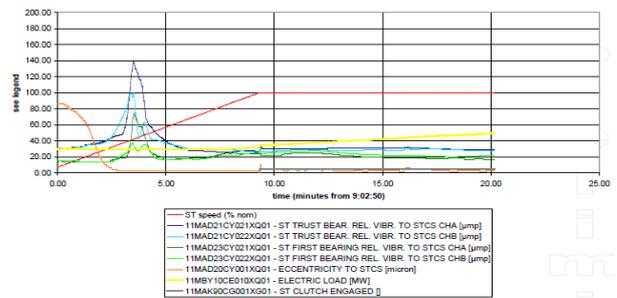
Figure 13. Startup of ST, cold condition

Vibration up to 140 μm 0-p at MAD21 brg. were observed during the startup in cold condition. This vibration level is about twice the vibration observed during the previous cold startup, but at the same level of other hot starts.

At load, the vibrations are at the usual levels (30 μm 0-p for brg.MAD21, 20 μm 0-p for brg. MAD23)

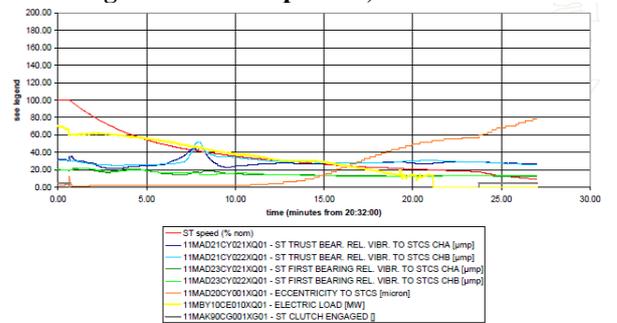
Figure 14. Shutdown of ST

The shutdown of ST was with low vibrations at brg. MAD21 (just above 50 μm 0-p), there were no significant vibration at low speed, eccentricity initially regular with some increase after turning gear engagement at low speed (max value from the data available 100 μm).

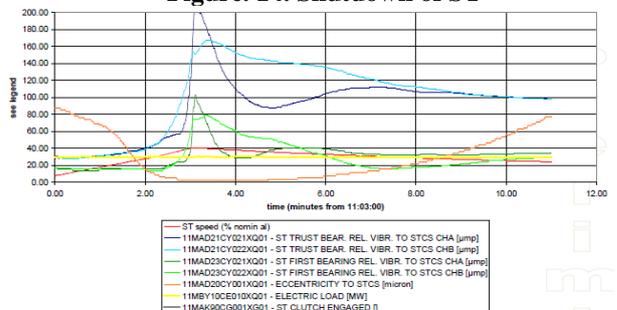
Figure 15. Failed startup, warm condition

At the restart of ST in warm condition, 15 hours after the trip, the vibration increased soon to high levels causing the trip of the unit. The vibration levels just before the trip were within normal values as well as the eccentricity.

- 7) The vibration levels reached during the failed startup, were unusually high. The causes cannot be defined from the data collected.
- 8) Deepest analysis of vibration behavior (including vibration phases, etc) were necessary and should be carried out to find out the root causes of the high vibration levels occurring during the hot startups. This should be done using data collected with TVA system (both recorded or of new startups and shutdowns) or with other advanced methods directly on site

- 11) In order to avoid the ST trip during the hot starts, due to high vibration three corrective actions were recommended. To increase the threshold and time delay of trip for relative vibrations and to increase the gradient of the speed near the critical velocity.
