# How to ensure better consideration and mitigation of the shrinkage–swelling risk of clays?

Steve Gruslin\*, Tiffany Hennebaut and Mattia Tirone

The studied case is a single-family building affected by differential settlement in the south of Luxembourg.

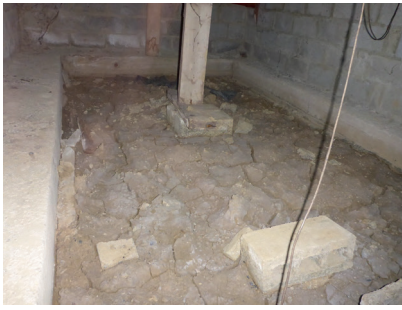
Figure 5: Desiccation crack inside a ventilated void of a house without a basement. The clays are totally dry on the inside, but their water content continues to vary on the outside, causing differential settlement and the appearance of cracks.

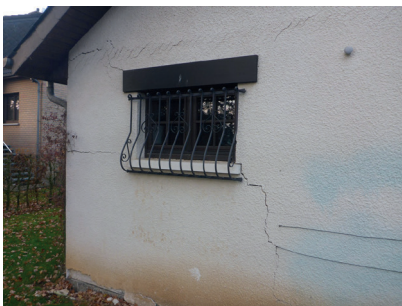
Figure 6: Cracks typical of a shrinkage-swelling phenomenon.

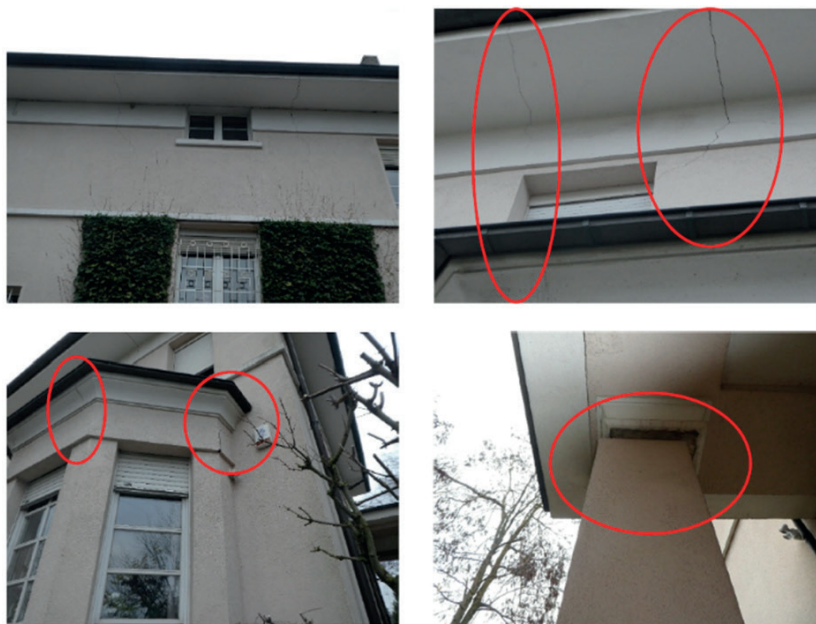
Figure 10: Cracks in the walls and rotation of the entrance pillar.

The current owner has occupied the building during the last 20 years. During this time, microcracks were noticed but their size did not affect the aesthetics and structure of the building. From March 2018, the magnitude and diffusion of the cracks suddenly increased, especially on the south-southwest side (*Figure 10*). The crack patterns show a rotation of the building in the south-west direction. Due to its relatively low weight and a higher foundation level, the entrance suffered major rotations, as visible in *Figure 10*.

The analysis of the behaviour of the cracks from the crackmeter measurements and the data collected in the geotechnical investigations led to the conclusion that the phenomenon was indeed linked to the shrinkage–swelling of the clays situated at the level of the foundations. The significant evolution and formation of cracks that took place during the year 2018 could be explained partially by the diminishing water balance that characterised the preceding period. Furthermore, the presence of dense vegetation and large trees along the house and the property limits accentuated the problem. Other factors could have been the south-west exposition of the damaged part of the house, which was more subject to the drying process and the downspout malfunction.

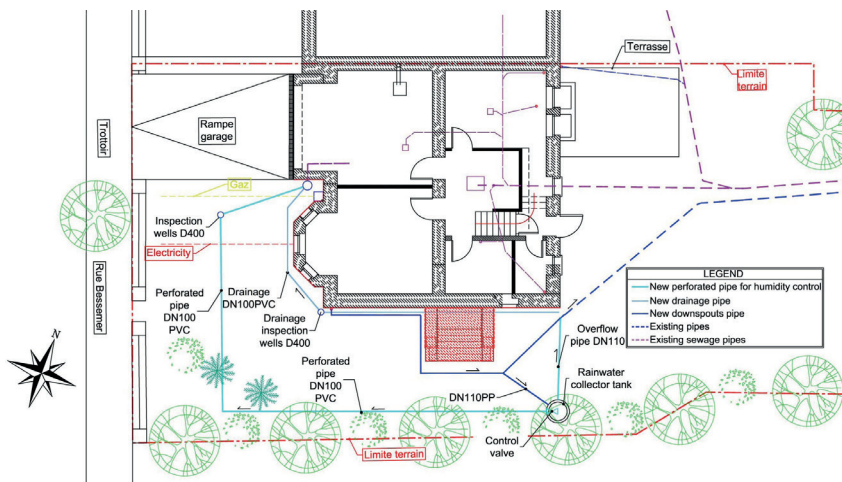
Figure 12: Project plan overview.

The main measure was the installation of a DN100PVC perforated pipe along the west and south sides at approximately 4.50 m away from the house foundations. The installation depth was set at -2.70 m, on

The entrance was founded on a more superficial layer (-2.40 m), was thus more sensitive to the shrinkage–swelling phenomenon, as more superficial soil is more affected by variations in the moisture content due to seasonal effects. Consequently, the entrance was demolished and rebuilt with a new foundation at the same level as the building. The project overview is highlighted in *Figures 12 and 13*. Some photos of the intervention are shown in *Figure 14*.

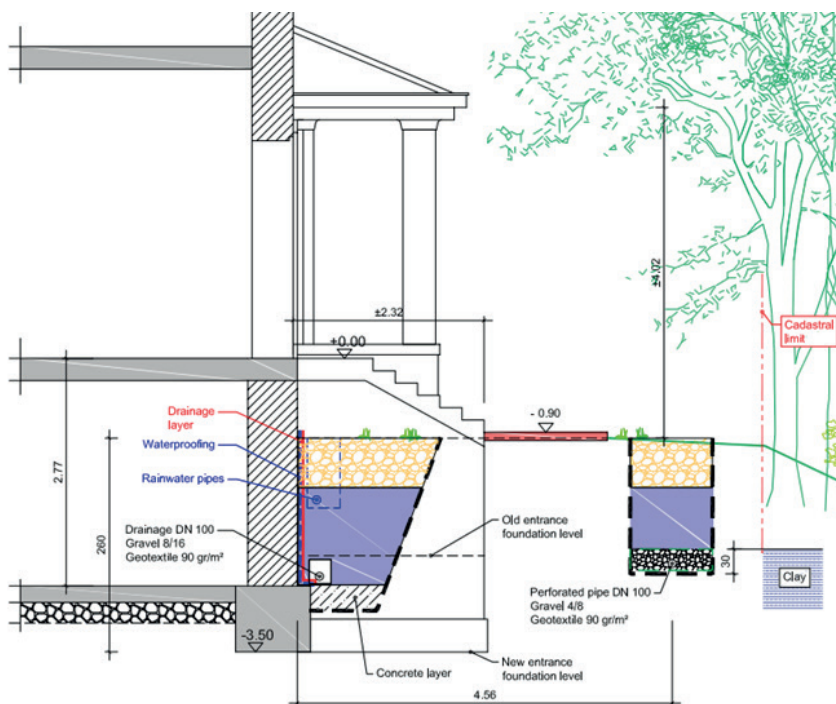
Figure 13: Project section view.

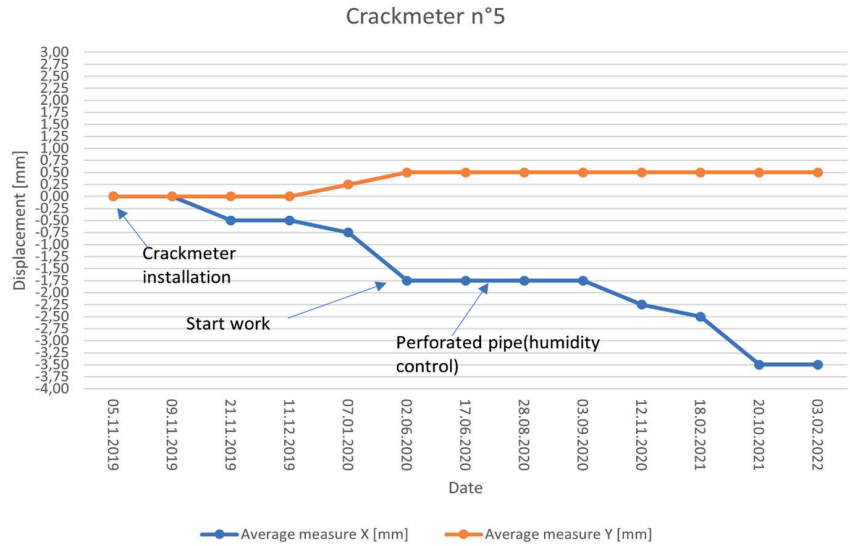
The crackmeters were monitored during and after the stabilisation works. Figure 15 shows the evolution during the months following the intervention of the most critical crackmeter (No. 5), located at the south-west corner of the building (the most damaged part).

The analysis of the data shows the cracks started closing right after the crackmeter installation (November 2019). This is probably due to a seasonal effect. The perforated pipe for soil moisture control was operational from the end of July 2020. *Figures 15-17* show that between autumn 2020 and February 2022 the crack size has been generally decreasing. Crackmeter No. 1 is less impacted due to its location at the north-east side of the construction, which was less damaged.

Figure 15: Measurements from crackmeter No. 5 (Nov. 2019 to Feb. 2022).
