ENVIRONMENTAL EFFECTS, CAUSED BY THE M_s 6.7, M_b 6.9, NOVEMBER 19th, 1912, ACAMBAY EARTHQUAKE, MEXICO

Reassessment of intensity and macroseismic field with the ESI-07 scale

ACAMBAY EARTHQUAKE

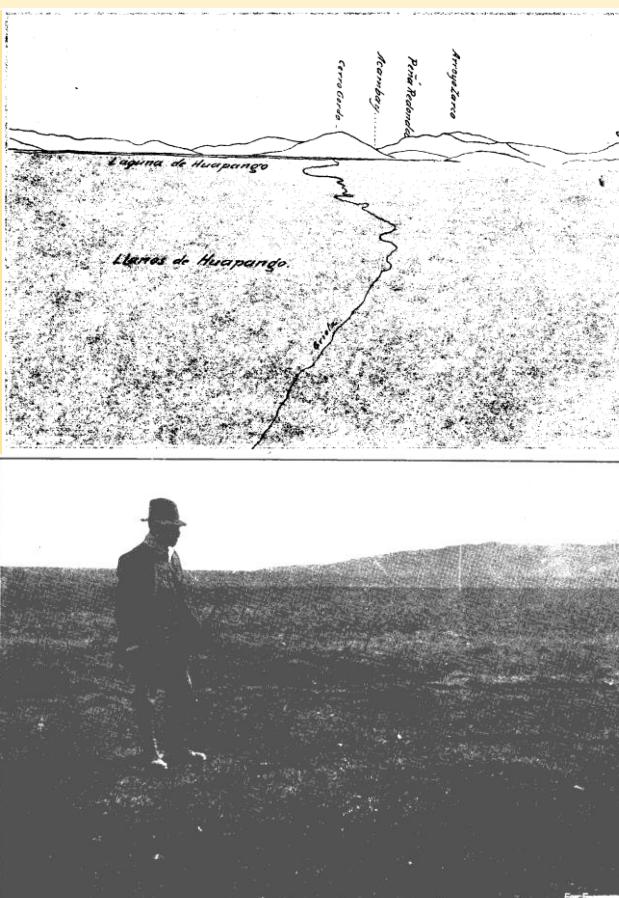
Site number	001
Latitude	2199870.73
Longitude	424178.73
Distance from epicenter	11.64 km
Locality	31-Huapango Valley I Rancho de "El Fresno"
Type of effect	Tectonic Surface rupture
Description	Starts with a width of 12 centimeters and unevenness of 5 centimeters towards the West, spanning a length of 75 meters; it changes its course in N. 12° W and with the same width for more than 20 meters, observing in this part an unevenness of 14 centimeters, revealed later by a system of several parallel cracks of approximately 3 meters equidistance.
ESI intensity	IX
Geomorphologic setting	It begins at the drainage line of the portion of the valley bounded to the north by the hills of Palos and El Pelón and to the south by those of Enitzí and Natejé of the Sierra de San Andrés Timilpan.
Photographic documentation

Fig. 22, plate XIV in Urbina and Camacho (1913). Branched part of the crack of the northern system, in the plain of Huapango, ranch of "El Fresno".

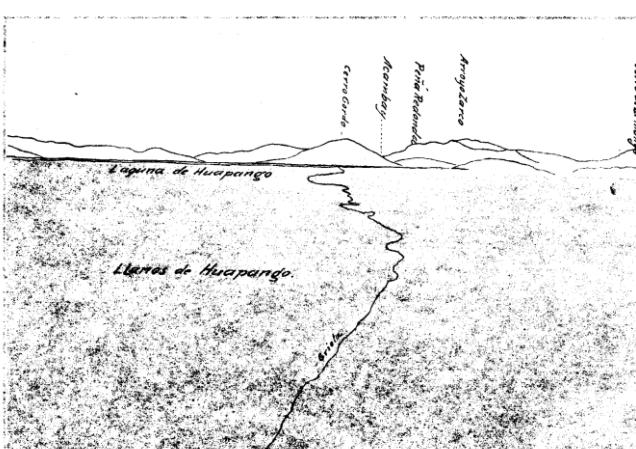
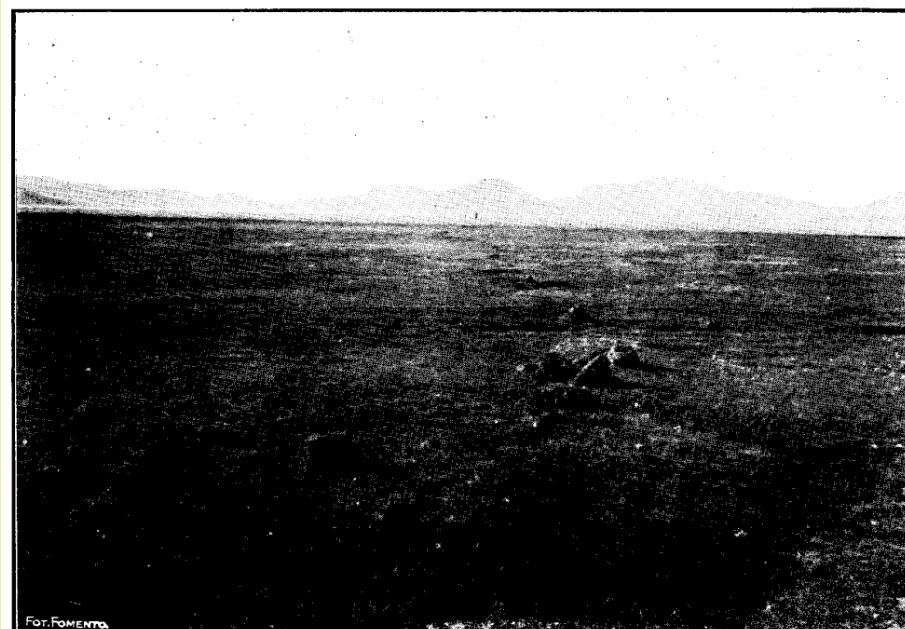
Site number	002
Latitude	2199852.50
Longitude	424137.54
Distance from epicenter	11.87 km
Locality	31-Huapango Valley II
Type of effect	Tectonic Surface rupture
Description	Vertical displacement of 3 cm and 6 cm width.
ESI intensity	VIII
Geomorphologic setting	This one begins to the N of the previous one, with direction N 21° W, parallel to the drainage line and later with a curved part of concavity towards Timilpan.
Photographic documentation

<p>FOT. FOMENTA.</p>
<p>Fig. 23.—Bordes saltados de la grieta y curso sinuoso de la misma en el mencionado llano de Huapango</p>	
sources	Urbina and Camacho, 1913.

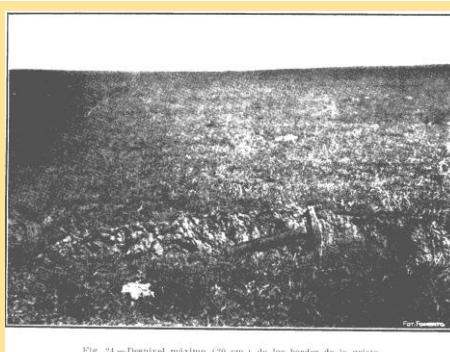
<p style="text-align: center;">Fig. 24.—Desnivel máximo (20 cm.) de los bordes de la grieta en el mismo llano de Huapango</p>

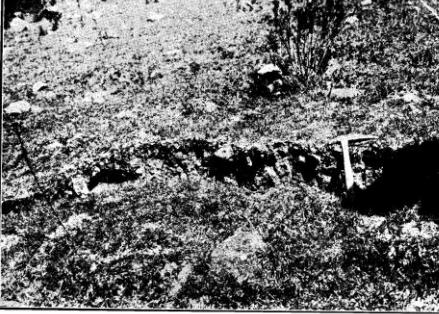
<p>Fig. 25.—Grieta en la ladera meridional del cerro de "La Joya," al N.W. de Acambay (sistema septentrional).</p> <p>Fig. 25. Crack on the southern slope of "La Joya" hill to the N.W. of Acambay (northern system).</p>

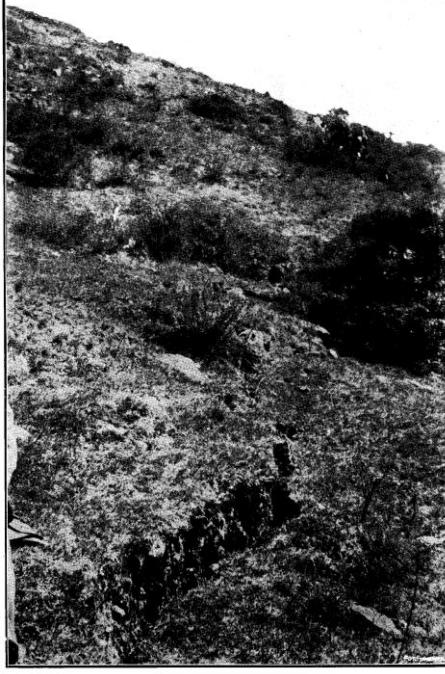
<p>Fig. 27.—La misma grieta de la fig. 25, tomada longitudinalmente para mostrar también la pendiente del terreno.</p>
sources	Urbina and Camacho, 1913.

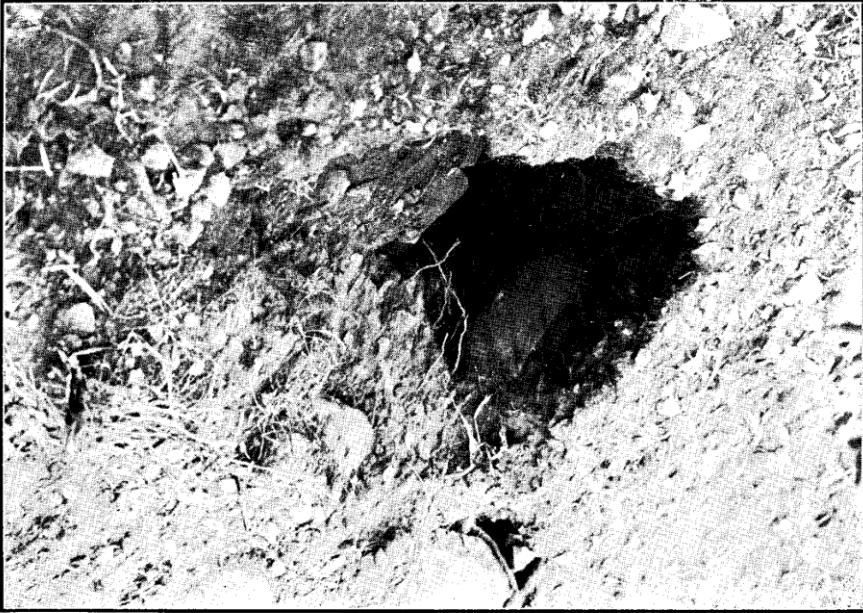
Site number	008
Latitude	2209635.75
Longitude	408941.00
Distance from epicenter	7.07 km
Locality	Peña de Huamango
Type of effect	Tectonic Surface rupture
Description	Crack 100 meters long and 6 centimeters wide, oriented S 10° E. This crack serves as a link with the general system. In a section, an oval-shaped hole was formed due to the effect of the earthquake, elongated from east to west, with an approximate area of one square meter, inclined and quite deep.
ESI intensity	X
Geomorphologic setting	The descent of the hill is steep (34° slope) and is covered by loose cultivated land.
Photographic documentation

<p>Fig. 29.—Hundimiento de terreno flojo, en fuerte pendiente, a consecuencia del temblor, situado al W. de la Peña de Huamango, cerca de un ramal de la grieta septentrional y donde nace un arroyo.</p> <p>“Fig. 29. Subsidence of loose ground, on a steep slope, as a result of the earthquake, located to the W of the Peña de Huamango, near a branch of the northern crack and where a stream is born.”</p>

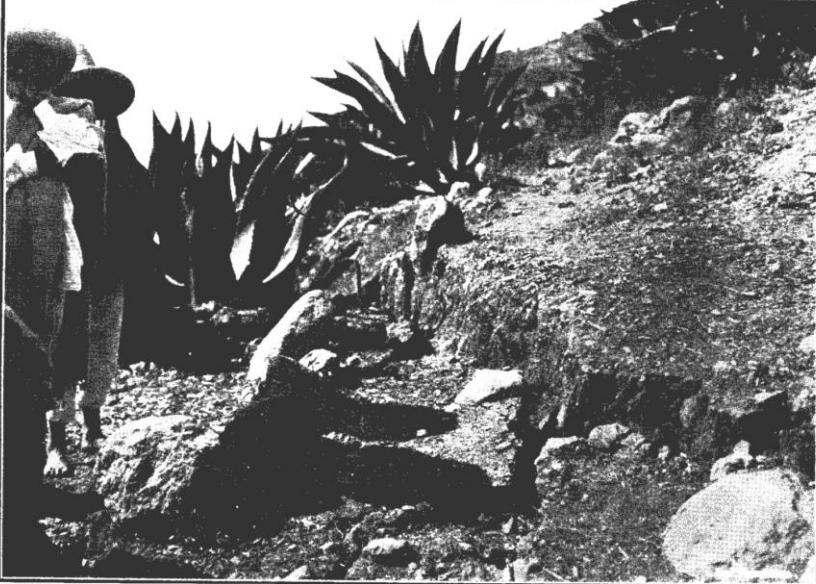
<p style="text-align: center;">Fig. 28.—La grieta del sistema septentrional que pasa por la falda meridional del cerro "Tixmadeje," la más cercana al pueblo del mismo nombre, con desnivel de 50 cm., en terreno inclinado 30°.</p> <p>Fig. 28. The crack of the northern system that passes through the southern slope of the "Tixmadejé" hill, the closest to the town of the same name, with a drop of 50 cm., on 30° inclined terrain.</p>

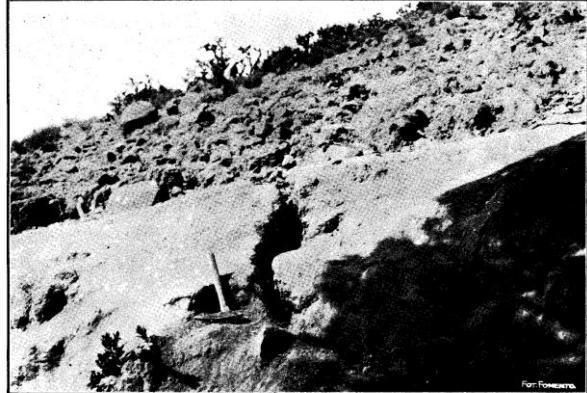
<p style="text-align: right;">FOT. FOMENTO.</p> <p>Fig. 30.—Aspecto de la grieta en la falda de Xidó, sobre el camino de Sotiles al Agostadero, perteneciente al sistema septentrional</p>

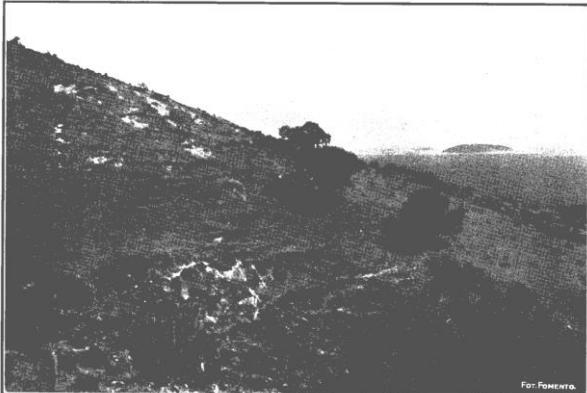
<p style="text-align: right;">FOT. FOMENTO.</p> <p>Fig. 31.—Curso de la misma grieta, fotografiado en el sentido longitudinal para mostrar la inclinación del terreno</p>

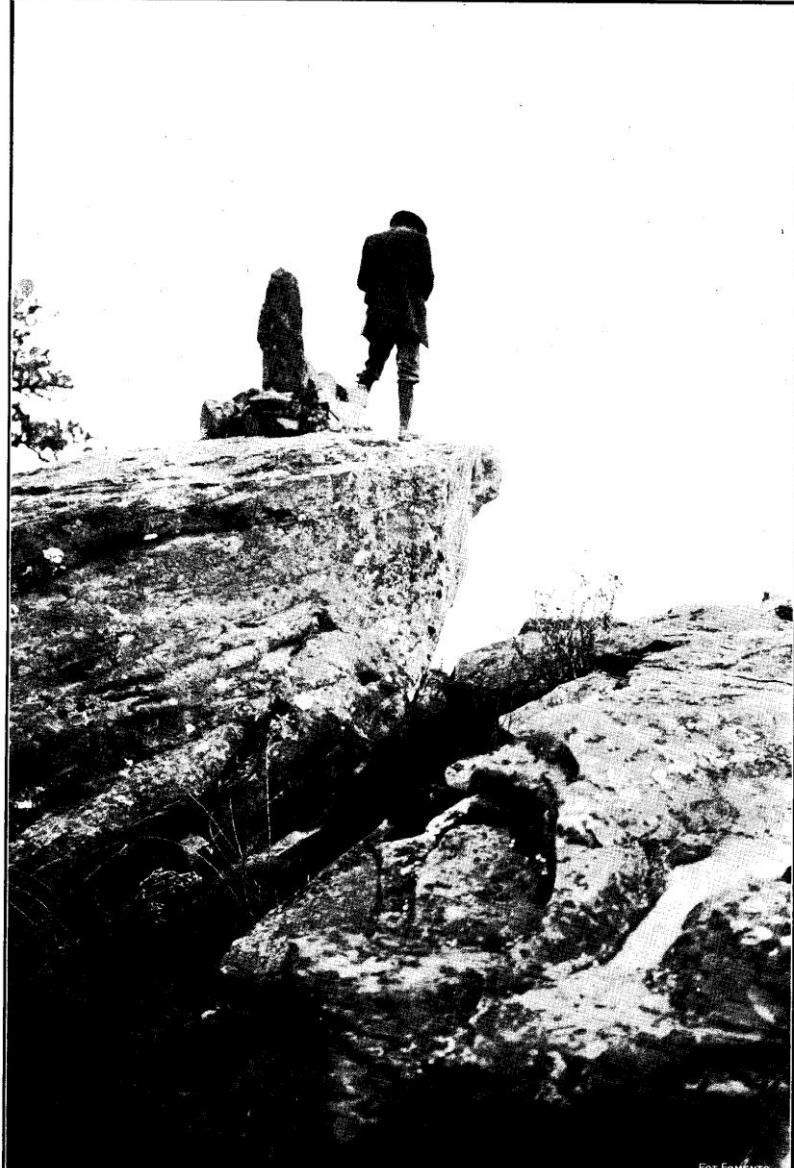
<p>Fig. 32.—Grieta del sistema central en la cima del cerro de "El Aguaje." Aparece en un afloramiento de andesita de hiperstena.</p> <p>Fig. 32. Crack in the central system at the top of "El Aguaje" hill. It appears in a block of hypersthene andesite.</p>	
sources	Urbina and Camacho, 1913

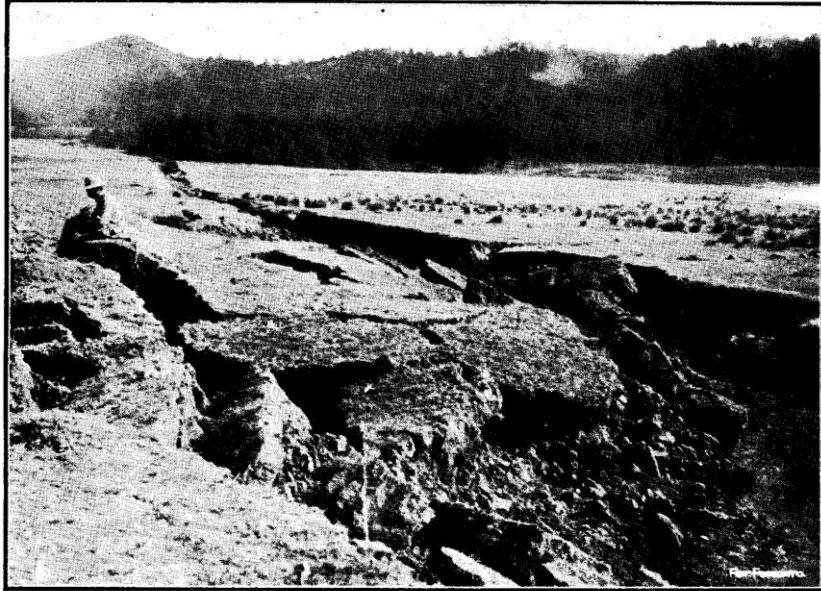
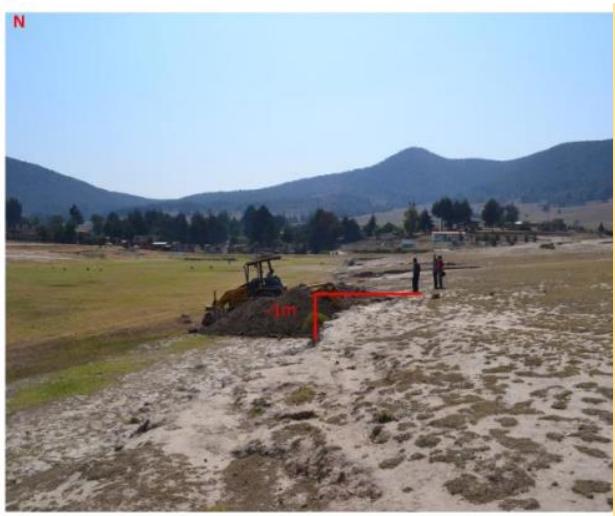
<p>Fig. 33.—Despedazamiento del terreno en el extremo de una grieta del sistema central, en el fondo del valle de San Pedro el Alto, cerca de la presa del mismo nombre.</p>

<p>Breaking up of the land at the end of a crack in the central system, at the bottom of the San Pedro El Alto valley, near the dam of the same name.</p>
sources	Urbina and Camacho, 1913

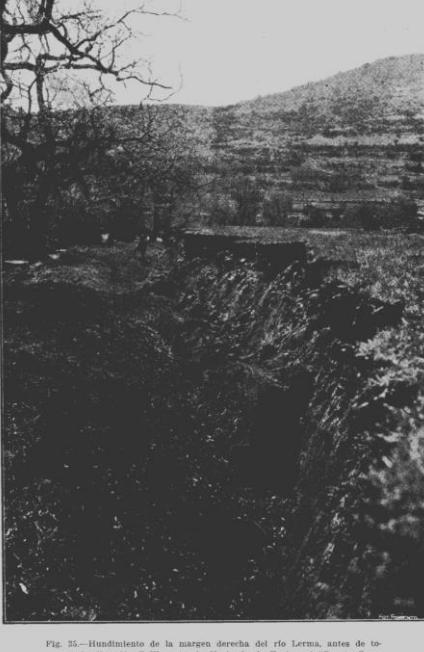
<p>Fig. 35.—Hundimiento de la margen derecha del río Lerma, antes de tomar la dirección E.-W., entre la Hacienda de Toxi y el "Puente Grande".</p> </div> <div style="text-align: center;">

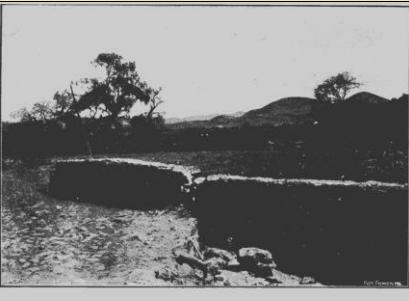
<p>Fig. 37.—Efecto del hundimiento mencionado sobre el "Puente Grande".</p> </div> <div style="text-align: center;">

<p>Fig. 37. Effect of the aforementioned sinking on the "Puente Grande"</p> <p>Fig. 38. Appearance of the subsidence e seen from the front, at its maximum unevenness.</p>

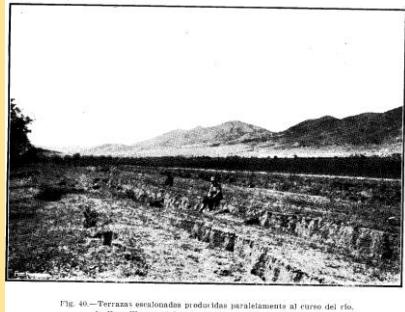
Fig. 40.—Terrazas escalonadas producidas paralelamente al curso del río, de E a W, por el hundimiento de la margen derecha

Fig. 40. Stepped terraces, produced parallel to the course of the river, from E to W by the subsidence of the right bank.

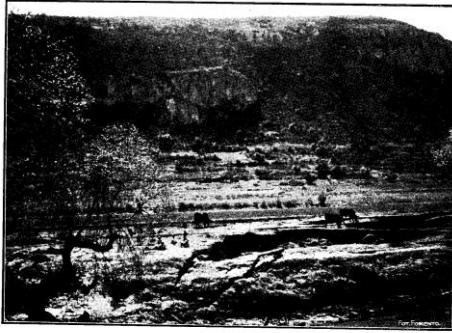
Fig. 41.—Agrrietamientos y hundimientos en la margen izquierda del mismo río, al pie y paralelamente a los acantilados del cerro de "El Batán."

Fig. 41. Cracks and subsidence on the left bank of the same river, at the foot and parallel to the cliffs of "El Batán" hill.

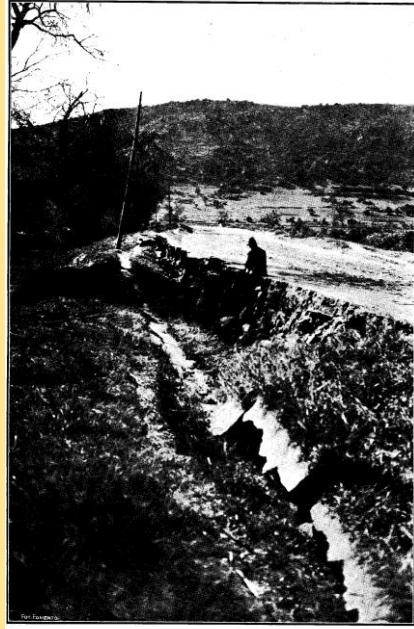
Fig. 42.—Agrrietamiento y hundimiento con derrumbe parcial de los bordes, producidos entre el borde del camino y la margen derecha del mismo río.

Fig. 42. Cracking and sinking with partial collapse of the edges, produced between the edge of the road and the right bank of the same river.

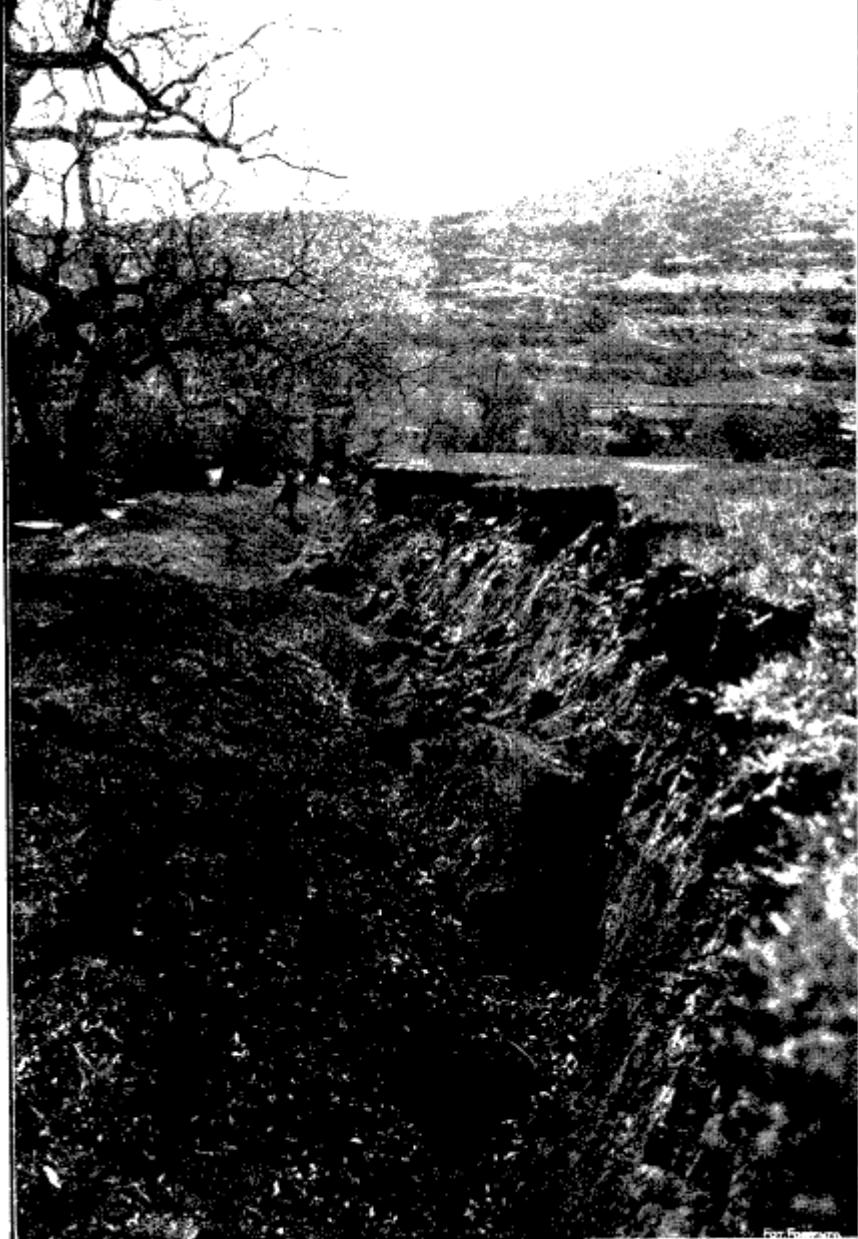
<p>Fig. 35 - Desplazamiento de la margen derecha del río Lerma, antes de tomar la dirección E-W, entre la Hacienda de Taxitl y el "Puente Grande."</p>

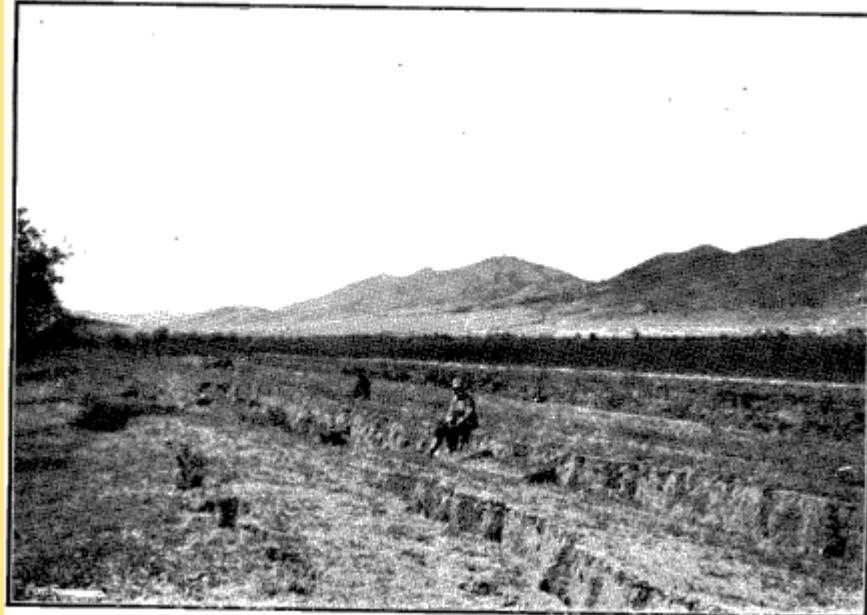
Fig. 40.—Terrazas escalonadas producidas paralelamente al curso del río, de E. a W. por el hundimiento de la margen derecha

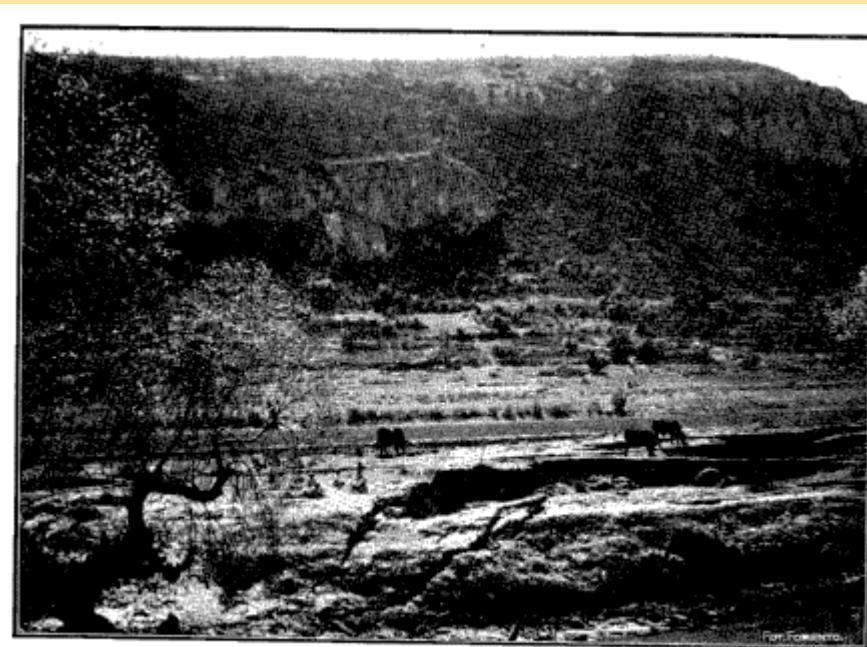
Fig. 41.—Agrietamientos y hundimientos en la margen izquierda del mismo río, al pie y paralelamente a los acantilados del cerro de "El Batán."

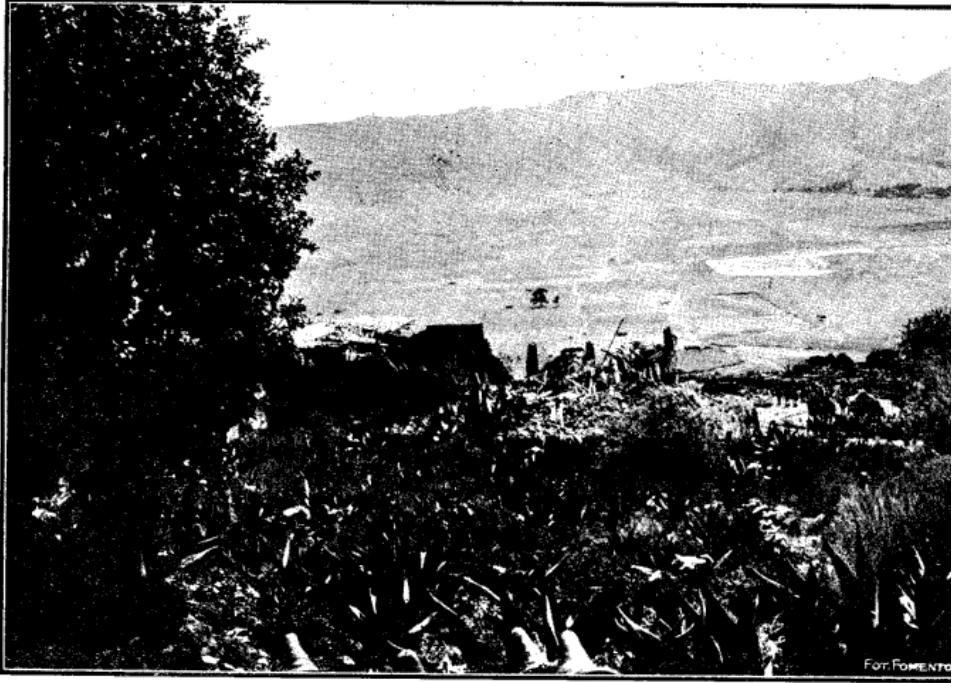
<p>FOT. FOMENTO</p> <p>Fig. 48.—Aspecto del núcleo del pueblo de Santa María Tixmadeje, destruido por el temblor, y atrio de la iglesia donde se encuentra el bloque que cayó de los acantilados del mismo cerro.</p>
sources	Urbina and Camacho, 1913

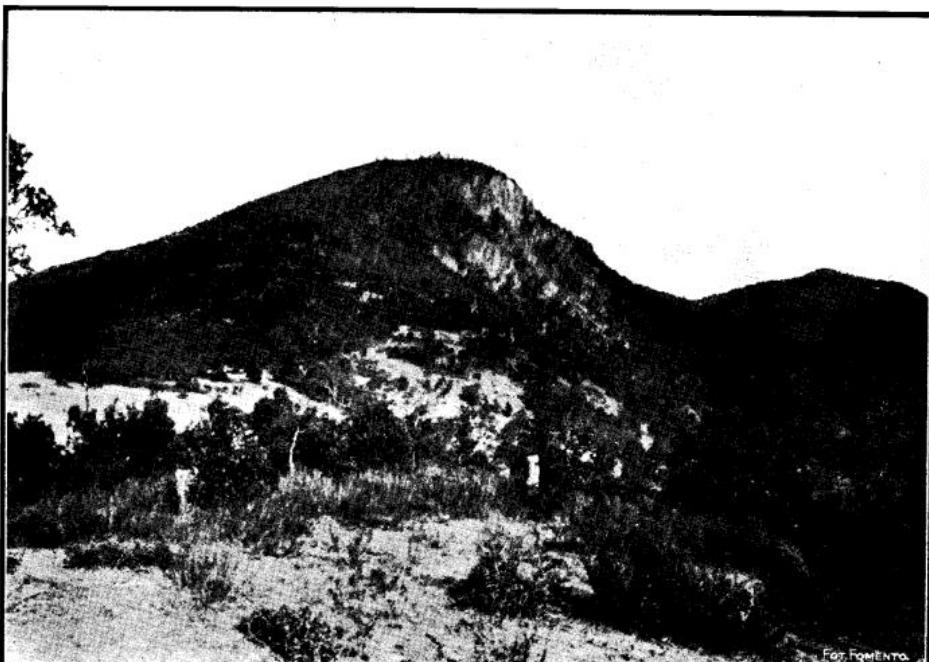
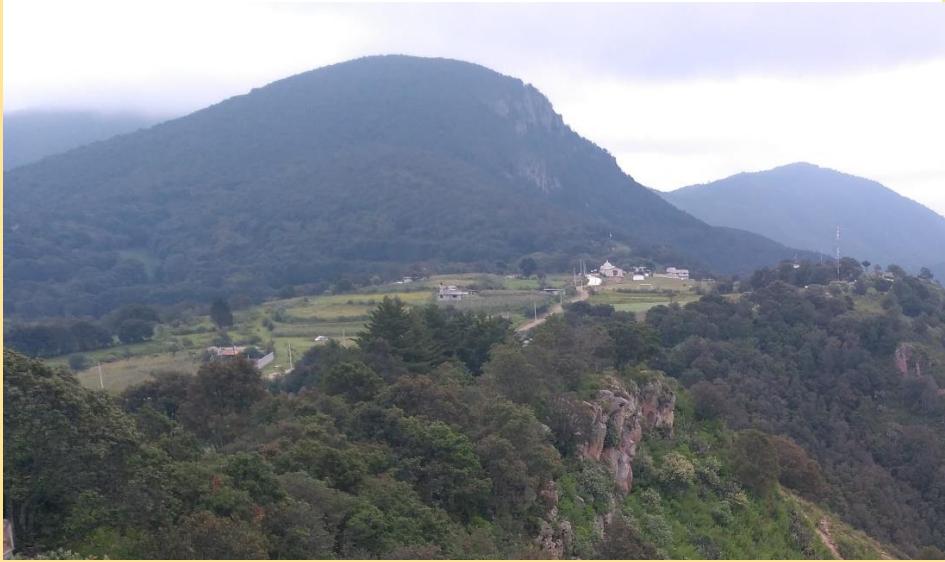
Site number	031
Latitude	2208999.25
Longitude	2208999.25
Distance from epicenter	5.08 km
Locality	Peña Larga
Type of effect	Landslide and Rockfall
Description	The face of the Peña Larga cliff (3150m), "a portion was divided in two due to movement, according to a fracture directed from east to west, and the boulder that remained to the north rotated approximately 30°, separating from the southern block. It is a hill, "its southern portion has almost disappeared". Estimated volume 100000 m ³ .
ESI intensity	IX
Geomorphologic setting	Landslide and Rockfall 230 m to SE (Labradorite).
Photographic documentation

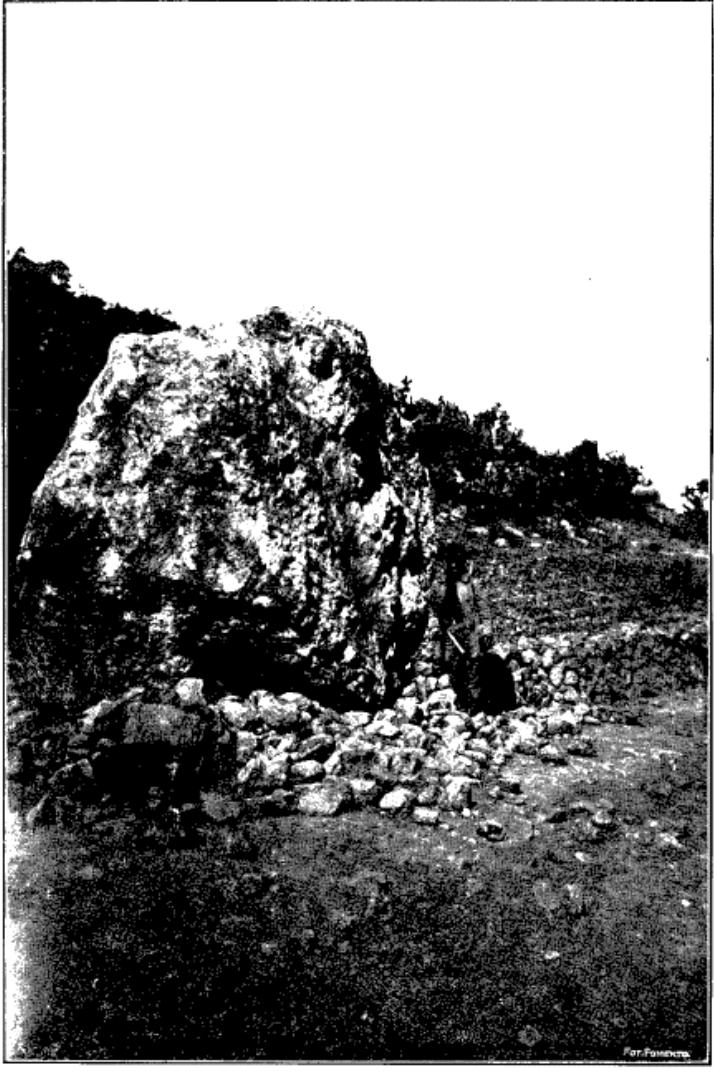
Site number	039
Latitude	2201494.00
Longitude	393424.10
Distance from epicenter	19.90
Locality	Cerro Temascalcingo (Baixté)
Type of effect	Rockfall
Description	Fall of 44 m ³ andesite block. The boulder came off the Baixté hill with a trajectory towards the N 45° E, stopping at the edge of the road from "Puente" to "Oro", cracking part of the road. The boulders came off the hill. The blocks, when detached and rolled, marked their passage with destruction of fencing and vegetation.
ESI intensity	VIII
Geomorphologic setting	Hills and steep cliffs.
Photographic documentation

Fig. 45- Gran bloques de andesita que cayó del cerro de Baixté justo al camino de "Puente" al "Oro," a consecuencia del temblor, causando pequeños agrietamientos en el suelo.

Fig. 45- Large block of andesite that fell from Cerro Baixté, next to the road from "Puente" to "Oro," as a result of the earthquake, causing small cracks in the ground.

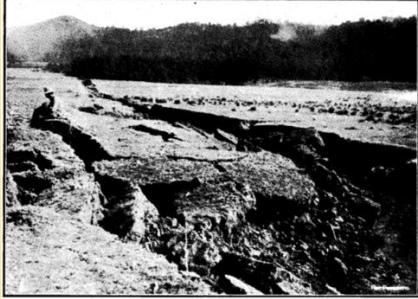
<p>FIG. 22.—Desplazamiento del terreno en el extremo de una grieta del sistema central, en el fondo del valle de San Pedro el Alto, cerca de la presa del mismo nombre.</p>

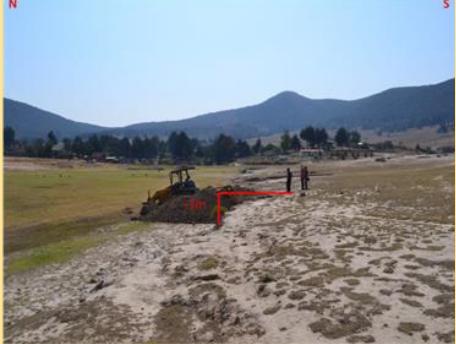
<p>Escarpment on the Temascalcingo fault, southern edge of the San Pedro El Alto dam. a) Effect caused by the Acambay earthquake of 1912 (Urbina and Camacho, 1913). b) Current escarpment (2015) in the same place described by Urbina and Camacho (1913)</p>

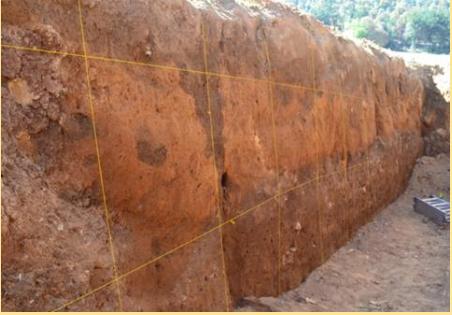
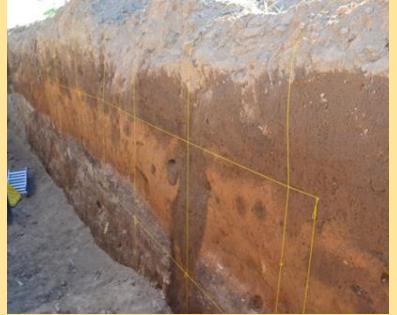
Site number	050
Latitude	2200207
Longitude	400032
Distance from epicenter	13.64 km
Locality	San Pedro El Alto (Trench 2)
Type of effect	Surface faulting
Description	15 cm vertical displacement. Trench opened in the flat part of the bottom of the valley of San Pedro El Alto, at the site reported by Urbina and Camacho (1913) as a flat place where a 50 cm wide crack was opened towards the valley of the dam.
ESI intensity	IX
Geomorphologic setting	This place is located in the San Pedro Valley, near the old dam. It corresponds to a volcanic-lacustrine sequence.
Photographic documentation

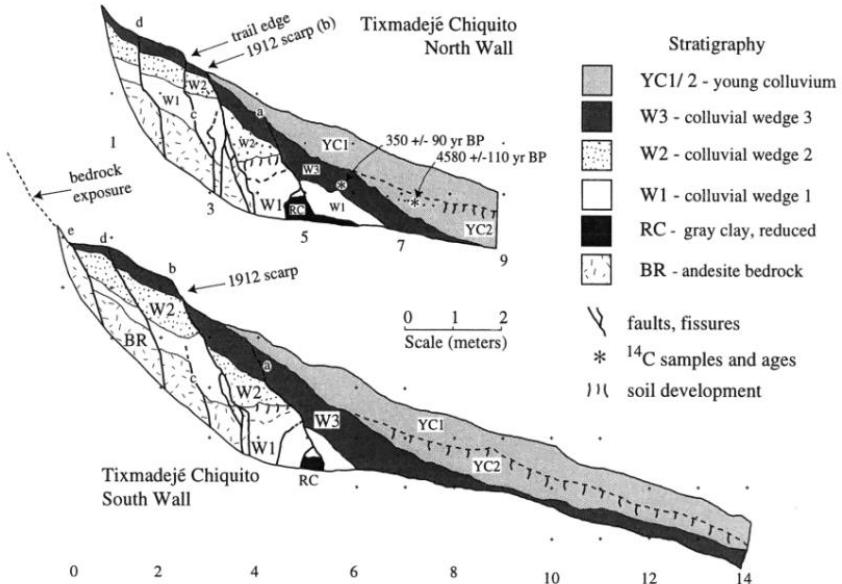
Site number	051
Latitude	2209871.33
Longitude	406372.72
Distance from epicenter	9.03 km
Locality	Tixmadejé Chiquito
Type of effect	Surface faulting
Description	Landgridge et al. (2000) propose that this segment is part of the main structure that broke in the 1912 earthquake. The trenching analysis indicates that the observed scarp is associated with a subvertical fault, cutting through trench deposits and displacing bedrock at the trench bottom. The displacement measures are 46 cm on the north wall of the trench and 58 cm on the south wall.
ESI intensity	X
Geomorphologic setting	Close to the slope break, the trench was dug into a steep escarpment-shaped area, altered by a pathway along its base. This hand-excavated trench at Tixmadejé Chiquito is positioned within a topographic transition, signifying the change from weathered andesitic bedrock to colluvium.
Photographic documentation

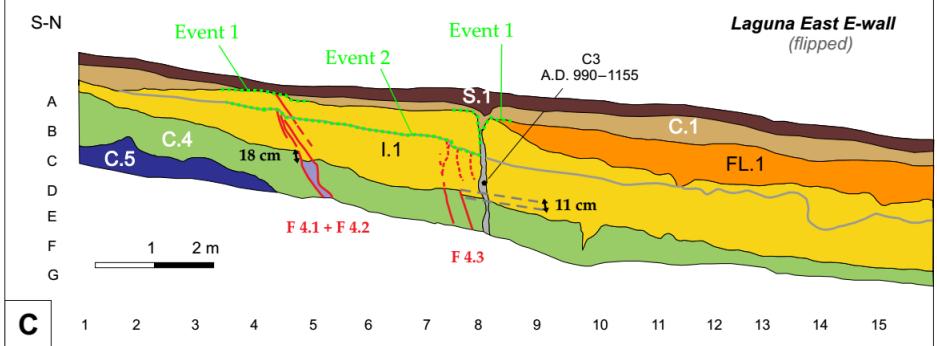
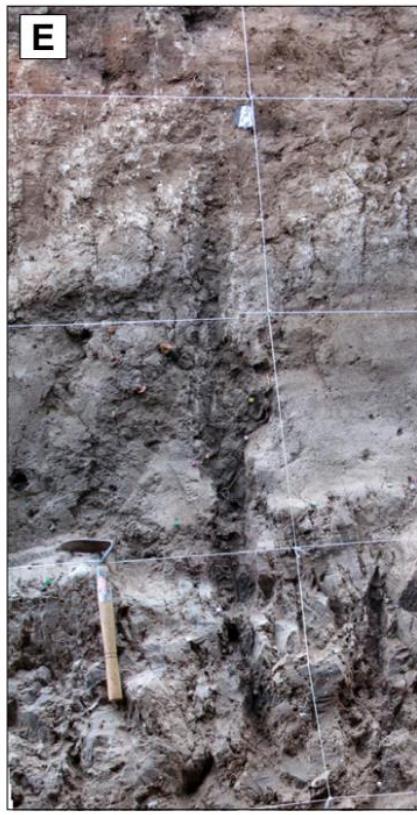
Site number	054
Latitude	2198183
Longitude	388882
Distance from epicenter	24 km
Locality	Laguna Bañi
Type of effect	Ground crack
Description	Fracture parallel to the fault, 26 cm wide, identified in one of the walls of an excavated trench. The fracture is possibly younger than the sediments that fill it.
ESI intensity	VIII
Geomorphologic setting	The site is located in an area of sag pond created by the fault, where the Bañi Lagoon could have formed.
Photographic documentation

<p>The diagram illustrates a trench log for the 'Laguna East E-wall (flipped)'. The vertical axis on the left lists layers A through G. Layer A is brown, B is light green, C is dark blue, D is grey, E is light green, F is yellow, and G is brown. A fracture labeled 'Event 1' is shown in layer A, dipping downwards. Another fracture labeled 'Event 2' is shown in layer B. A scale bar indicates 1 m and 2 m. A horizontal axis at the bottom is marked from 1 to 15. A note states: "Event 1" in the trench log represents the fracture that most likely was generated during the 1912 Acambay earthquake.</p>
