*A paper to be presented at the Charlotte meeting
of the American Institute of Electrical Engineers,
March 30-April 1, 1910.*

A PRACTICAL METHOD OF PROTECTING INSULATORS FROM LIGHTNING AND POWER ARC EFFECTS

BY L. C. NICHOLSON

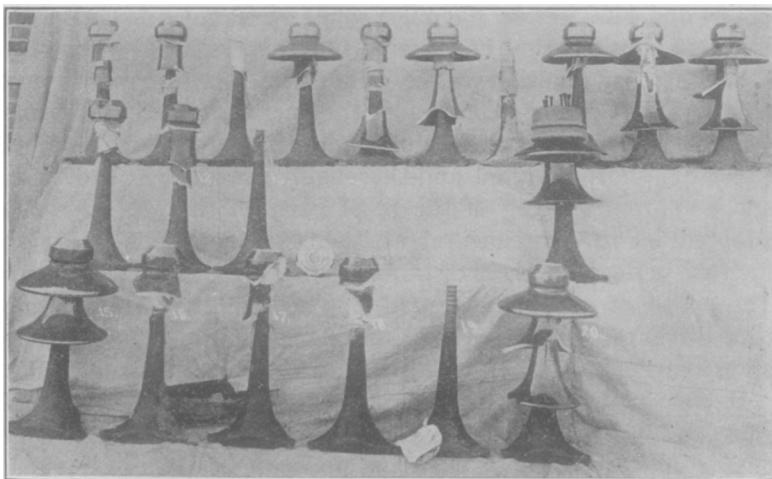
Fig. 6 shows a collection of twenty derelicts, resulting from a single severe storm, and gives a fair representation of how insulators are destroyed by lightning in combination with high-power effects.

FIG. 6.—Insulators removed from the line after damage by lightning and power effects

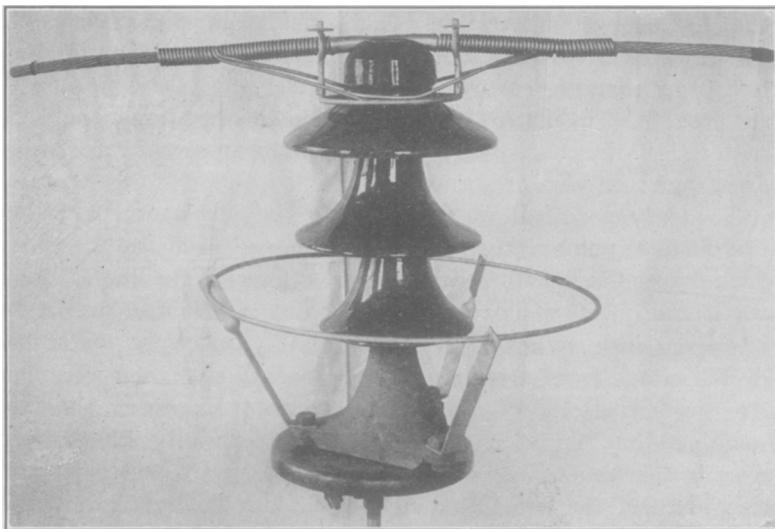
FIG. 7.—Arcing rings, to prevent injury to insulators by power effects

A device for rendering insulators fire-proof, or rather proof against injury by power arc in the event of a flash-over, was developed to meet an obvious need. As shown by Fig. 7, this device consists of two metal rings concentric with the insulator, a lower one which is situated near the base being considerably larger in diameter than the insulator parts, and supported by grounded metal risers attached to the pin; and an upper one somewhat larger than the neck of the insulator, just opposite the tie-wire, suspended from the transmission cable, and electrically connected to it. Details of construction are evident from the figures.

These rings serve as electrodes, to which the power arc automatically transfers immediately after its formation between

the tie-wire and pin, over the surface of the insulator. When holding between these rings, the arc is removed sufficiently from the insulator to prevent injury to the porcelain by heat.

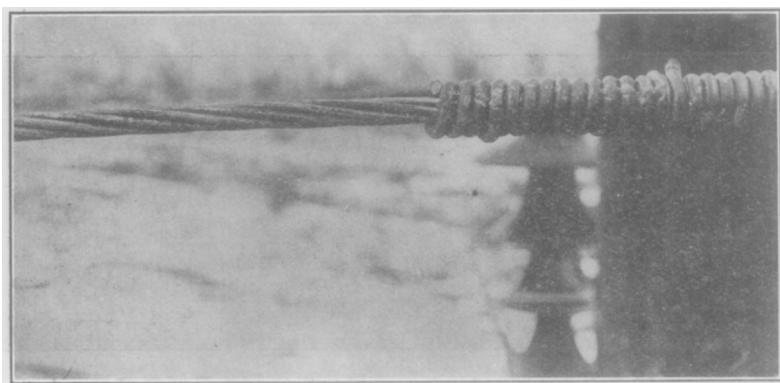
FIG. 9.—214,000 cir. mils aluminum cable burned by three applications of a 1200-ampere arc

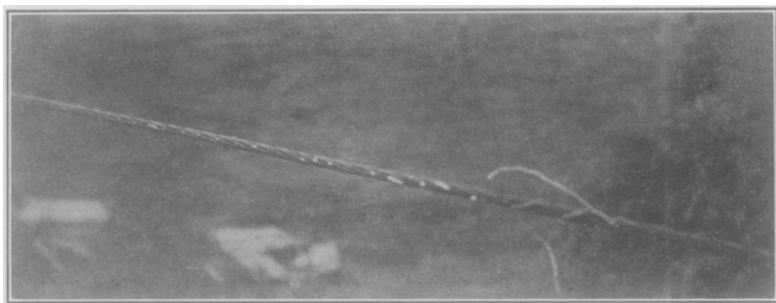
are not more exposed to burning with arcing rings than without them, and in neither case is the burning at all serious. Fig. 10 shows a section of cable blistered in service by a short-circuit arc from a generating capacity of approximately 60,000 kw.

FIG. 10.—214,000 cir. mils aluminum cable burned in service by a short-circuit arc from six 10,000-kw. generators

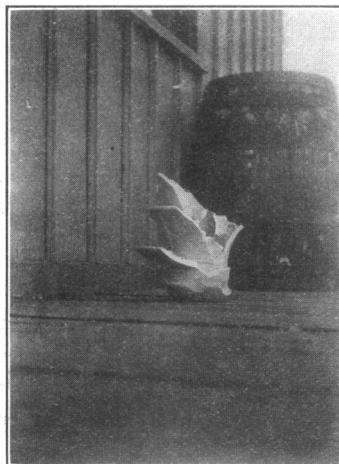
A typical case showing the manner in which insulators are destroyed by power arcs is shown in Fig. 13, which depicts an insulator destroyed in service by a power arc following a flash-over by lightning.

Item 1 shows that one insulator was disabled on the reinsulated lines against 54 disabled on the non-reinsulated lines. Fig. 13 pictures the one insulator lost on the reinsulated line. This is a clear case of breakage by power arc, after flashing over by lightning. It occurred early in the year, before inspection of the work has been made. This failure was due to improper installation of insulator and ring. The 54 insulators disabled on the non-reinsulated lines were destroyed in the same way as were those lost in former years, *viz.*, shattered by lightning, shattered by power arc and punctured.

(a) Broken by power arc. Insulator and rings were improperly installed.

FIG. 13.—Four-part insulator destroyed by power arc. The only insulator disabled on the re-insulated lines 1909

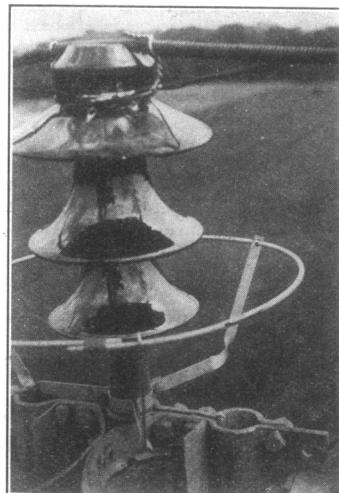
FIG. 14.—Insulator, protected by lower arcing ring, which flashed over successfully

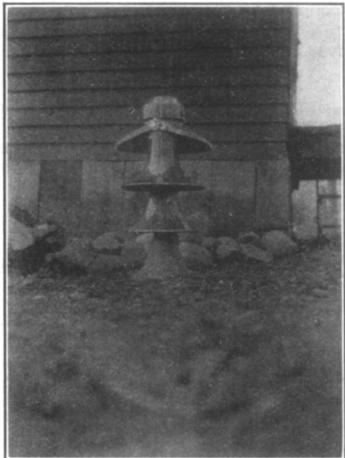
Fig. 15 pictures an insulator, the headpiece of which was broken by a power arc, burning the tie-wire in two. Eight

others were affected similarly. No upper arcing rings were installed on any of the insulators which were broken in this manner.

FIG. 15.—Insulator injured in head-piece by power arc. No upper arcing ring was installed

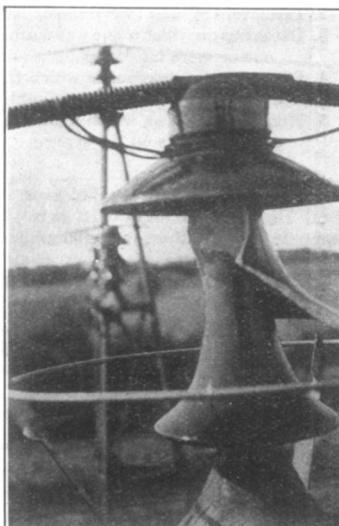
Fig. 16 shows the damage done by lightning stress to a three-part insulator. It had not flashed over. Three were injured in this manner.

FIG. 16.—Insulator with second shell injured by lightning shock
