Characterization of seawater reverse osmosis fouled membranes from large scale commercial desalination plant

Capsule Summary: This study reveals an autopsy study of a fouled seawater reverse osmosis membrane, used for two years in Benisaf Water Company desalination plant in Algeria, to study membrane performance degradation.

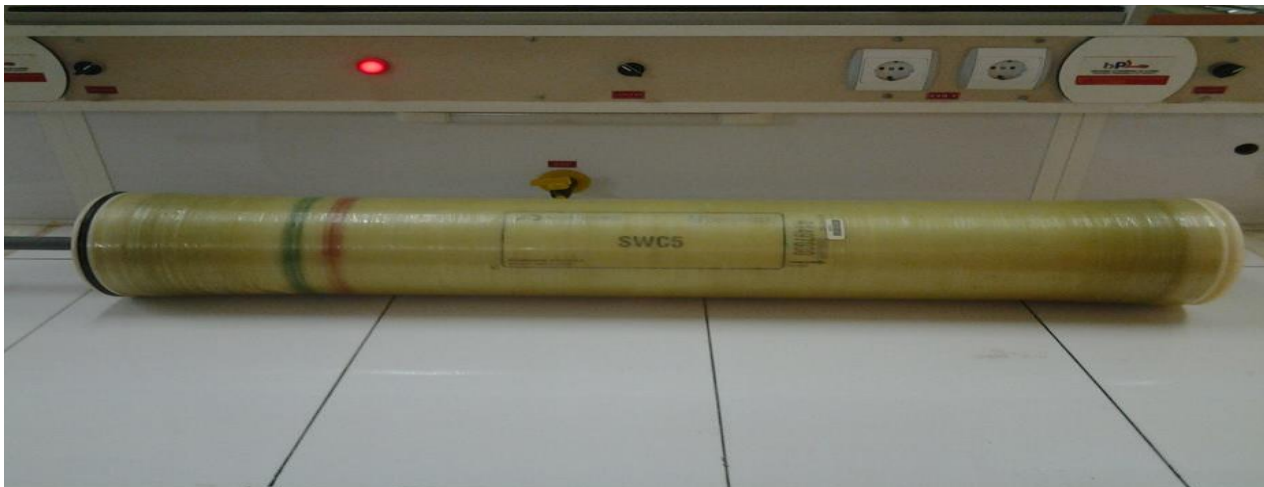
Fig. 2: The fouled RO membrane element

The fouled RO membrane element (HYDRANAUTICS SWC 5) serial number: A1497030 selected for the autopsy study had been in service for nearly 2 years in a water treatment facility operated by Benisaf Water Company of Ain Temouchent in the Ouest of Algeria. The RO desalination plant was integrated into the water treatment facility in response to the increased salinity of sea water in the region. The plant was capable of producing 200000 m³/day of permeate and included a concentrate recycle stream to improve recovery up to 45%. A maleic acid-based antiscalant was used in the RO operation. Prior to the RO treatment, the raw water from catchments in the Grampians Ranges and stored in open reservoirs had undergone a pre-treatment process including coagulation (iron chloride), pH correction, and cartridge filtration using 5 and 1 mm pore size filters. The filtered water had a pH of 7.18 and a turbidity of 0.08 NTU. Chemical

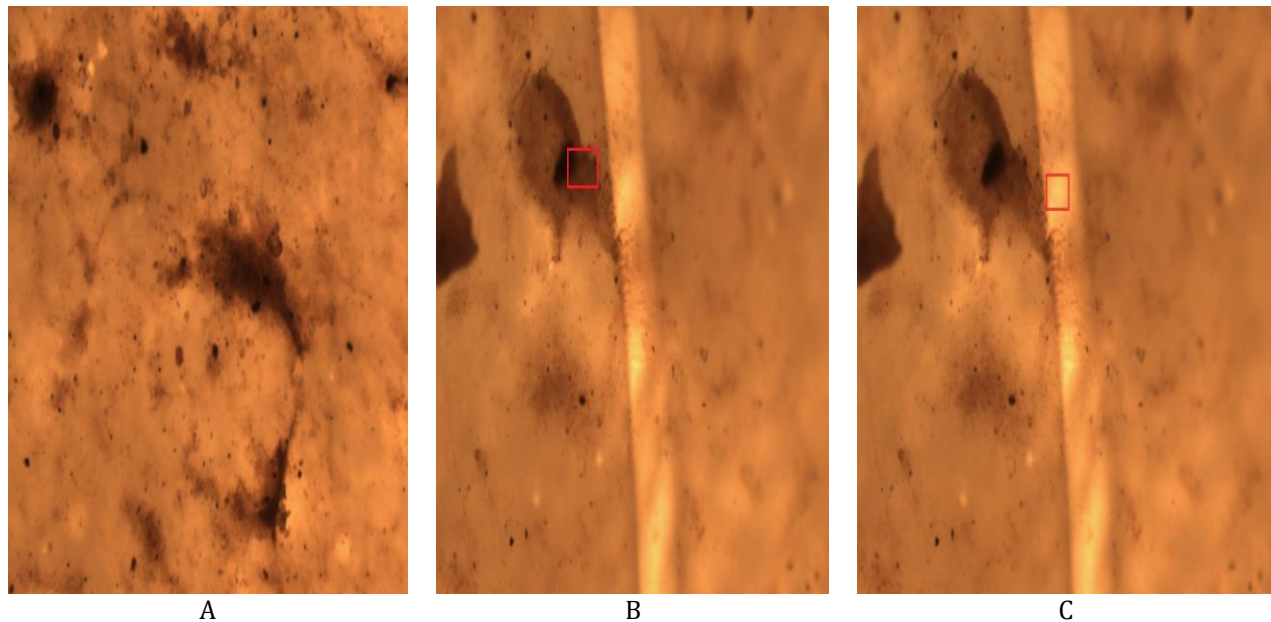
Fig. 3: Optical images of the membrane surface (b) in the vicinity and (c) in site of the feed spacer

Figure 3 shows the optical images of the membrane surface at different locations. Microscopic observation of samples reveals the importance of fouling deposition in the membrane surface. We notice that the distribution of the fouling charge is unequal on the surface with the presence of brown stains. We can also observe that the zone outside the feed spacer (Figs. 3-b) is more charged than the area below it (Figs. 3-c). The fouling particles act as a barrier and prevent the water from diffusing through the membrane which reduces the performance of the operation. The SEM images show the morphological aspect of the fouling as well as the importance of the thickness of the layers (Fig. 4). The deposits were distributed unevenly across the membrane surface. We also notice that the zone outside the feed spacer is more loaded than the other zone as shown in figure 5. Inspection by SEM EDS confirms the diversity of the fouling composition layer across the surface of the membrane and provides a better understanding of the nature and method of layer development. As shown in Figures 5-6, a typical fouled membrane surface consisted of particulate matter embedded in an apparently amorphous matrix (Thuy et al., 2007). Associated EDS analyses indicate that the particulate matter had relatively high levels of C, O, Al and Si.

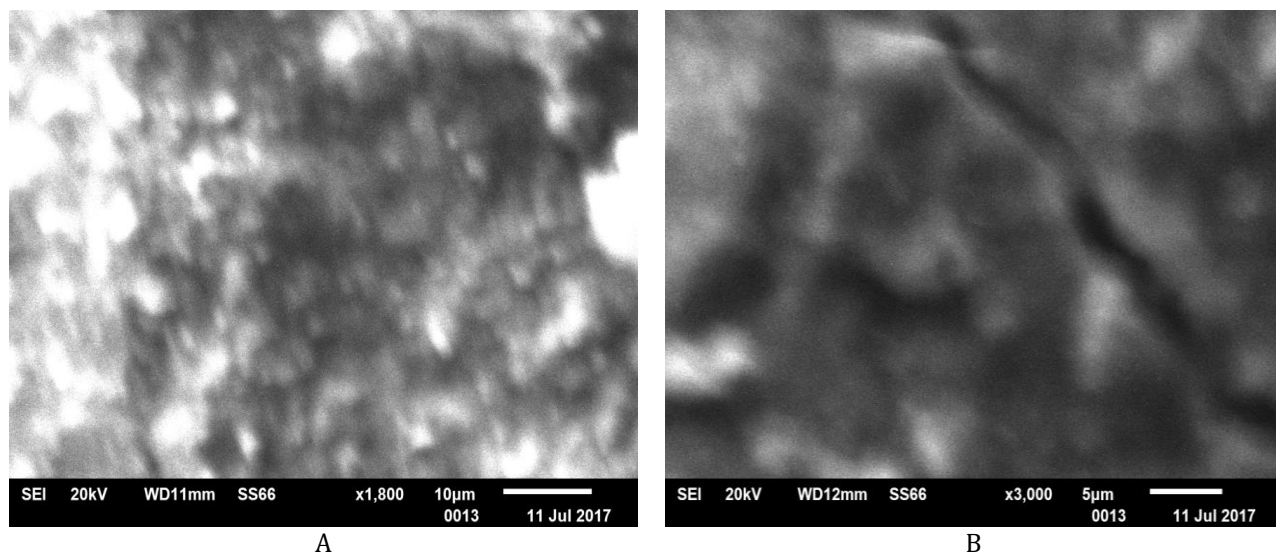
Fig. 4: SEM images of the membrane surface

The C and O peaks are likely due in part to organic and/or biological materials. The high levels of Al and Si in the particulate matter suggest that it was mainly aluminium silicates which are common foulants in RO operations (Thuy et al., 2007). The use of iron chloride as coagulant prior to the RO treatment could also elevate the Fe concentration in the RO feed which can prove the presence of iron dioxide in the foulants.

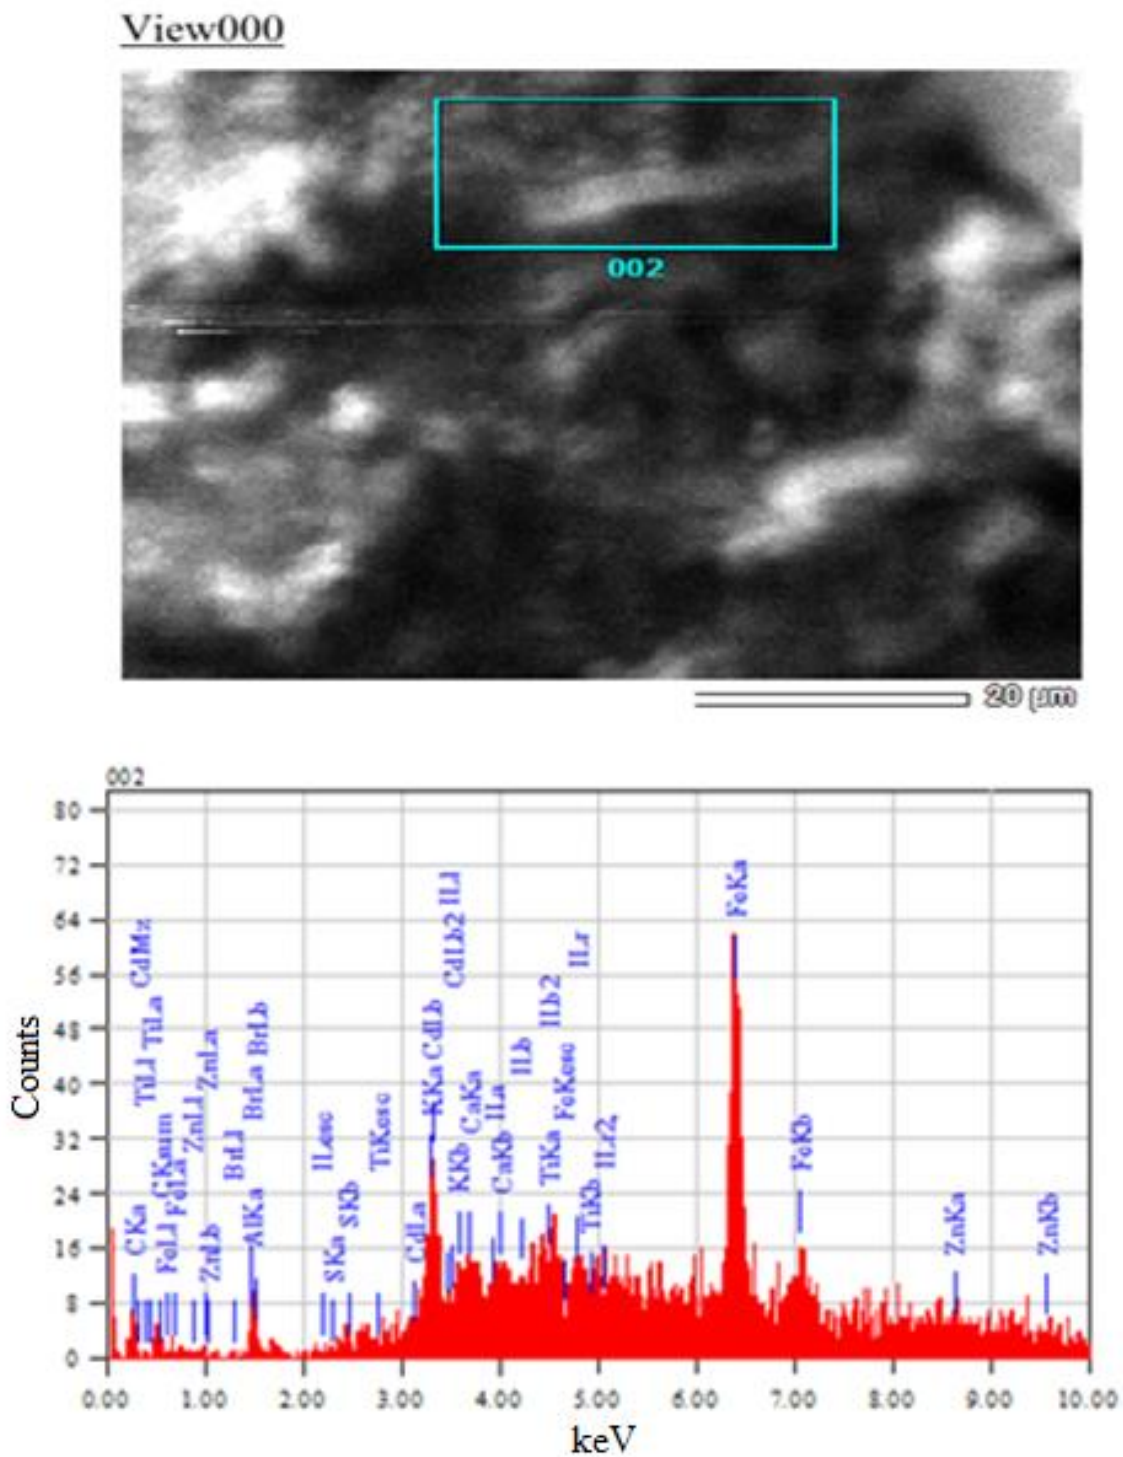
Fig. 5: SEM image and micrograph of the membrane surface – out of the feed spacer

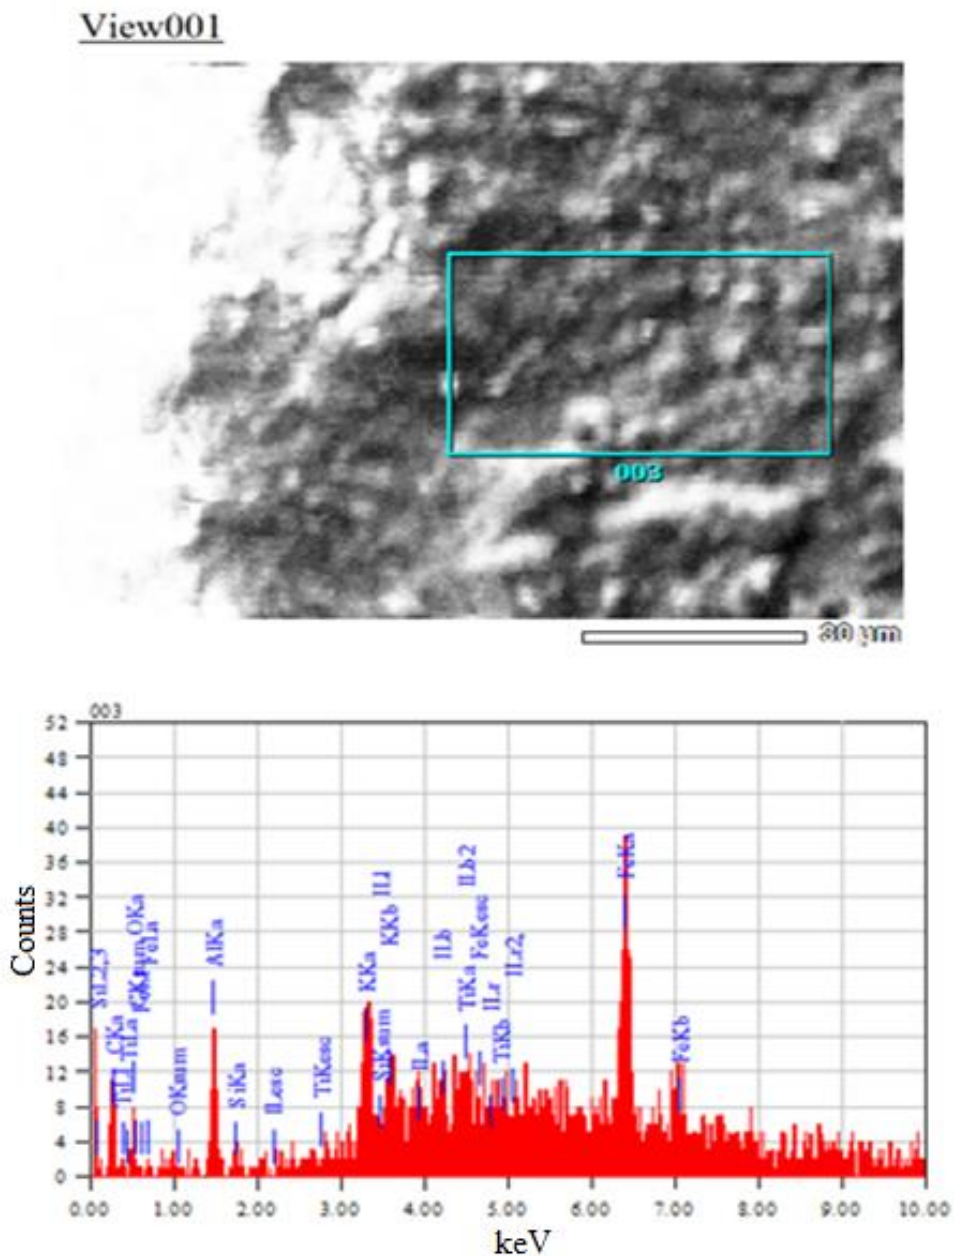
Fig. 6: SEM image and micrograph of the membrane surface – under the feed spacer

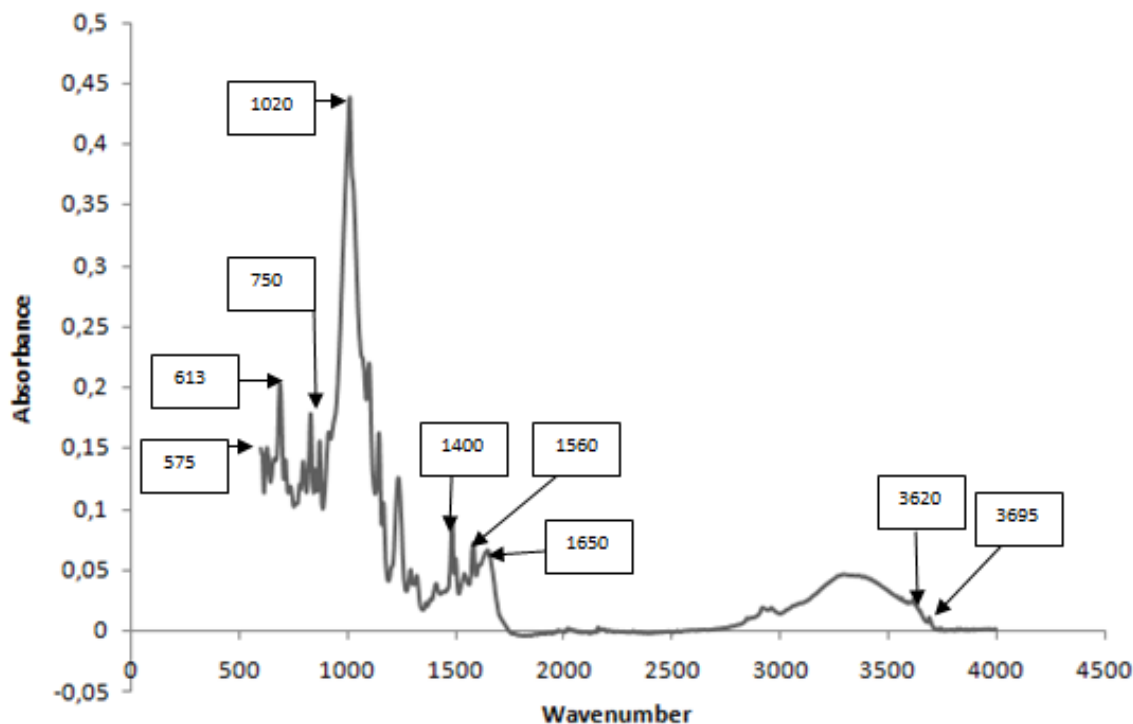
Figure 7 shows the FTIR spectrum obtained for the fouled membrane. A typical FTIR spectrum of the fouled membrane extract is shown in Fig. 7. The main absorption bands were in the vicinity of 1020 cm^{-1} (Si-O and Al-O) of silicate. In addition, the mass around 575 cm^{-1} suggests that the fouling is composed of amorphous structures of phosphates. The band in the vicinity of 613 cm^{-1} indicates the presence of iron sulfate, 600–800 cm^{-1} could be due to aromatic compounds, 1400 cm^{-1} could be due to aliphatic C-H deformation, C-O stretching and O-H deformation of phenol.

Fig. 7: FTIR spectrum of the fouled membrane extract

The bands in the range of 1500- 1650 cm^{-1} are due to (amide I and N-H deformation + C-N stretching of amide II, symmetric stretching of COO⁻). This band may indicate the presence of protein, 3620 cm^{-1} and 3695 cm^{-1} aluminum silicate.
