THE
INSTITUTION
OF
CIVIL ENGINEERS.

(Paper No. 3016.)

“The Security of Some Locomotive Fire-Boxes.”

By WILLIAM THOW, M. Inst. C.E.

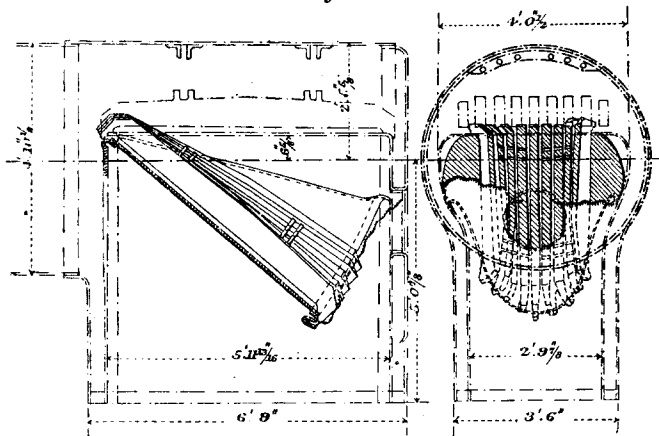
Figs. 1.

had travelled 210,800 engine-miles, the Author was led to experiment on the strength of copper plates of the kind generally used in the fire-boxes of English locomotives. The fire-box which failed was of ordinary design and modern dimensions, *Figs. 1*, and belonged to one of a set of ten engines constructed in

1889. Nine roof stay-bars were employed to support the roof-plate, and they were tied in twelve places by links and pins in the usual way, to angle-bars riveted to the semicircular iron crown-plate. The copper plates in the roof, back and sides, were $\frac{1}{2}$ inch thick and were stayed in the usual manner, the former to the roof-bars by set-screws, and the back- and side-plates to the outer shell by copper stays placed at the ordinary pitch of 4-inch centres. The working pressure in the boiler was 150 lbs. per square inch, and the safety-valves were found, after the collapse, to be in good working order for that pressure. The two lead plugs were found intact, and the plates had not been overheated, nor were there signs of shortness of water. The nature of the fractures in the copper plates distinctly showed the material to have been of good quality. The details, including the foundation-ring and the fire-hole, were of ordinary type, the sides and roof were in one plate, copper rivets were used in the joints of the tube- and back-plates with the usual lap and pitch; there was, in short, no special feature in construction or in proportions to deprive the fire-box of a character thoroughly representative of many locomotive fire-boxes now built or in use. Indeed, those of some modern engines, working at considerably higher pressures, are of larger dimensions, and are not better, if, indeed, as well, stayed to sustain greater loads than this box had to carry.

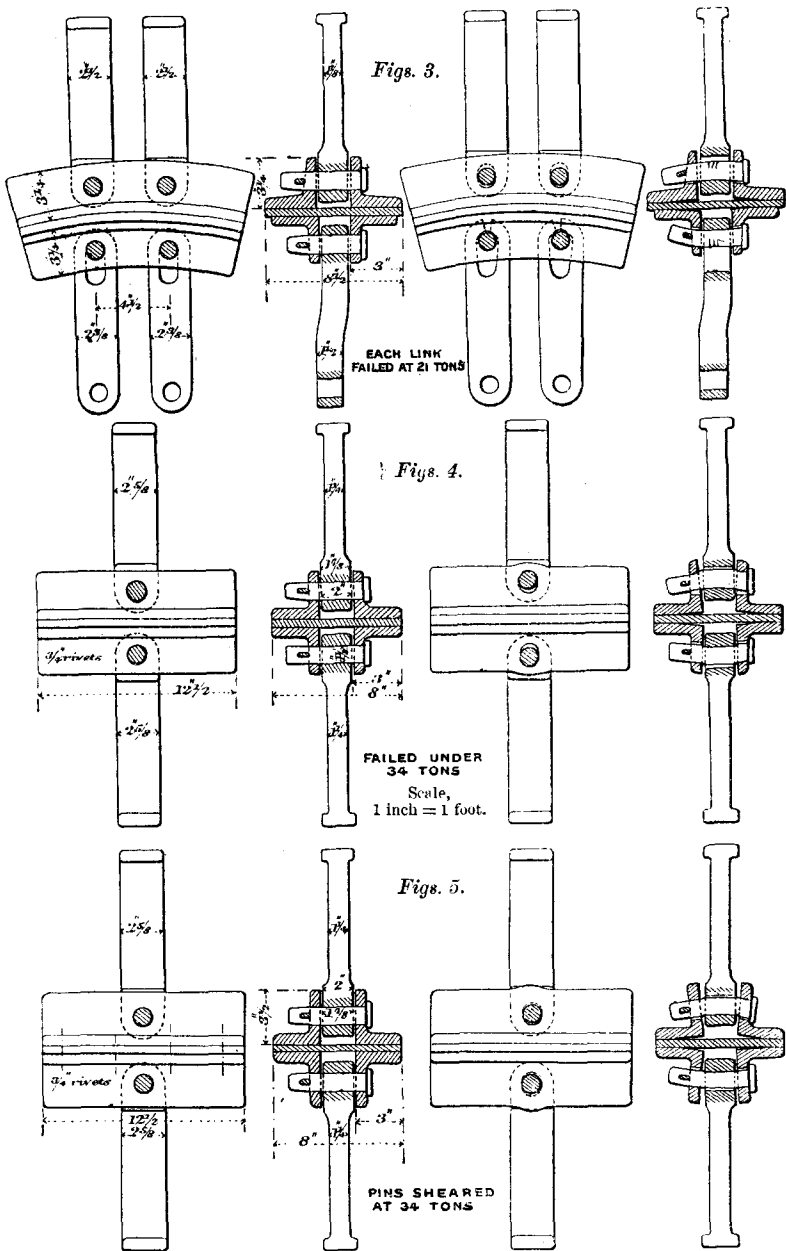
For the purpose of ascertaining the actual resistance opposed to the load on the roof of this copper box, the following experiments were made. The breaking strength of the links, pins, angle-bars and roof-stay jaws, for the case in question, were readily ascertained in the testing-machine; and, deducting their combined ultimate strength from the load imposed on the roof of the fire-box when multiplied by any required factor of safety, the copper tube- and back-plates ought to resist the remainder by their strength as columns or beams. A test-piece made from the original links, pins and angle-bars taken from the boiler which failed is shown in *Figs. 3*; the breaking strength of the connection was 21 tons, the links and pins fracturing at that stress. To discover the ultimate strength of new pieces, made of the best materials and workmanship but still preserving the dimensions originally adopted by the makers, a test-piece, *Figs. 4*, was torn asunder under a load between 33 tons and 34 tons, through the shearing of the pins, the fracture of one eye of the link and the elongation, almost to the point of rupture, of the holes in the angle-bars. That test was repeated with stronger

angle-bars, *Figs. 5*, but the pins again sheared at a load of less than 34 tons. The original strength of each of the connections provided by the makers was, doubtless, considerably less than 33 tons, because the parts were roughly made and proportioned. They are of a character frequently used in contract work in consequence of a want of correctly appreciating their importance and value. It too frequently happens that such links, although of excellent material, have the appearance of having been cut off the merchant bar to the required lengths and used without any of the smithing or forging which is necessary to apply the material most effectively against the stress. Those taken out of the boiler which failed had not 64 per cent. of the strength of the special test connections of similar dimensions shown by *Figs. 4*. Neglecting this inferiority, although important, it is seen that the maximum ultimate strength of the twelve connections, even under the most favourable conditions as to material and workmanship, cannot be greater than $33 \times 12 = 396$ tons.

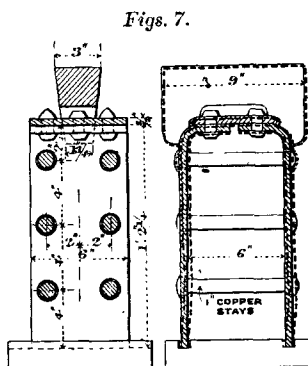
It was considered that the manner of imposing the load by the ends of roof-stay bars on the curves and horizontal flanges of the tube- and back-plates, was less direct than in the first experiment, and less favourable to the resistance of the upper or flanged portion of such plates; therefore a new test-piece, *Figs. 7*, was constructed, so as to represent more closely the actual conditions. Two vertical plates, flanged to the usual radius, were riveted to a horizontal plate which represented the roof; and a short roof-bar, machined and accurately fitted, was made to span the piece and to impose the load on the curved portions and flanges of the vertical

plates, thus resembling the conditions of actual practice. The vertical plates were tied together by horizontal copper stays, pitched at 4-inch centres. To avoid the slipping of the plates on the machine table, which was experienced with the first experiment, the lower edges of the vertical plates, at a distance of 4 inches from the line of nearest copper stays, were inserted into grooves cut to receive them in a base-plate. The top surface of the roof-bar and the bottom surface of the base-plate were parallel. Datum points were carefully laid off on each side of this specimen, giving vertical and triangular distances, and special appliances for detecting movements were employed. A load of 5 tons was first imposed, and was gradually increased by increments of not less than 1 ton, until a load of 20 tons rested on the specimen, when one side of it showed slight shortening. The load was removed and the specimen returned to its original length and shape. A load of 20 tons was again imposed, and the shortening on the same side re-appeared. The load was gradually increased to 25 tons, under which one side shortened $\frac{1}{32}$ inch and the other side less than $\frac{1}{64}$ inch. The load was entirely removed and a permanent set was observed. The limit of elasticity in this piece seemed to be 4 tons per square inch, but the

manner in which the specimen behaved under the test justified doubt as to the reliability of such a conclusion. It will be noticed, *Figs. 6*, that the specimen bent over its base-plate towards one side, and it is believed that movement was due to the interposition of a ball-and-socket bed-plate between the bed of the testing-machine and the base-plate of the specimen. It is probable that the centre of pressure on the roof-bar did not coincide with the centre of the ball-and-socket, therefore a diagonal stress would be set up in the specimen, bending it bodily towards one side, and thus interfering with the correctness of the test. The load of 25 tons was reimposed and was gradually increased by 1-ton additions up to 35 tons, when one side showed a shortening of $\frac{3}{32}$ inch and the other of $\frac{1}{16}$ inch. At 37 tons the plates yielded sideways considerably, and the load was removed. Permanent distortion of the plates appeared between 31 tons and 32 tons, and it is assumed that

in this specimen the ultimate resistance was not greater than $5\frac{1}{4}$ tons per square inch. The cross-sectional area of this specimen was 6 square inches as in the former case.

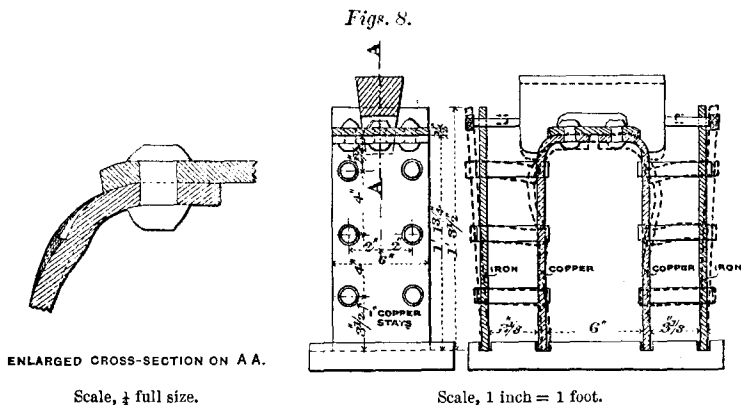
With a view to ascertain the effect of adding iron plates outside the latter specimen and staying them to the copper plates—more representative of fire-box conditions—another test-piece was prepared, *Figs. 8*. The arrangements of the copper plates and roof-stay in this case were the same as those in *Figs. 7*, except that the copper plates were stayed to their corresponding iron plates instead of to one another. The area of the cross-section of the copper was, as before, 6 square inches, and the lower edges of all the plates rested in grooves cut in a base-plate, the bottom of which rested directly on the machine bed-plate, without any ball-

and-socket refinement between them. This specimen was loaded with 10 tons without showing any movement. Increments of 2 tons were gradually applied up to 18 tons, when a very slight change in its length appeared. Additions of 1 ton were made until a load of 28 tons was reached, when a slight increase in the horizontal distance between the copper plates below the top of copper stays was observed, and a small change also occurred in the shape of the curves joining the vertical sides to the flanges. The load was entirely released, and the specimen returned to its original form and dimensions. It was reloaded with 28 tons in one amount and 1-ton additions up to 33 tons were imposed. Under that load a marked change appeared; the distance apart of the copper plates between the two top rows of stays had increased fully $\frac{1}{3}\frac{1}{2}$ inch, and one of the curves

under the roof-bar had slightly flattened. The load was again removed, and recovery to the original shape was found to be only partial. The limit of elasticity had been passed at about $31\frac{1}{2}$ tons, or $5\frac{1}{4}$ tons per square inch of section. The load of 33 tons was replaced and the change of form reappeared. Increments of 1 ton were added, and at 35 tons the distance of the copper plates between the two top rows of stays increased $\frac{1}{16}$ inch. At 40 tons it became fully $\frac{3}{32}$ inch greater than the original measurement. It was manifest that this specimen was weakest between the top and second lines of stays, and that the load on the haunches from the roof-bar had overcome the resistance of the copper plates as columns. Between 40 tons and 42 tons, the haunches began to flatten out; one of them had moved a bare $\frac{1}{16}$ inch and the other a full $\frac{1}{32}$ inch, and at 45 tons the vertical copper plates had spread, in the widest part, $\frac{3}{16}$ inch. At 47 tons this distance increased to $\frac{3}{8}$ inch, and the specimen suddenly collapsed and assumed the shape shown by the dotted lines in *Figs. 8*, when the load reached 48 tons. There is no doubt that under a load of 42 tons the ultimate resistance of this specimen was reached, and it was only a matter of time for the distortion, which had then set in, to increase and produce complete collapse. This test confirmed the result obtained in the case of *Figs. 6*, namely, that the ultimate strength or resistance to buckling between the lines of stays of $\frac{1}{2}$ -inch copper fire-box plates, when cold, cannot be taken as more than 7 tons per square inch. The elastic limit of this specimen appeared to exceed that obtained from the first test-piece in the ratio of 5.25 to 4.7, but an elastic limit of 5 tons per square inch is all that the experiments made by the Author will justify when the copper plates are loaded as columns and when they are cold.

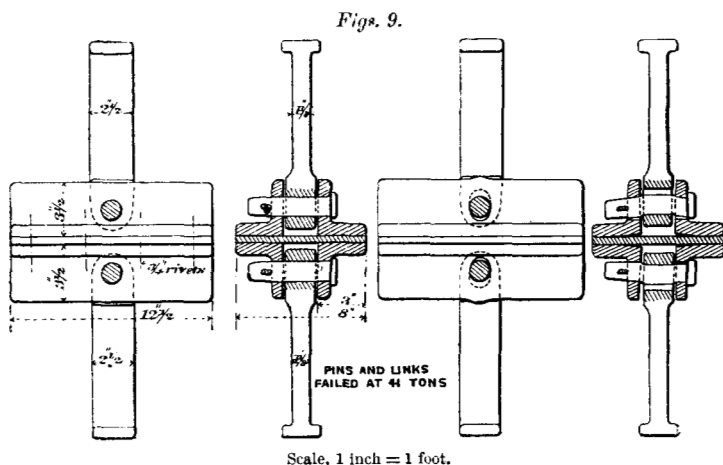
corrugating between the horizontal lines of the copper stays. In the case of the box which failed, it has been shown that if there had been a factor of safety of 4, a total resistance of 848 tons ought to have been opposed to the load of 212 tons due to the working pressure on the roof. Assuming that the sling-stays and their connections act in perfect harmony with the resistance of the copper tube- and back-plates—an assumption which the Author has given important reasons for doubting—452 tons is the resistance which remains for the plates in question. What is the proof that they possess that capacity? Their capacity to resist change of form would appear, from the experiments, to be limited to 5 tons per square inch of cross-section—a resistance far too small in this and many other cases to provide an adequate factor of

safety. The fire-box in question had, at the time of its failure, no factor of safety. Whatever it may have previously possessed, when all its copper stays in the top row of the back-plate were sound, vanished when a portion of them broke and left the copper plate free to corrugate and fold. Considering the difficulty and uncertainty generally experienced in detecting the fracture of solid copper stays, the risks involved in present methods of constructing and working some locomotive fire-boxes are too serious to be neglected. It must be regarded as unsatisfactory that a fire-box of ordinary and representative character depended for its safety on the soundness of a few copper stays. As an immediate precautionary measure, in addition to other methods of strengthening, the Author has removed the solid stays from the top two rows

of the fire-boxes under his charge, and has replaced them with hollow stays. He has also introduced an intermediate row, pitched diagonally between the two upper rows, in all cases where long roof-bars are used, so as to assist the copper back-plates under the ends of the roof-bars to resist bending stresses. In all the engines recently introduced on the New South Wales railways, the Belpaire box is used. The enlarged sling-links and connections, which have been adopted to replace the defective details shown by *Figs. 4*, are indicated in *Figs. 9*; their breaking stress is 41 tons.
