AN ELECTRICAL SURVEY IN THE BOROUGH OF  
MANHATTAN, NEW YORK CITY,  
SHOWING RESULTS OF STRAY CURRENT MEASUREMENTS BETWEEN  
ELECTRIC RAILWAYS, UNDERGROUND PIPES, ETC., ALSO  
RESULTS OF TESTS ON THE BROOKLYN BRIDGE.

BY A. A. KNUDSON.

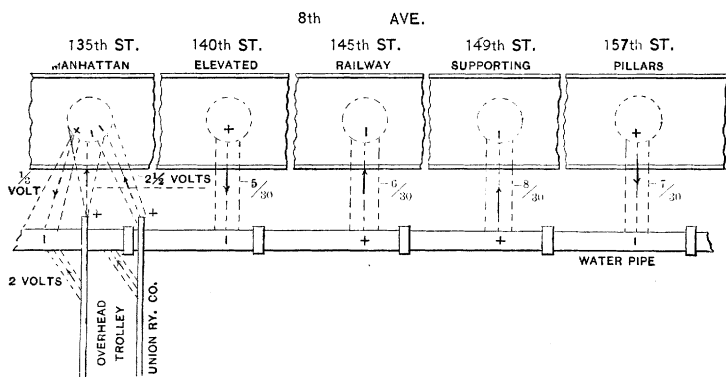
FIG. 1.

The starting point as already stated was at 157th street; from this point down to 135th street the tests are given in a table, as well as in plan, Fig. 1. The table gives both day and night tests for comparison, while the plan gives the day tests only.

The current passes into the water pipes and "L" structure from the rails of the trolley road at 135th street (they being positive) from 2 to  $2\frac{1}{2}$  volts maximum, then along the pipes for five blocks to 140th street, then reverses and passes along the "L" structure for another five blocks to 145th street, where it again reverses and takes the water pipes to another reversal at 157th street.

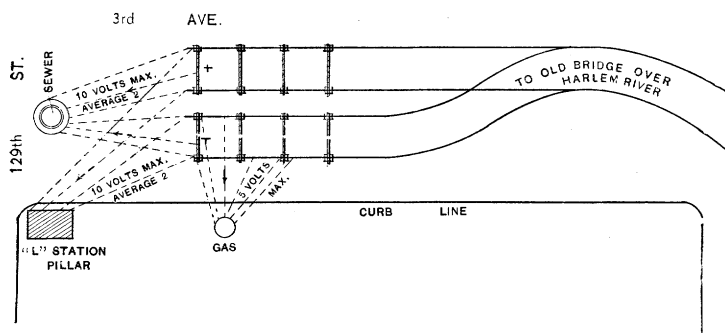
FIG. 2.

the city where another branch of the Union railway is located. Tests made here show even more pronounced results than at the branch running through 135th street to the west side. It may be stated that the power-station of this road is located on the Bronx river in Westchester county.

Something more than a year ago when these tests were made, this branch had a terminus at Third avenue and 129th street, immediately in front of the "L" station, the cars then passing over the Harlem river at the old wooden bridge, which is now being removed. The cars now pass over the new public bridge recently opened, to the new terminal at Lexington avenue. Fig. 2 shows the location of the old terminal when these tests were made, as well as the difference of potential.

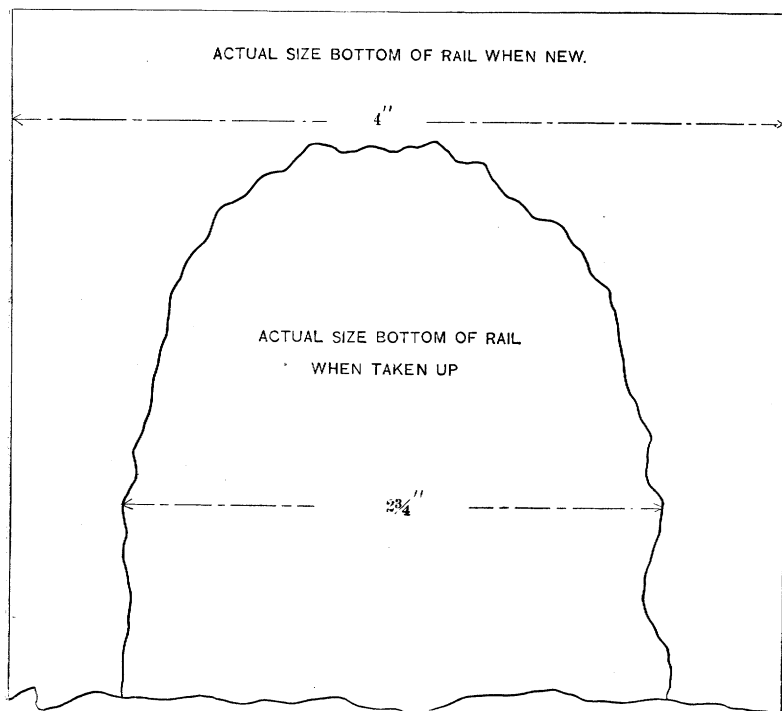
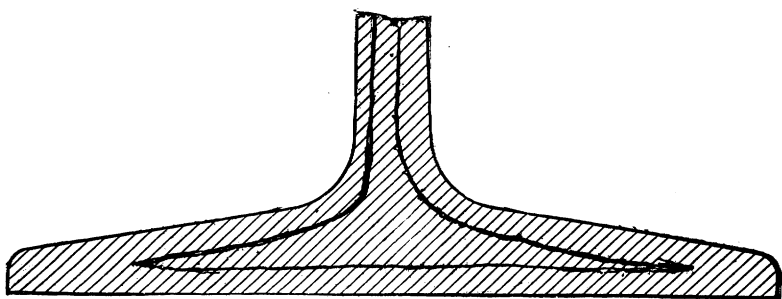
FIG. 3. Plan.

end of one of the four rails which composed that terminal switch, the ends of the other rails all being in just about the same condition. Fig. 3 shows a comparison of the size and shape of the rail when new and its present condition; the position of the out-lines as to each other being about as shown. From the condition of these rails now, it is quite plain that a large amount of metal

has been removed from them by electrolysis. The original size of the rails was furnished by the company supplying the rails, they being 70 lbs. to the yard; furthermore, the bottom sides of all these rails were cut by the current down to knife edges for several feet back from the ends. These edges were irregular in shape and somewhat jagged in appearance.

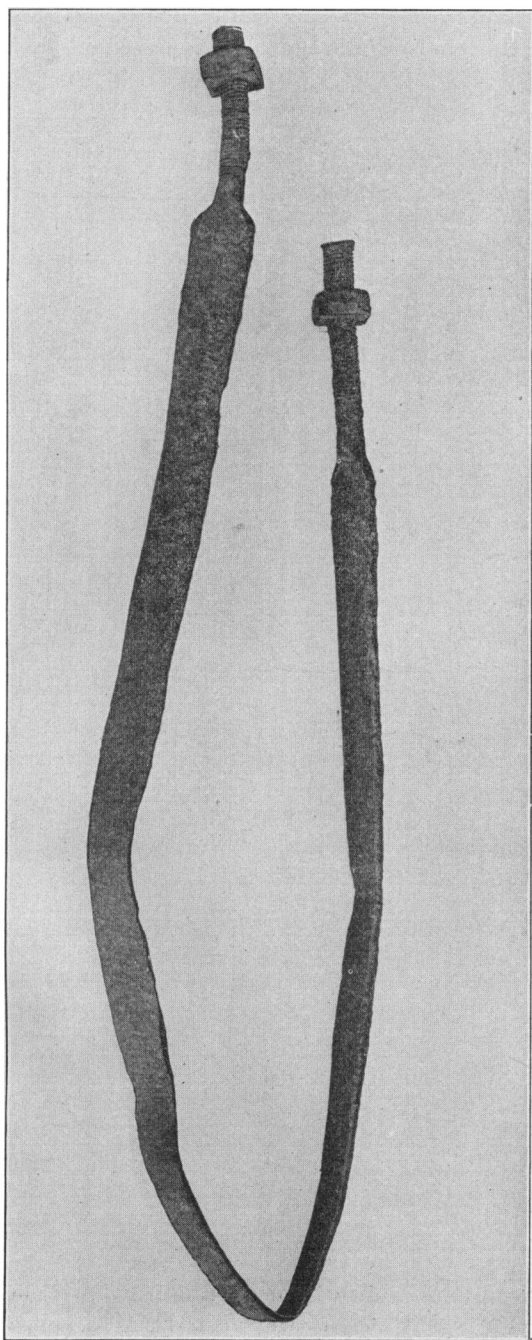
FIG. 4.

Another feature of interest is the condition of the cross-bars or tie-rods which keep the rails in position. These bars, which were originally  $1\frac{1}{2}$ " wide by  $\frac{3}{8}$ " thick, were nearly all so eaten away that the middle portion was missing, the ends protruding from the rails at from 6" to 12". Fig. 4 gives a view of one of these bars which was conveniently left behind when the other materials were removed. It is the only one I saw which was intact, and is in a much better state of preservation than the others, consequently not an average sample.

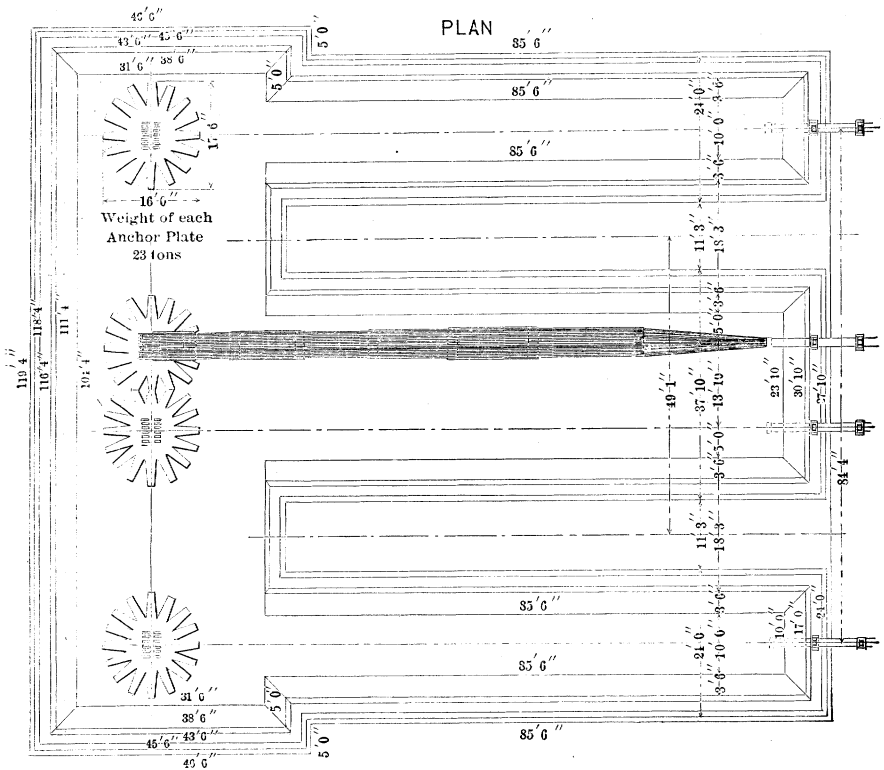
FIG. 7.

The polarity of both of these railway systems now operated on the bridge, indicates that these currents escape from their lines, but it is also quite likely that currents are even now coming over the bridge as they were a year ago. Only an extended investigation would determine these points, even if it were desirable that they should be known.
