Discussion.

STRENGTHENING OF THE TEES VIADUCT, BARNARD CASTLE.

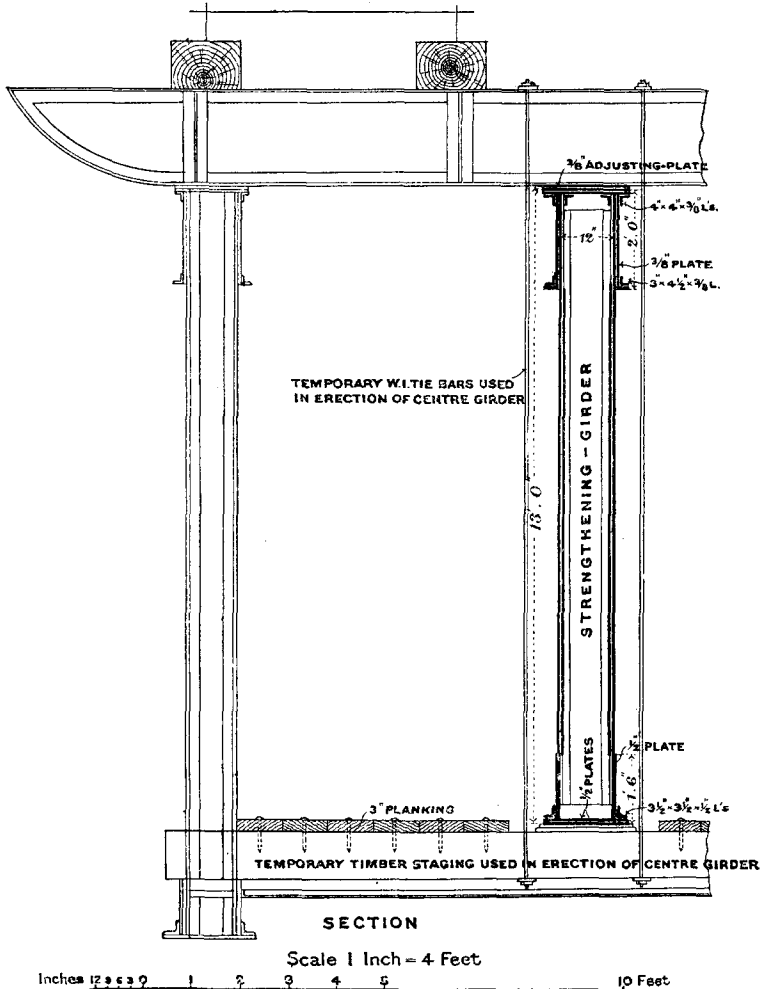
Fig. 17.

STRENGTHENING OF THE TEES VIADUCT, BARNARD CASTLE.

centre girders on all the spans, which relieved the existing girders of a large part of their work (Figs. 16 and 17). Care had, of course, to be taken to adjust the load properly between the new central girder and the side girders by means of adjusting-plates under the cross girders. When tested, it was found that the adjustment had been accurately done; when both roads were loaded all three girders deflected alike; and when one road only was loaded a less deflection was obtained on the central girder than on the outside girders. That was a successful piece of work, which had cost about £3,000 for four spans of 120 feet. Another case with which he had dealt was a viaduct at East Row,

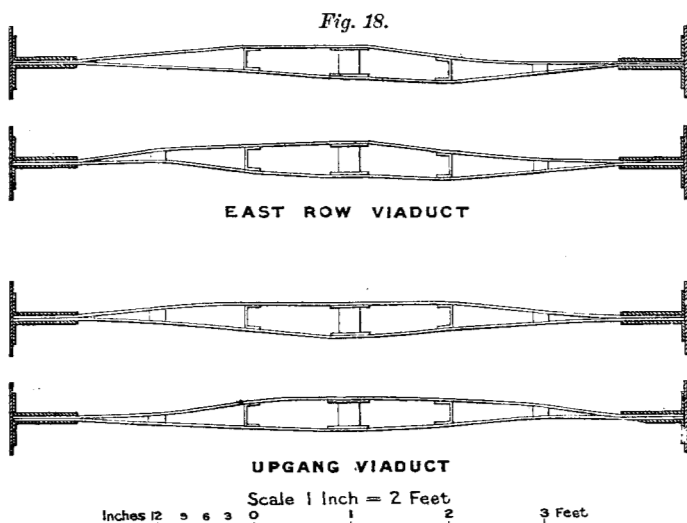
Mr. Cudworth. near Whitby, where the cross bracing of the girders was very defective (*Figs. 18*). It was a shallow viaduct of no great height, and it had been possible in that case to take out the old girders from

DEFORMED STRUTS REMOVED IN COURSE OF STRENGTHENING.

under the floor, leaving the old flooring, and to put new girders under the latter, so that the upper part of the bridge remained as it was, but with new girders. The work had been executed

successfully at a cost of £2,600 for five spans of 60 feet. A Mr. Cudworth, similar viaduct over a very deep ravine at Upgang, near Whitby, had required strengthening where it was not possible to get even temporary support from below. In that case, while the girder was of the same type as the girders of the West Lynn Bridge, it had been the bracing which was at fault, and not the flanges, the former having been badly designed and much crippled. Fresh bracing was put in without removing the old (*Figs. 19*). Verticals were put in at the centre of each panel; end bracing was then put in connecting the panels, and that bracing had to be carried round the old bracing. It had rather a singular appearance, but it had been

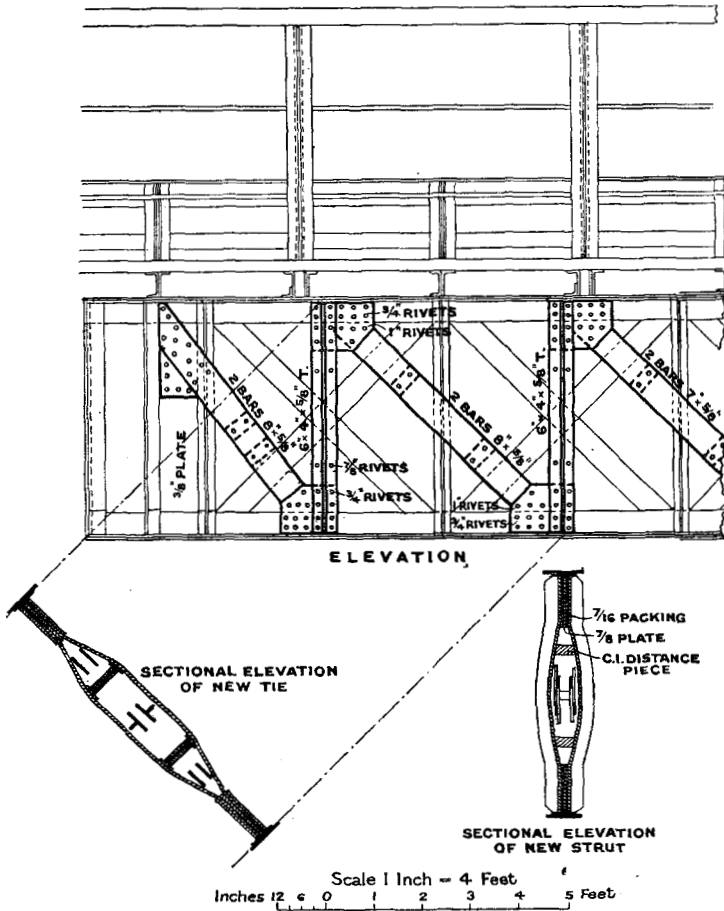
Figs. 19.

STRENGTHENING OF THE UPGANG VIADUCT, NEAR WHITBY.

very successful, and not at all costly. About £800 was spent on the viaduct, which consisted of five spans of 60 feet, and no trouble whatever had been experienced since. The Author had referred to the great difficulty of adding to the flanges of the West Lynn Bridge. Mr. Cudworth remembered one case on the North Eastern Railway where the flanges of a bridge had to be added to, although not to so large an extent as on the West Lynn Bridge. The bridge, which crossed the River Eden at Musgrave, near Kirkby Stephen, consisted of three spans of 66 feet, the width of the flange being just the same as that of the West Lynn Bridge, namely 2 feet. The method adopted (*Fig. 20*) was much the same as in the work carried out at the West Lynn Bridge, rivets being cut out and

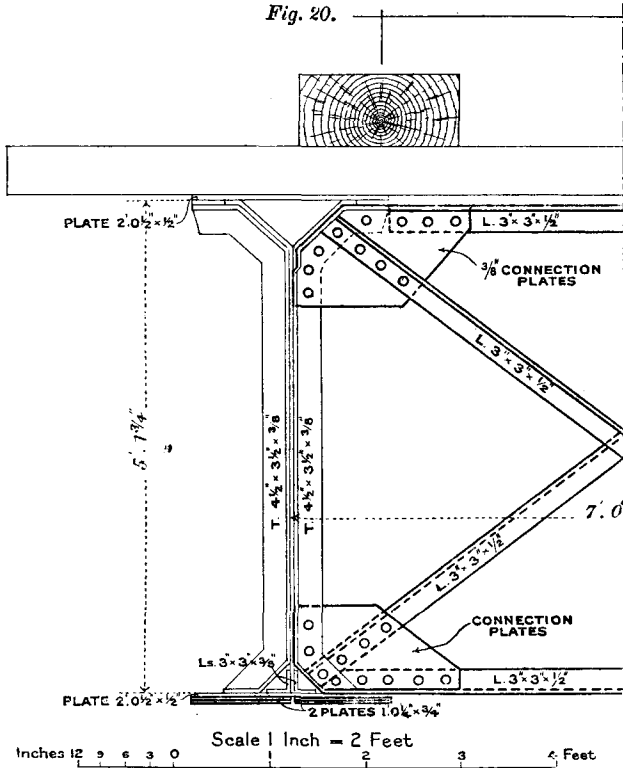
STRENGTHENING OF THE MUSGRAVE BRIDGE, NEAR KIRKBY STEPHEN.

Mr. Cudworth. bolts substituted, but the work was done half at a time. The old cover-plates were cut down the middle of the girder and one-half was removed first; then new plates were added, which were secured by bolts, and riveted up during the week, the plates being

put in on the Sunday when there was no traffic. Such treatment had been much more feasible in the Musgrave Bridge than in the West Lynn Bridge, because the dead load did not bear nearly such a high ratio to the total load; so that while the rivets were all out, and the bottom plate was being added, what was left of the bridge

was quite sufficient to carry it during the operation. The effect of the work had been to reduce the deflection of the bridge from a little more than $\frac{1}{2}$ inch to about $\frac{3}{8}$ inch. The bridge had stood very satisfactorily ever since, and the cost of the work had been only £350. The Paper did not refer to the renewal of wrought-iron bridges, but he would like to say a word in favour of what might be called the flat-floor type of bridge. The Author, in referring

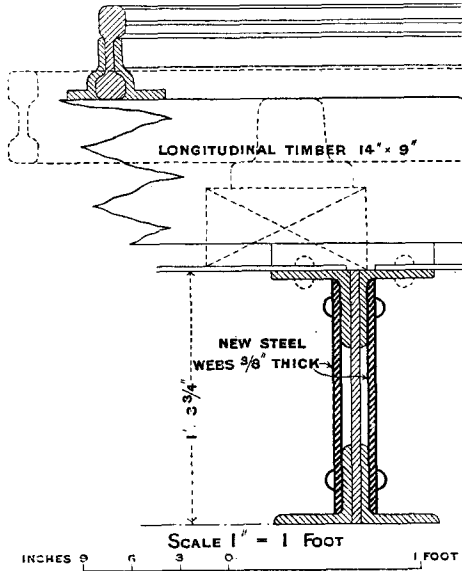
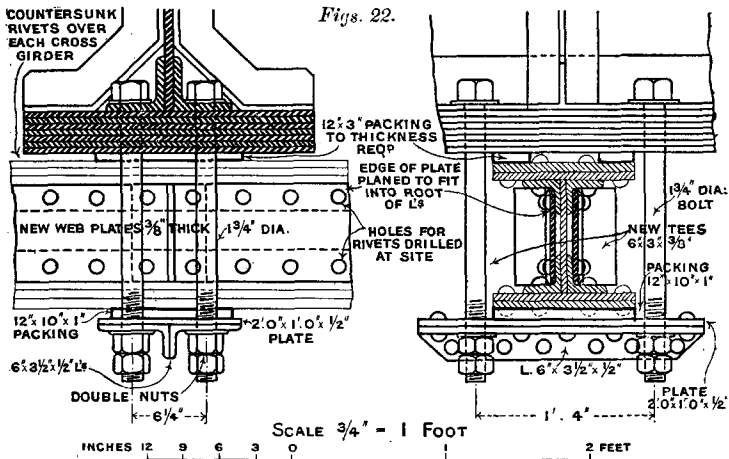
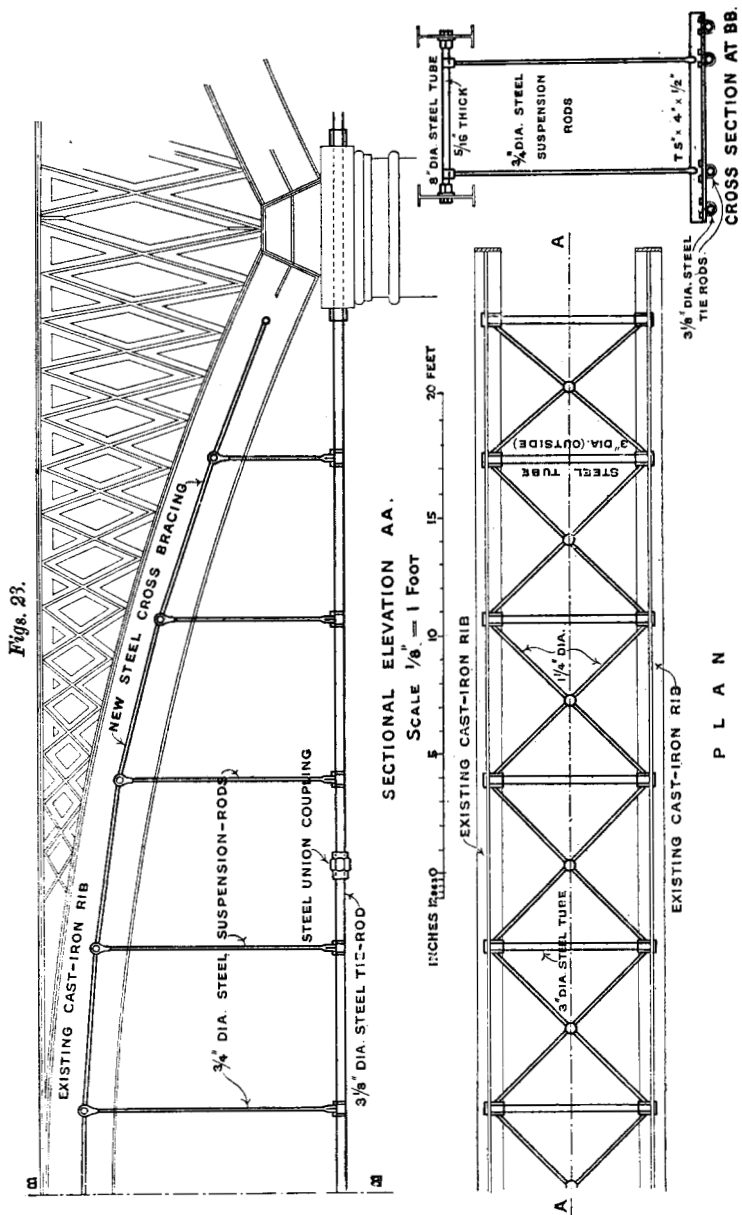
Fig. 21.

Mr. Sadler. wrought-iron structure built in 1879, and strengthened in 1904. The cross girders, which carried two roads, were 26 feet 6 inches

long and only 10 inches deep in the web, giving a ratio of depth to span of about 1 : 32. A new centre girder had been

STRENGTHENING OF BRIDGE OVER RIVER OUSE, HUNTINGDON.

Mr. Sadler, put in, as shown, and the cross girders had been hung from it by four $1\frac{1}{2}$ -inch bolts carrying supports underneath the girders. The cross girders had thereby been made into continuous girders, and although the flanges had been strong enough for this the webs had not, and two new webs had been riveted on each side of the old webs as shown in the diagram. *Figs. 23* referred to a cast-iron arched bridge, of three spans of 77 feet each, over the River Ouse just outside Huntingdon. The drivers had complained that the arch moved under the train, and on the bridge being examined, it had been found that the arches had no struts at all. Struts and cross bracing had been put in as shown in plan, and tie-rods had been fastened from springing to springing,

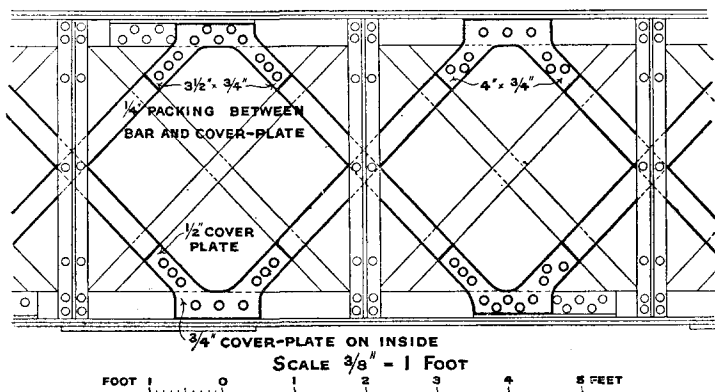
Fig. 24.

and supported from the arches to prevent sagging. This work had been done 10 years ago and had proved very satisfactory. *Fig. 24* was an example of a lattice-girder bridge deficient in shearing- and rivet-area, which had been strengthened by putting in fresh lattices in the manner shown.
