(Paper No. 2642.)

“Beetaloo Water-Works, South Australia.”

By CHRISTOPHER JOBSON, Assoc. M. Inst. C.E.

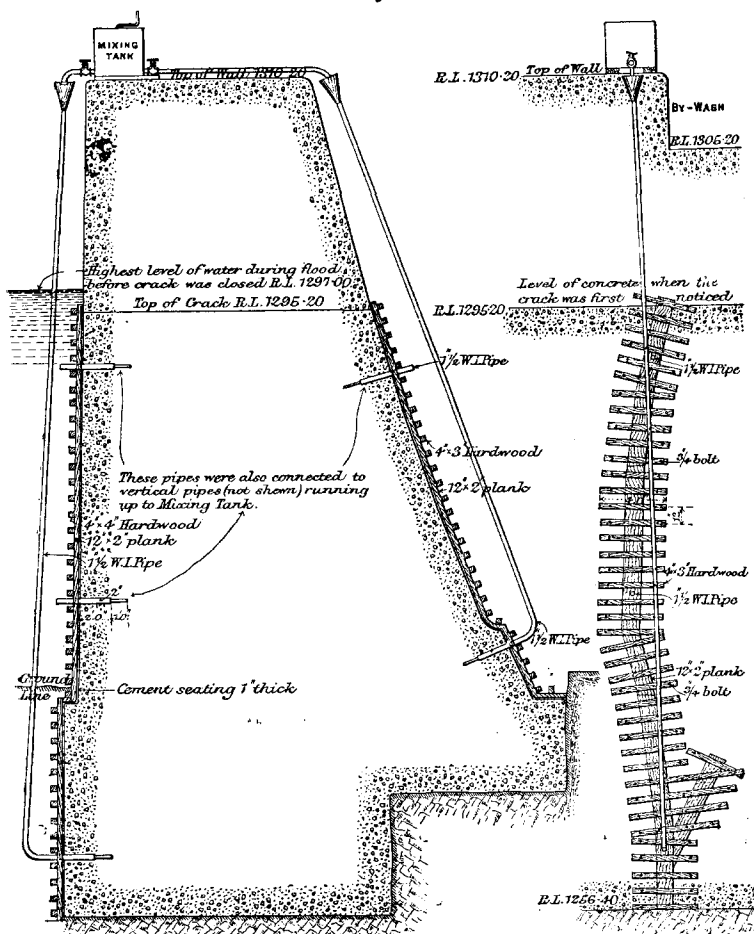
Figs. 4.

The second of the exceptions before alluded to relates to a crack which appeared in the western end of the dam. It was first noticed as a fine hair-crack on June 30, 1890—eighteen months after the commencement of the dam—and three days afterwards it had opened out to a bare $\frac{1}{8}$ inch wide. It was 145 feet 3 inches from the centre-line of the dam and extended vertically from the then surface (1,295·2 feet above datum) down to 1,274 feet; then turned at a right-angle and ran westwards horizontally for 12 feet; then turned again and ran vertically downwards to the foundation. It extended in a nearly straight line across the then top of the wall and continued down the inner face in a direction corresponding to that pursued on the outer face. The edges of the crack were parallel, that is, the opening was of the same width at the top of the dam as at the bottom.

From daily examinations it was ascertained that no movement occurred after the first three days; nor was any movement perceptible at different periods of the day, which might have been attributed to changes of temperature. The concrete along both edges of the crack was tested and appeared to be of first-class quality. A peculiar feature was that the opening of the horizontal portion was of exactly the same width as any portion of the vertical crack, as if the portion of the dam on the eastern side of the crack had settled bodily and at the same time drawn away from the portion on the western side; but the most careful examination failed to show that such was the case.

quite unable to come to any conclusion as to which of the above forces caused the crack. His theory—put forward with much hesitation—is that the shale-bands, which are wider at the higher levels of the western end of the dam than at any other point, became saturated with water, swelled and lifted the western end of the dam upwards and outwards at the same time. Exactly one week from the first appearance of the crack, water made its appearance on the outer side. The quantity coming through at first was small, but it gradually increased until it reached 1.66 gallon per minute—at which rate of discharge it remained. The level of the water behind the dam at that time was 1,296.7 feet above datum. The water did not come through the whole length of the crack on the outer side, the highest point of discharge there being 1,276 feet above datum.

GROUTING APPARATUS FOR STOPPING THE CRACK IN THE DAM.

The arrangements for forcing the grout into the crack are illustrated in *Figs. 4*. A row of holes, 24 inches deep, was first drilled on each side of the crack. These holes were 12 inches apart vertically, and 3 feet horizontally; $\frac{3}{4}$ -inch bolts, with double nuts, as used in the framing of the dam, were cemented into them. On each side of the crack a seating of neat cement, 6 inches wide, was rendered over the face of the dam. Upon this seating, when dry, a 12-inch by 3-inch plank, truly planed on the surface, was placed, and held in position by cross-pieces of hard wood, 4 feet long, which were attached to the wall by the bolts on each side of the crack. Previous to the seating being finished, 3 holes to take $1\frac{1}{2}$ -inch wrought-iron pipe were drilled into the concrete to a depth of 3 feet on the line of the crack. Into each of these holes a $1\frac{1}{2}$ -inch wrought-iron pipe was introduced for a distance of 2 feet. The pipes passed through

Vent-holes bored in the planks permitted the escape of air and any water which might have been in the crack previous to the admission of the grout. The joints of the pipes were first tested with water; the water was then allowed to escape, and, while the surfaces were still wet, the grout was run in through the lowest pipe on the inner side and rose nearly to the top of each of the remaining four pipes, passing through the crack to the outer side of the dam. In order to make certain that the crack was completely filled, the other pipes were then charged to the top with grout. Two days were allowed to elapse before the planks were removed; the crack was then found to be perfectly filled from bottom to top, the neat cement showing like a thin inlaid strip, $\frac{1}{8}$ inch wide, along the face of the dam. The pieces of pipe were then removed, the seatings were cut off the faces of the dam and the place was flushed over with cement rendering. The operation effectually stopped the crack.

Since then, up to March, 1891, no trace of further movement has been observed, either in the neighbourhood of the crack or in any other portion of the dam.
