## “Underpinning Great Yarmouth Town Hall.”

By FREDERIC ELIOT DUCKHAM, M. Inst. C.E.

THE new block of municipal offices and law courts at Great Yarmouth was opened by H.R.H. The Prince of Wales, in 1882.

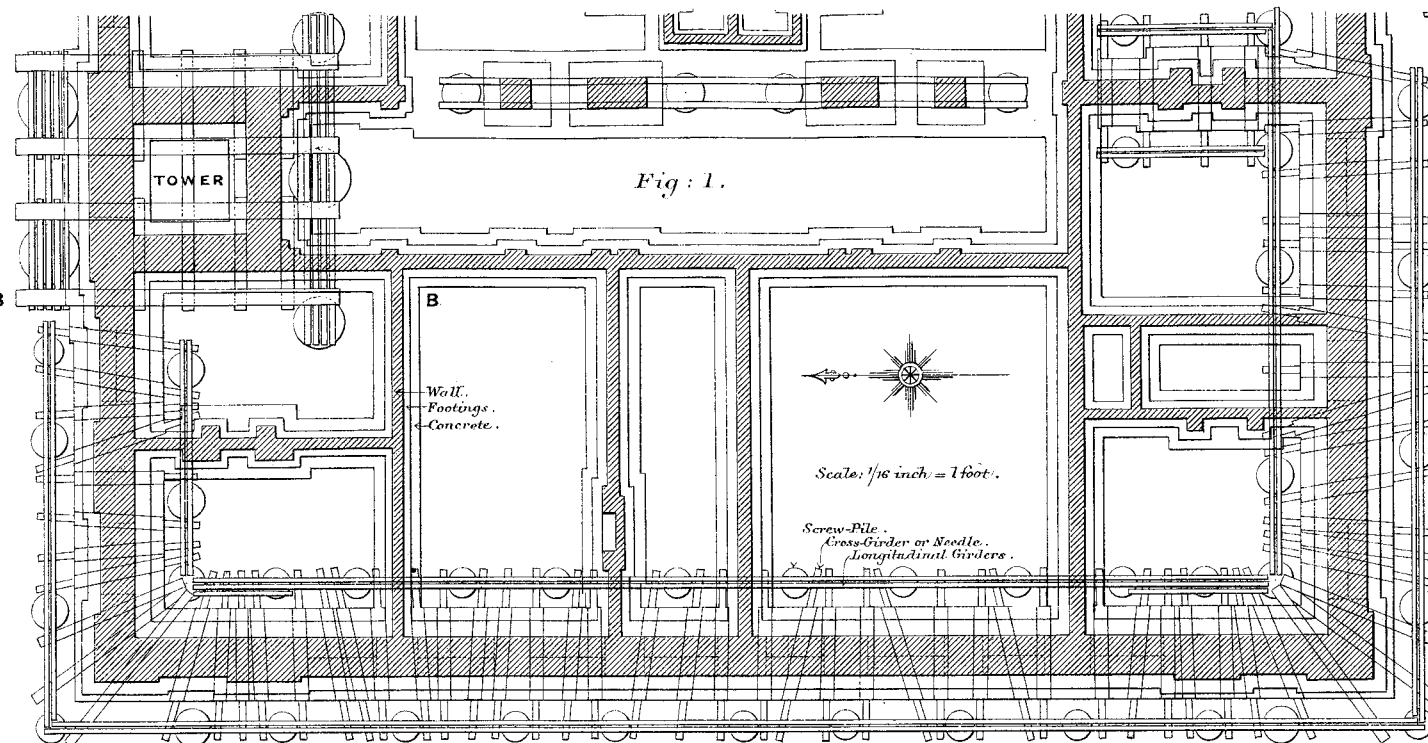
By November 1886, the west or river front of the building, when compared with the east side, was found to have sunk  $12\frac{1}{2}$  inches at its ends and 8 inches at its centre, and there were some fissures in it as well as in the north and south walls. The building had not only settled but leaned towards the river. The Town Council therefore resolved to demolish the western portion of the block with the view to its being re-erected on more stable foundations.

The prominent features of this scheme were:—1st. The insertion of cast-iron screw-piles at intervals of about 9 feet inside and outside the main walls (Plate 8, Fig. 1). These piles were to be about 23 feet long, screwed, say, 3 feet into the gravel bank, the metal to be  $1\frac{1}{4}$  inch thick, the screw to be 12 inches greater in diameter than the piles and of 6 inches pitch, the piles when down were to be cleared of earth and filled with cement concrete. The diameters of the piles were to be 2 feet and 2 feet 6 inches, to carry an approximate weight of, say, 35 to 50 tons respectively; but it being stated that the soil of the district injuriously affected cast-iron, the diameters were increased to 2 feet 6 inches and 3 feet, that, in the event of the iron failing, the internal concrete columns might safely take the weight.
