“Slips and Subsidences on the Ceylon Government Railways.”

By AUSTIN GEORGE COOPER, M. Inst. C.E.

*Author's Reply to the Discussion and Correspondence.*¹

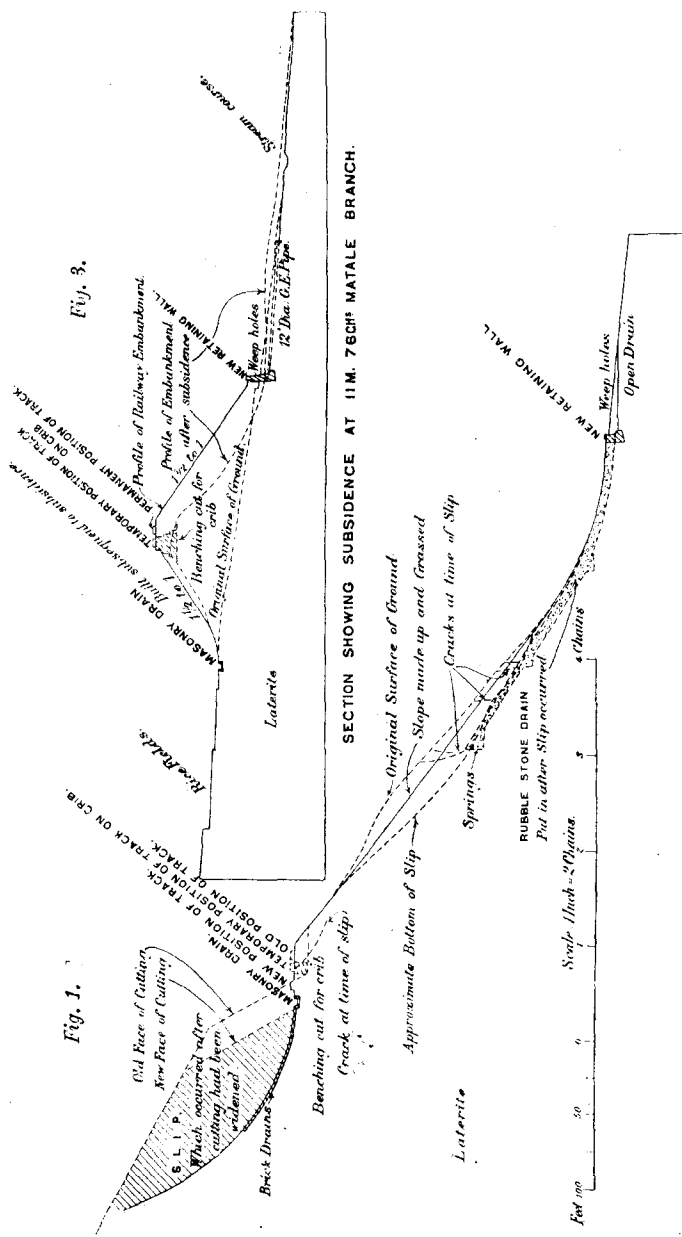
SECTION OF SLIP AT 152 M. 20 CH^s, MAIN LINE.

Mr. COOPER, in reply, remarked that cross sections were submitted with the Paper, but, being only profiles, they were not considered to give much additional information, and they were not reproduced. He now submitted sections with more detail, giving such information as was available in regard to the strata immediately underlying the surface of the slips described (*Figs. 1-3*, pp. 312 and 313).²

The sections in *Figs. 1-3* are taken as follows:—*Fig. 1*, on a straight line passing through the slip and through the middle of the retaining-wall; *Fig. 2*, the “section through slip” on a line approximately parallel to, and a little to the right of, the middle line of rubble drains; the “section through detached portion of slip at Haputale end,” on a line at right angles to the retaining-wall, through the middle of the slip; *Fig. 3*, on a straight line through the middle of the retaining-wall and approximately at right angles to the wall.—Sec. INST. C.E.
