(*Paper No. 3876.*)

“The Strengthening of the Roof of New Street Station,
Birmingham.”

By WILLIAM DAWSON, M. Inst. C.E.

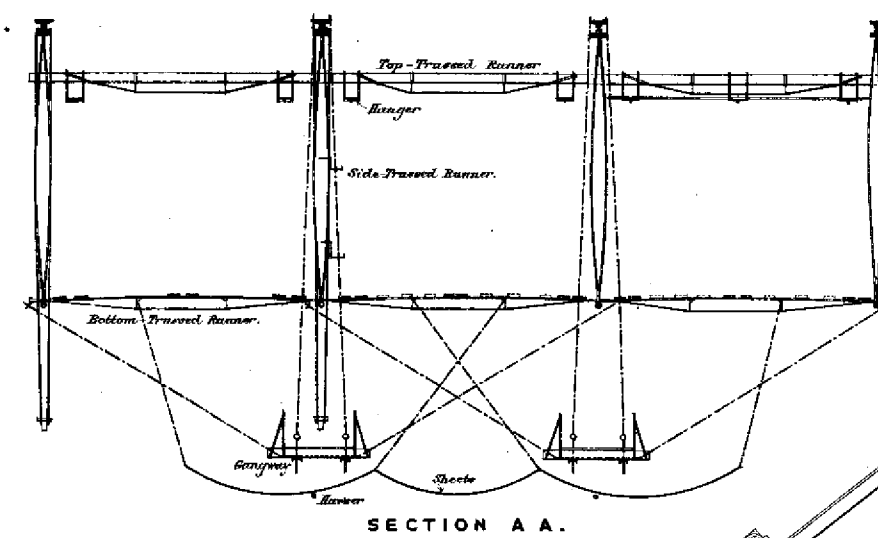
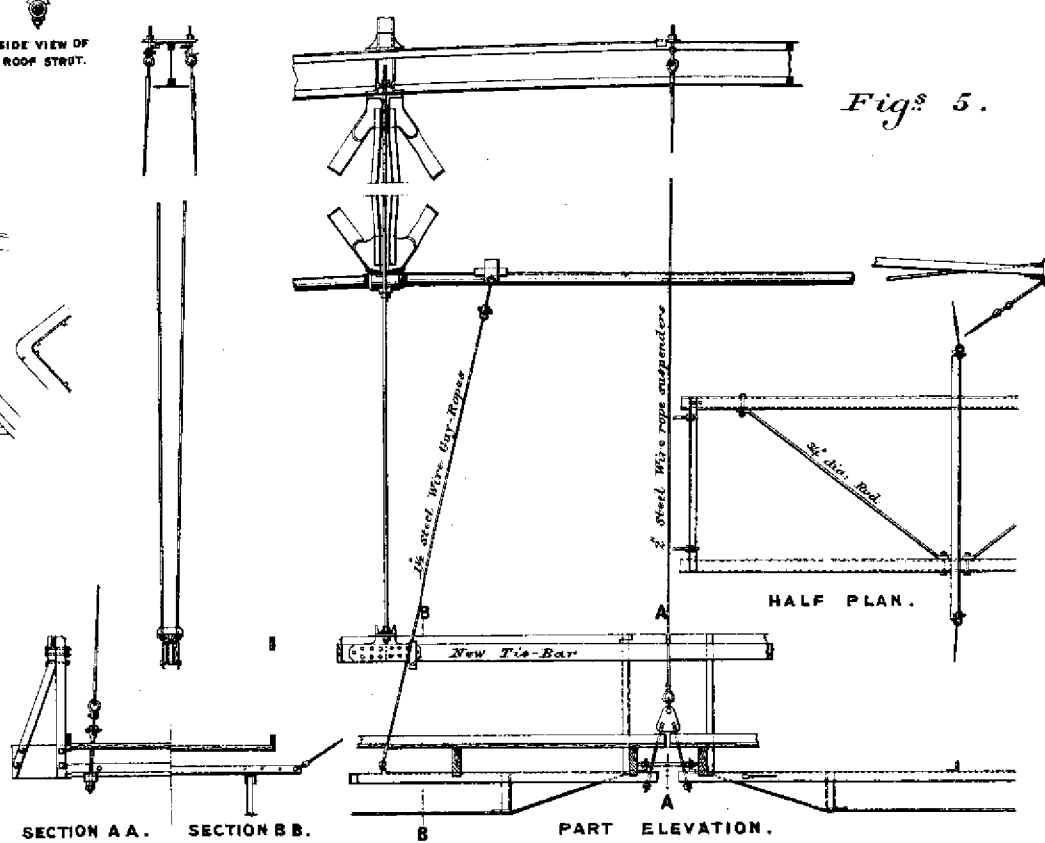
ARRANGEMENT OF SCAFFOLDING.

The scaffolding adopted, shown in Figs. 4 and 5, Plate 3, involved placing a load of 24 tons on each principal, which would have produced an additional stress of $26\frac{1}{2}$ tons on the existing tie-rod. In order to avoid this additional stress, a steel-wire hawser with a breaking strength of $63\frac{1}{2}$ tons was attached to the feet of each principal during the whole of the time scaffolding was suspended from that principal. The hawsers were provided at each end with long screws, which at the column end passed through springs securely nested in a channel-bar bracket bolted to the shoes of the principals, as shown in *Figs. 3*. The length of the screws allowed for adjustments to suit the varying spans of the principals.

The general arrangement of the scaffolding is shown in Figs. 4, Plate 3. It will be seen from the Section A A that sufficient scaffolding was provided to enable the work of fixing the tie-bars to be continued without interruption. Thus, while the scaffolding required for fixing the tie-bar to one principal was in use, the other set of scaffolding was being moved forward from the principal in the rear to the one in advance of the work. Runners between adjacent principals and along a principal were fixed as shown, to facilitate this work; and altogether the scaffolding was found to answer its purpose very satisfactorily.

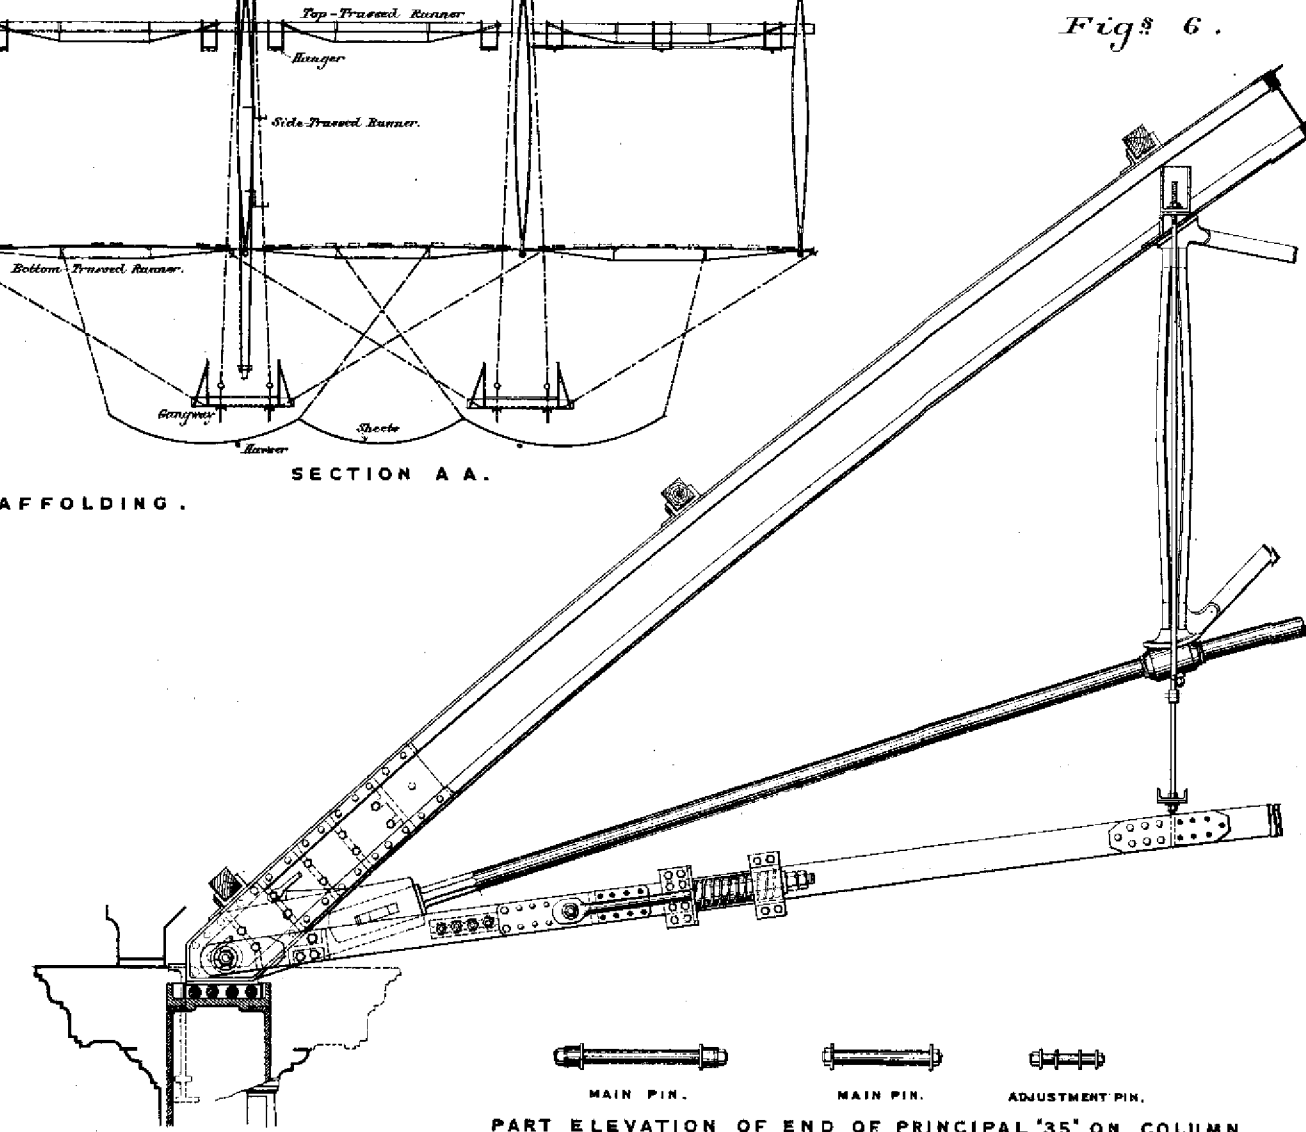
Fig. 6.

In strengthening a roof or any engineering structure by the addition of auxiliary members, it is of course very important that initial stress shall be put upon the latter, or in other words, that the old members shall be relieved of a certain amount of the stress; and where the amount can be determined accurately this procedure makes the work much more satisfactory and efficient. The method adopted in the present case for ascertaining accurately the amount of stress put upon the new bars was the employment of calibrated springs, secured temporarily to the new tie-bars in the manner shown in Figs. 6, Plate 3.

The old tie-rods were subject to considerable vibration, especially when the painters' scaffolding was being moved along the roof from one bay to another. In order to obviate this, two longitudinal tie-rods have been fixed from end to end of the roof, as shown at B B in Figs. 6, Plate 3. Each of these tie-rods is provided with a collar bolted around the old tie-bar at one-third points in the span of the roof, and is also provided with a coupling-box in the centre of each bay, so that any required adjustment can be made to keep the old roof-principal strictly in line.

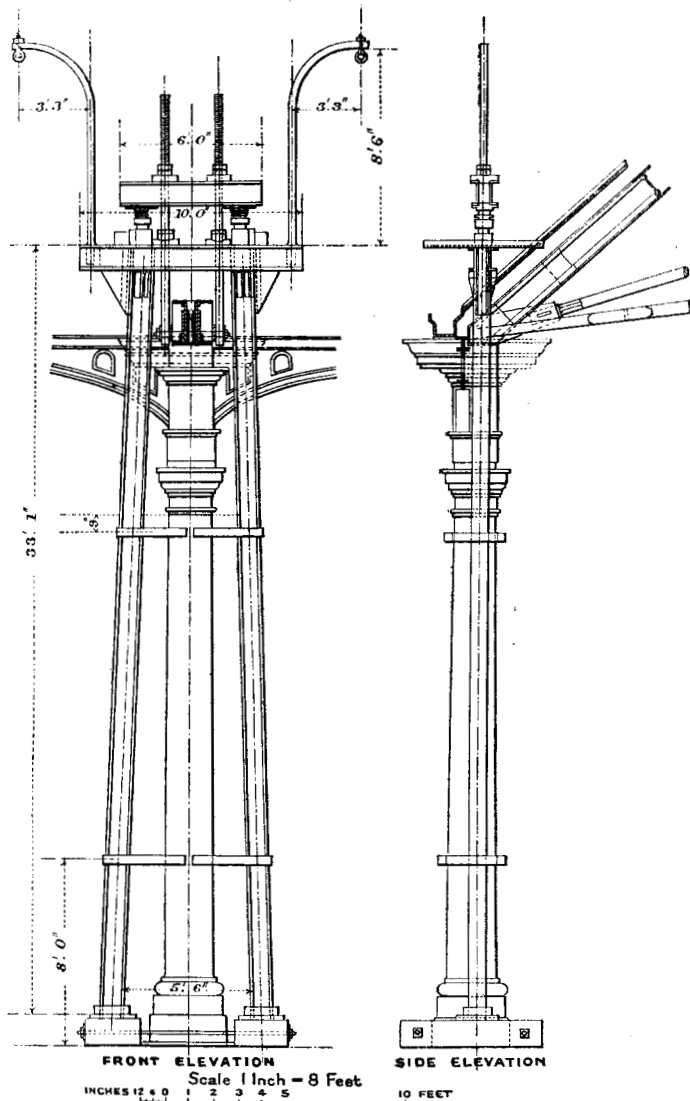
Figs. 8.

While the adjustment was in progress, the end of the principal was lifted entirely off its bearing by a specially-constructed derrick provided with long rods forming a sling (*Figs. 8*). The object was to ensure that none of the stress put upon the springs could be transferred to the columns in any way, otherwise the efficiency of the whole operation would have been seriously impaired. The adjustment, therefore, was made with the principal swinging clear of its bearing. Moreover, there would have been some risk to the column itself had not the weight of the principal been removed before the adjustment was made. The weight lifted by the derrick was 42 tons at a level of 35 feet above the ground.

Roller-bearings had been provided in the original design of the roof, but after lifting the principals it was discovered that the rollers were completely rusted up and were of no value for the purpose intended. They were therefore removed and replaced by solid packings.
