**EDEN ISS**

## D5.1 – Initial System Test Report

**WP 5.1 – Transportation and Setup**

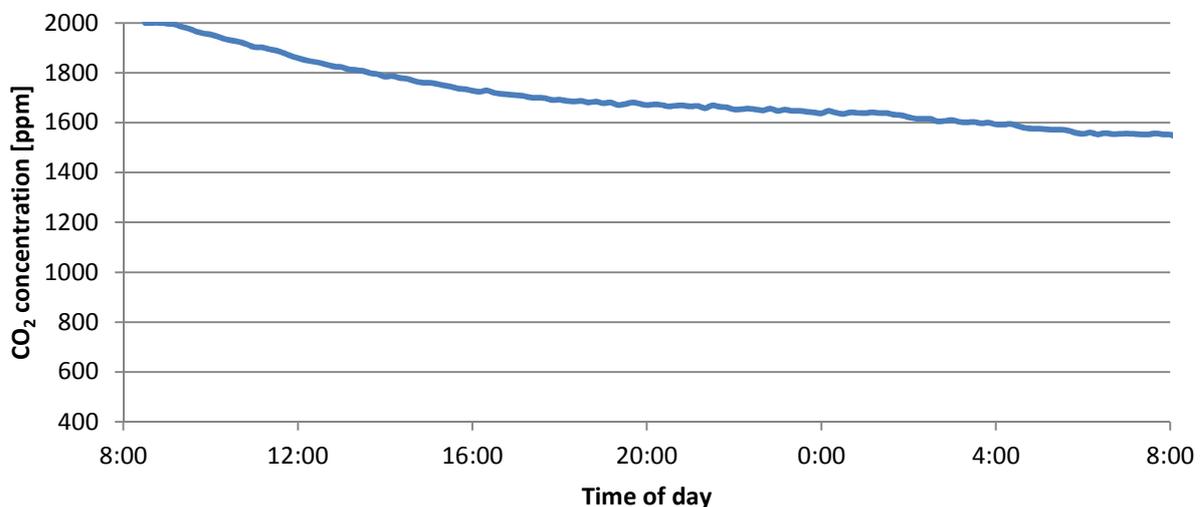
The air exchange rate test was conducted by first increasing the CO<sub>2</sub> concentration well above the level of the surrounding environment. The concentration in the FEG was raised to 2000 ppm, while the surrounding environment has an average concentration of around 400 ppm. As test results can be influenced by the metabolism of plants or humans, it was conducted before plants were planted in the FEG and without anyone in the facility. The concentration decay of CO<sub>2</sub> can then be used to calculate the air exchange rate. Figure 11 shows the results of the test conducted during the initiation phase of the MTF. The CO<sub>2</sub> concentration was logged for a period of almost 24 hours. Over this period the concentration dropped from 2000 ppm to 1550 ppm. The calculated air exchange rate is lower than 50% air volume per day. For comparison, the maximum permitted leakage requirement defined at the beginning of the project was 500% air volumes per day. In the case of FEG leakage rates, a more accurate value could be obtained with a longer duration test (i.e., allowing the FEG CO<sub>2</sub> concentration to drop to values closure than actual ambient values). This was, however, not possible during the MTF initiation phase as the deployment team members needed to work in the facility to complete their tasks before the end of the field season. A longer duration test is thus planned for the next MTF maintenance period between November 2018 and January 2019.

Figure 11: CO<sub>2</sub> concentration inside the FEG during the air exchange test with carbon dioxide as tracer gas.

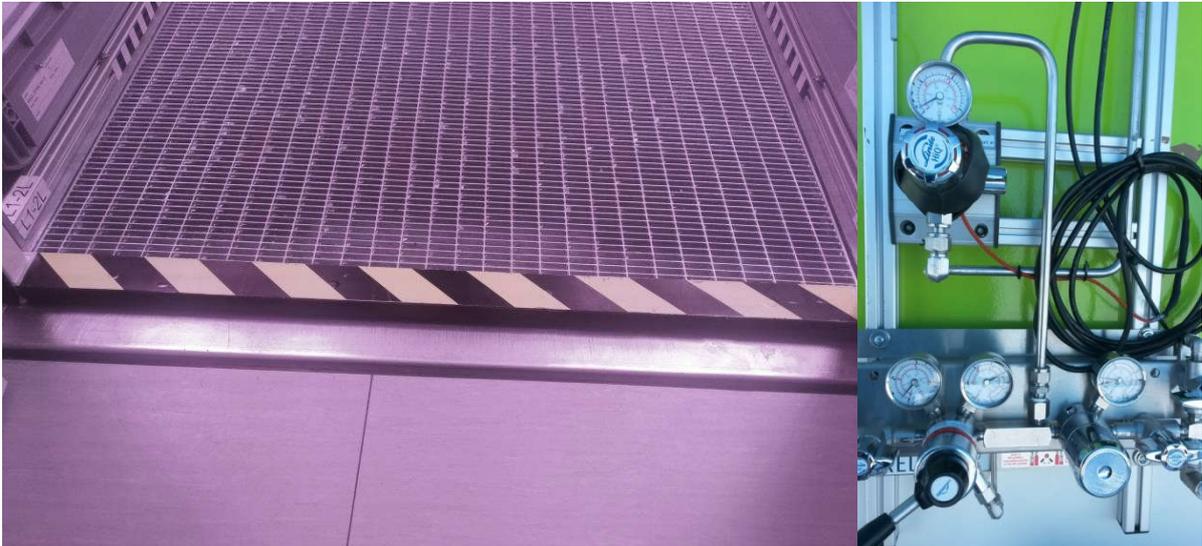
- *Service Section to FEG door not opening fully.* As described previously, great effort was placed on getting the Service Section and FEG containers to line up properly on the elevated platform. The result was that the containers were approximately 1 to 1.5 cm further separated from each other than they were in Bremen (where the containers were installed directly on the ground) and that one container was angled slightly with respect to the other. The latter was apparent from the perspective that the Service Section to FEG door (installed on the frame of the FEG container) could not be fully opened, as it would bump directly into the Service Section floor. Several adjustments had to be made to the door, the first is that it was moved up as much as possible on its hinges and the rubber installed on the underside of the door was removed. As removing the rubber insulation on the bottom of the door reduced the atmospheric closure of the FEG, a permanently installed bar including a band of rubber insulation was installed directly onto the floor of the FEG. When the door was closed it would push up against the rubber and seal the door connection (Figure 12, left).

Figure 12: (Left) Floor installed door bar with insulating rubber. (Right) CO<sub>2</sub> distribution system with installed secondary regulator heater.

- *Blockage of flow through the secondary CO<sub>2</sub> regulator.* Although detailed analysis showed that problems due to low temperature were not likely to arise with the CO<sub>2</sub> distribution system even if it were to be placed outside the MTF, on several of the cold days of the deployment phase it was observed that even with the internal CO<sub>2</sub> solenoid valve open, no CO<sub>2</sub> would flow into the FEG. Following leak checks, testing and additional observations, it was concluded that this was a result of CO<sub>2</sub> freezing up within the secondary regulator of the CO<sub>2</sub> distribution system (Linde W20/B regulator with 0.5 to 10.5 bar output, part number: 7616606). When a small amount of heat was applied to the regulator a small grain of CO<sub>2</sub> ice could be heard as it was dislodged and CO<sub>2</sub> could then flow again. To combat this problem, a small electric heater was installed directly onto the regulator body and a minor amount of insulation added (see top regulator in Figure 12, right). Control logic was built into the Argus control system to activate the heater on a set schedule and no additional blockages in the CO<sub>2</sub> delivery system were observed.
