**EDEN ISS**

## **D5.3 – Environmental Control Performance**

**WP 5.2 - System & Component Demonstration**

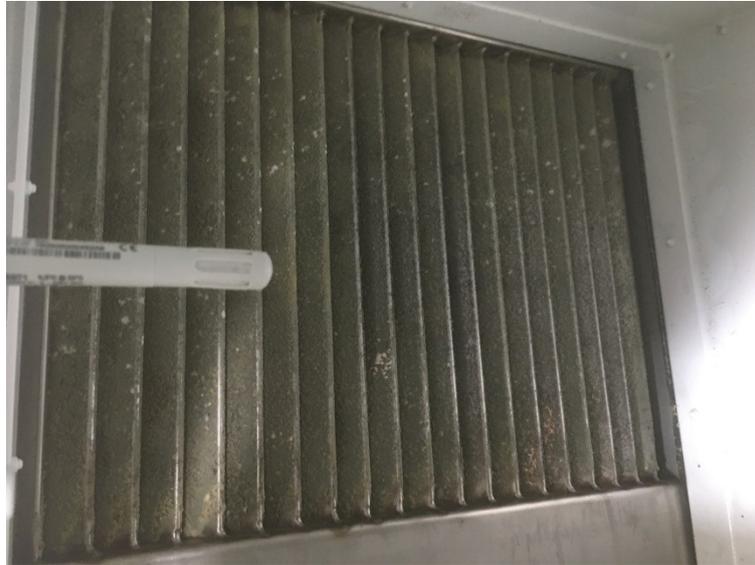
An additional issue was discovered only after the experiment phase in the summer season 2018/19. While opening the air channel of the AMS to replace the heating elements, the team on-site discovered an extensive biofilm on the surfaces of the cooling coil, see Figure 1-7.

Figure 1-7: Photo of the biofilm on the cooling coil during the inspection in January 2019.

- 1) Biofilm growth on cooling coil: As mentioned before extensive biofilm growth was discovered on the AMS cooling coil during the inspection in the summer season 2018/19. An anti-microbial coating could be one solution.
- 2) Cooling coil sizing: The cooling coil should be exchanged with one of a larger cooling surface area. This action is not trivial, because of the volume assigned to the AMS in general and the cooling coil in particular. Probably the exchange of the cooling coil to a larger one requires extensive reconfiguration of the AMS and TCS rack. A detailed investigation on this option is planned for summer 2019 to see whether this system improvement can be performed in the summer season 2019/20.

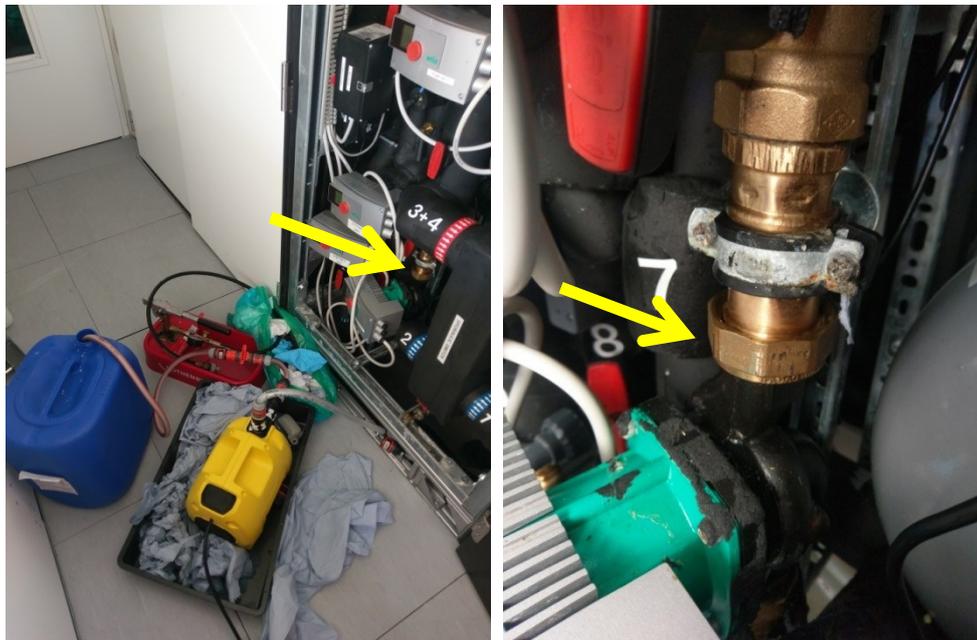
The alignment of some of the pipes is incorrect. As a result, some force is required to fix the screw connection(s). The resulting tension on the pipes and the screw connection resulted in leakage in the WT2 (Heat exchanger 2) cooling loop on the 24<sup>th</sup> of February and the 12<sup>th</sup> of March (see Figure 2-4).

Figure 2-4: Overview of thermal subsystem rack. Arrow pointing at leak spot.

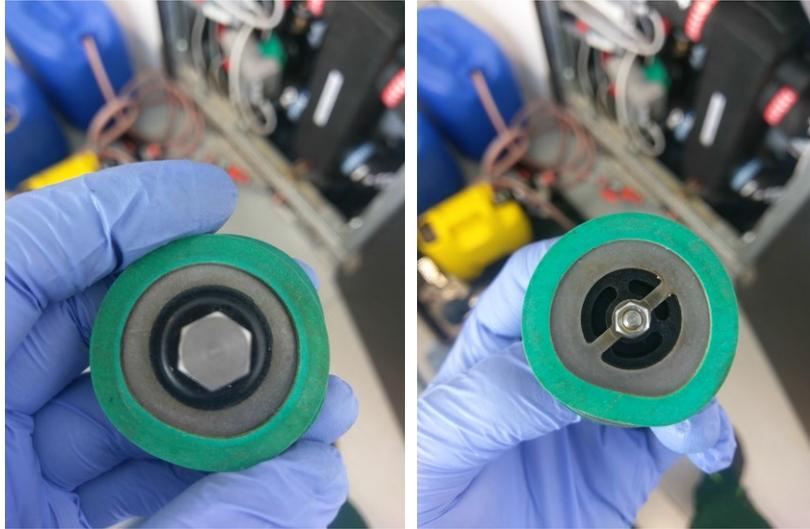
**Figure 2-5: Sealing O-rings of the flow-back valve after screw connection was opened.**

After the first leak, the screw connection was opened and the seals and flow-back valve inspected. No visible signs of damage of the seals (see Figure 2-5). Sealing O-rings were cleaned, Vaseline was

put on and the O-rings were put back into the screw connection. Fluid was pumped back into the cooling loop and the leak appeared to be sealed. Spill was cleaned up over the following week.

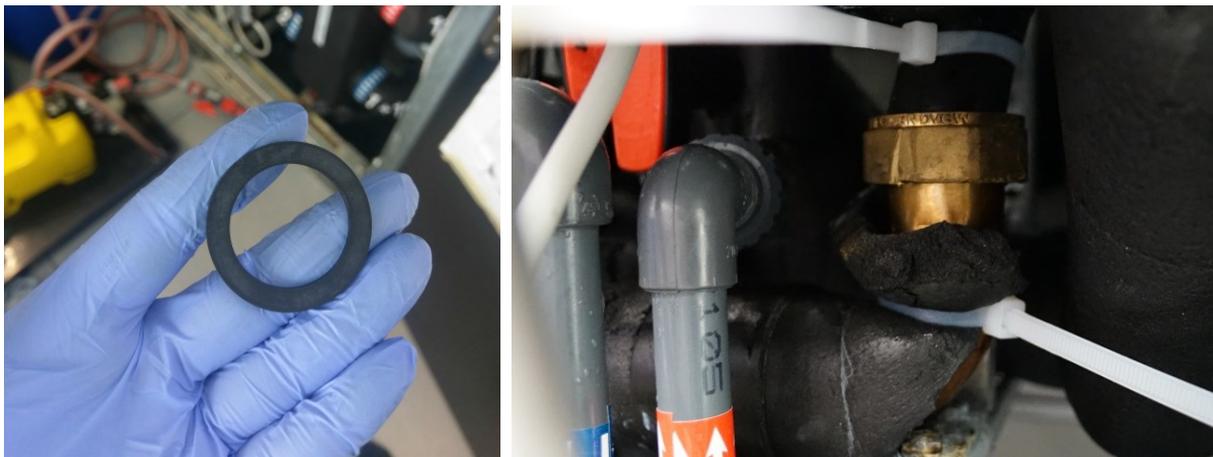
**Figure 2-6: Left: New rubber O-rings; Right: Cable ties below pump WT2. Pipe fixated to metal strut behind insulation.**

After the second leak, the same procedure was used. Additionally, O-rings were replaced by new rubber O-rings (see Figure 2-6 left). Large cable ties have been added to relieve some of the tension on the connection (see Figure 2-6 right).

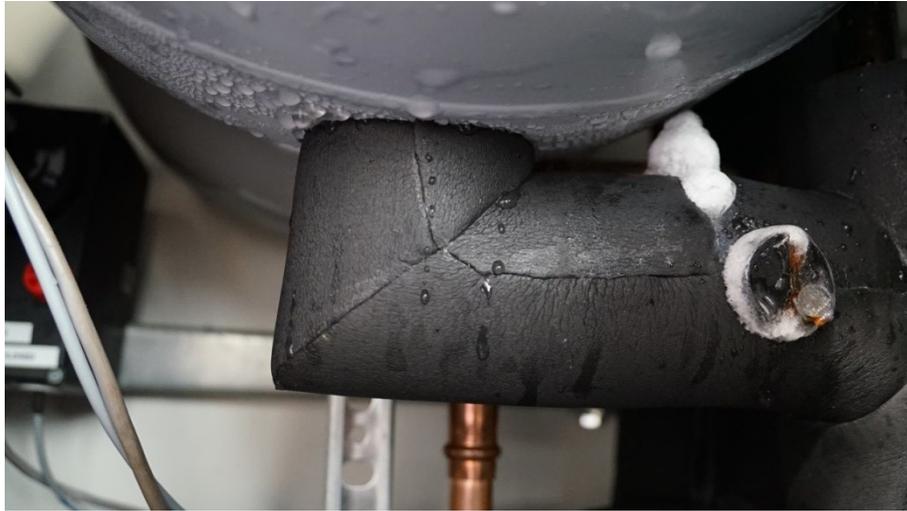
At the 14<sup>th</sup> of March ice formation in the thermal subsystem rack could be observed (see Figure 2-11), probably caused by frozen condensing water from the air in the SES. No actions were taken.

Figure 2-7: Thermal system condensation.

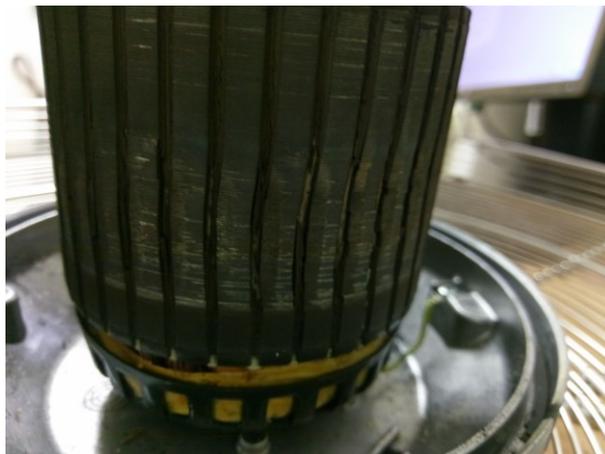
One free cooler fan broke on the 18<sup>th</sup> of May (see Figure 2-8). Likely cause is suspected to be the high temperature differential between the outside and inside of the fan motor.

Figure 2-8: Damaged free cooler fan motor

Broken fan disconnected from free cooler control box so that the remaining fan can work. Free cooler is manually switched off, only on during warm periods / periods without wind, when the free cooler temperature rises too high.

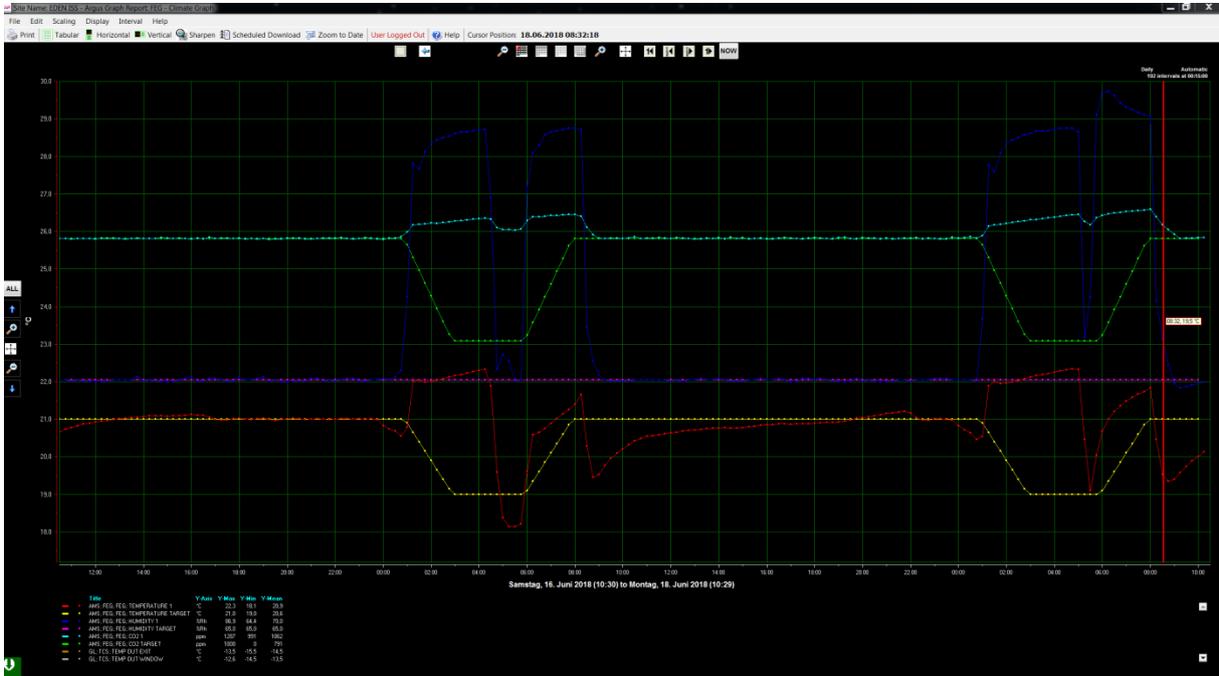
During the nights from the 15th until 18<sup>th</sup> of June temperature increases in the FEG (no cooling), accompanied by a simultaneous increase in the AMS cooling loop coolant temperature to 20+ degrees (see Figure 2-9 and Figure 2-10).

Figure 2-9: FEG Climate.

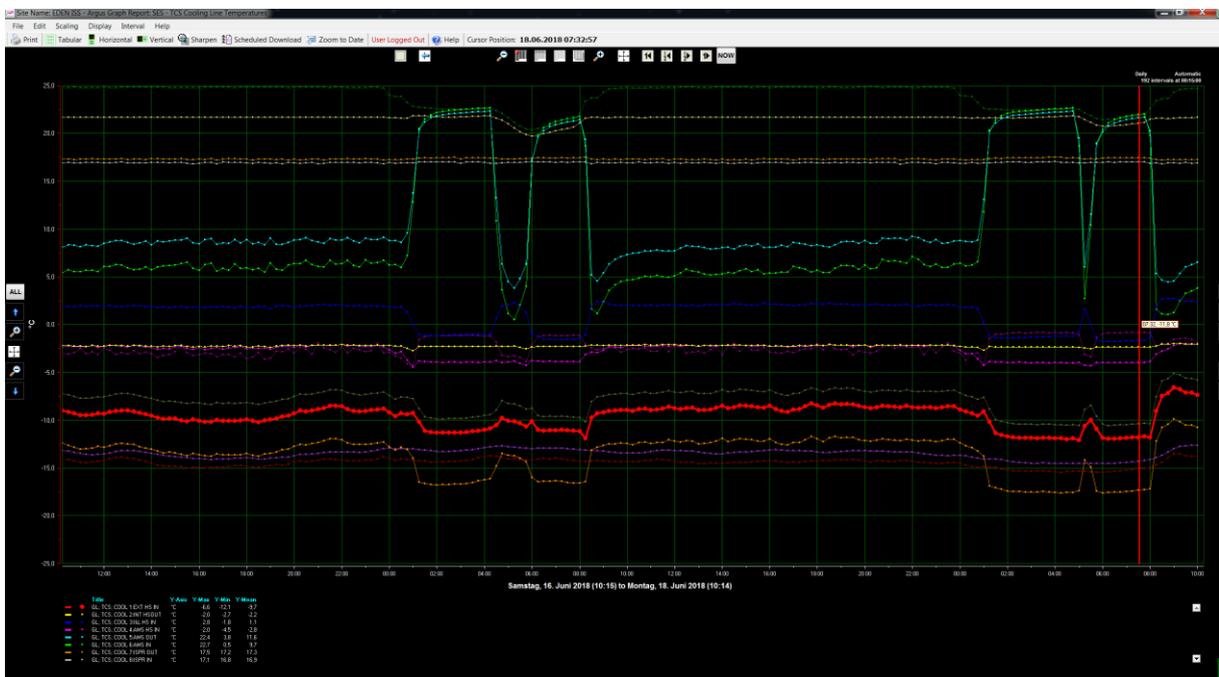
Figure 2-10: Coolant temperatures.

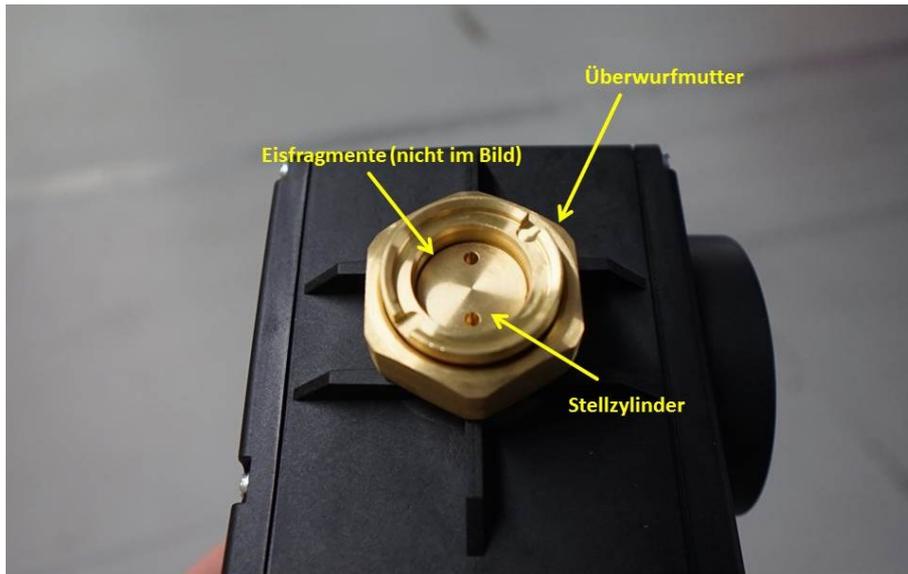
This behavior of the system was caused by the free cooler 3-way valve getting stuck in close position due to ice fragments between the valve and the actuator (see Figure 2-11). This prevented the system from removing heat out of the system, resulting in the increase in AMS loop coolant temperature, which subsequently prevented cooling of the FEG.

Figure 2-11: Free Cooler valve actuator.

Free cooler fan was turned on manually. This caused a temperature drop in the external cooling loop to  $-15\text{ }^{\circ}\text{C}$ . This in turn caused the freezing of the actuator of the free cooler 3-way valve (probably condensing humidity inside the actuator).

Actuator was removed for inspection and drying. ILS turned off for the night.

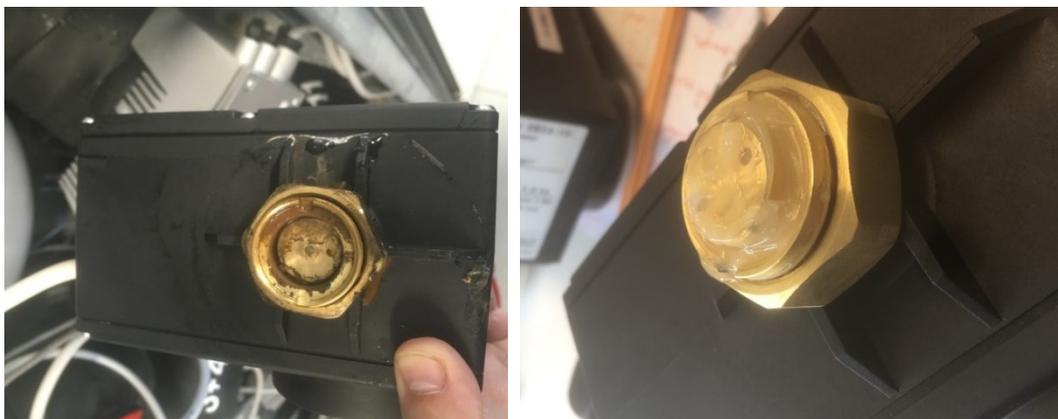
Figure 2-12: Left: Old valve actuator with condense water on piston; Right: New valve actuator with grease on piston.

- Broken Free Cooler fan was replaced with new one (see ID 29).
- Broken TCS temperature sensor 4 AMS IN was replaced with new one (see ID 46)
- Installation of bucket below the TCS rack, which collects the cooling fluid in case of overpressure in the cooling loops.
- Replacement of valve actuators of the Free Cooler loop and the ISPR loop (see Figure 2-12). Grease was put on the pistons of the actuators to prevent that the 3-way valve getting stuck due to ice fragments between the valve and the actuator (see IDs 39, 42, 47).

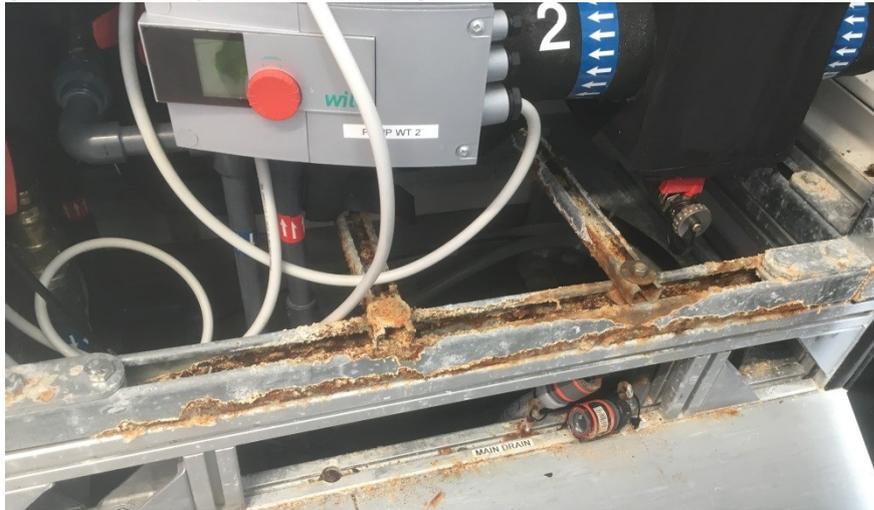
Figure 2-13: Rust at the metal structure of the TCS rack.

- Remove rust from the metal structure of the TCS rack, caused by condensation and cooling fluid leakage events during the overwintering season (see Figure 2-13).

Unfortunately there was no antirust agent on site to protect the TCS rack from further corrosion. For this reason it would be useful to take antirust agent to Neumayer Station III in the next summer season and cover the metal structure with it.

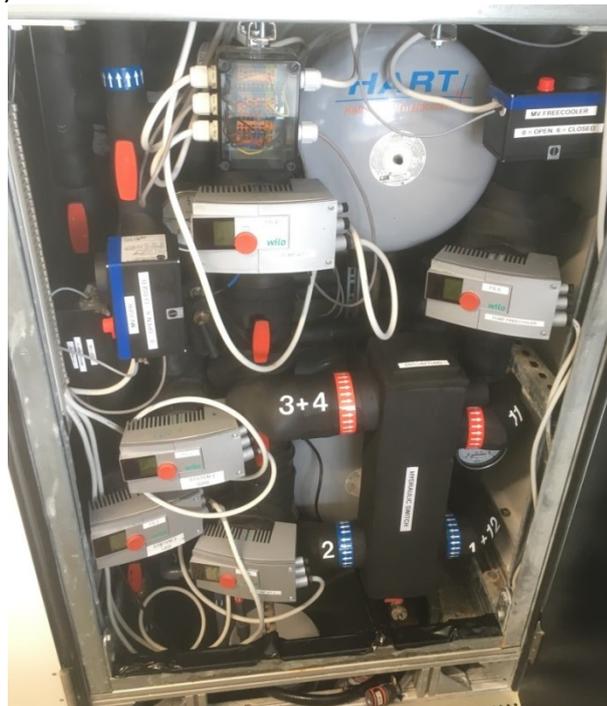
Figure 2-14: Insulated Thermal Control System.

- Insulation of the TCS system at the positions where condensation was detected during the overwintering season and where insulation was removed to exchange the system parts under it (see Figure 2-14).
