Renewable Energy

Outdoor detection and visualization of hailstorm damages of photovoltaic plants

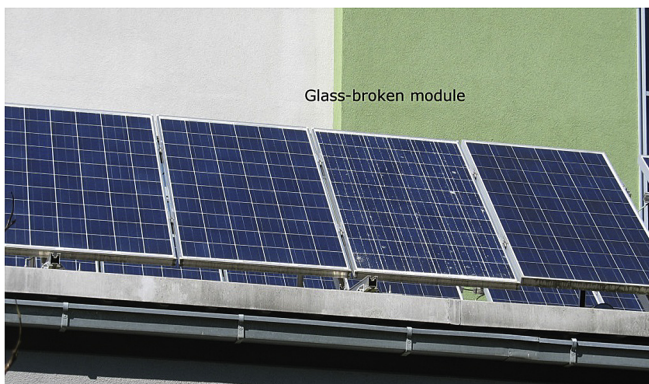
Fig. 1. Module with broken glass after hail storm (plant 3).

After a heavy hail storm in summer 2015, all three PV power plants showed visible damage with some glass-broken modules: 4 (out of 80), 3 (out of 510) and 1 (out of 32) were affected for plants 1, 2 and 3, respectively. Modules with broken front glass count as severe/strong damage (Figs. 1 and 2) as this damage has a direct impact on the yield of the PV-plant.

The broken modules were exchanged shortly after the hail event due to safety and performance reasons. For plant 1 the change was at 21st of July 2015, for plant 2 the change was at 11th of August 2015.

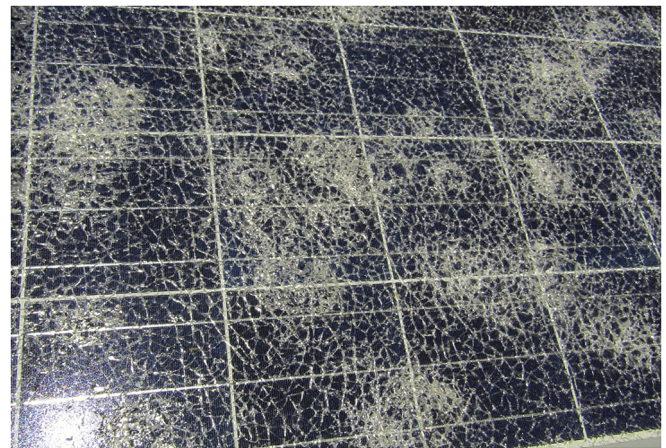
Fig. 2. Module with broken glass after heavy hail storm (plant 1).

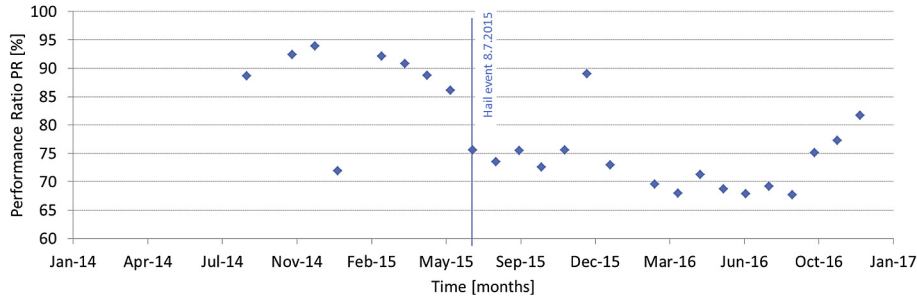
The immediate effect of heavy hail storm can be detected in the monitoring portal of the whole plant 1 (Fig. 3). A loss in the PR of plant 1 of about 10–20% could be observed directly after the hail event. In other cases, like for plant 2 and 3, the effect of the storm is inconspicuous in the PR (Figs. 4 and 5).

Fig. 3. PR before and after hail event for Plant 1.

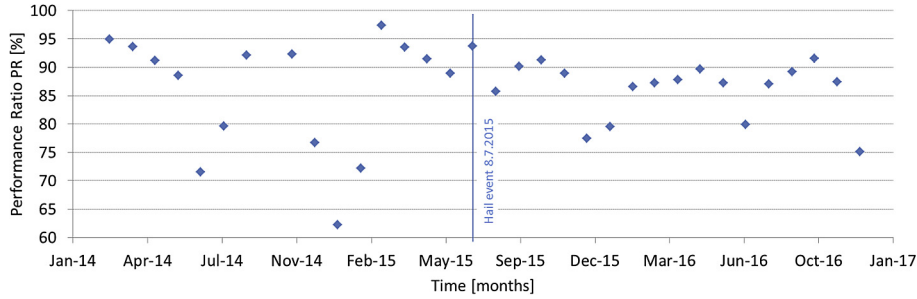
Fig. 4. PR before and after hail event for Plant 2.

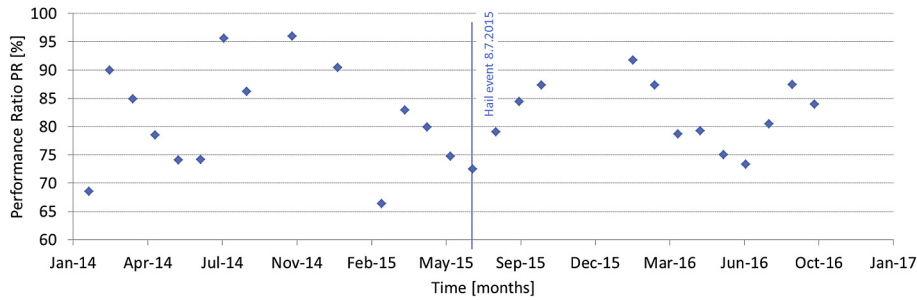
Fig. 5. PR before and after hail event for Plant 3.

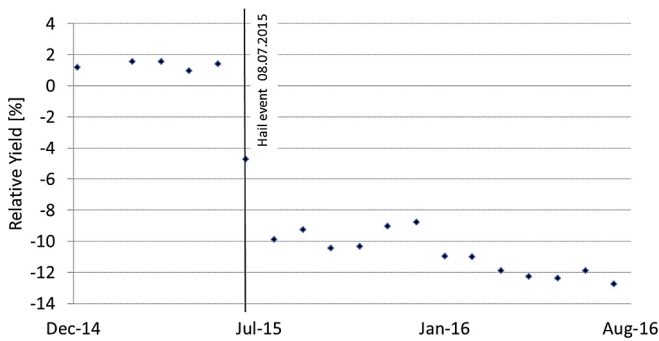
Despite a PV module with broken front glass, which is caused by the hail storm, we do not find a drop in the PR of plant 3. Therefore we evaluate the yield of the broken module relative to an undamaged PV module. In Fig. 6 we show the monthly relative yield as quotient of the yield for the glass-broken module to the adjoining reference module. Before the hail storm, the selected two modules showed nearly identical yields with a deviation of only 1–2% from the expected value. After the hail a drop in the relative yield of –10% is observed and in the following an accelerated degradation rate is found for the broken module.

Fig. 6. Yield of a hail affected module relative to a reference module before and after the hail storm (Plant 3). The module front glass broke during the hail storm.

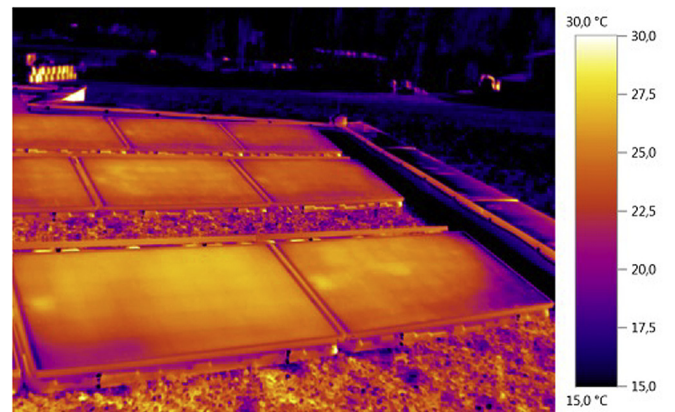
All three power plants are analyzed with thermography in order to find out if damaged modules with broken glass are detectable by their thermographic images (see Figs. 7–9). It can be seen that modules with hail affected damages show no or very little features in their thermographic image when investigated after the hail event.

Fig. 7. TG image of plant 1.

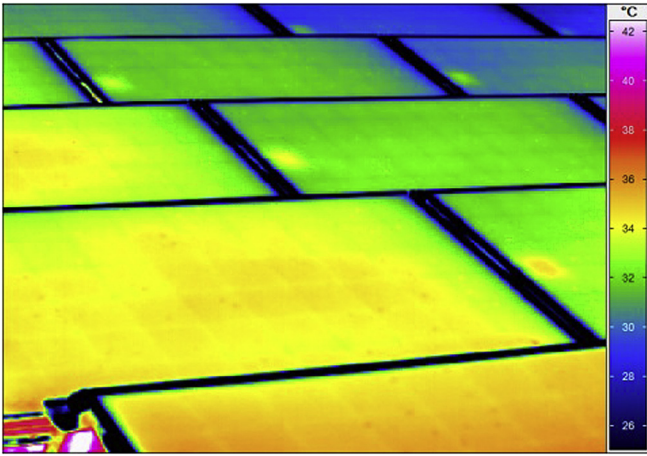
Fig. 8. TG image of plant 2.

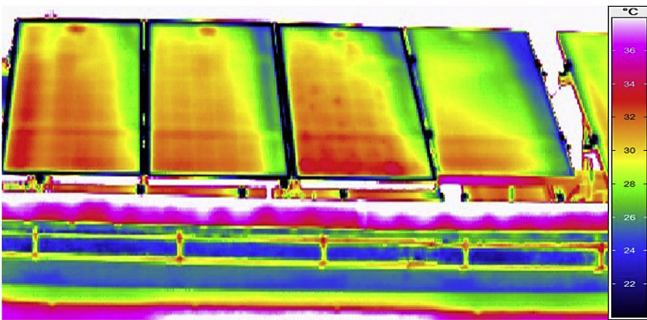
Fig. 9. TG image of plant 3.

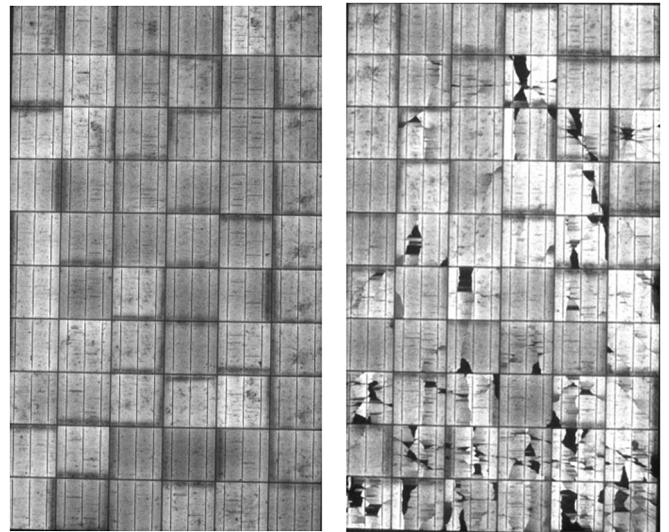
Fig. 12. a, b: EL image of hail affected modules of plant 3 (left – hardly damaged, right – glass-broken module with a relative yield loss of –10% due to cell cracks).

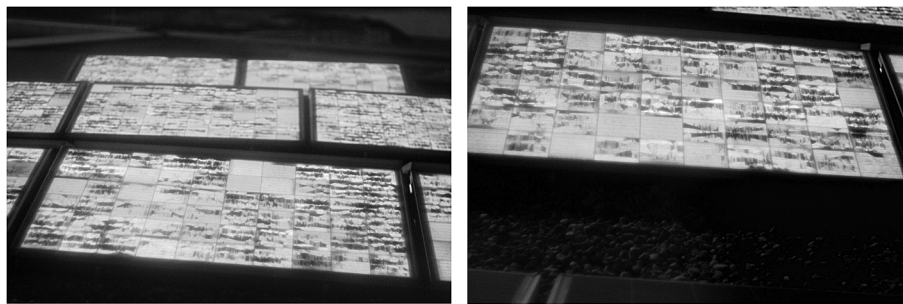
it can be clearly seen that many modules of plant 1 show countless broken cells. Although the glass of these modules is still intact, the cell damage as detected by EL is severe (as shown in Fig. 10) and explains the measured yield, respectively the performance loss of this plant after the hail event. Two sample-modules were taken from the plant and tested in the laboratory with a module flash test

system. Sample module one shows a power drop from 250 Wp to 163 Wp (−35%) and sample module two from 250 Wp to 177 Wp (−29%) relative to the initial flash report.

Fig. 10. a, b: TW-EL image of hail affected modules of plant 1 (glass not broken, ~ –30% power loss due to micro cracks).

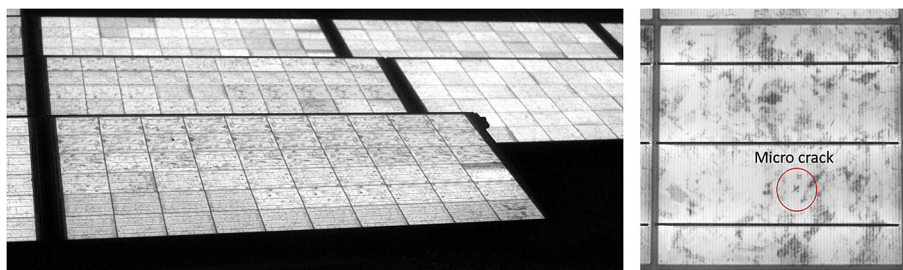
any abnormalities after the hail storm: the main fraction of the solar cells does not show any cracks, only a detailed analysis of individual cells give evidence for the presence of micro-cracks. Detection of micro-cracks by twilight EL in combination with UV-fluorescence measurements is described in detail in [chapter 3.4](#).

Fig. 11. a, b: TW-EL image of hail affected modules of plant 2 (no loss detectable, only tiny cross micro cracks).

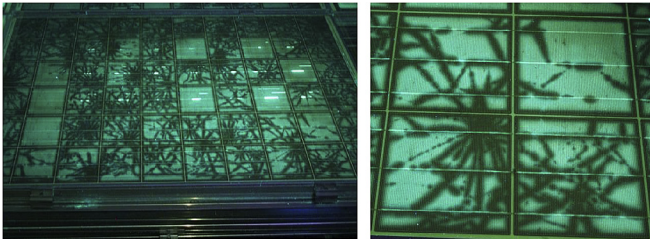
UV-Fluorescence images are taken of the hail-affected power plants ([Figs. 13 and 14](#)). The direct impact of larger hail stones on the cells can be seen in the UV-F pattern ([Fig. 13a, b](#)) which directly

Fig. 13. a,b: UV-F image of a hail damaged module of PV-plant 1 and details with spider web appearance due to micro cracks.

reflects the cobweb-shaped cracks in the cells starting from the impact-centre. Next to strongly affected cells with numerous cell-cracks also intact cells exist within the same module. The extinctions of the UV-fluorescence above cell cracks allows for the clear visualisation of cell-damages without interfering with the electrical system of the module. The cell cracks visualised with UV-F are in perfect agreement with cell breakages as detected by EL (Fig. 10a, b).

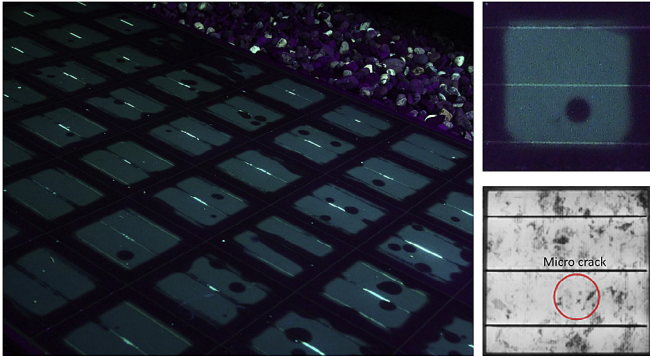
Fig. 14. a,b,c: left: UV-F images of a module in PV-plant 2 and details of one cell with cross-micro crack (UV-F and EL).

cracks, especially in plant 2 there are several modules found with extraordinary point-shaped extinctions (Fig. 14) of the UV-F which cannot be explained unambiguously at the first sight. Additionally performed high resolution EL-measurements of the effected cells directly in the plant suggest, that small cross-shaped micro-cracks in the cells lead to the extinction-points in the UV-Fluorescence pattern. In order to prove this assumption, an imitation of this effect was performed with specially prepared test modules in accelerated aging tests (see Chapter 3.5).

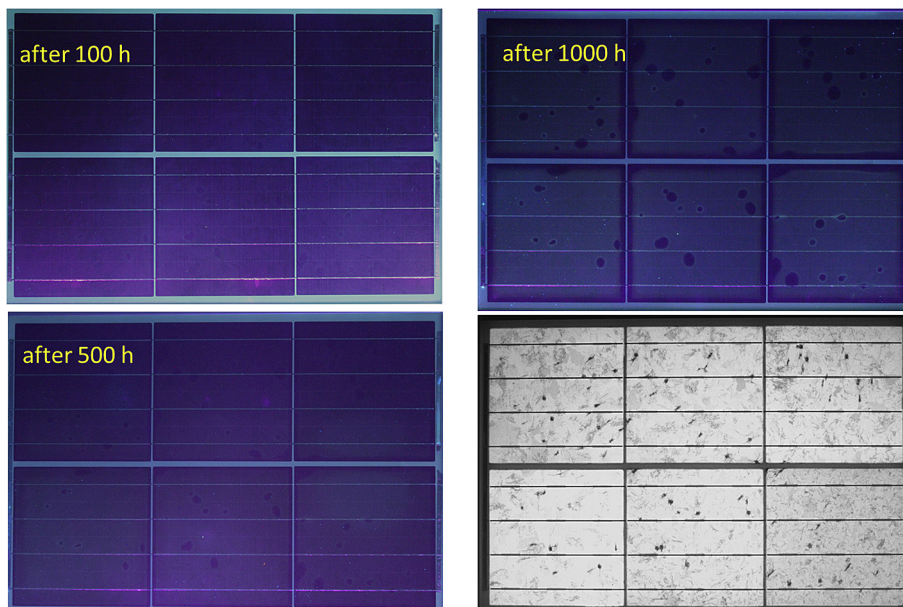
In order to prove that the point shaped extinctions in the UV-F observed in plant 2 originate from (possibly hail-induced) micro cracks in the cells, test modules were produced and part of them deliberately stressed in order to simulate local mechanical impact. EL proved the formation of micro-cracks (see Fig. 15). These test modules were then subjected to accelerated aging and the development of characteristic UV-F patterns is monitored in Fig. 15a–c.

Fig. 15. UV-F images of test module with micro cracks after a) 100, b) 500 and c) 1000 h of artificial sunlight at 1000 W/m² and d) initial EL-image of test module.

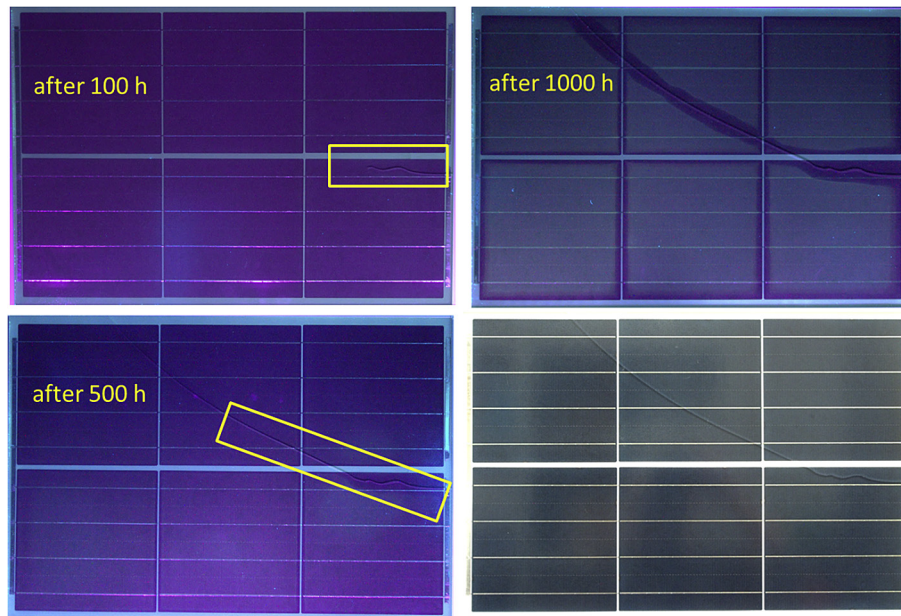
The comparison of the EL and UV-F images in Fig. 16 clearly proves that the point-shaped UV-extinctions originated from cross-shaped micro cracks in the cells.

The effect of glass breakage on the formed UV-F pattern is visualised in Fig. 16. Beneath the glass breakage a line shaped extinction of the UV-F takes place, the broadness of the extinction increases with increasing exposure time.

Fig. 16. UV-F images of test module with glass breakage after a) 100 h, b) 500 h and c) 1000 h of an artificial sunlight at 1000 W/m^2 and d) photograph after 1000 h.
