Project report – AM 4 Industry

LBM Additive Manufacturing Defect Catalogue

Acronym	AM4Industry
Full title	AM 4 Industry - quality assurance and cost models supporting the widespread use of additive manufacturing
Web	www.am4industry.com

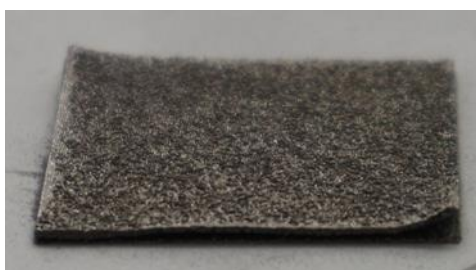
During the layer-wise solidification of the feedstock material in the LBM process, thermally induced residual stresses arise. These residual stresses can lead to deviations from the nominal geometry due to shrinkage and distortion. To prevent distortion or even detachment of the component from the building plate, as shown in Figure 3, the building plate can be preheated in order to reduce the temperature gradient.

Figure 3: Detachment of the component from the building plate (mid-process)

Besides reducing distortion, preheating also prevents stress-induced micro-cracks in the component. In addition, improved heat dissipation from the component into the building plate can be attained by the use of suitable supporting structures. In case of poor adaptation of these supporting structures to the geometry of the component, the component may be bent upwards, resulting in curvature. If this happens during the LBM process, there is a risk that the coater will collide with the component. This can cause a process breakdown, or even damage to the coater unit.

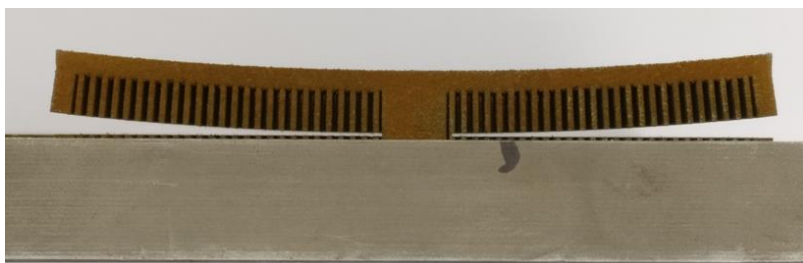
Figure 4: Residual stresses become apparent during separation from the building plate (post-process)

To prevent post-process distortion as indicated in Figure 4, it is recommended that the component is separated from the building plate after the appropriate post-heat treatment.

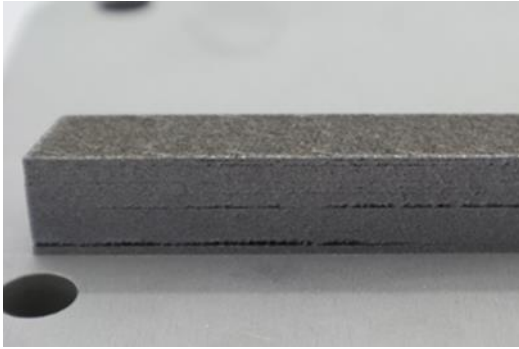
During LBM it is also possible that entire layers become detached from the solid material. This macroscopic defect is referred to as delamination (Figure 5). Insufficient layer bonding can occur due to lack of energy input, incomplete particle melting or contaminations in the feedstock material. Delaminations cannot be eliminated using post-heat treatment.

Figure 5: Macroscopic delamination

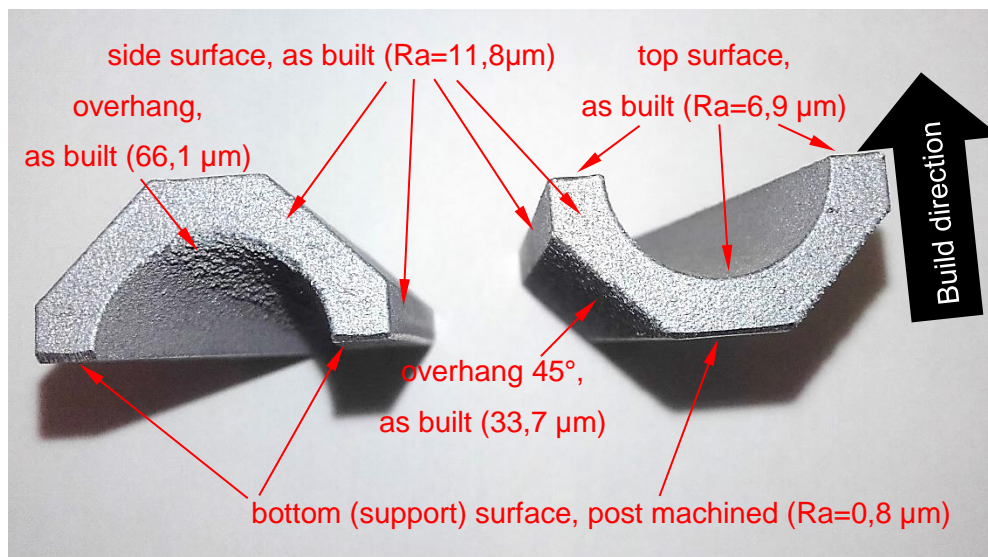
On the one hand, the surface quality of components manufactured using LBM depends on the appropriate processing parameters. On the other hand, the alignment of the geometry in the building space also affects surface quality. In particular, surfaces manufactured parallel or perpendicular to the construction panel are generally of better quality than overhanging surfaces. Overhanging surfaces have a lower roughness because more powder particles adhere to these surfaces.

Figure 6: Roughness (AlSi10Mg) influenced by build direction

In order to be able to use LBM-manufactured components industrially, it is often necessary to reduce surface roughness by using suitable finishing processes.

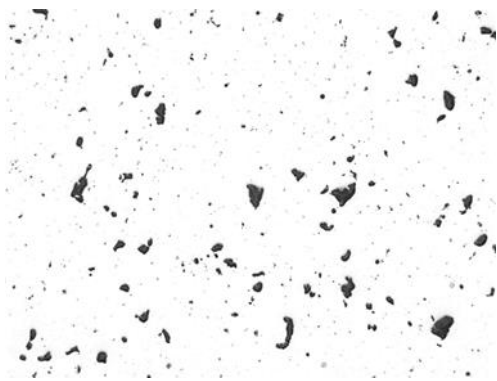
Porosity inevitably occurs in the LBM process. Thus densities of one hundred percent can be hardly achieved. A distinction is made between circular pores, usually gas pores, and irregularly shaped pores, referred to as bonding defects. Both types of defect can be seen in the exemplary micro-section in Figure 7, which was deliberately produced with insufficient energy input. Gas pores are formed either by trapping gases from the atmosphere or through the evaporation of certain alloy elements. Gas pores are circular and often form due to the high energy input into the material. Their distribution in components is random. Lack-of-fusion defects result from insufficient melting of the feedstock material. With materials that are easily oxidised, oxides can reduce the melt flow, resulting in poor coverage and thus to lack-of-fusion defects.

Figure 7: Micro-section of AISi10Mg test sample with insufficient energy input, resulting in porosity (circular and irregular pores)

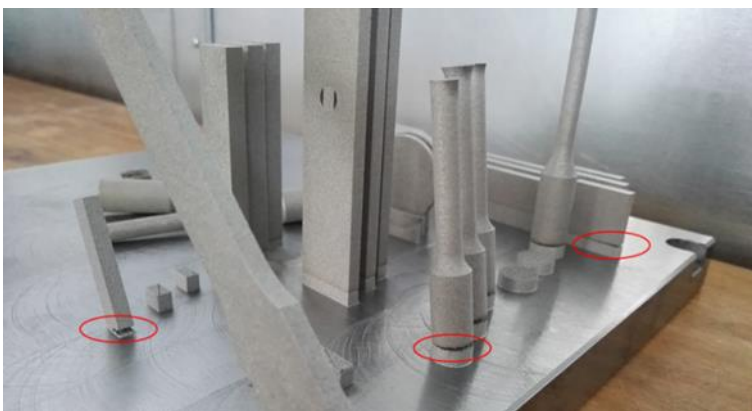
In the worst case scenario, the build job must be rejected because components are bent. This can be caused by a collision of the recoater with component layers that have been bent due to previous exposures on account of thermal stresses caused by weak geometrical stability of the component areas, or alternatively, by omitting or installing inadequate supports. A weak support strategy can lead to a break in the interface between the support and the component, or between the support and building platform. Of course, if the geometrical stability of the component is weak, a break in the weakest part of the component may occur.

Figure 8: Break in the interface between support and component due to weak support strategy

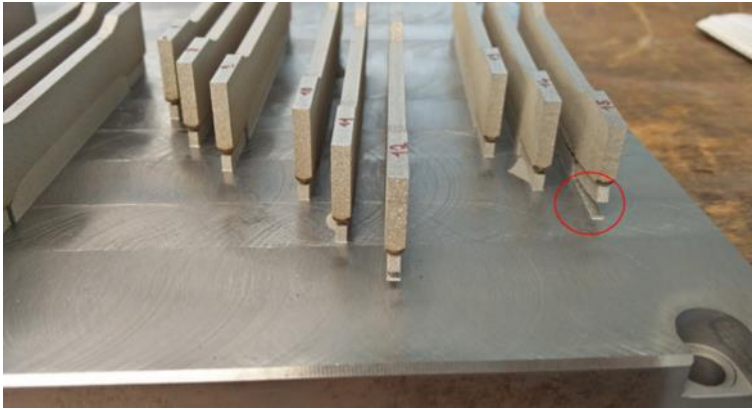
Figure 9: Break in the interface between support and building platform due to weak support strategy

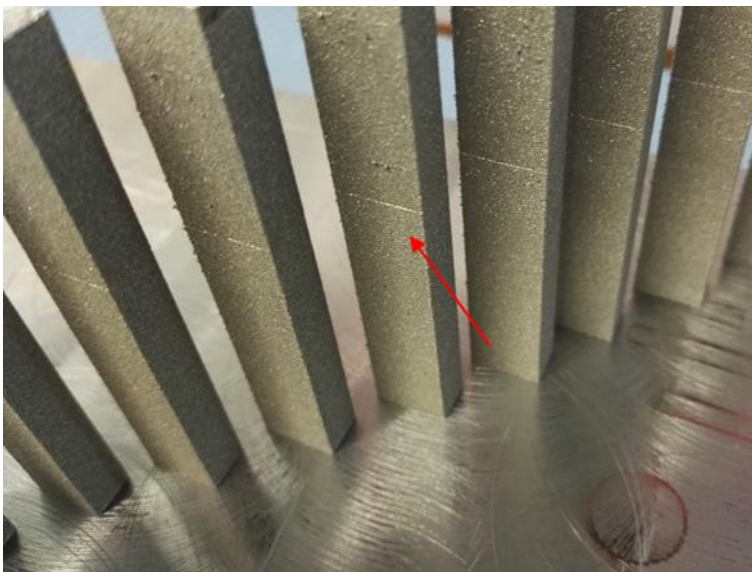
After the building job is continued, traces of this event are usually visible on the component if the pause lasts longer than a few hours.

Figure 10: Marks caused by pausing a building job

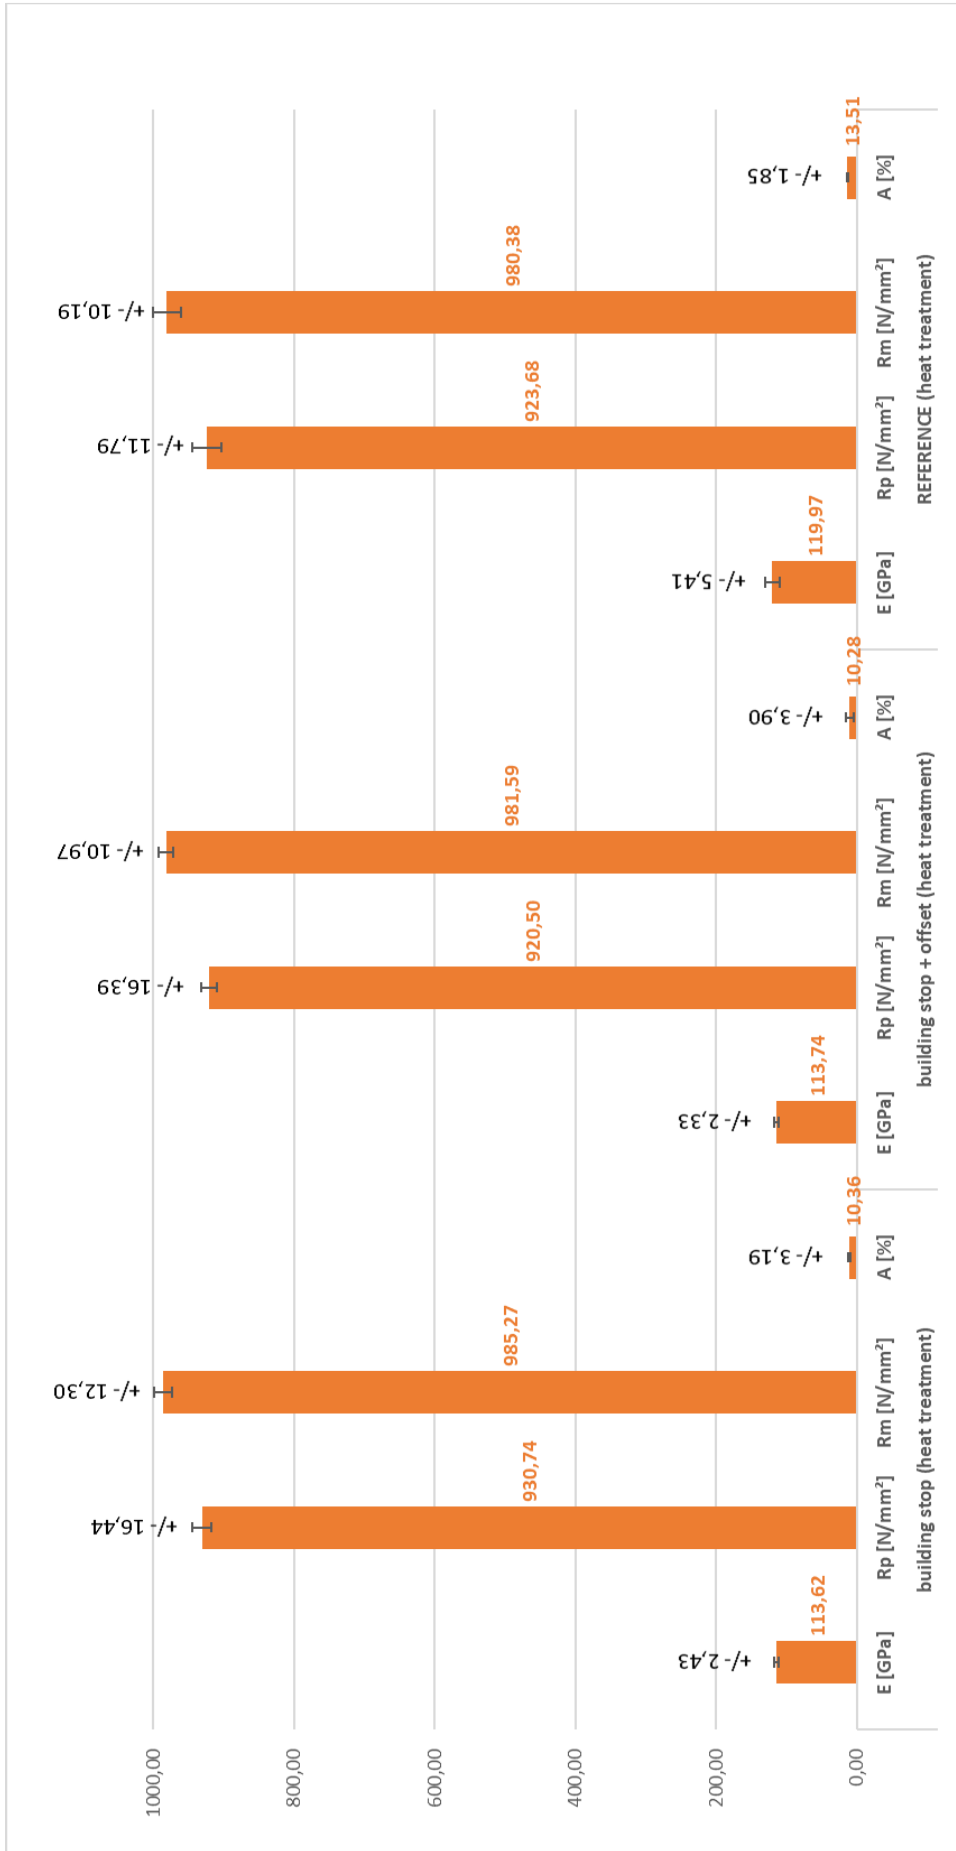
The result of the tensile tests (according to ASTM E-8) is shown in the following diagram (see Figure 12). Compared to the reference component, there are almost no differences in Young's modulus (E), yield strength (R_p), ultimate strength (R_m) and elongation at break (A). The only striking difference is the standard deviation of elongation at break. Here, the average value is below the reference value. The standard deviations for an interrupted building job are also twice as high as the reference value.

Figure 12: Tensile test diagram – effect of pausing building jobs Impact of blocked inert gas flow

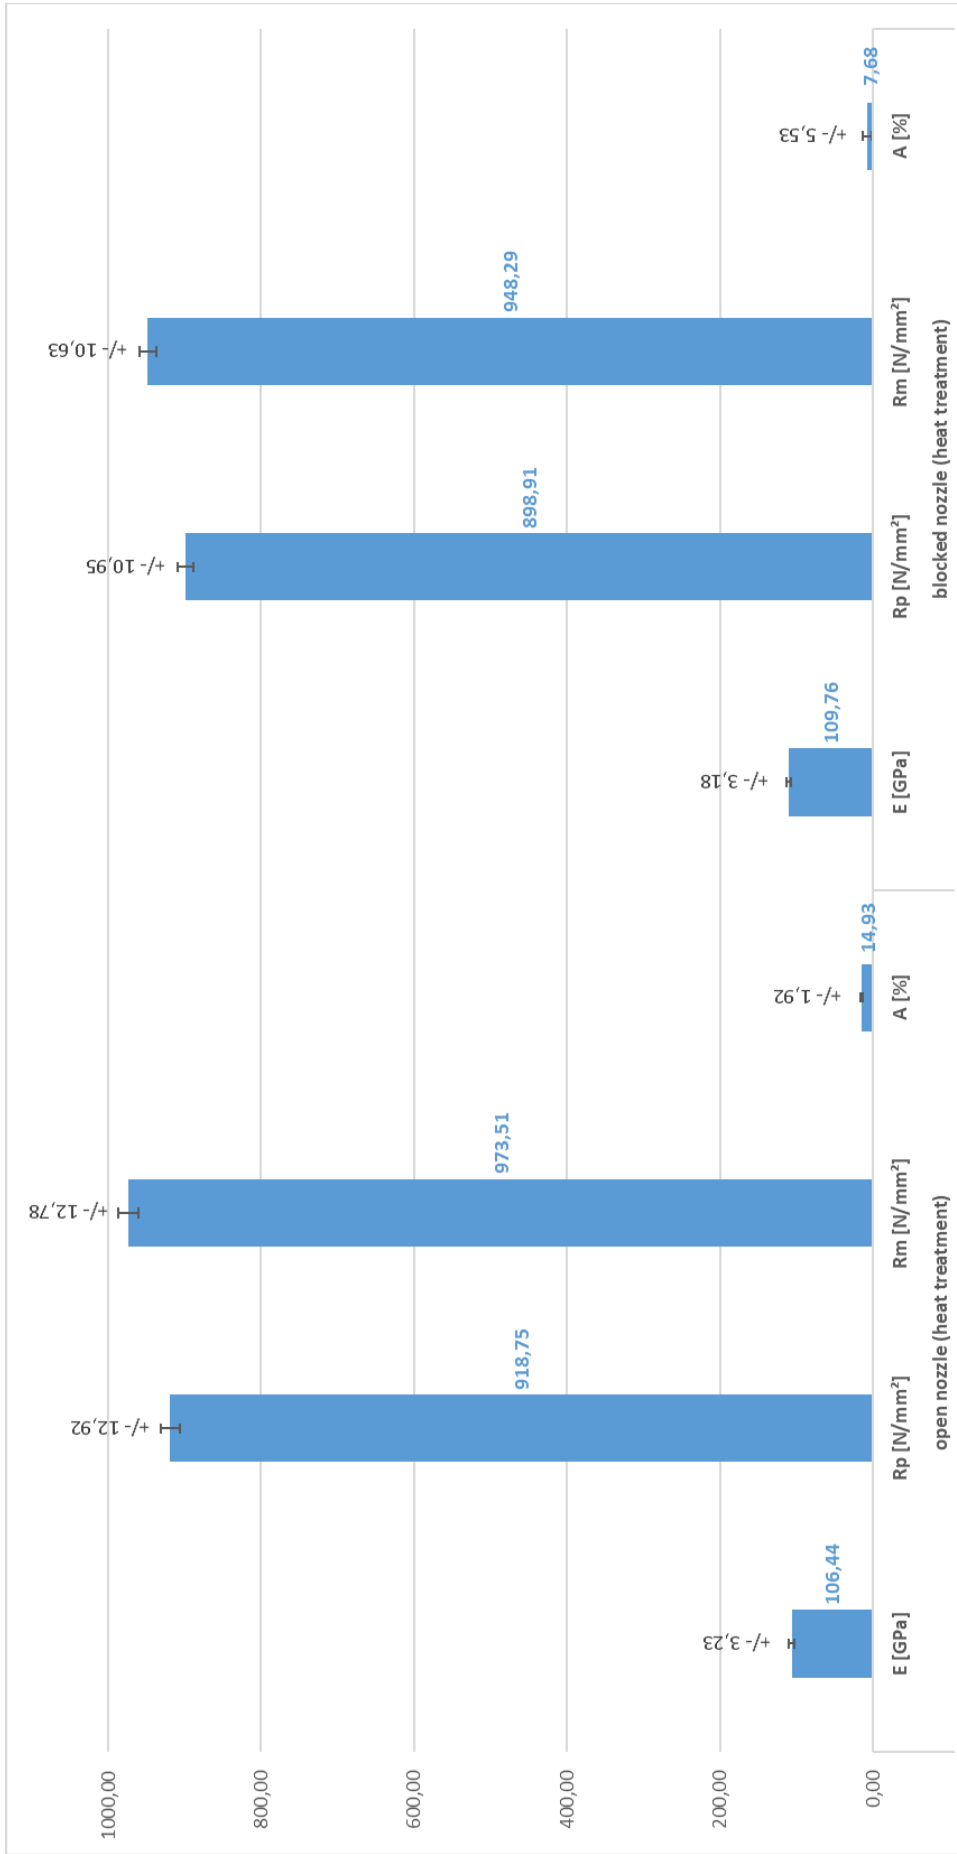
The tensile test results (according to ASTM E-8) of the blocked nozzle samples actually show some differences to the open nozzle samples.

The yield strength (R_p), ultimate strength (R_m) and elongation at break are lower than the values of the open nozzle samples. When comparing the standard deviation, the only significantly higher value for the blocked nozzle samples is represented in elongation at break.

Figure 15: Tensile test diagram – impact of blocked inert gas flow compared to the fractured surface of the tensile samples (see pictures below), there is also a difference. While the samples in the area of the blocked nozzle (right side of building platform, Figure 13) showed

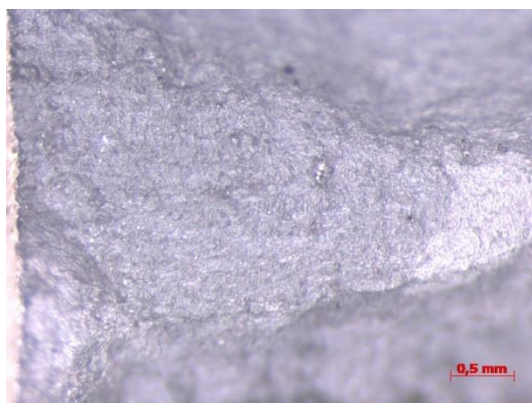
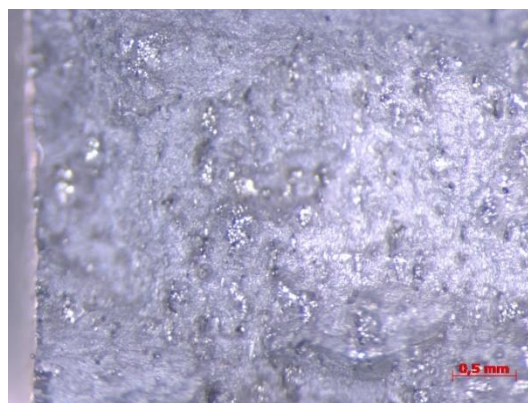
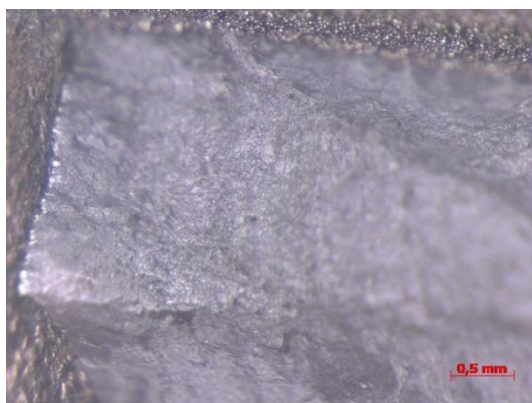
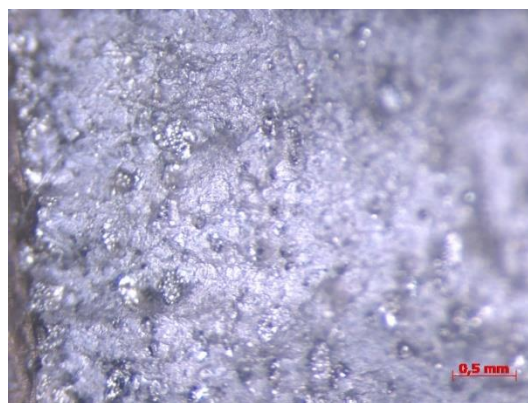
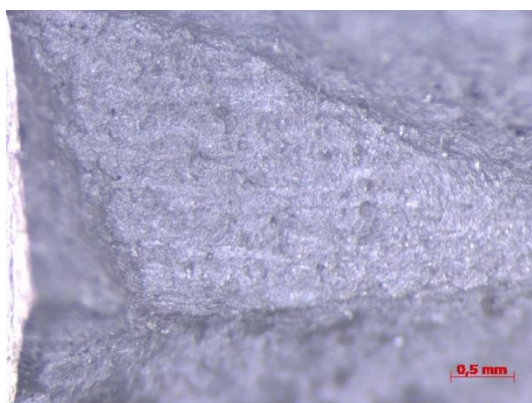
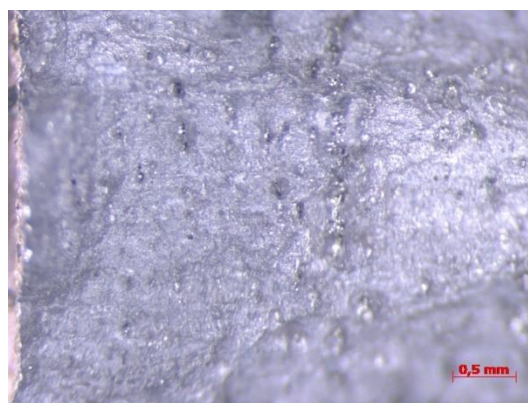
Firstly, due to differences in particle size and shape compared to LBM powder, weld spatter can lead to inhomogeneous melting and thus to spatter inclusions, or even pores (see Figure 16 to Figure 21). Secondly, blockage of the local inert gas flow can lead to local flow disturbances and thus to an improper welding atmosphere.

Figure 16: Sample 6 (open nozzle, near gas inlet)

Figure 17: Sample 1 (blocked nozzle, near gas inlet)

Figure 18: Sample 8 (open nozzle, middle of gas inlet and outlet)

Figure 19: Sample 3 (blocked nozzle, middle of gas inlet and outlet)

Figure 20: Sample 10 (open nozzle, near gas outlet)

Figure 21: Sample 5 (blocked nozzle, near gas outlet)

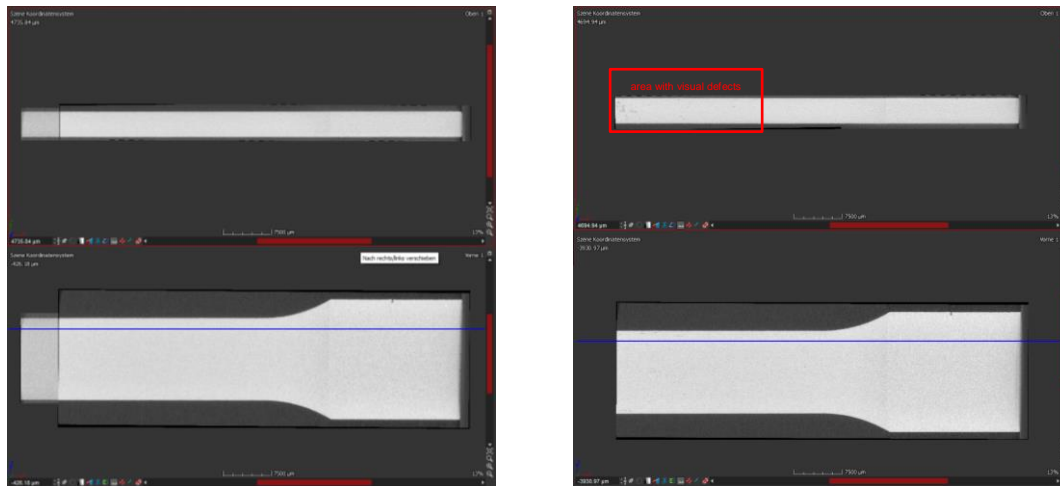
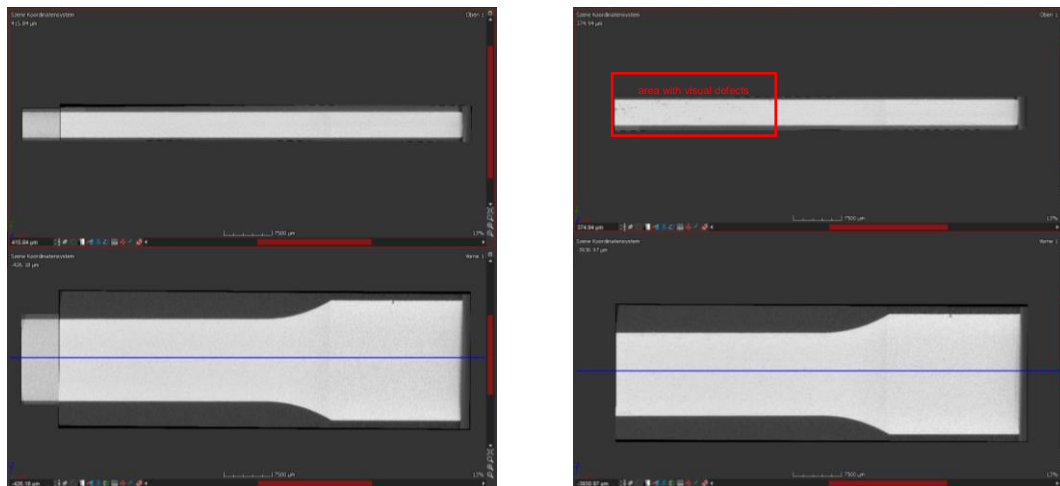
The CT analysis again showed these errors in the samples. Sample 2 from the right side and sample 7 from the left side of the building platform are compared in two layers (visual defect area in layers 153 and 297 from the top). Almost every layer of sample 2 showed weld spatter defects, while sample 7 showed no defects.

Figure 22: Layer 153 from top surface sample 7 (left), sample 2 (right)

Figure 23: Layer 297 from top surface sample 7 (left), sample 2 (right)

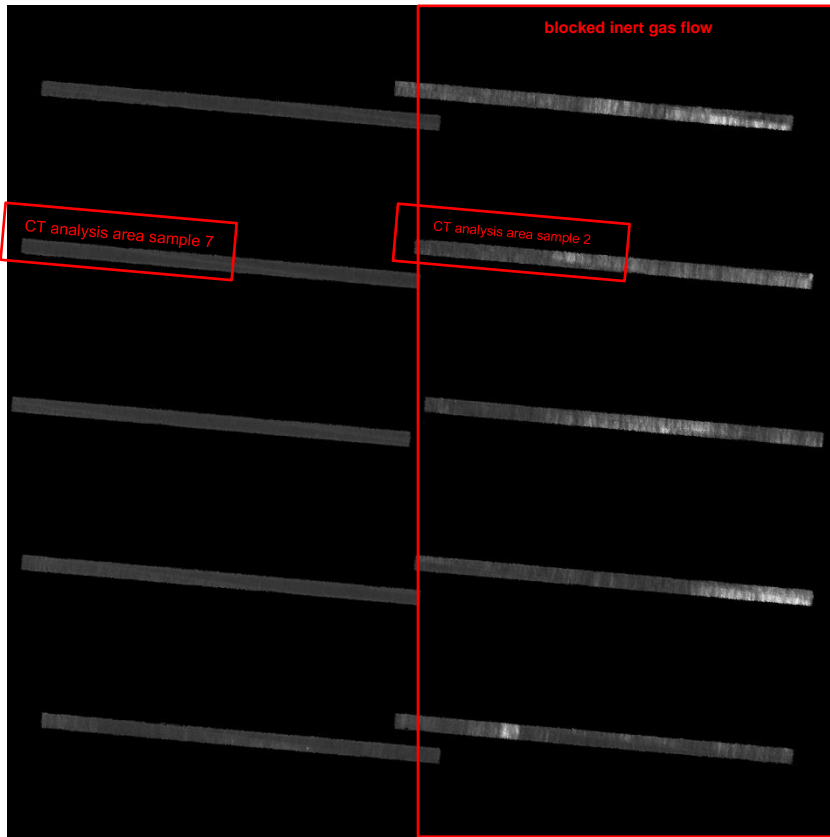
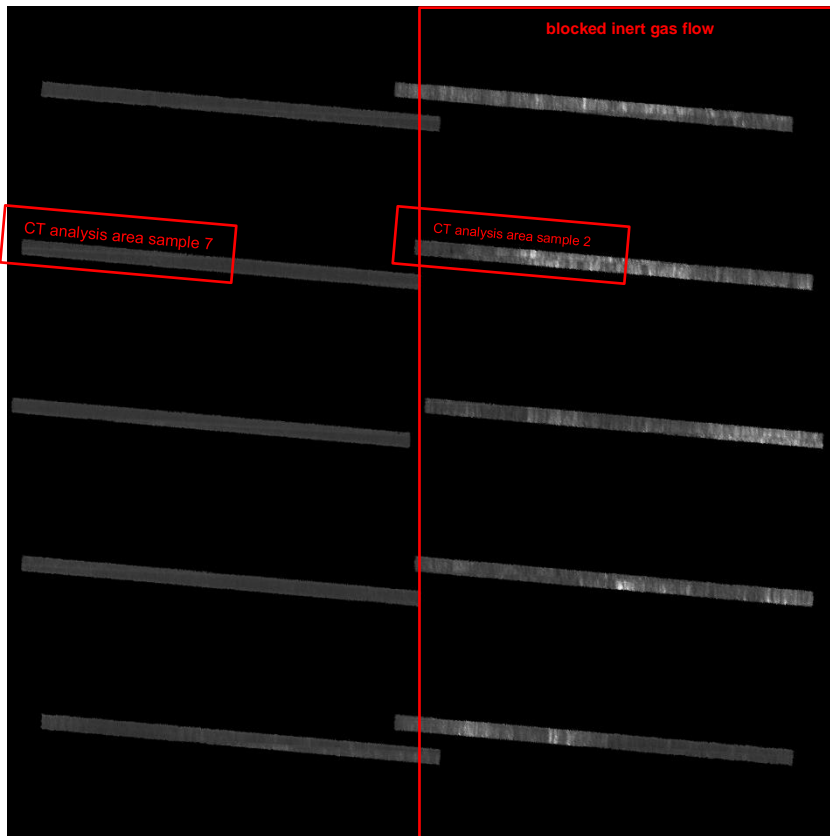
FOTEC's layer monitoring system identified the weld spatter errors as well. Melt pool layer monitoring measures the emitted light every $20\ \mu\text{m} \times 20\ \mu\text{m}$ over the entire building platform and calculates an average value from the values for a point of $100\ \mu\text{m} \times 100\ \mu\text{m}$. It clearly shows the defects (brighter areas) on the right side of the building platform. Here, too, the layers from the CT analysis from Figure 22 and Figure 23 before the CT analysis are shown in the subsequent figures.

Figure 24: Melt pool monitoring at FOTEC (Layer 153 from top surface)

Figure 25: Melt pool monitoring at FOTEC (Layer 297 from top surface)

Therefore, melt pool monitoring could be used to detect weld spatter inclusion faults during building jobs. Through implementation of a limit of reflected laser power scrap parts / regions could be identified and documented.
