Crack Healing of High Temperature Hydrogen Attack Corrosion by Heat Treatment

Azzura Ismail, Azlizul Aizat Razali, Asliaty Atim, Muhammad Amin Ali, Hariti Hasan

Keywords : Carbon steel, annealing, hydrogen attack, failure analysis

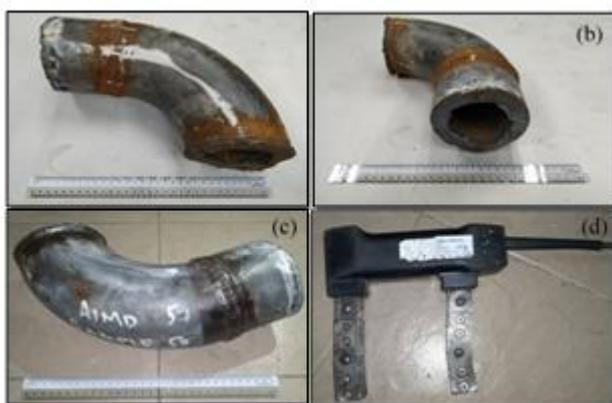
Fig 1. Failed pipe preparation for MPI

Visual identified cracks presence on circumference (concave surface) inner surface of the carbon steel caused by the hydrogen attack. Fig 1(a) showed the carbon steel pipe that already undergoes failure due to hydrogen attack which has been cut by oxy-acetylene torch cutting and wire-cut EDM cutting on the welding area (high-stress area).

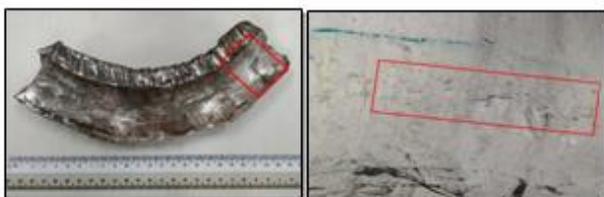
The procedure for MPI began by cleaning the sample from rust, oil, grease, paint and any contaminations using wire brush and remover. The cleaning process involved using the MPI spray kit that consists of a remover, followed by applying the base and finally the contrast enhancer spray. A clean specimen is shown in Fig 1 (a)-(c) was needed to avoid hindrances which might occur during the MPI procedure. Then, the magnetic field was introduced into the specimen by using a hand-held magnetic yoke (Fig 1d) which induced a magnetic field between two poles and in order to have a proper inspection, every inspection area needed to be rotated to detect horizontal and vertical discontinuities. It was important to ensure that the specimen was being magnetised during MPI while the ferromagnetic medium particles were still airborne and free to be attracted to the leakage fields. The size of indication, intensity and the amount of magnetic field could provide a rough estimation of the discontinuity size. After the HTHA had been discovered through the MPI technique, the failed area was cut using oxy-acetylene torch cutting and wire-cut electrical discharge machining (EDM) cutting, as shown in Fig 2 before proceeding with the heat treatment by annealing.

Fig 2. Crack finding in curvature area

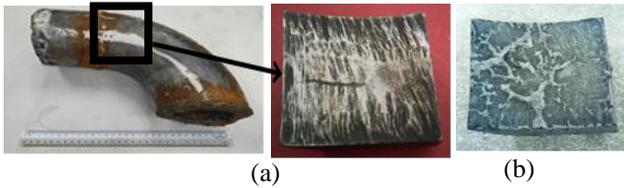
Heat treatment was done on the specimen to observe the reduction of crack length after undergoing heat treatment. It was annealed to 850°C with a holding time of two hours. The crack length of the specimen is reduced to 9 mm from 13mm after undergoing heat treatment with a total crack reduction of 30.77% as shown in Fig 3 while Table 2 listed the crack reduction. Visual inspection also identified of oxide layer during heat treatment was fragile and can easily scrapped off.

Fig 3: Crack on the surface of carbon steel (a) before and (b) after heat treatment

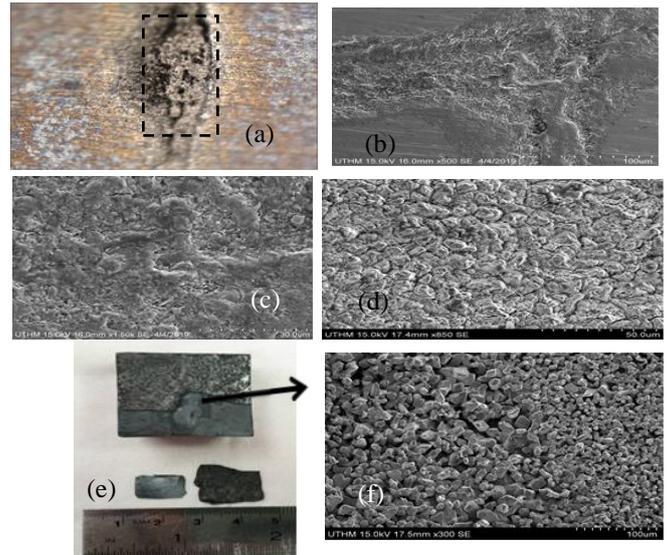
By observing the crack under the optical microscope, the images of the crack were obtained. The crack on the carbon steel specimen was caused by the formation of methane gas (CH_4), results from reaction of hydrogen with carbon in the steel. As the temperature and pressure were high, the methane gas did not escape and causing cracks on the wall of the carbon steel pipe (High Temperature Hydrogen Attack). Hence, Fig 4 below showed the crack that was contributed by the methane gas. The crack image that was observed under an optical microscope is 10x magnification.

Fig 4: Crack on carbon steel at different magnification and oxide layers (right bottom).

SEM result on the metallography was done before the specimen which is the carbon steel undergo heat treatment and also after undergoing heat treatment. Fig 4 (e) and (f) show the crack surface image observed by SEM showing intergranular cracks of corrosion. Moreover, decarburization occurs where carbon steel loses the amount of carbon. It can be seen in Fig 4(b). The difference between the crack area and the not affected area showed that decarburization has occurred to the carbon steel that has been subjected to HTHA. The microstructure also was identified after the heat treatment. It was revealed that the surface was fully covered by oxide layer after the heat treatment. Fig 4 (e) and (f) how the base metal after heat treatment without oxide layer attached. The surface denser with porous granulations showing some carbon missing during hydrogen attack. The white granules seem to appear in numbers on the surface without an oxide layer. The oxide layer easily peeled off showing that a fragile and crystalline like structure (Fig. 4 (f)) was formed during heat treatment.

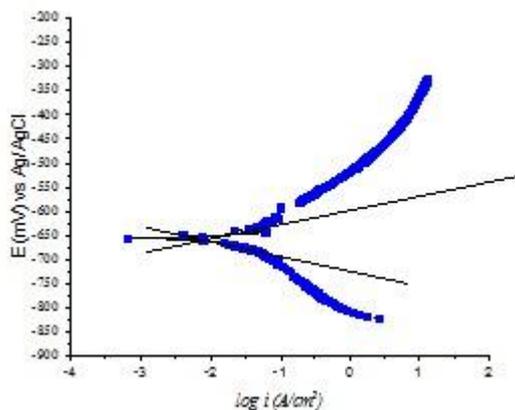
The electrochemical was run for Tafel scan to identified current density after the sample had gone through heat treatment. The scan rate used is 2mV/sec where the area of the specimen is 8 cm². The value of corrosion current density (I_{corr}), corrosion potential (E_{corr}), open circuit potential (OCP) and corrosion rate (CR) can be obtained. Tafel plot as shown in Fig 3 gives the values 17.974 μ A, -656.783 mV and - 656.9 mV for I_{corr} , E_{corr} , OCP respectively.

The corrosion rate was then calculated and given to value 26.081 mm/year. Quite a high rate due to oxidation reaction to give oxide layer for protection purposes. This gives a sign that the corrosion rate characterised the value of oxidation rate to formed oxide layer on carbon steel.

Fig. 5: Electrochemical by Tafel scan to identify current density and other corrosion properties
