Deterioration of a Building through Environmental and Anthropological Causes

A residential house in Sagar Nagar, Visakhapatnam [7], has been identified for the case study. The house is a perfect example of the condition that will be witnessed when maintenance is not done regularly for a building by the occupants. A duplex house, with greater percentage of open spaces in the site, was originally intended to be used as a weekend farm house. Over the years, the building has become prone to various factors leading to its current state. Hence, a study of its current condition would give us results that would be helpful in understanding the problems caused when the maintenance strategies are not followed.

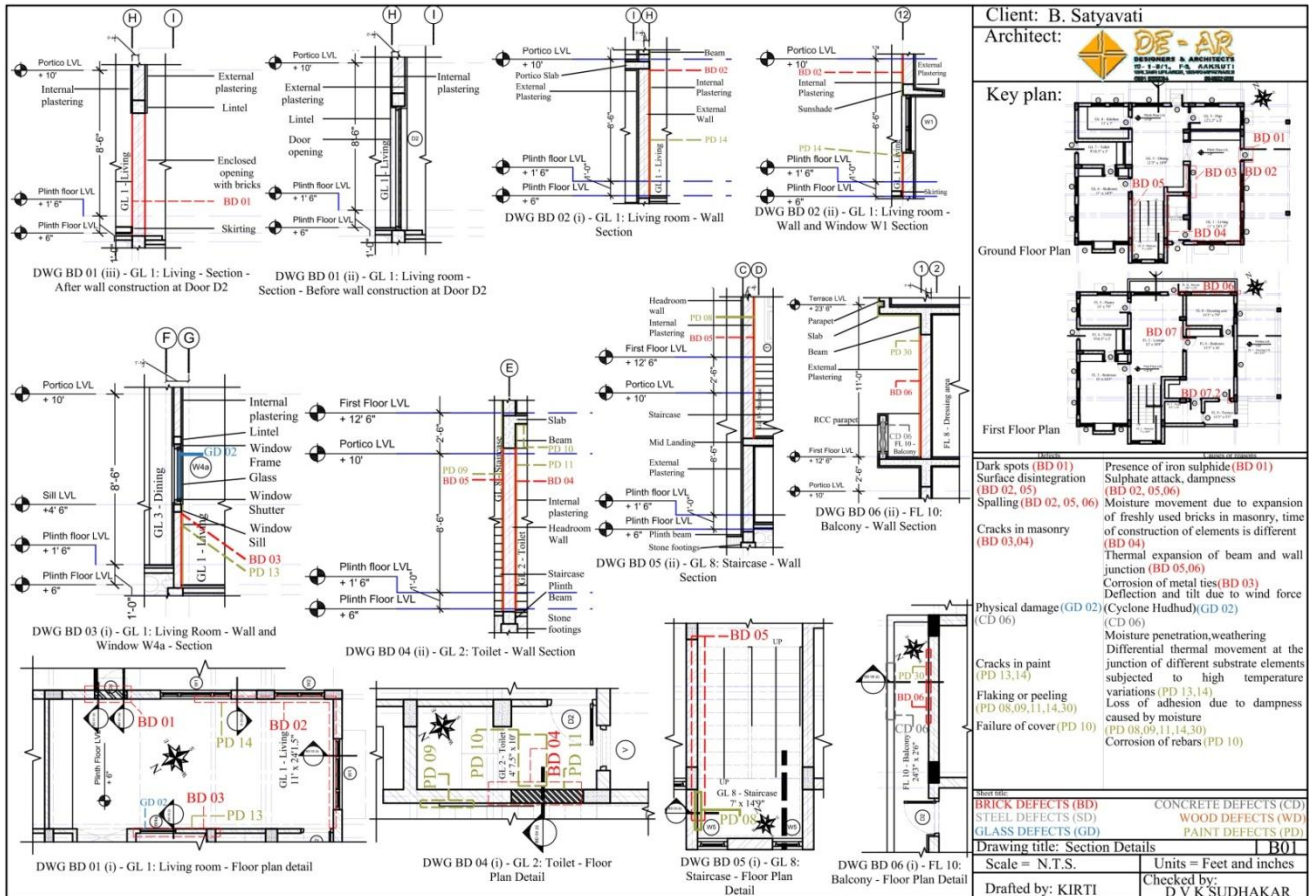
Figure 8 – Sheet B01: Architectural drawings of brick defects (BD) [4], [5], [10]

Patches or dark spots [5] on the surface of the brick [figure 6 (BD 01)] and cracks at the brick junctions due to the use of freshly used bricks in masonry that lead to expansion in response to the moisture movement [4].

Different time of construction of the wall [figure 9 (BD 04)] led to the difference in the coefficient of thermal expansion among its adjacent walls causing the development of cracks prone to the atmospheric agents.

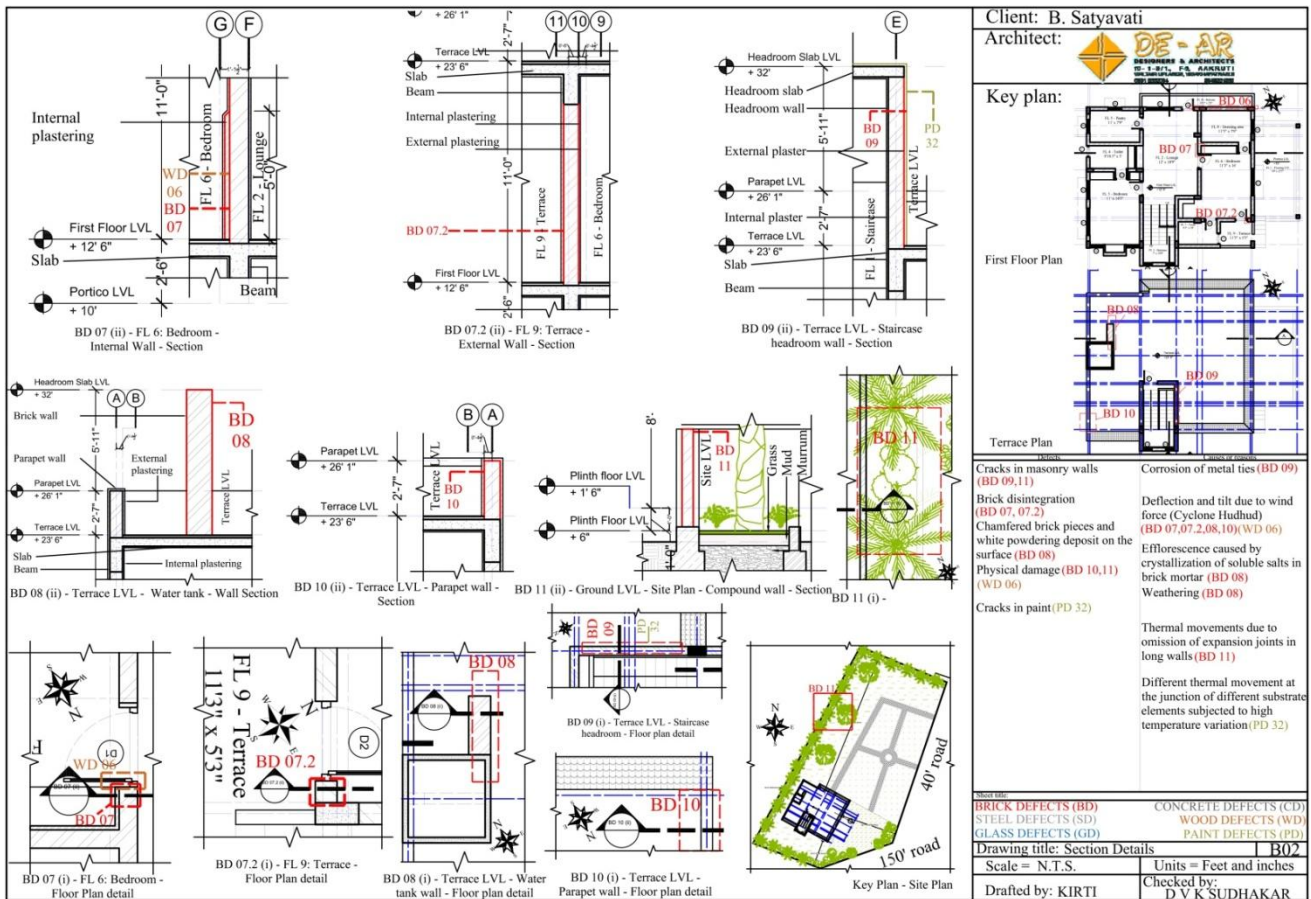
Figure 12 – Sheet B02: Architectural drawings of brick defects (BD) [4], [10]

Difference in their coefficient of expansion and contraction has led to the cracks at the junctions [figure 13 (b) (BD 03), 14 (BD 09)] resulting in the corrosion of metal ties which further expands the cracks.

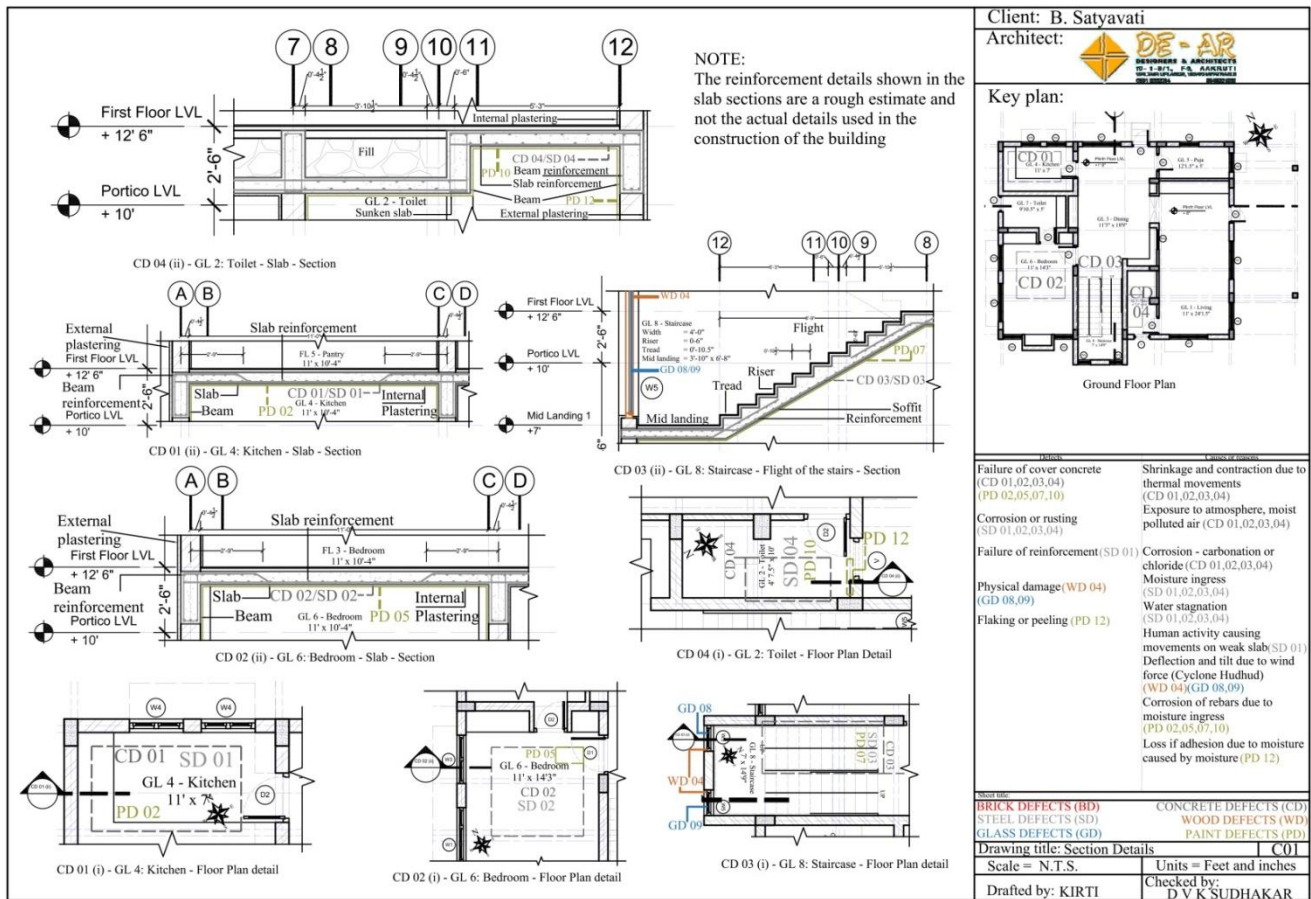
Figure 20 – Sheet C01: Architectural drawings of concrete defects (CD) [4], [10]

The defects in the components of a framed structure building would lead to the decrease in the stability resulting in its collapse after a brief period of time. Concrete slabs are the components that have been severely damaged.

The deterioration of the paint coats [figure 29 (b), 47, 49] and loss of concrete cover [figure 21 (b), 22 (b), 24 (b), 28 (b), 29 (b), 30 (c), 31, 32 (d)] are observed in most of the R.C.C components of the building.

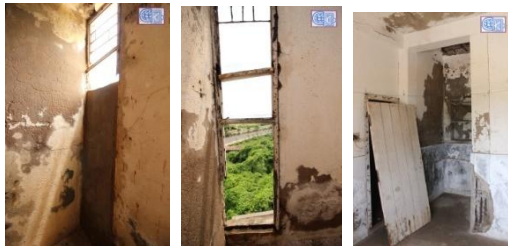
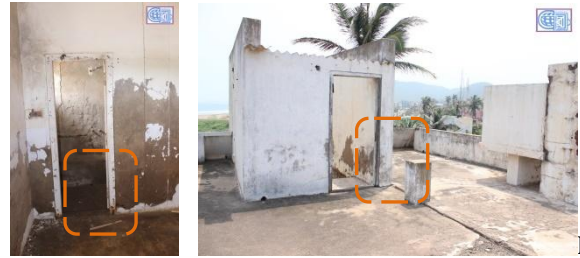
Figure 41 – (WD 03, 07, 09, 10) Wood defects (a) GL 8: Staircase – Window W5 – south east corner view (b) FL 1: Staircase – Window W5 – south view (c) FL 6: Bedroom – Door D2 – south west corner view (d) FL 6: Bedroom – north east corner view (e) FL 6: Bedroom – Door D2 - View (f) GL 1: Living – Door D2 – West view (g) Terrace level: Staircase headroom – Door D1 – South view

Distortion, surface damage [figure 36, 41 (d), (e)], rupture [figure 15, 16, 24 (c)], longitudinal cracks [figure 41 (a), (b), 50 (a), (b)] and cracking of glass panels [figure 41 (a), (b), 50 (a), (b)]

Wood has remained least affected among all the materials as the rate of degree of deterioration was very less. Only due to the physical damage [figure 41 (c)], the wood material became prone to remaining defects.

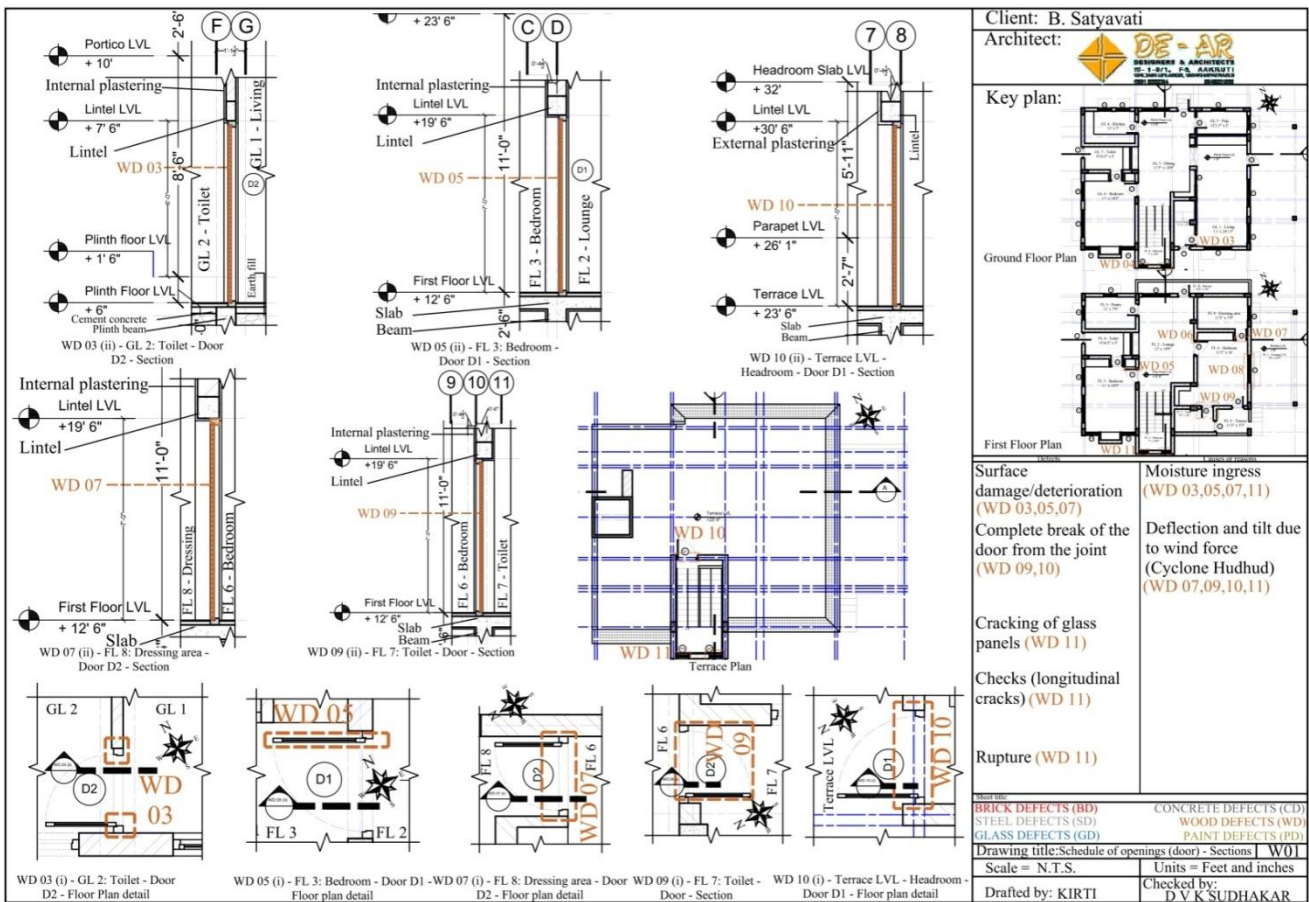
Figure 42 – Sheet W01: Architectural drawings of wood defects (WD) [4], [5], [10]

Wood is used for the frames and shutters of the doors and windows in the building. A total of 9 wood defects in number have been identified.

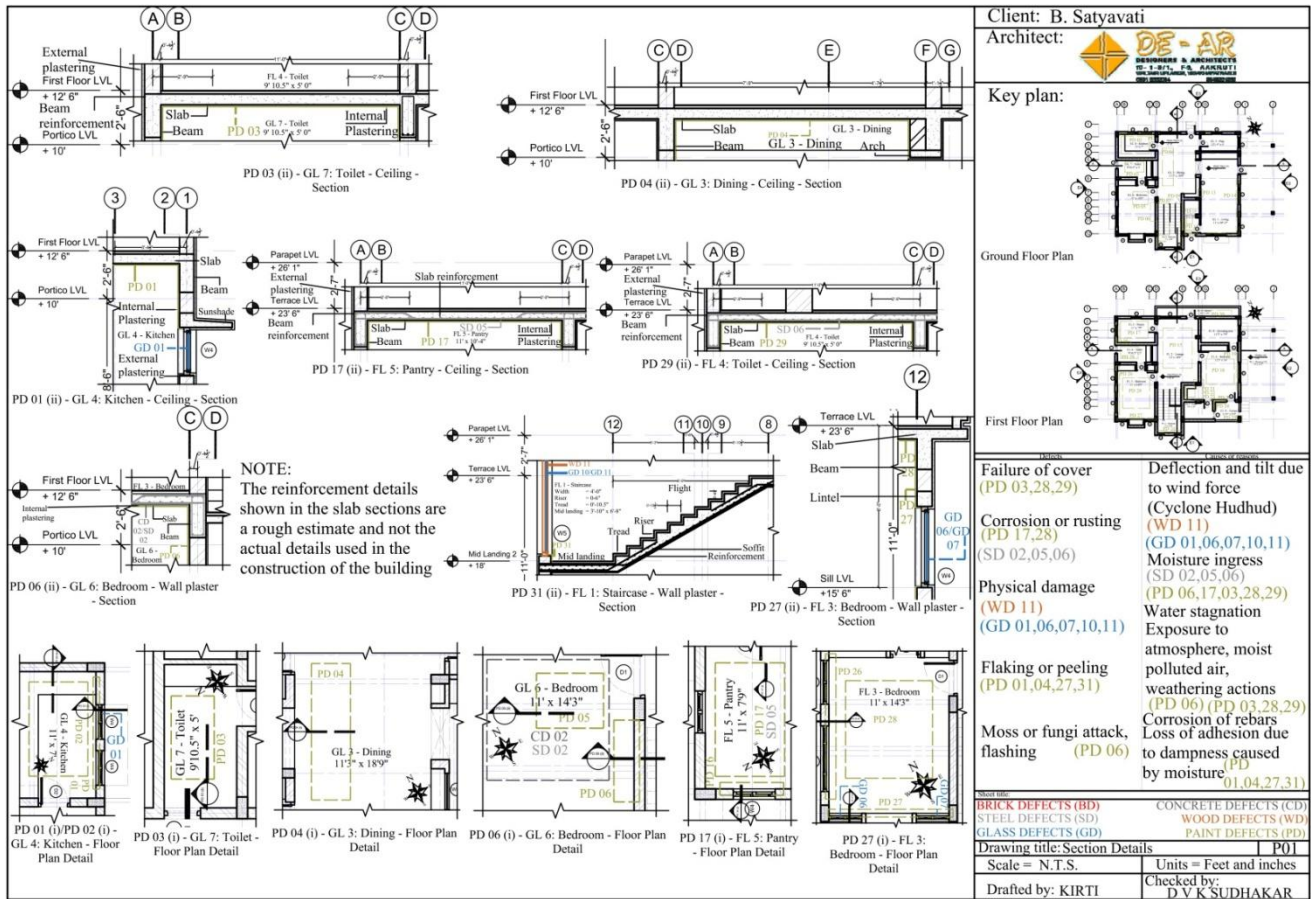
Figure 43 – Sheet P01: Architectural drawings of paint defects (PD) [4], [5], [10]

Loss of paint coats due to dampness, weathering actions, lack of regular maintenance, brown patches of red oxide on the surface due to corrosion of steel bars [figure 28 (b), 29 (b), 34 (b), 47, 49] and loss of coat cover due to corrosion [figure 51]

Re-plastering of the surfaces at regular intervals is to be done to ensure a good quality of paint against the climate. Alkali resistant paints should be used in coastal areas for better resistance against weathering [5]. Paint defects are observed within a short span of building functional life.
