The Conservation of Sixteenth Century Church Santa Maria of Montedecoro in Maddaloni

Abstract

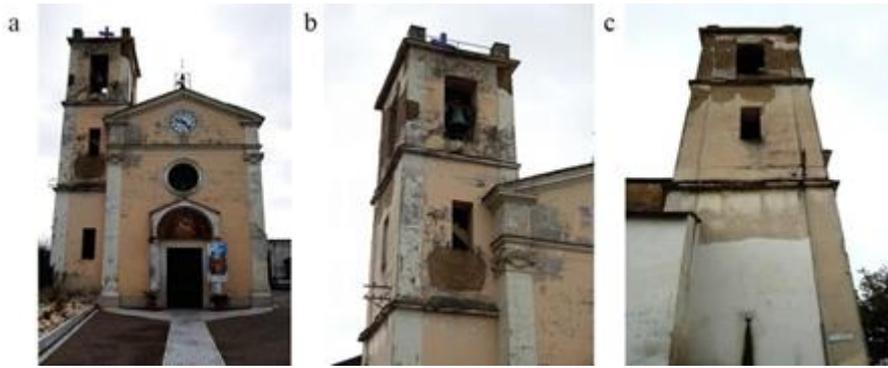
The deterioration detected in the building’s cognitive phase presented several features: on the outside there was a general state of degradation due to the plasters that were detached and to the painting that were damaged; the covering mantle was compromised and disconnected, depriving the Church of an adequate waterproofing. The bell tower, built in the first half of the twentieth century, had large surfaces of fallen plaster, erosion and differential degradation of the surfaces, as shown in Figure 2. Its protection has been recently modified, and now on the last roofing slab there are four tufa blocks that hold a simple protective grid, on which a bright blue PVC layer insists, in contrast with the surroundings. The interior of the church showed different type of recent interventions; in the side chapels there was a 80s-style floor, not adequate to the historical artistic environment, while the flooring of the nave was in 60s-style (in colored conglomerate).

Figure 2. Degradation state of the bell tower

The structure appeared to be compromised also under the static profile, since there was an accentuated crack pattern in the bell tower, due mainly to out-of-plane overturning mechanisms. The tower had two main problems: a global overturning and a local slide due to different causes. The first probably linked to a settlement at the street level. Surveys performed at a depth of 9 meters from the street level showed that the ground between 3.50 and 5.00 meters had a significant percentage of humidity and water compared to the average, due to a loss of the water supply at few meters from the bell tower. In relation to the second problem, two sides of the church were more compromised and marked by large diagonal cracks. The mechanical phenomenon is ascribable to the sliding towards the street due to a failure of the wall structure. The global overturning was also attested by the detachment of the internal staircase from the perimeter wall of the tower with cracks that open from the bottom upwards. The accentuation of recent mechanisms and the fall of materials from the bell tower and from the church could be due to a differential movement of the foundations and to the vibrations that vehicles cause on the bumpy road surface. The bell tower, of more recent construction than the church (1942) as demonstrated by the study of the pattern bond of walls, was built by placing some new walls on church's walls. The other walls of the bell tower appears only leaning against the lateral wall of the church to which it joins. Quite frequently, bell towers are only in contact with other lower structures. In these structures, the presence of horizontal constraints at different heights can profoundly modify the seismic behaviour of the bell tower: the limitation of slenderness and the introduction of localized stiffening elements produce stress concentrations and considerably increment in vulnerability (Faella, Giordano & Guadagnuolo, 2010). Surveys into the ground up to 1.50 meters deep along the boundary wall with the street showed a greater quantity of water under the church, mainly if compared to that found in the most superficial internal areas. The vault of the nave has a longitudinal crack and other less obvious cracks. The analysis of the upper floor showed that the roof warping was modified in recent times, laying part of the roof on the perimeter walls of the church and not on the orthogonal walls, as the original building. A part of the roof has been raised and the timber structure has been replaced with steel carpentry. This change led to a new static arrangement of the church, resulting in unforeseen lateral thrusts. In order to define the most relevant consolidation to adapt to strengthen the structure, it was necessary to assess the seismic safety of the bell tower, as shown in the following.

The strengthening of the bell tower structures was finalized to improve both the static and seismic capacity, on the base of the previous numerical analyses. It concerned: the realization of micro-piles for the soil consolidation and the foundation strengthening; the removing of concrete elements; the insertion of tie bars at the level of the ornamental cornices; the filling of the passing cracks with tuff and hydraulic lime; the protection of the iron elements; The rerofit or reconstruction of the damaged ornamental cornices; the demolition of the incongruous tuff structures; the installation of a new steel cross on the top of the structure. In order to ensure the outflow of meteoric water and to make the architectural issue coherent with the context, it has been realized a pyramidal shape for the bell tower termination, made by a timber structure covered with roof tiles. Finally, after the strengthening, the value of bell tower seismic safety indices were re-evaluated. The compressive strength of masonry walls was increased up to 1.6 MPa, based on the strengthening performed. The new minimum safety index was equal to 1.27, thus making the structure capable of withstanding a seismic event.

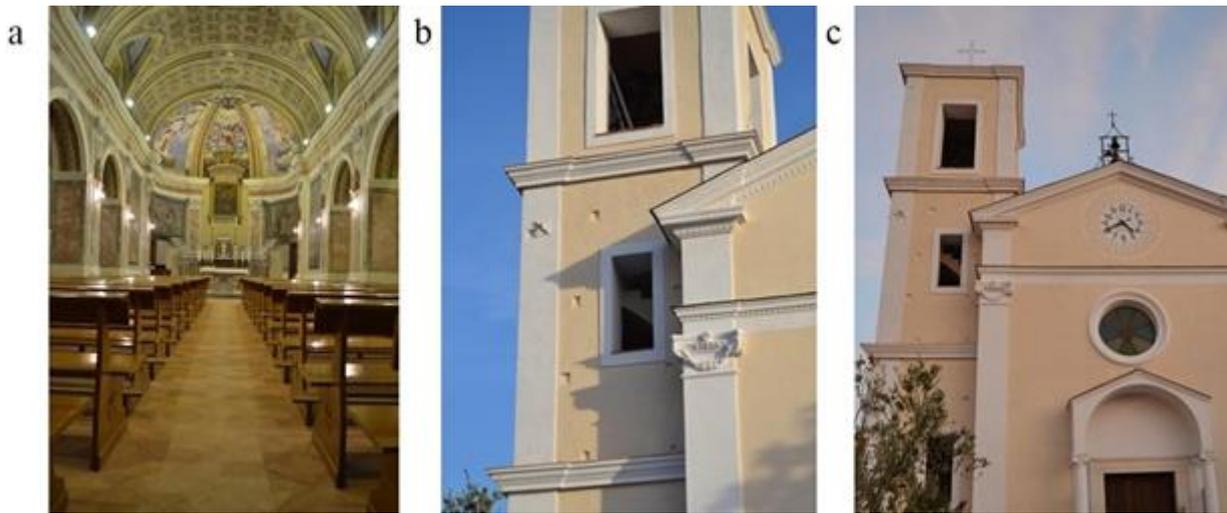
Figure 3. Church and bell tower after restoration and retrofitting

The Church has required interventions aimed at the architectural restoration of the complex in a unitary manner and in compliance with the fundamental principles of conservation, such as unity of method, respect for the historical framework, possible reversibility of the interventions and compatibility of the materials used. The restoration design was drafted by one of the authors, the architect Mariano Nuzzo. The design was based both on several in situ surveys performed to know all the geometric data, the mechanical characteristics of the materials, the properties of the structural elements and on the study of previous surveys and monitoring performed on other similar buildings. In fact, the careful application of the available testing techniques provides much reliable information that allow to identify the best strengthening solution (Faella, Frunzio, Guadagnuolo, Donadio & Ferri, 2012), (Pérez-Gracia, Caselles, Clapés, Martínez & Osario, 2013), (Lignola & Manfredi, 2010), (Bosiljkov, Uranjek, Zarnic & Bokran-Bosiljkov, 2010), but the results of any previous monitoring can be crucial for the reliable design of interventions on ancient structures (Monaco, Guadagnuolo & Gesualdo, 2014), (Gesualdo, & Monaco, 2015). Indeed, sometimes the structural conception of the building or inadequate retrofitting (Guadagnuolo, Faella, Donadio & Ferri, 2014) are the main cause of damage or collapses. The design envisaged the pre-consolidation of the decorated surfaces of vaults, the removal of the flooring of the side chapels, the cast of traditional screeds with subsequent laying of traditional terracotta pavements and the installation of some new timber frames. The choir was covered by plywood and plasterboard panels to hide the degradation of the wood, removing the incongruous additions and cleaning the chestnut wood underneath, integrating it only where necessary. Other interventions concerned the relocation and restoration of part of the presbytery balustrade that was found in the church. The disassembly of the 70' floor in the side chapels allowed the discovery and subsequent restoration of the original terracotta floors, which were cleaned and left exposed, but also allowed to have information on how realize the new terracotta pavement (shape and size). The interventions then involved the dismantling of the marbles at the base of the largely loose and disconnected arches of the hall. The restorations carried out outside the complex concerned: the filling of the passing cracks with tuff flakes and hydraulic lime, the demolition of the incongruous additions, the recovery and reintegration of the plaster, the restoration of the stuccos, the regimentation of the rainwater through the restoration of the original paths, the painting of some walls with lime paint and natural pigments and the replacement of the marble inserts in the churchyard with porphyry cubes similar to those existing in shape, color and size, as shown in Figure 3. A new electrical system was arranged under the new flooring, trying to use the original electrical routes and limiting the new ones to the essentials (mostly realized in the side chapels, where the plasters have already been replaced several times during the years).
