## Combating WEC Throughout The Drivetrain

› Paul Brda – Strategic Segment Manager

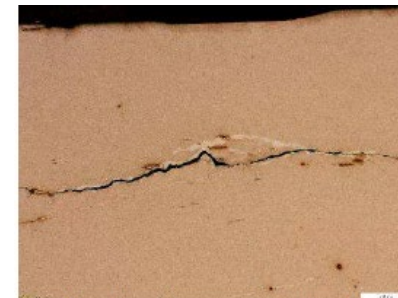
GS roller surface, magnification: 50x

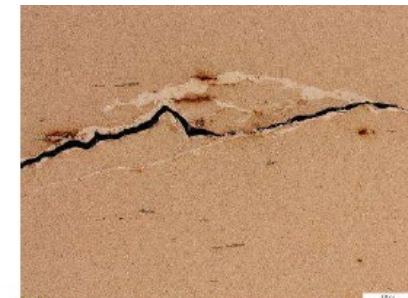
White structure and cracking, magnification: 100x

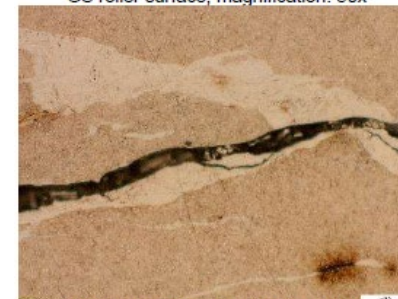
White structure, magnification: 500x

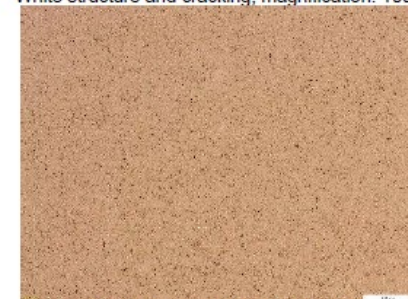
Roller Core, magnification: 500x

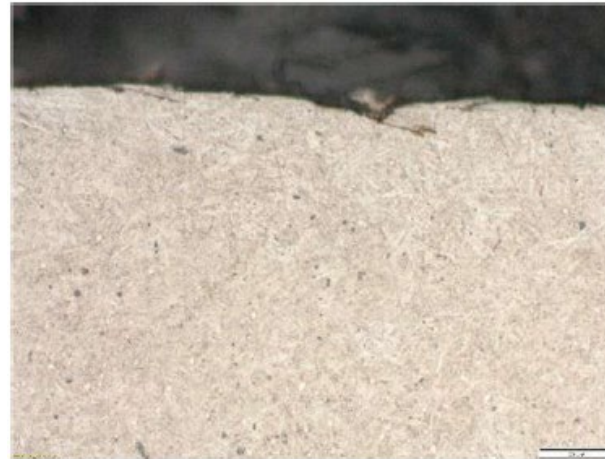
- The fracture origin on the outer ring (OR) was beneath the spalled raceway. Pitting corrosion was found on the Inner ring (IR) and OR and confirmed by SEM/EDS analysis.
- White structure was found below cracks and corrosion pitting found on the outer ring.

OR raceway surface cracks and peeling

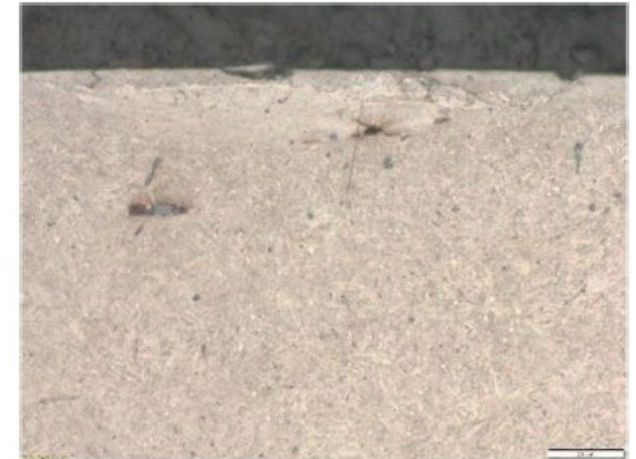
White structure on the raceway surface,  
Magnification: 500x

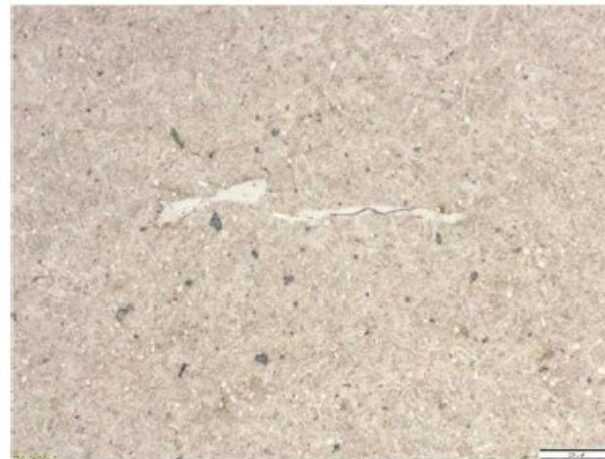
White structure below the raceway surface,  
Magnification: 500x

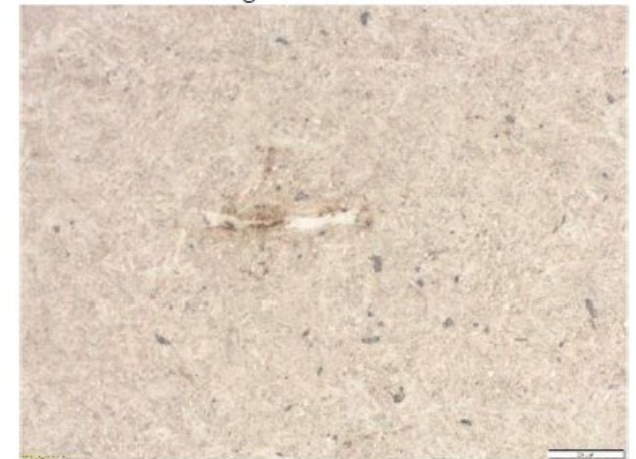
White structure below the raceway surface,  
Magnification: 500x

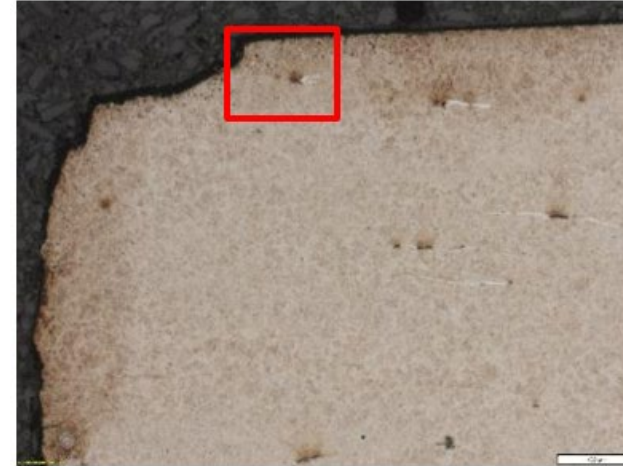
- Both samples exhibited detrimental white structure near the fracture surface.
- The white structure found is likely the result of a breakdown in the lubrication and hydrogen embrittlement, resulting in the creation of brittle white structure where cracks originated.
- New non-tempered martensite was found on sample #1 at the fracture surface and is most likely due to the high load and rubbing between the fracture surfaces after hydrogen embrittlement had occurred.
- Both samples appear to be through-hardened steel with a 1  $\mu\text{m}$  layer of black oxide coating.

Circumferential cut of the fracture surface, Magnification: 100x

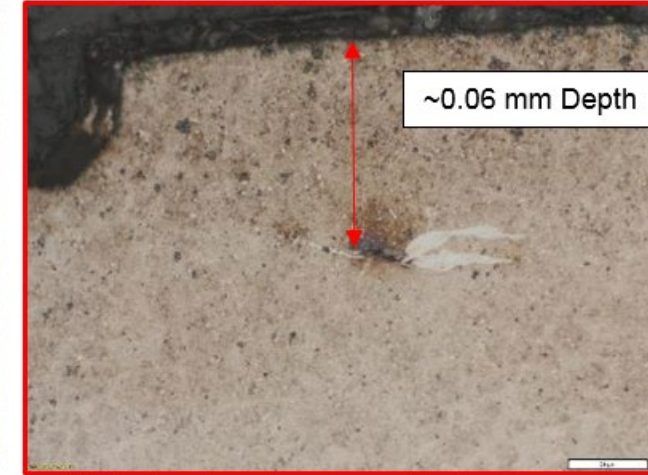
White structure found near the fracture and raceway surface, Magnification: 500x

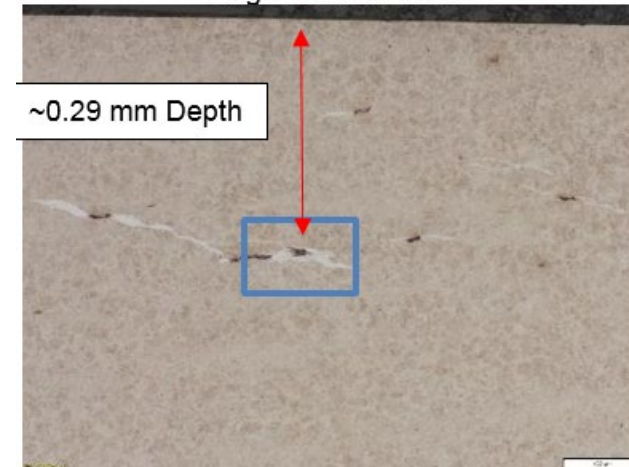
Additional white structure, Magnification: 100x

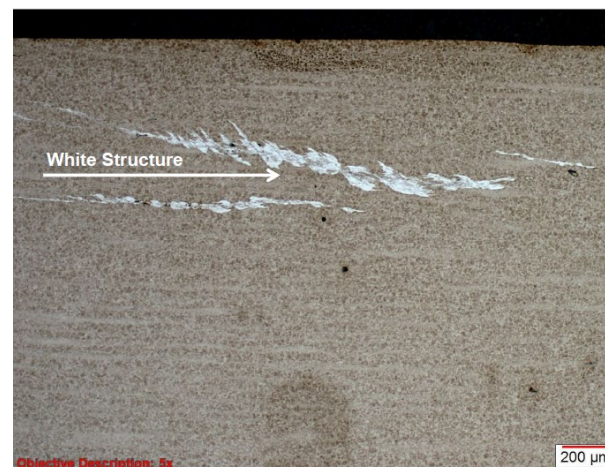
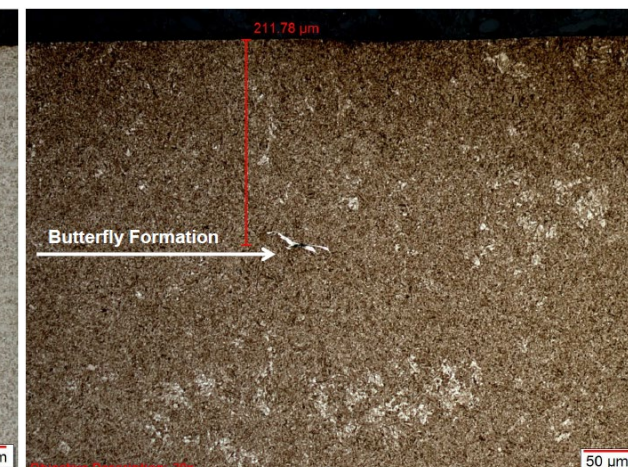
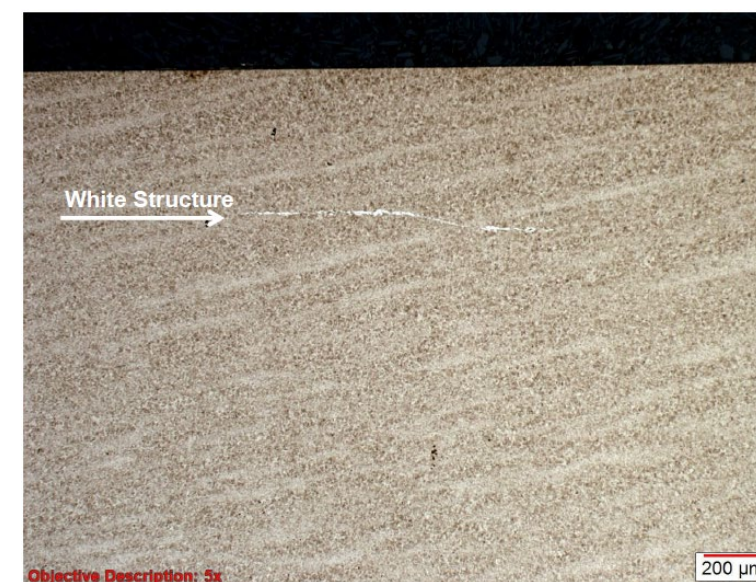
- Both outer rings exhibited a through hardened microstructure (difficult to discern visually whether bainite or martensite).
- Both inner rings exhibited a carburized case and core microstructure.
- White structure was observed in both outer rings
- Outer ring 30328 exhibited a thin layer of new martensite on the raceway surface. This would be consistent with frictional rubbing due to skidding of the rollers on the surface.
- Early butterfly formation was observed in inner ring 30328 at  $\sim 200\mu\text{m}$  beneath the raceway surface.
- No observations of white structure were made in inner ring 31328.
