I.FAST

Survey of AM applications and strategies for repairing components by AM

DELIVERABLE: D10.2

Document identifier:	IFAST-D10.2
Due date of deliverable:	End of Month 24 (April 2023)
Report release date:	30/04/2023
Work package:	WP10: Advanced Accelerator Technologies
Lead beneficiary:	RTU
Document status:	Final

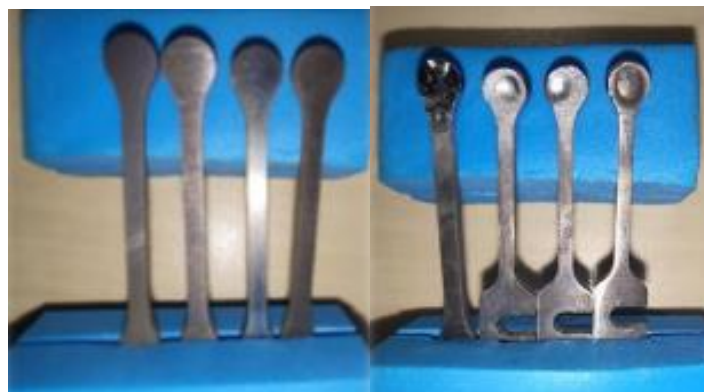
Fig. 20 Unused and used tantalum electrodes

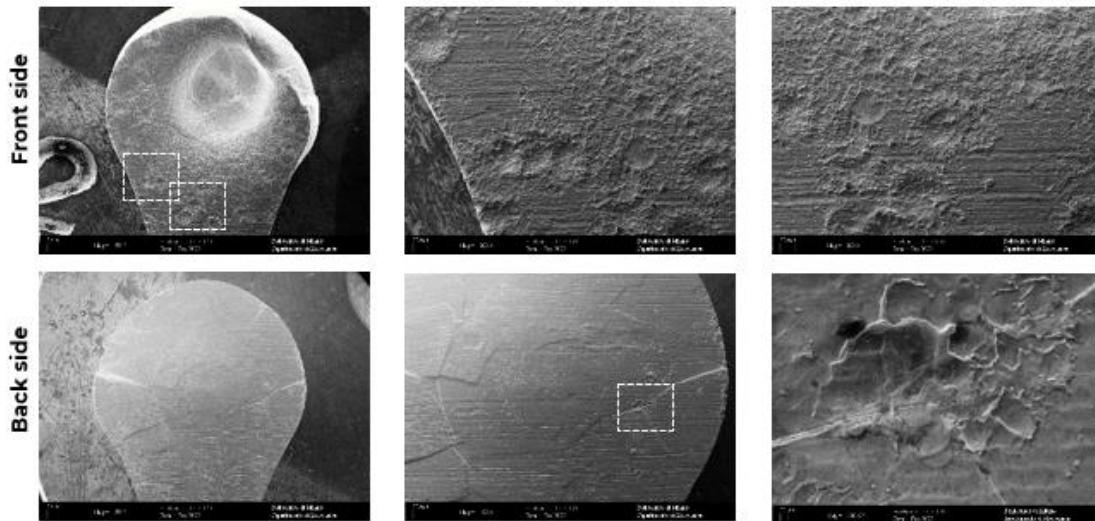
Fig. 21 Electrode surface morphology by SEM

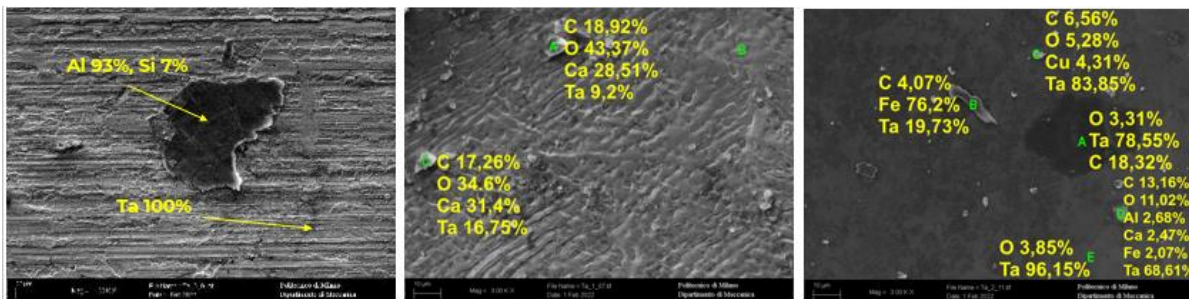
Electrode surface spectroscopy reveals surface contamination by various particles – organic and inorganic (Fig. 22). 3D scanned models show severe deformation of material – deviation from form is up to 2/3 of electrode thickness (Fig. 23). Grain microstructure analysis reveals extreme grain growth at the tip of electrodes – in some cases single grain structure dominates the whole damaged area (Fig. 24). Consequently, undesirable mechanical properties of material at the tip (for example large hardness) will make it difficult to machine samples.

Fig. 22 EDS results of electrode surface

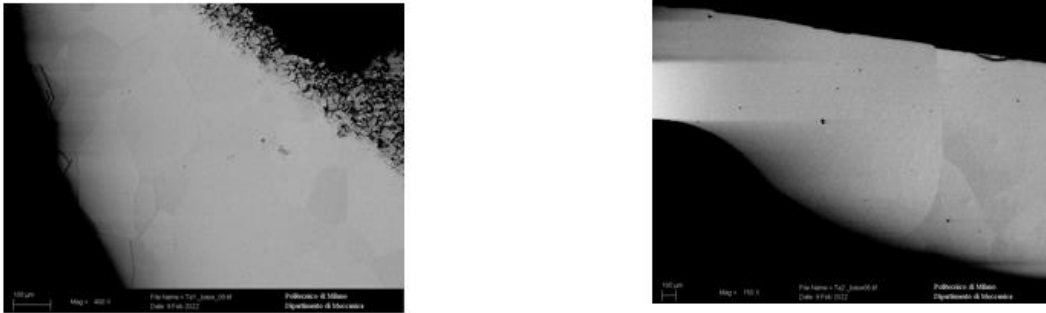
Fig. 24 Electrode microstructure

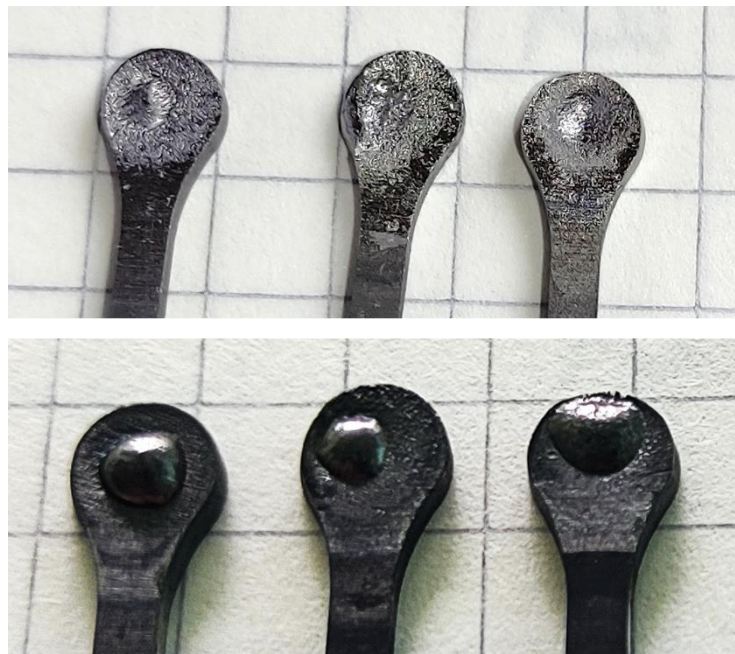
Fig. 28 Damaged electrodes (top) and repaired electrodes(bottom) using wire DED

Parameter	Electrode		
	W1	W2	W3
Laser power (W)	1000	1000	1000
Wire feed rate (mm s ⁻¹)	50 (start/end speed)	50 (start/end speed)	50 (start/end speed)
	20 (normal speed)	20 (normal speed)	20 (normal speed)
Shielding gas pressure (bar)	2.5	2.5	2.5
Preheating time (s)	1	1	1
Deposition time (s)	0.2	0.4	0.6

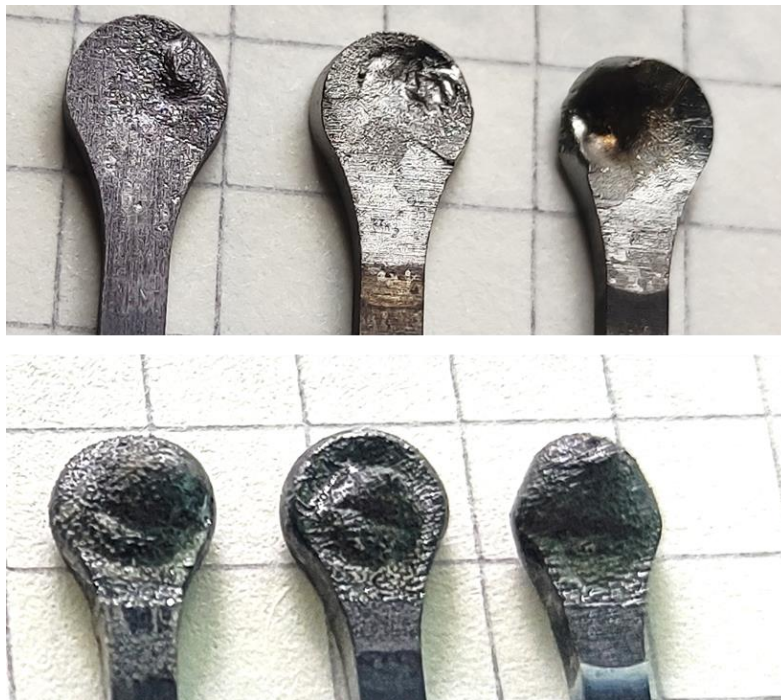
Fig. 29 Damaged electrodes (top) and repaired electrodes(bottom) using powder DED

Parameter	Electrode		
	P1	P2	P3
Laser power (W)	800	800	800
Powder feed rate (g s ⁻¹)	2	2	2
Carrier gas flow rate (l min ⁻¹)	6	6	6
Shielding gas flow rate (l min ⁻¹)	12	12	12
Deposition speed (mm min ⁻¹)	400 (inner circle)	400 (inner circle)	400 (inner circle)
	600 (middle circle)	600 (middle circle)	600 (middle circle)
	600 (external circle)	600 (external circle)	600 (external circle)
Circle radius (mm)	0.4 (inner circle)	0.4 (inner circle)	0.4 (inner circle)
	0.9 (middle circle)	0.9 (middle circle)	0.9 (middle circle)
	1.5 (external circle)	1.2 (external circle)	1.2 (external circle)
Deposition time for dots (s)	-	-	0.5

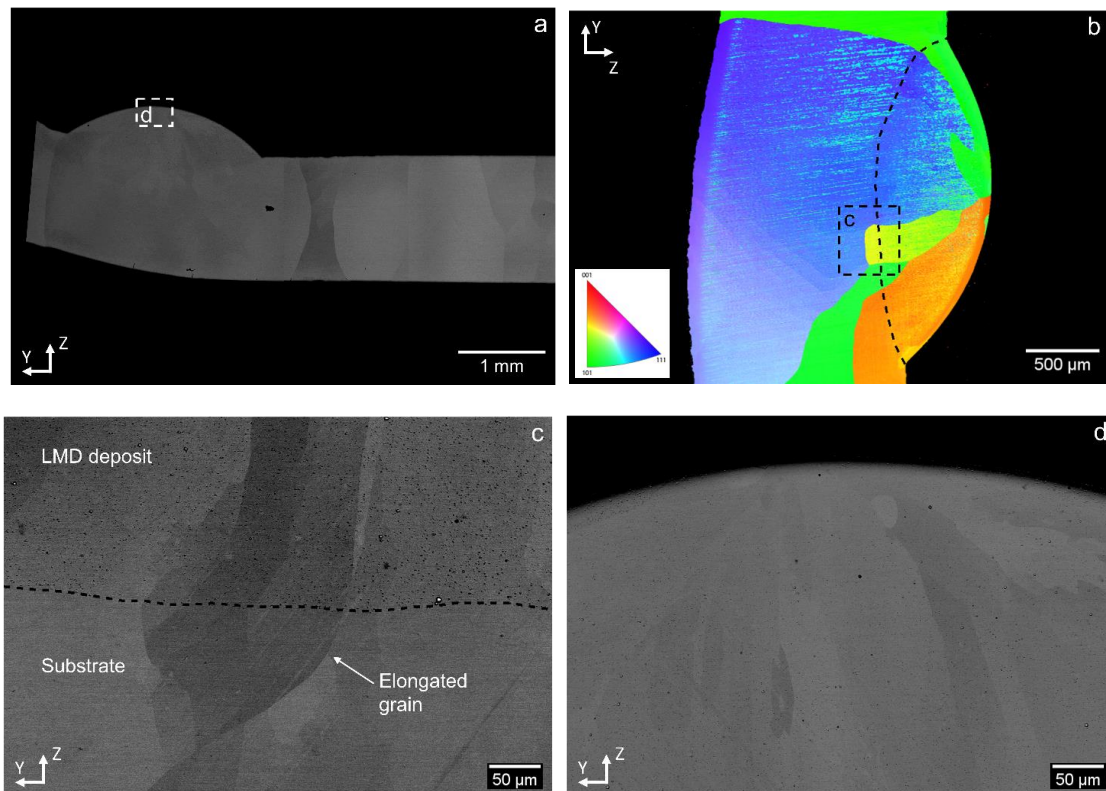
Fig. 30 (a, c-d) SEM and (b) EBSD images of the electrode W2 repaired by wire-based DED.

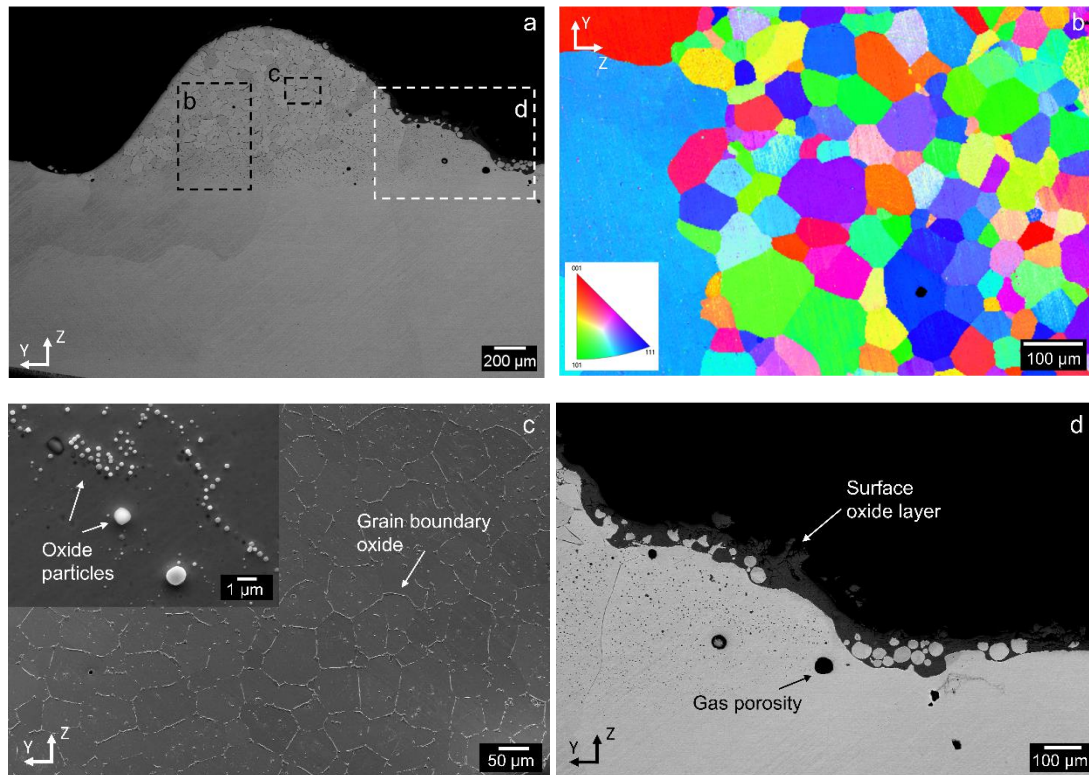
be endogenous defects stemming from the native oxide layer that covers the surface of the initial powder material or may be due to instabilities in the shielding gas flow during the repair process. A 60 μm thick oxide layer also covers the external surface of the deposited dome.

Fig. 31 (a-b,d) SEM and (c) EBSD images of the electrode P2 repaired by powder-based DED.

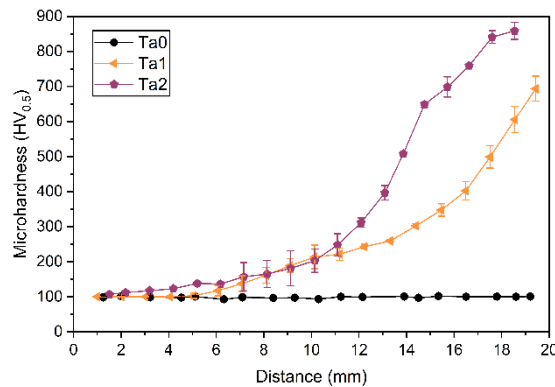
The hardness profiles measured along the body of the electrodes showed a progressively increasing trend from about 100 $\text{HV}_{0.5}$ at the base of the cathodes, which is in line with the typical hardness of annealed tantalum, to over 700 $\text{HV}_{0.5}$ in the regions near the head, as shown in Fig. 32a. This effect can be attributed to the entrapment of large amounts of hydrogen in the cathode head region, which is simultaneously exposed to ion bombardment and to the pure hydrogen atmosphere employed in the cyclotron, and to the formation of ion-irradiation-induced defects like sessile dislocation loops.

Fig. 32 Microhardness measured along the body of the tantalum cathodes. The error bars represent the standard deviation over three measurements.
