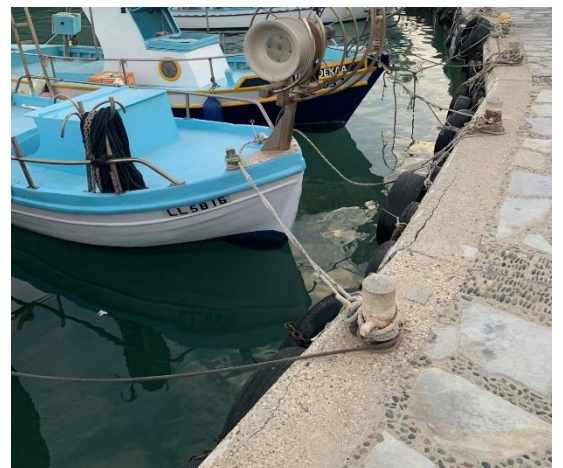
**Figure S3.3:** The fishing shelter of Agia Napa (images captured during site visits in Autumn 2021): (a) Overview of the port; (b) Defects (cracking) detected at the quay wall.

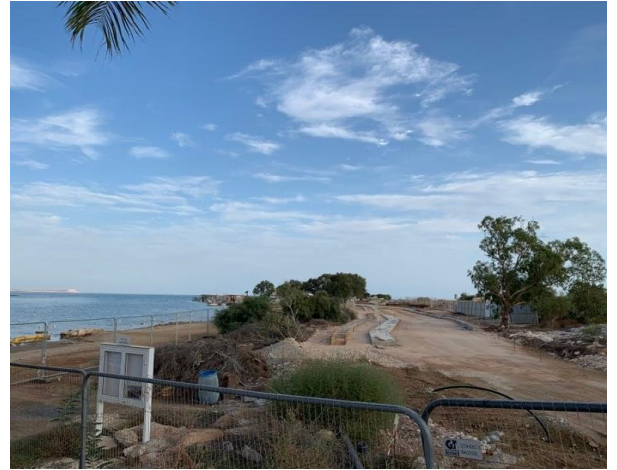
**Figure S3.4:** The fishing shelter of Liopetri (images captured during site visits in Autumn 2021): (a) Overview of the port; (b) Construction works in the area of the shelter.

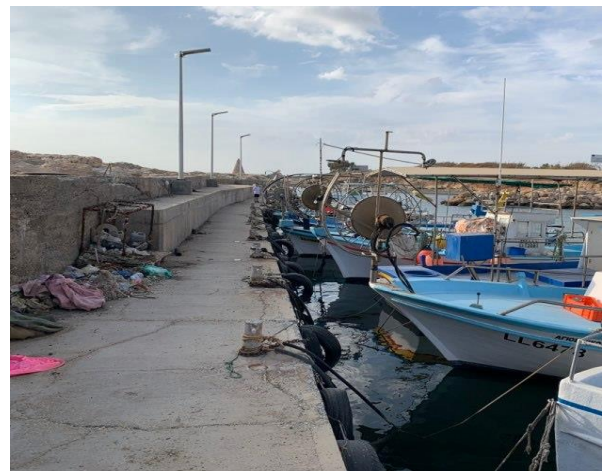
**Figure S3.5:** The fishing shelter of Xylophagou (images captured during site visits in Autumn 2021): (a) Overview of the port; (b) Defects (cracking) detected at the concrete wharf.

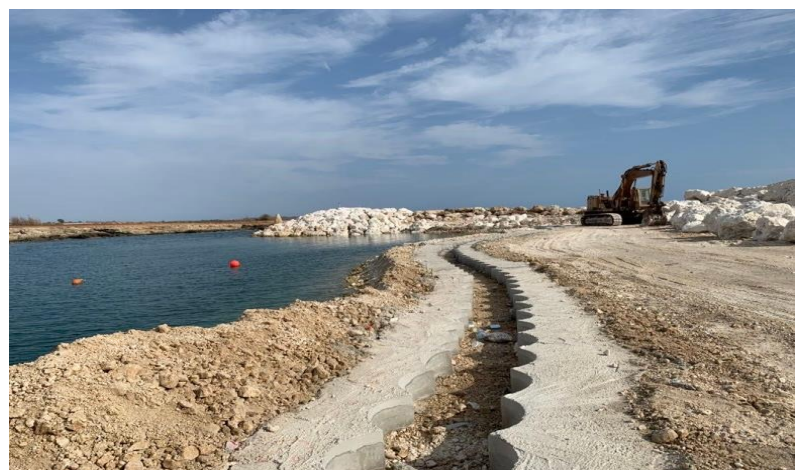
**Figure S3.6:** The fishing shelter of Ormideia (images captured during site visits in Autumn 2021): (a) View of the port facilities; (b) Construction works in the area of the shelter.

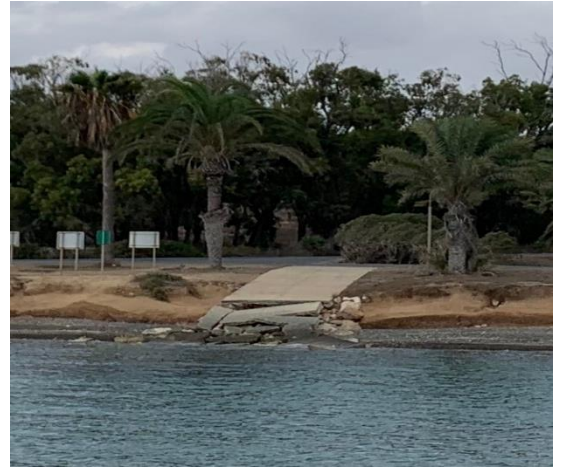
**Figure S3.7:** The fishing shelter of Xylotympou (images captured during site visits in Autumn 2021): (a) Overview of the port; (b) Failure of the boat slip.

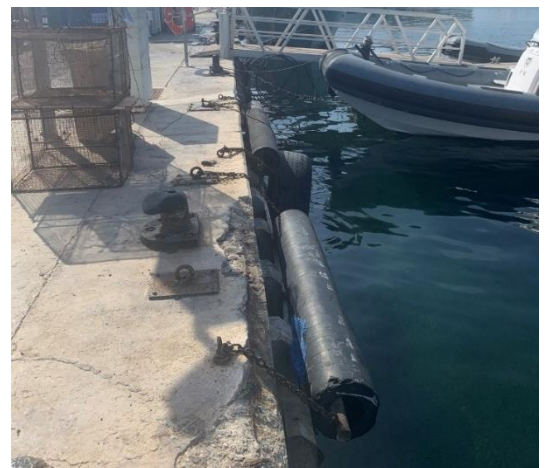
**Figure S3.12:** The fishing shelter of Paphos (images captured during site visits in Autumn 2021): (a) Overview of the port; (b) Defects (spalling) detected at the quay wall.

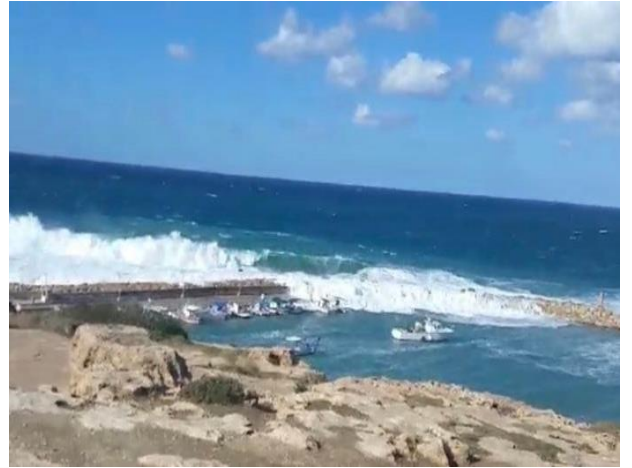
**Figure S3.13:** The fishing shelter of Agios Georgios (images captured during site visits in Autumn 2021): (a) Overview of the port; (b) Wave overtopping observed at the area of breakwater.
