FRACTURE ANALYSIS OF THE HYDRAULIC TRUCK CRANE ATLAS 3006

Conference Paper · June 2014

Fracture Analysis of the Hydraulic Truck Crane ATLAS 3006

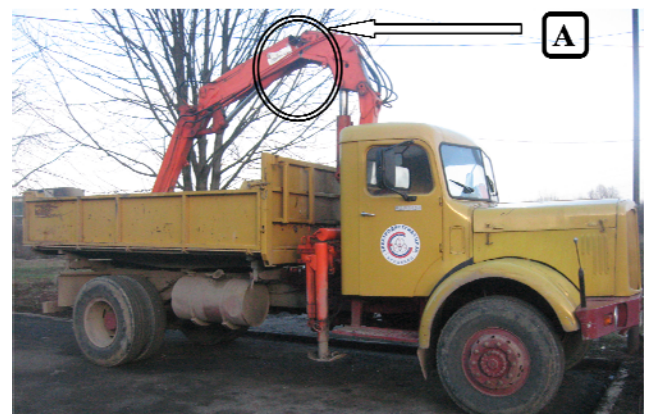
After more than 12 years of crane exploitation, during a regular overhaul, certain damages at the first jointed segment of the crane were noticed. This damage is at the point of connection between the hydrocylinder and the segment (detail "A" - Figure 2).

Figure 2. Point of the fracture initiation in the crane Atlas 3006

For the purpose of saving, the user himself, without any previous detailed analysis of the causes of damage, solved the problem of repairing the damage in the truck crane boom by welding at the point of cracking. The damaged

plates were connected by butt welding. After the repair, the crane was returned to exploitation.

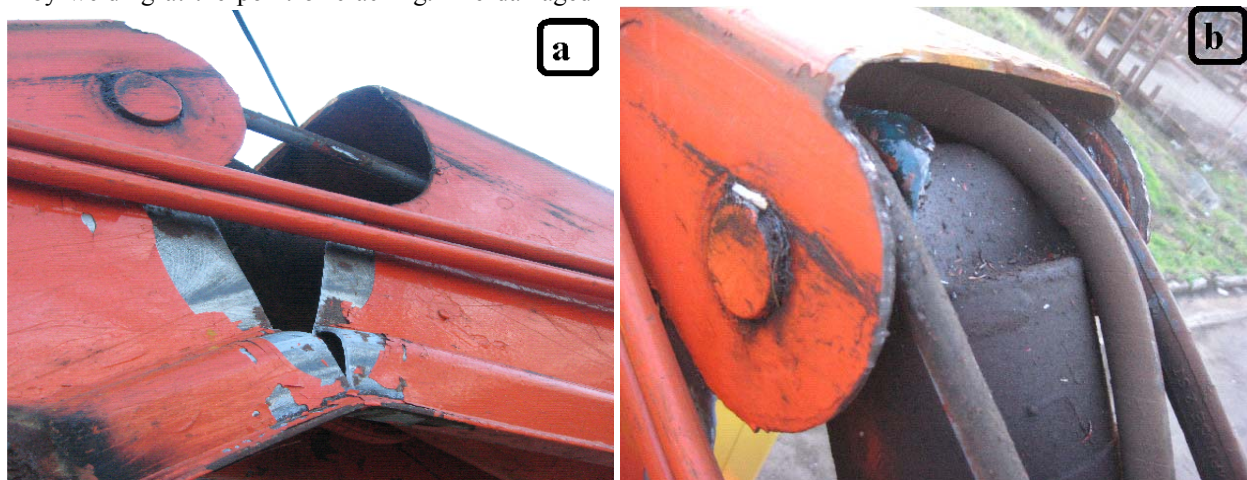
After more than 3 years of exploitation of the repaired crane, a fracture (Figure 3) occurred at the point where it had been repaired.

Figure 3. Point of the boom fracture in the telescopic truck crane ATLAS KRAN 3006 a) lateral side; b) upper side;

The fracture analysis clearly shows the fatigue fracture initiation which occurred in the transition zone between the weld and the base material as well as at the point of joining the plates with a large difference in thicknesses (Figure 3).

- The truck crane boom was not repaired in a prescribed and adequate manner. Such jobs should be entrusted to the companies which are specialized for that type of activity.

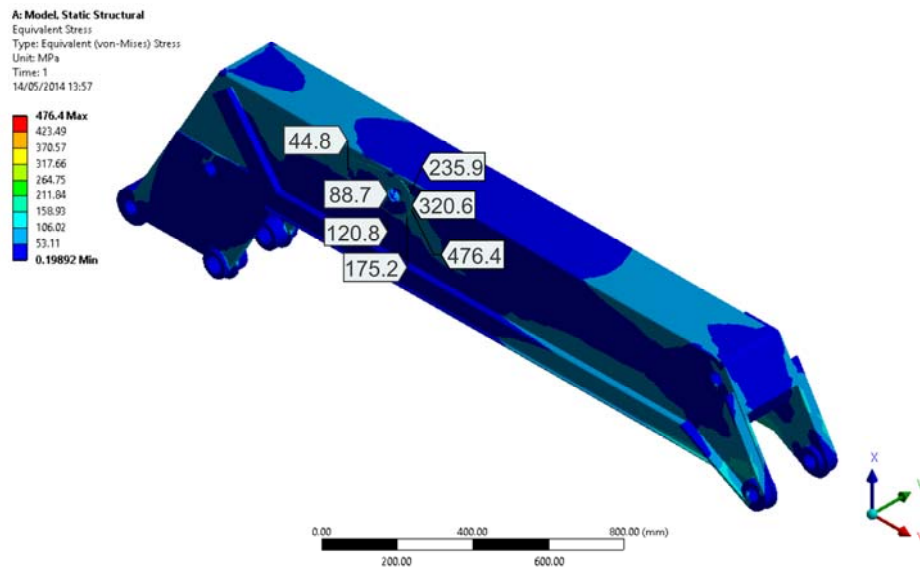
The uniaxial stress field, according to the Huber-Hencky-von Mises hypothesis, for load case I, is presented in Figs. 8 and 9.

Figure 8. Stress state of the first segment of the boom with characteristic values

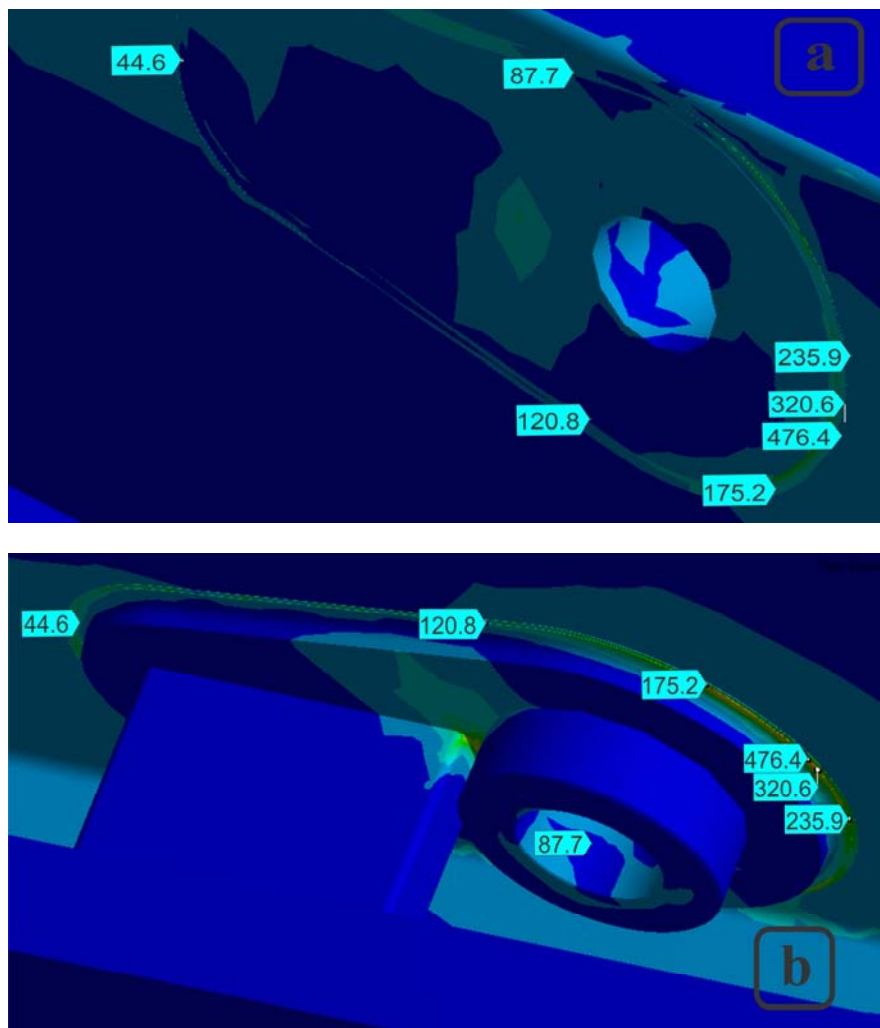
Figure 9. Stress state at the point of connection between the hydrocylinder and the first segment: a) outer side b) inner side

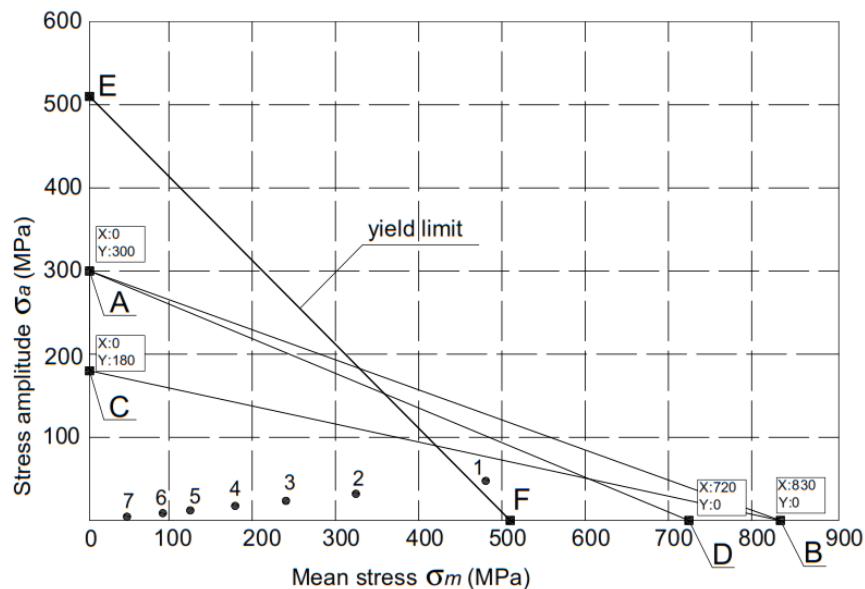
Figure 9. Goodman diagram in the weld zone

In Fig. 9, the mentioned points (1-7) are below the line A-B, which represents the fatigue boundary, while in Fig.10 the point 1 exceeds the fatigue boundary and thus fatigue safety is not provided.

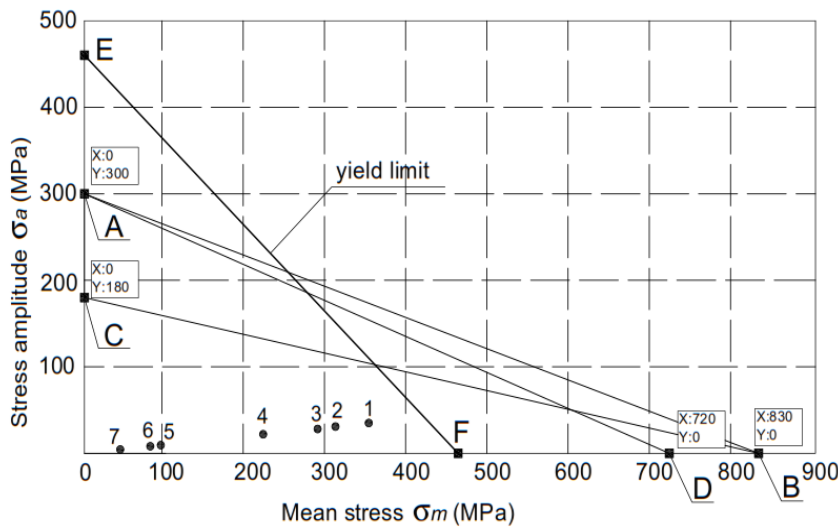
Figure 10. Goodman diagram for the base material

The line C-D was chosen to be the relevant fatigue line and in the first diagram in Figure 3.9 the point 1 does not exceed this boundary, but in the diagram in Fig.10 this boundary is already exceeded in terms of the position of the point 1 in the diagram.

- The critical value of stresses in the weld exceeds the fatigue boundary line. Therefore, fatigue failure
