Tahoe City 3/1/21

Plotting DO and temp in chambers

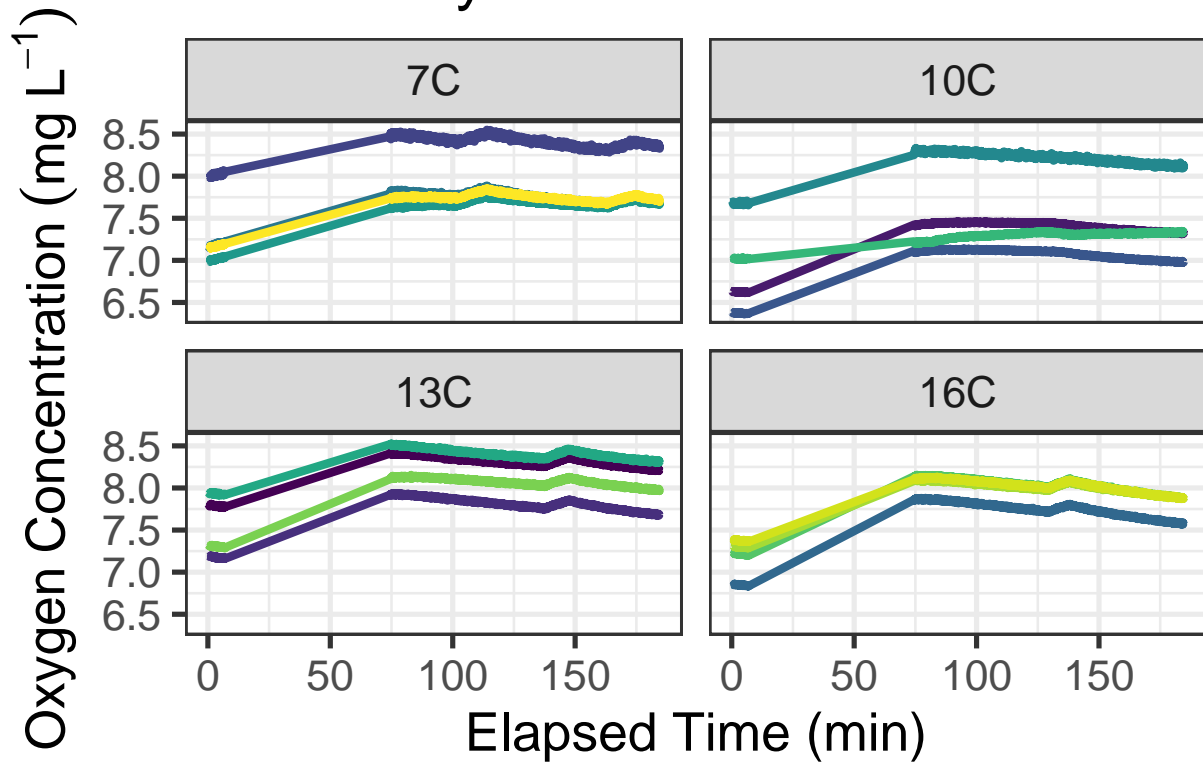
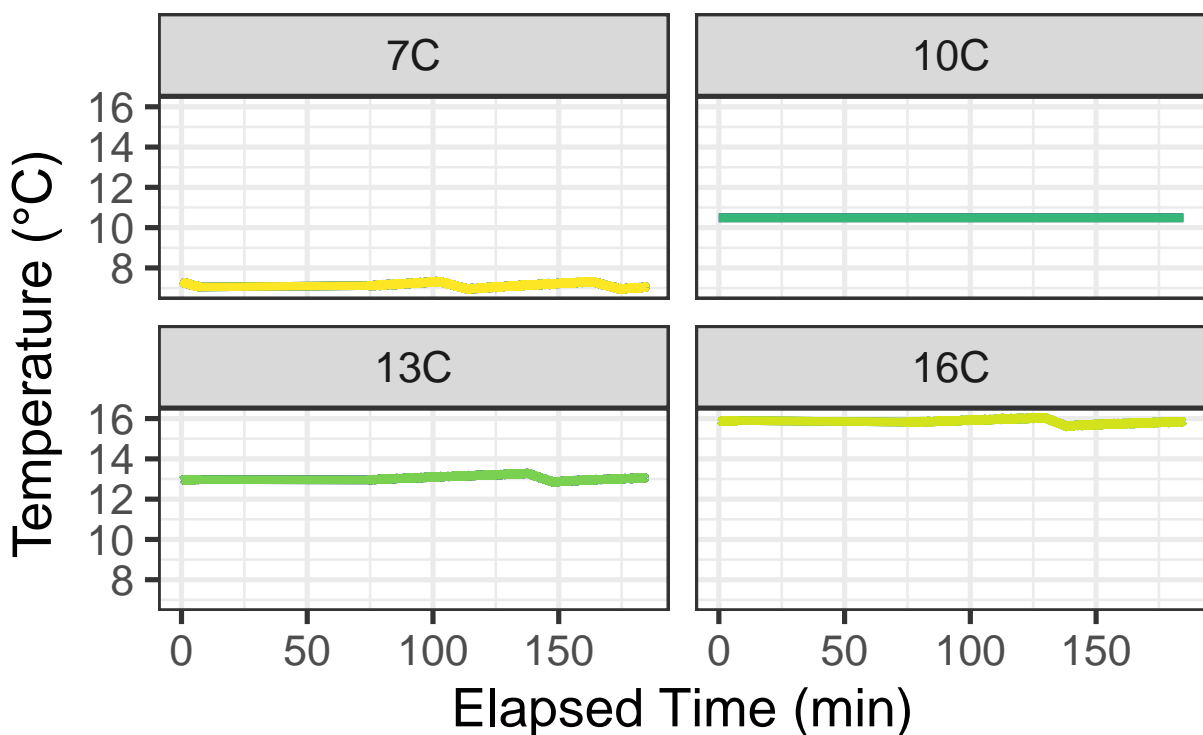
Tahoe City Incubation DO

Tahoe City Incubation Temperature

The weird changes in temperature that cause shifts in DO during the respiration period of the incubation are due to artificial changes in temperature measured in the waterbaths, but this does not reflect the temperatures on the inside of the chambers. This is because the oxygen concentrations measured in the chambers are incongruous with the temperature measurements in the waterbaths. The chambers tend to heat/cool at half the rate as the waterbaths, so temperatures are much more stable in them compared to the outside water bath. This fact led to errors in our oxygen measurements.

Possible remedies: 1) Drill holes in 4 unused chambers (1 for each tank), fill with water at same temperature as tahoe water, and place temp sensor from presens instrument in each one.

- 2) Place a Hobo logger in 4 unused chambers and post-process DO data from instrument using Hobo temperature data. This involves intercalibrating all temp sensors and adjusting DO data using the Hobo temp Data.
- 3) Splice together segments of respiration signals and remove areas of weird data caused by spurious temperature measurements.
