Irrigation Design and Specifications

Wind Damage

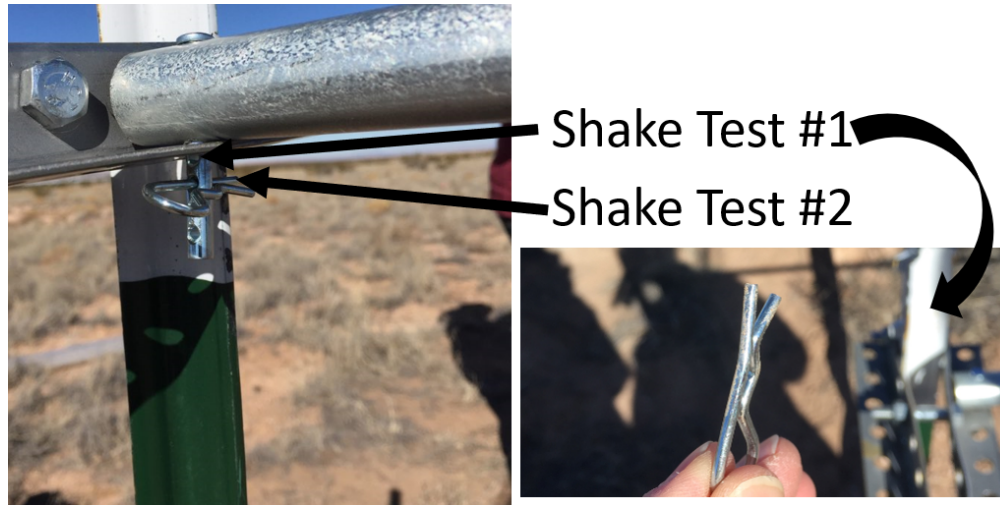
- The **pin** held up well but did have one questionable sign. At first, the pin was secured into the closest adjustable hole which gave the effect of a tightened bolt – i.e. direct contact of pin clip and hence no wiggle room. When this was the case, the shake test caused the pin clip to bend slightly (figure 5). However, a second shake test was performed with the pin clip secured through one hole lower than the former test, which allowed some wiggle room. This test (done with a new clip) did not cause clip bending.

- My guess as to why the pin held up in the second test is because of the reduction in stress that was afforded to the pin thread as a result of the wiggle room. In other words, the space in between 1) allowed the pin thread to **not** be under constant pressure and 2) dissipated some of the force of the shake before the pin clip hit the top of the bracket.

Figure 5: shake test 1 led to overstress of the pin thread and caused it to bend slightly (right); shake test 2 seemed to avoid this problem

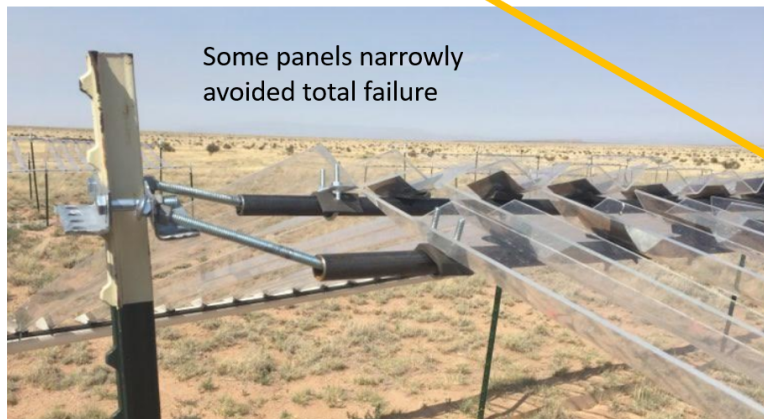
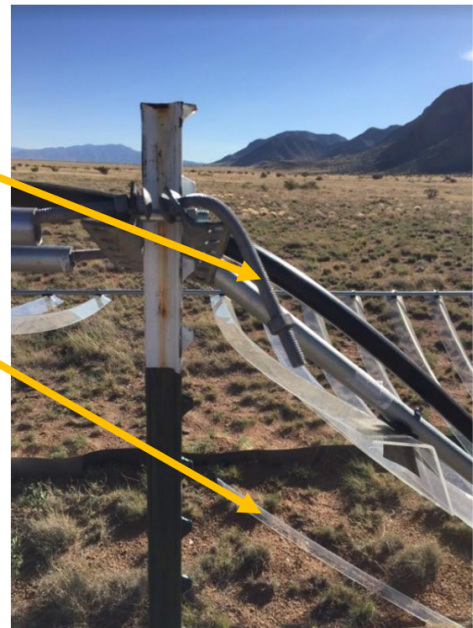
Storm #1 (June 2019)

The upper ends of the shelters, suspended 5' up the T-posts via carriage bolts, were more susceptible to wind. Failure to stay on the bolts led to whole panels (4 panels per shelter) flying off, damaging plastic shingles and bending hardware

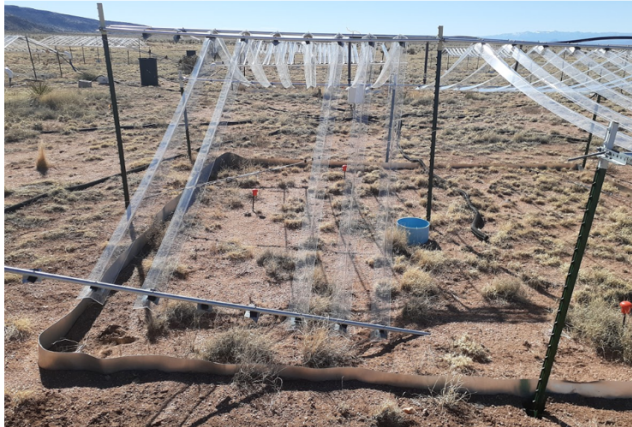
The same carriage bolt problem repeated itself, this time on the lower ends, which did not receive guy wires after storm 1

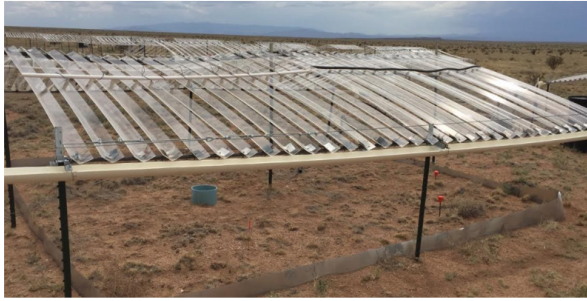
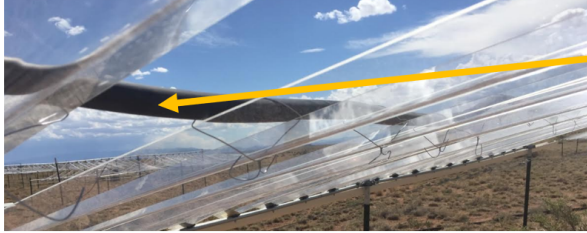
Solution to 'background wind' – as of summer 2020

This provides extra support and rigidity, so there is not 7+ feet of unsupported acrylic w/o a point of contact that is available to fly around in the wind

To combat shaking and breaking of shingles in the wind, a perpendicular stabilizer line is wire tied to individual shingles across the panel.

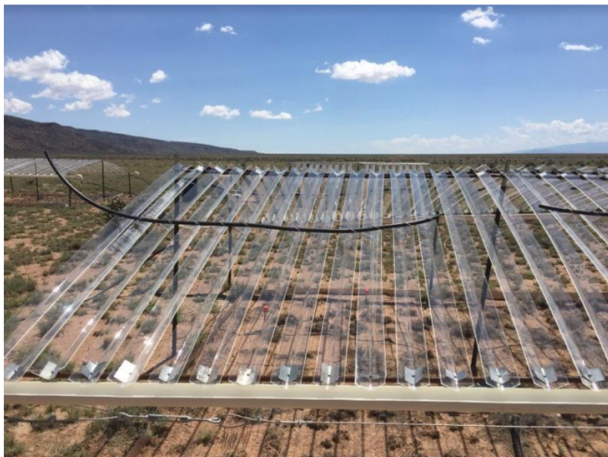
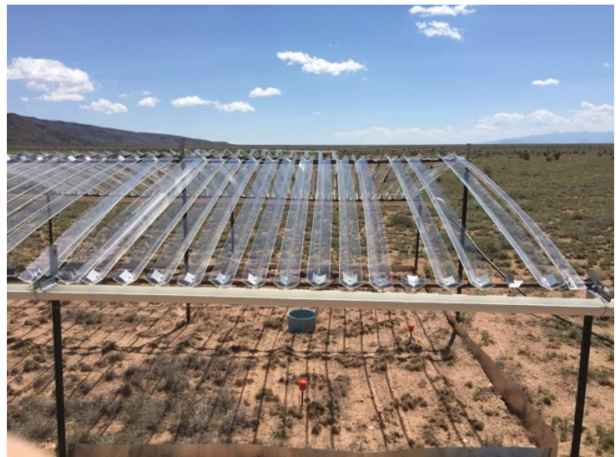
Stabilizer lines. Good news: after a high wind event, no shingles attached to stabilizer lines were broken (left) while others were (right). **Bad news:** winds can wiggle the line free; better ties/stoppers will be needed
