Photographic record of land degradation and resilience in Dogu'a Tembien after the shock of the Tigray war (northern Ethiopia)

Executive summary

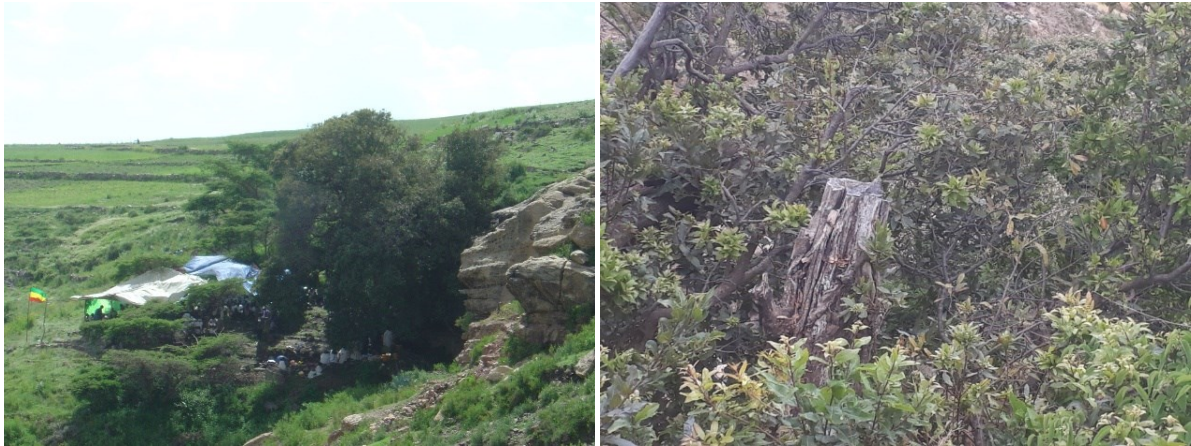
Figure 1. A conspicuous myrtle tree (*Myrica salicifolia*) at the upper edge of the May Ntebteb enclosure. At left, hosting the participants of the international HighLand2006 scientific conference [62, 63] (photo © Neil Munro); at right, its major branches were harvested by individuals in 2021 – a saw was used at night, so that cutting was silent, in contrast to the commonly used axe (photo in October 2023).

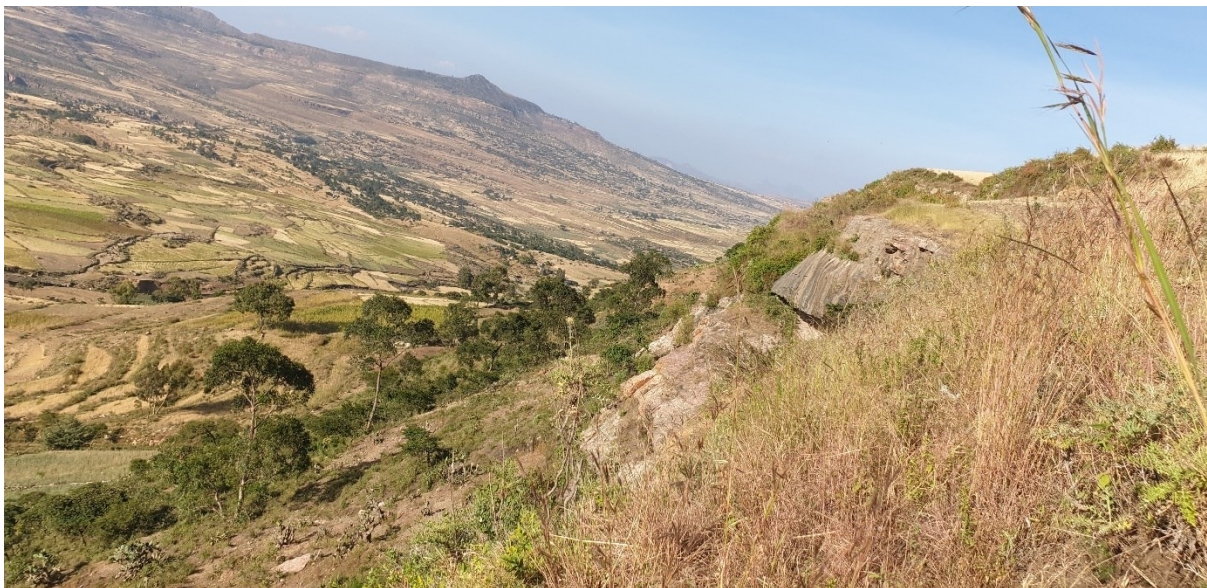
Figure 2. In the Khunale enclosure [40, 47, 48], many trees have disappeared, particularly at its western side, closest to the village (foreground of the photo, at the foot of the cliff). The cutting started with the war. There was lawlessness and people went into the enclosure to cut trees, indigenous trees as well as eucalypts. The cutting stopped around the time of Cessation of Hostilities Agreement in November 2022. There is poor regrowth of the trees, because this enclosure remained open for grazing. Photo in November 2023.

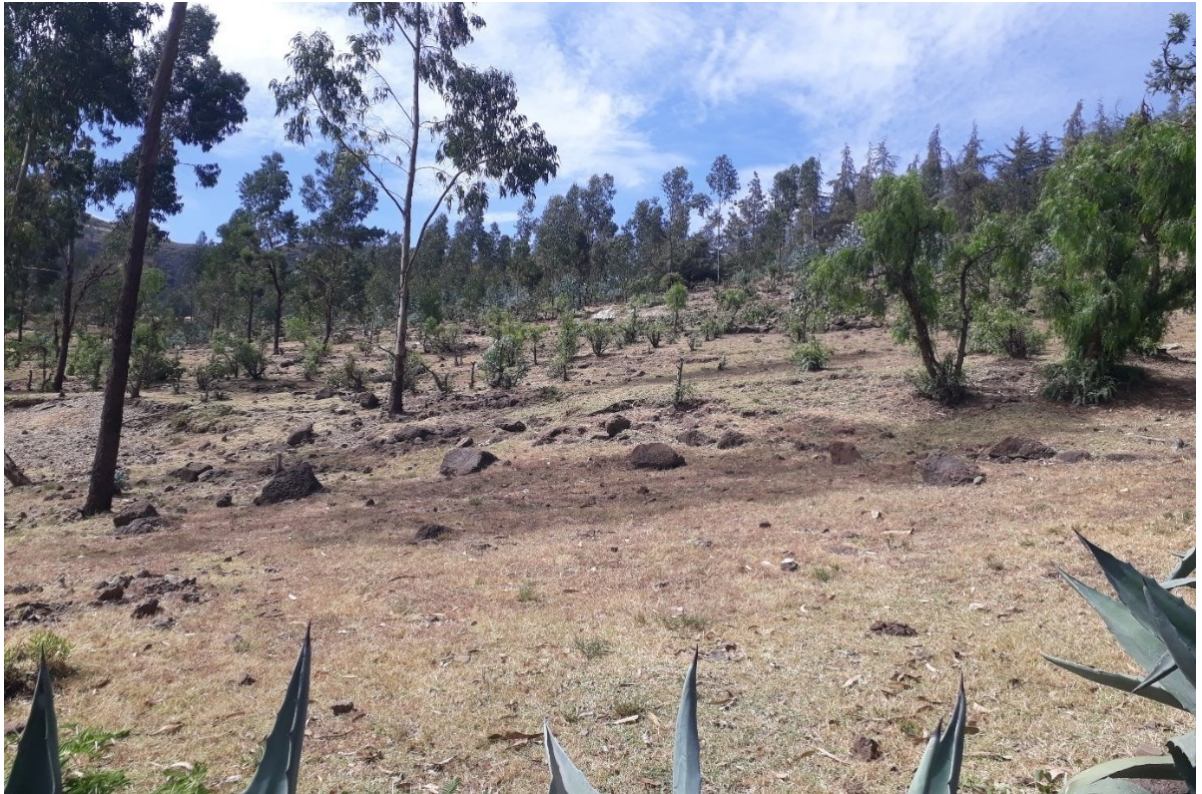
Figure 3. The experimental tree plantation of Dingilet, from which the villagers do not directly benefit) has been largely depleted from its trees (various eucalypt species, peppertrees, mulberry, moringa, ...) and grazed short, whereas the adjacent apple tree nursery had been well preserved throughout the war (Figure 34). Both sites depend on the local branch of the Bureau of Agriculture, and between the end of 2020 up to end of 2023 no staff visited the site. Photo in October 2023.

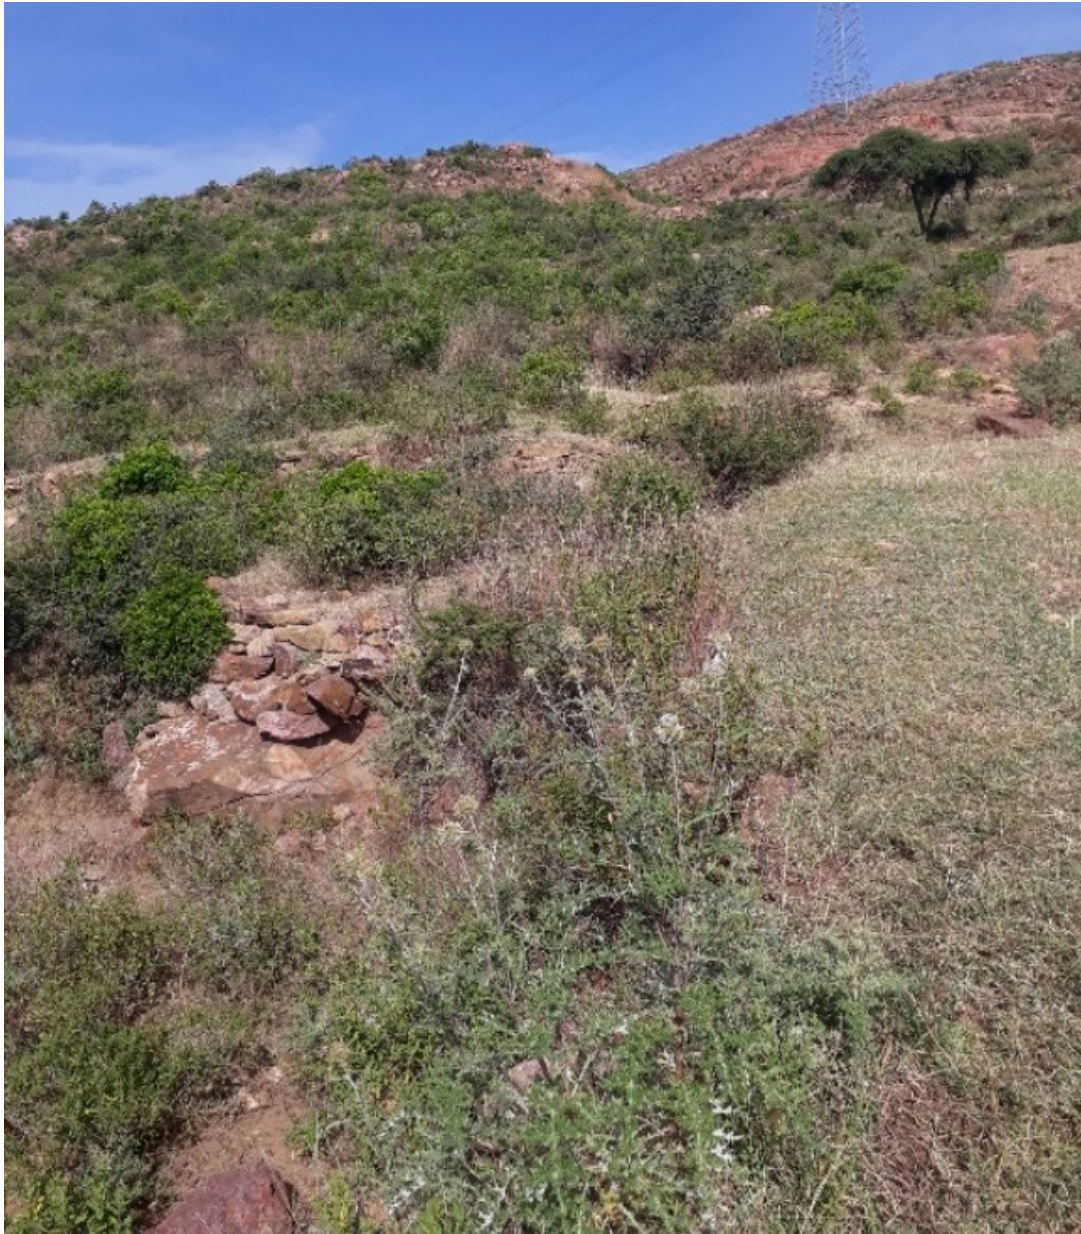
Figure 4. In Addi Qolqwal's enclosure (left part of the photo, taken in November 2023) there has been some wood chopping, but probably not worse than before the war. Some branches were cut from eucalypts, but this tree is typically grown to provide wood. Saplings of *Dodonaea angustifolia* had emerged, and remarkably, the gully at the edge of the enclosure is well controlled by check dams and the woody vegetation that has grown in it since twenty years [39].

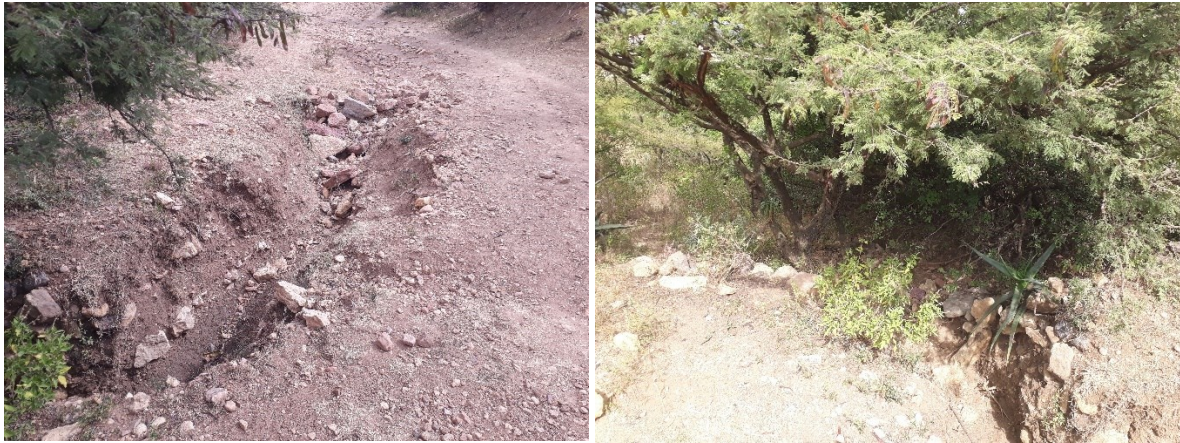
Figure 5. Along the rural road to Addi Qoylo gullies have occurred due to a lack of road maintenance since 2020 (left, looking upslope). The runoff path then leaves the road and enters into an enclosure managed by the “Trees For Farmers” [64] project (right, looking downslope). Though no salaries or payments were received during the war, the guards have continued protecting it and the enclosure stands nicely. The enclosure totally buffered the runoff coming from the road and the gully is discontinued and sediment is deposited. Photographs taken in November 2023.

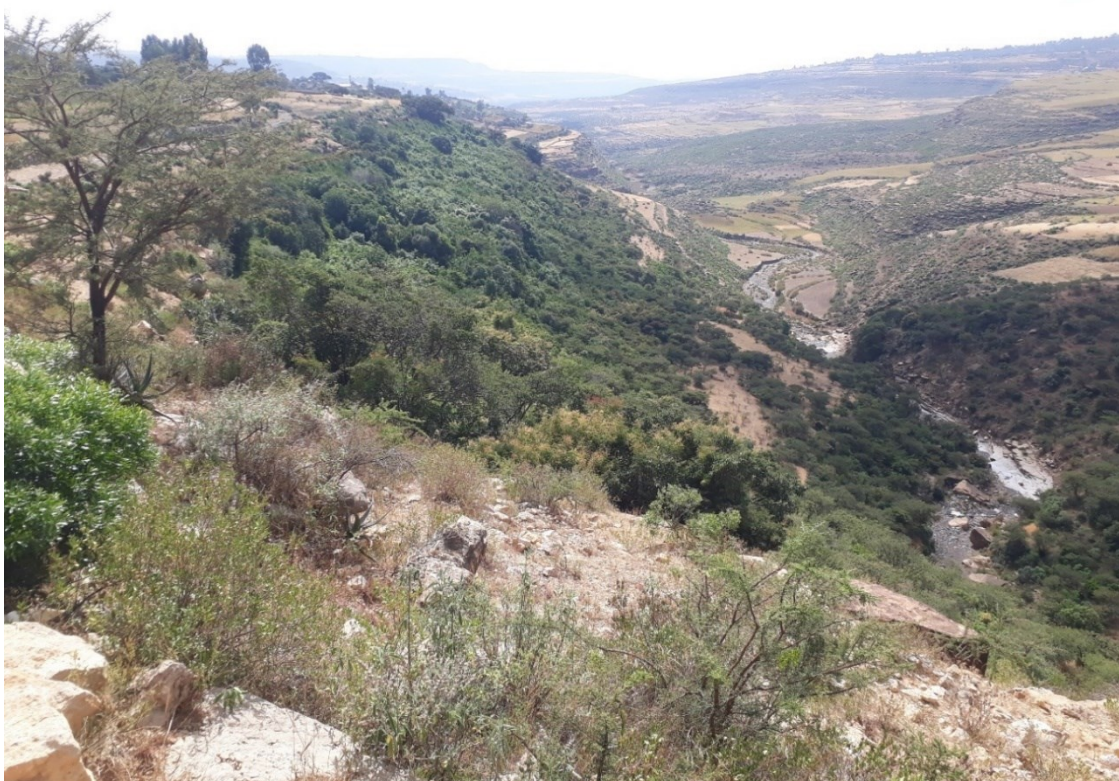
Figure 6. The Habdi Luqmut forest in Hech'i [30, 32] remained in a good shape throughout the war period, as observed in October 2023. Farmers reported that during that difficult time they did not cut wood from their forests or enclosures, or from other trees far away from the village: “We all have trees on our farmland boundaries and when we need wood, we cut it from there”. They also said that they are located too far from Mekelle or even Hagere Selam to organize charcoal trade, like Togogwa did for instance.

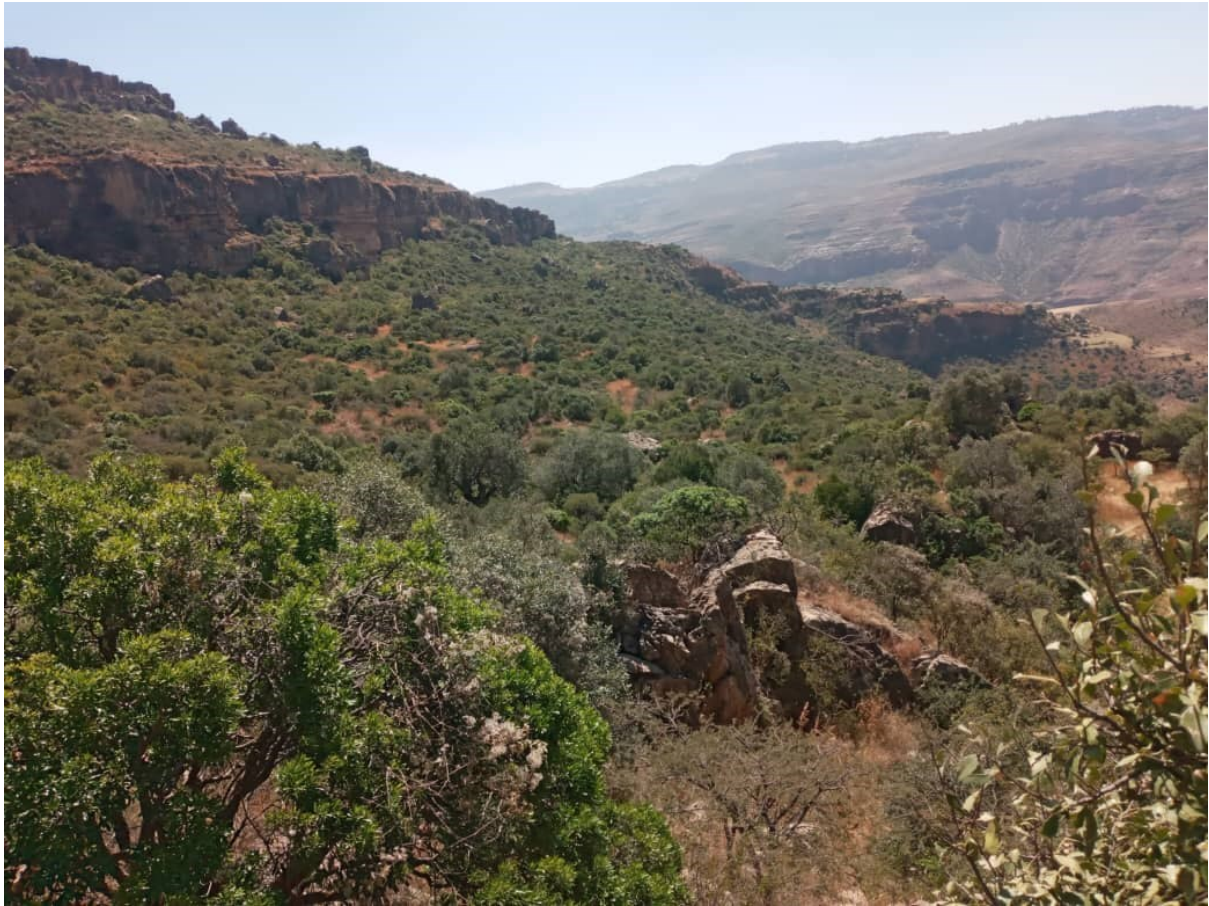
Figure 8. In the Debre-medhanit (Itay Sara) enclosure, managed by the EthioTrees project [65], no wood harvesting or grazing occurred in 2020-2022. In 2022, during and despite the blockade of Tigray, the villagers of Tsili, to which the enclosure belongs, received 1 M ETB as carbon offset payment, that was shared between 589 households. As the communities directly benefit from keeping their enclosures intact through payments for carbon certificates, there are fines for anybody who cuts trees illegally. This rule was maintained throughout the war. Also, adjacent enclosures have been well kept, as villagers hope that these will be included in the carbon project in the future. Photo taken in January 2024.

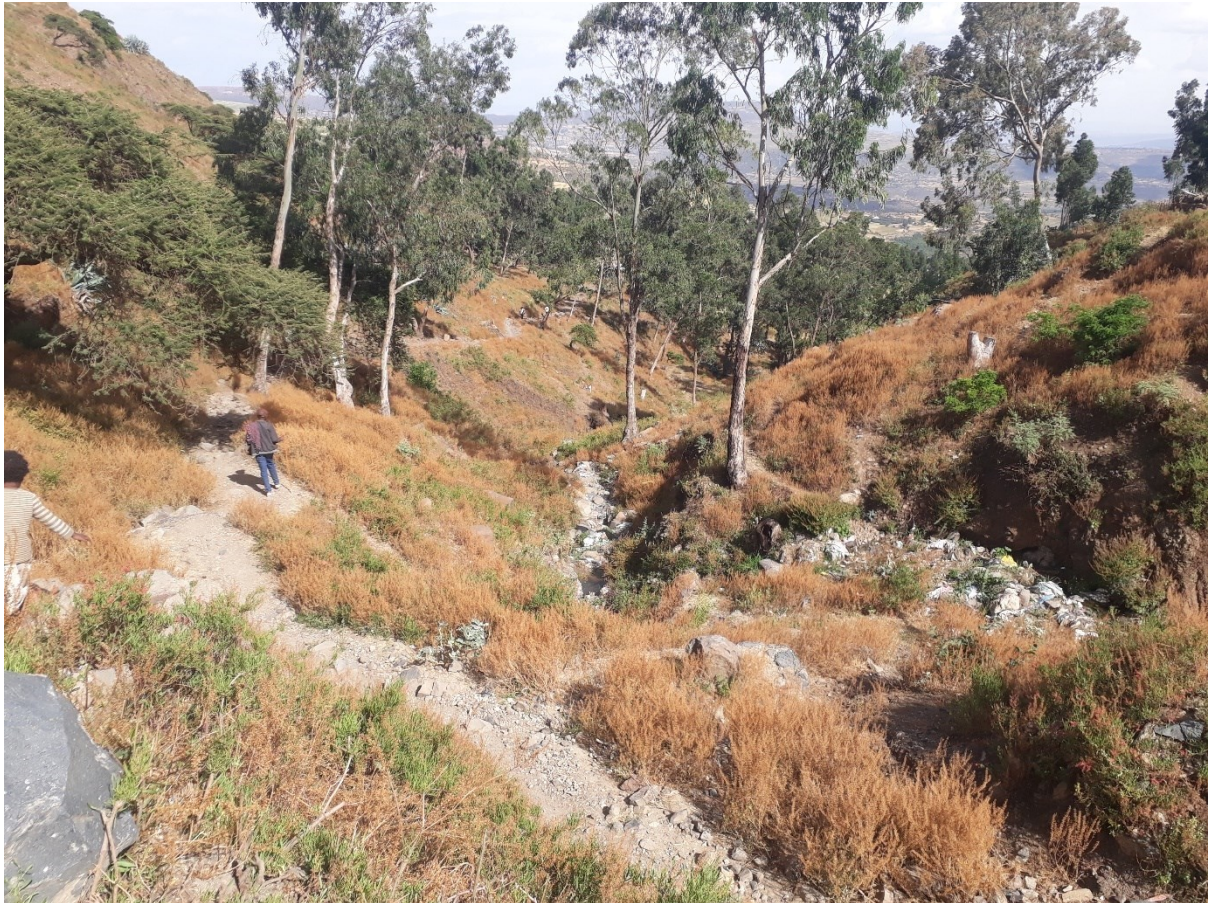
Figure 8. In the Gra Arho eucalypt plantation, which is at the edge of Hagera Selam town, many trees have been cut in 2021 and 2022. Many people were without income, so those who could sell wood had money to survive. There was almost no electricity at that time and firewood fetched good prices. The dominant dry brown herbs are a new invasive weed, *Salvia tiliifolia* (see Figure 9). Photo taken in October 2023.

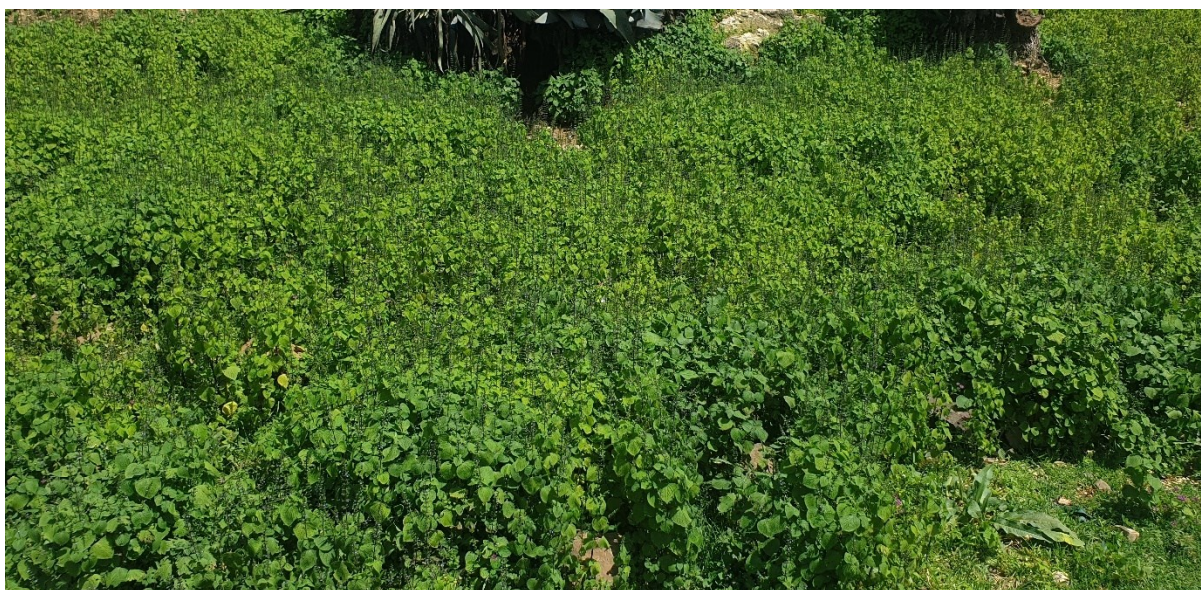
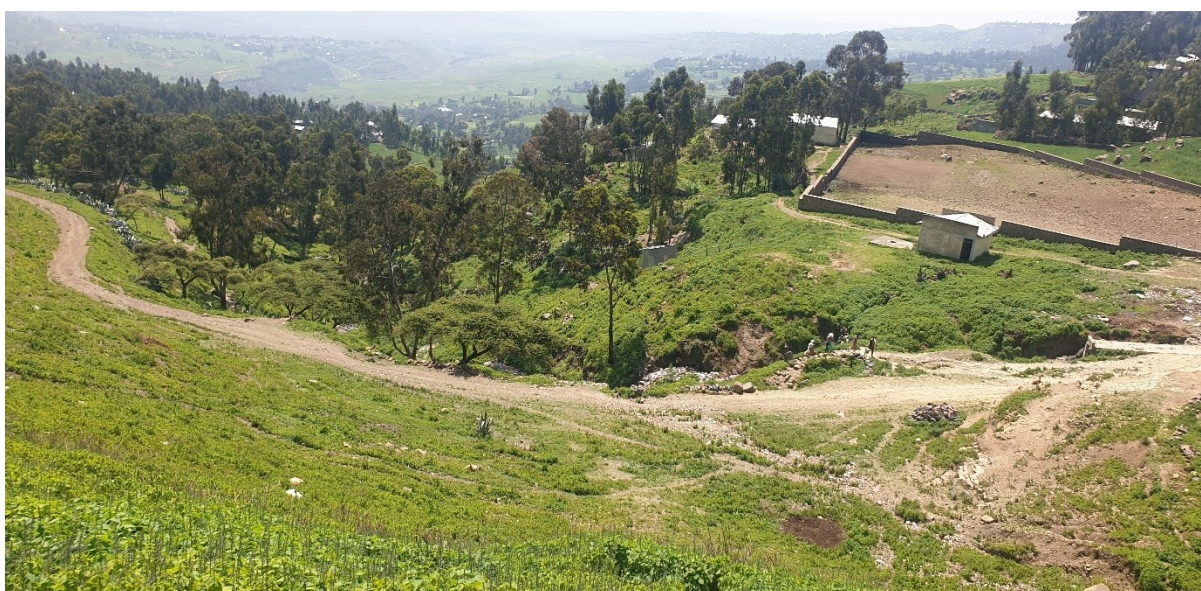
Figure 9. Since approx. 2019, *Salvia tiliifolia* has appeared in the study area, where it now occupies large areas, especially where soil is reworked, such as dumped soils, roadsides (here in Hagere Selam, along the old road to Mekelle, September 2024), building sites, but also in eucalypt plantations that were opened up due to war-related wood harvesting (Figure 8), and further down in fresh alluvium along rivers. The species is not toxic, but according to the farmers useless, and it occupies space. There is no local name for the plant, just “new weed”. On well-managed farmlands, one will generally not observe this weed because the farmers remove it very easily: easy to identify, easy to pick out. *S. tiliifolia* is now the main weed; it grows rapidly and even suppresses the other weeds. Native to Central America, it is a recent exotic invasive species in Ethiopia, first described in Ethiopia in 1996 [66]. It is now quite widespread over the Ethiopian highlands [67]. Its expansion into Dogu’a Tembien is relatively late. The wetter conditions in recent years (and even in the last decades), jointly with slowly increasing temperatures, may have contributed to the creation of a niche for the species, in line with observations of natural vegetation and crop belts that shift up the mountains in northern Ethiopia [68, 69]. The extent to which multiple traffic and war disturbances may have contributed to this spread is unknown.

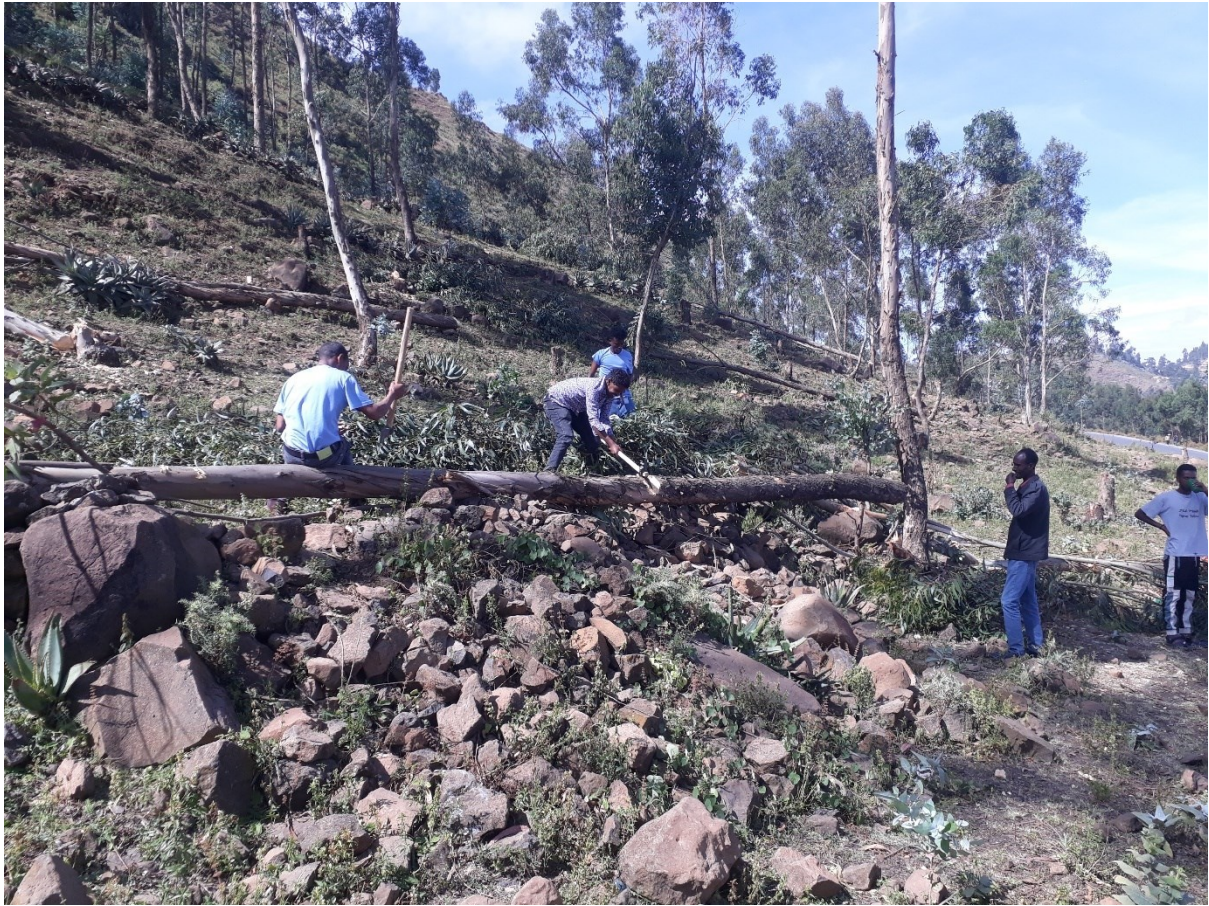
Figure 10. Since 2023, it is not allowed anymore to cut trees from the eucalypt plantations. Special permission is however given to TDF soldiers (Tigray Defense Forces), who get insufficient logistics and hence obtain permission from district officials to harvest trees for firewood, here on the slopes of Imba Zuw'ala (November 2023).

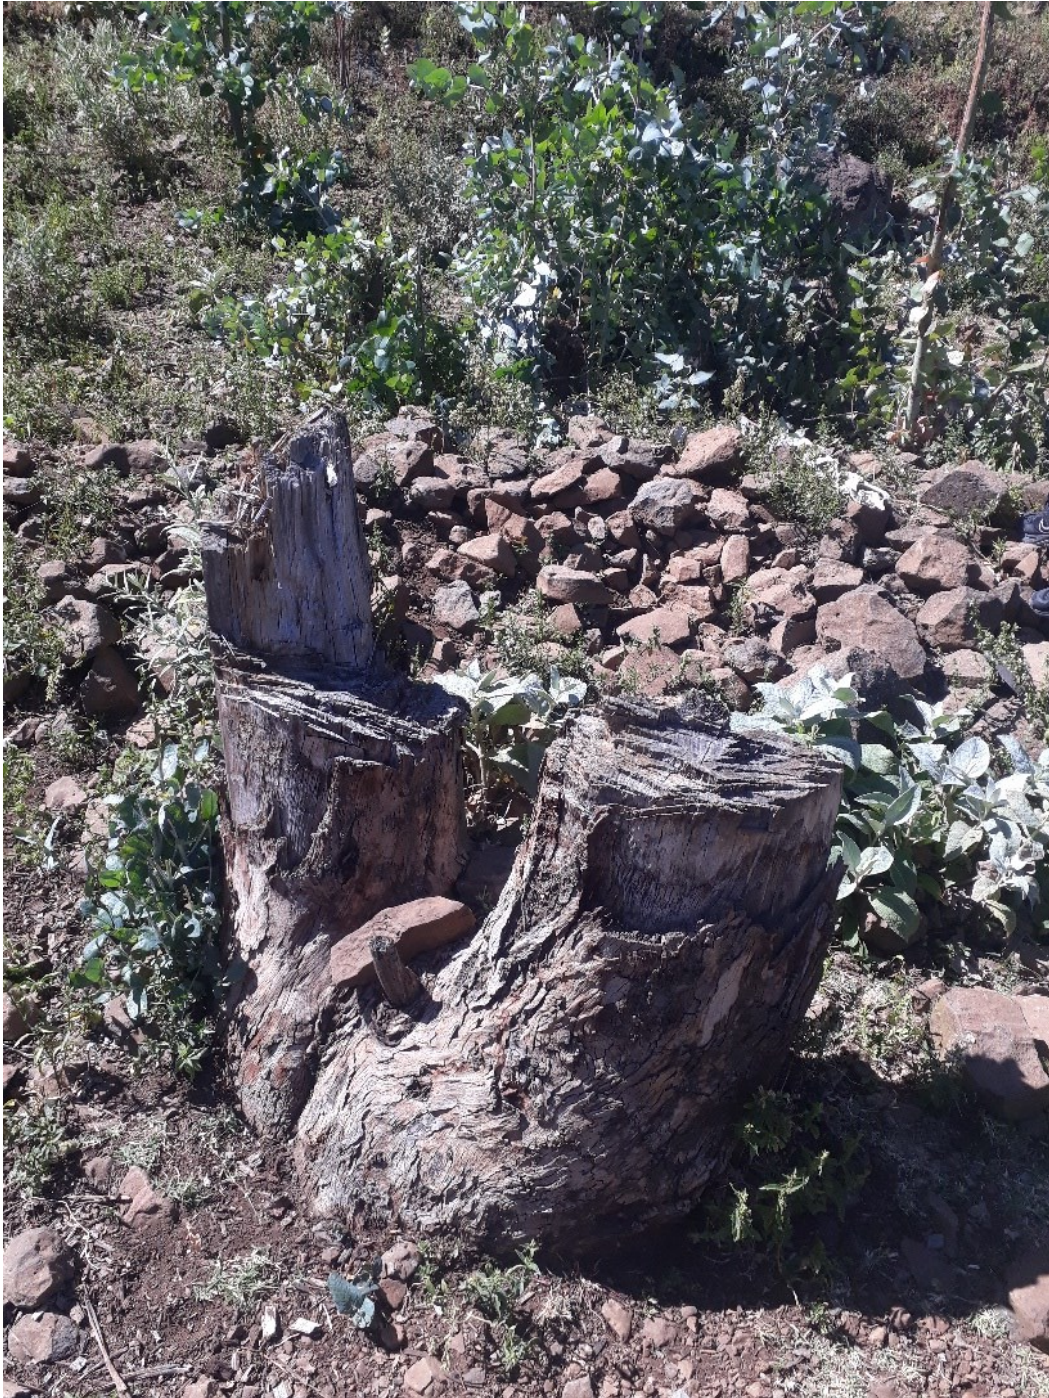
Figure 11. The Imba Zuw'ala eucalypt plantation was established around 2000, on communal lands that had been expropriated and transferred to the Maychew Particleboard Factory [70], yet claimed by the community. Many trees were harvested in this plantation during the war. There is coppicing on all stools, which indicates that after some years, the eucalypt tree cover will be strong again. Drawback is however the free grazing in such places; especially goats browse young *Eucalyptus* leaves in periods of pasture scarcity and damage the coppicing trees [71], which hampers regrowth. In addition, the undergrowth, which is typically very poor under eucalypts, is further removed, and this leads to a stronger runoff response and erosion, and less infiltration. Photo in October 2023.

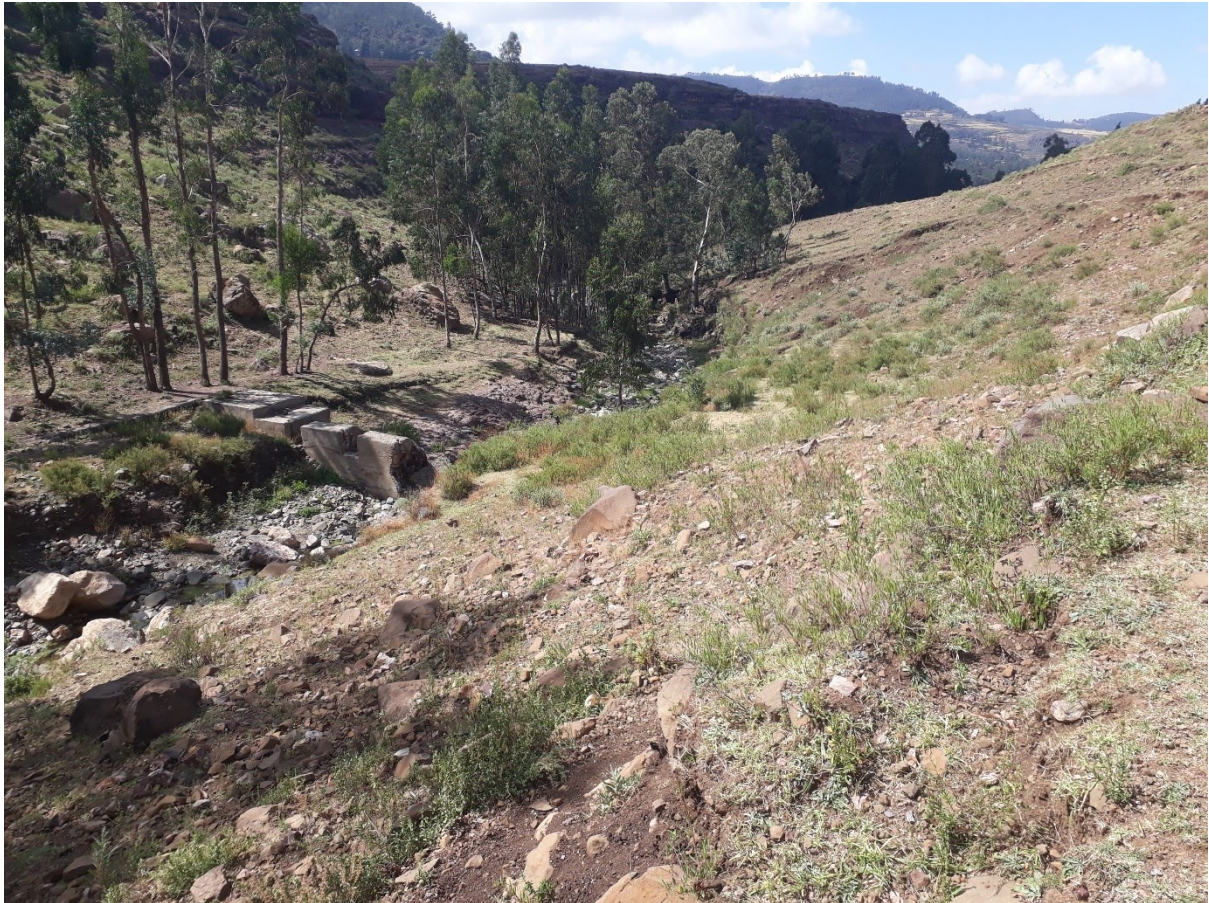
Figure 12. In the greenish Mehati Lahma gorge [41], the eucalypts have not been cut, in contrast to Gra Arho, or those along the main road. Whenever eucalyptus trees were cut for provisioning of armies, or for organized trade, it occurred in areas that are easily accessible, near towns, military camps or along roadsides. Photo in October 2023.

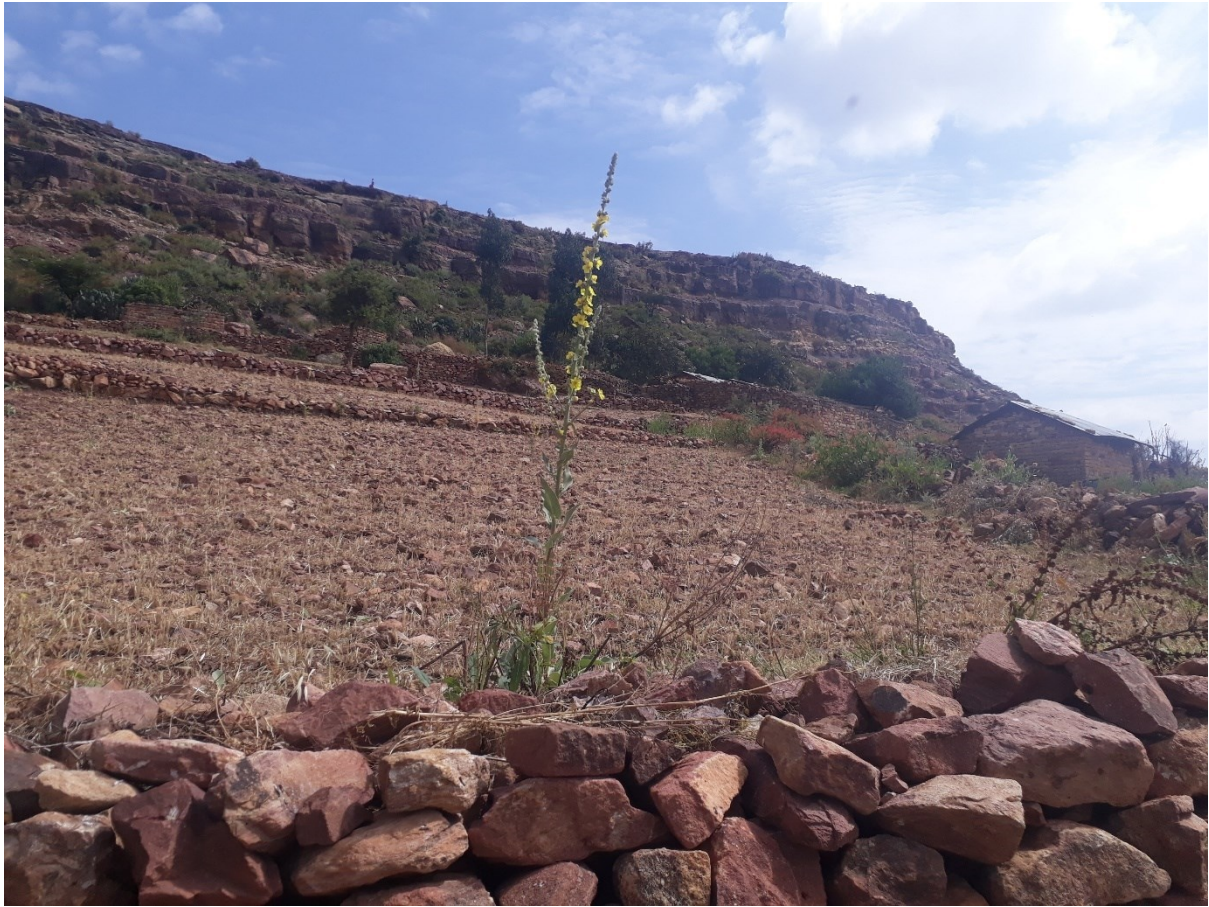
Figure 13. Near Addi Qolqwal, almost all stone bunds stand in October 2023 as they were standing before the war [18, 30]. At several places we saw that farmers have maintained their stone bunds.

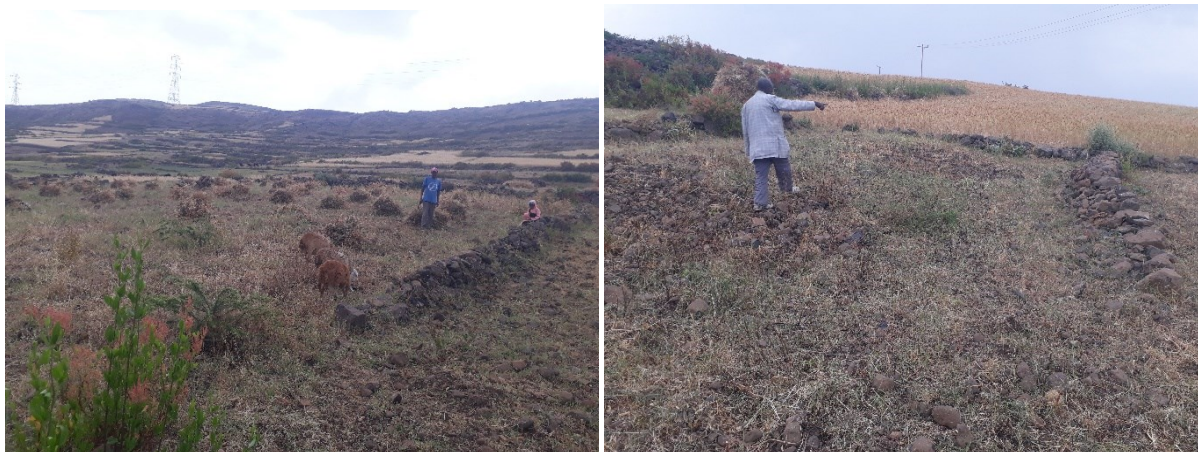
Figure 14. At Gra Mehaber, no overall collapse of the two-decades old stone bunds [10, 30-32, 44] was observed in October 2023. There are some small parts of stone bunds that have collapsed, even though no runoff had flown through it. The farmers' attitude is that they will wait whether the community comes to this area in the dry season and repairs it as part of the regular catchment management works, if not he will repair it himself by June, at sowing time (left). Another farmer showed a new stone bund that he constructed on his land, as he could not find off-farm employment at slack time and yet wanted to occupy his time usefully (right).

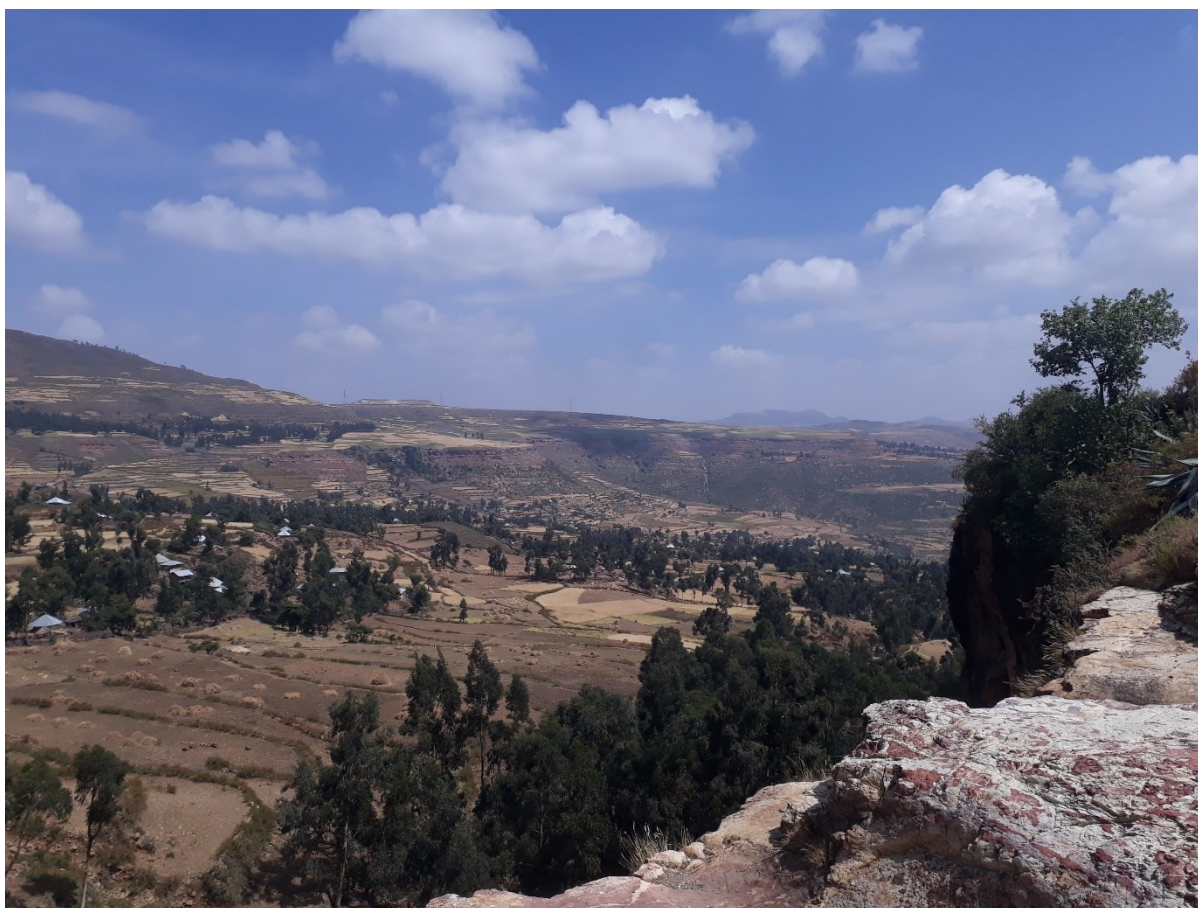
Figure 15. By October 2023, the stone bund landscape in the farmlands of Harena does not show evidence of any destroyed stone bunds, neither the existence of drainage lines induced by weaknesses in the bunds. The farmers have repaired any damage that may have occurred to these bunds near their village.

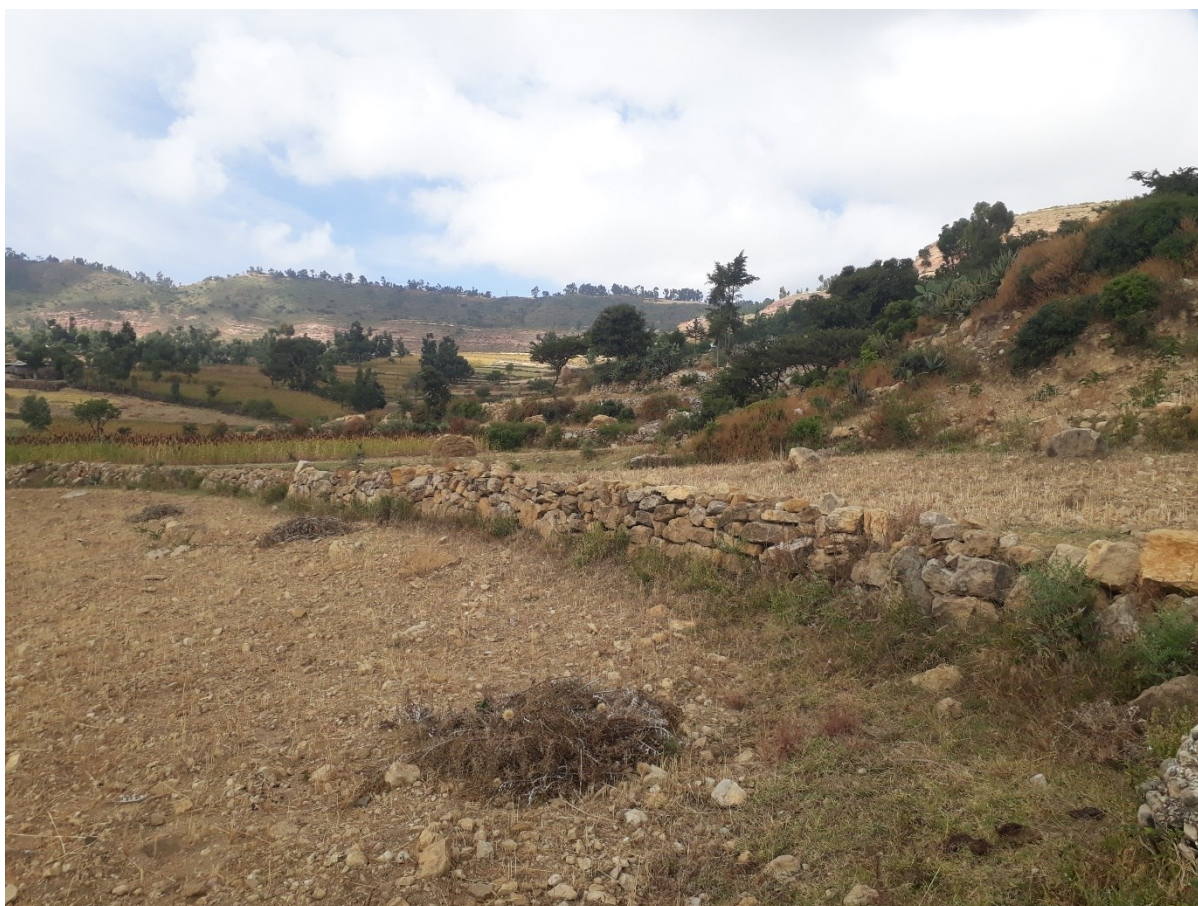
Figure 16. In the Argaqa area, all stone bunds, constructed in the years after 2000 [22, 23], were intact in October 2023. Overall, among the representative sample of 31 observed stone bunds (Table 2), 25 are in acceptable to perfect condition, four have collapsed in their upper part without generating concentrated runoff and two need rebuilding. Bunds built from limestone and sandstone are particularly in good condition (Figures 13 and 16), while those built from basalt require much more maintenance (four out of nine observed), which is clearly related to the irregular, often spherical shape of the rocks (Figure 14).

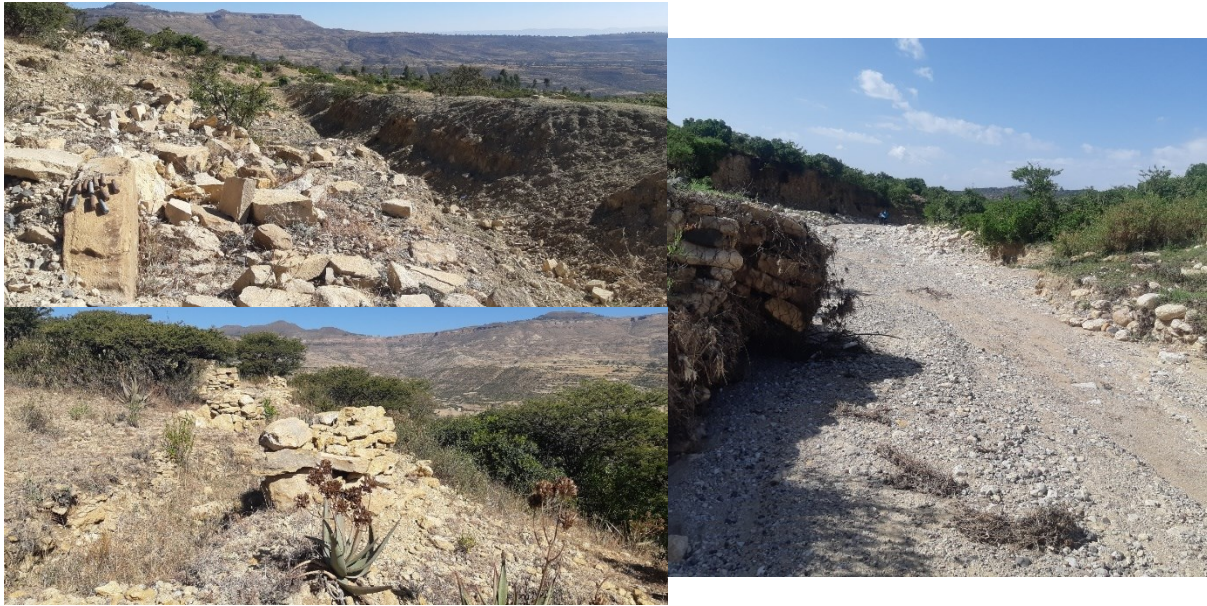
Figure 17. The large Afedena enclosure [16, 52] and its surroundings were heavily affected by the three-day Ala'isa battle in late 2020, where Ethiopian and Eritrean forces jointly took on the Tigray forces [72], with, in addition to numerous battlefield deaths, a lasting environmental impact. Upper left: a long defence trench off-contour has become a rapid drainage line. Locally, the vegetation has been largely depleted. Note the bullet casings on the left rock, collected in just a few minutes. Lower left: rocks were massively taken from physical conservation structures (stone bunds) to establish combat positions. As a consequence, at right, some 7 km downstream, one of the two large checkdams for gully stabilization near Tukhul [53] that were destroyed by floods in 2021 with the accumulated sediment behind it largely washed out in 2021, 2022 and 2023. We attribute this to the strongly enhanced hydrological connectivity in the battlefield, that occupied most of the catchment. Note that even before the war, the check dams were in a critical situation, mainly because the catchment had been insufficiently protected, while check dams were already built across the river in the lower part of the catchment. The battlefield-related degradation in the catchment led to a stronger runoff response, and the check dams were washed out. Left side photos in January 2023, right hand in May 2023.

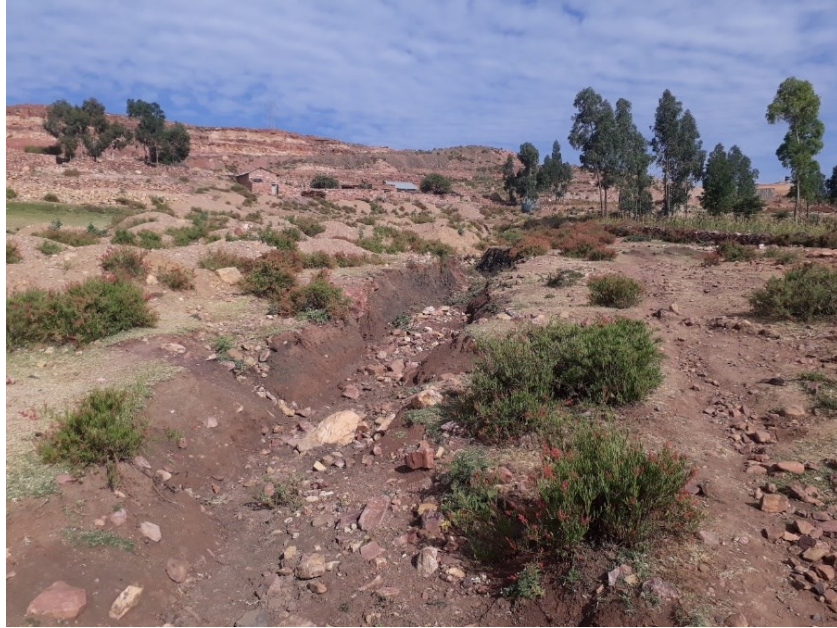
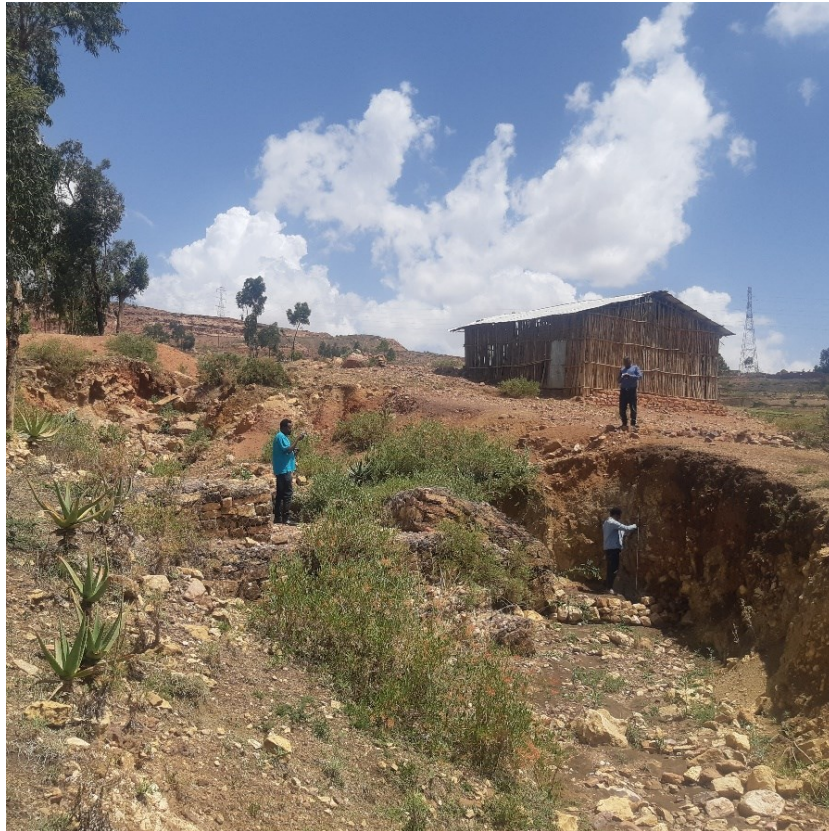
Figure 18. In Addi Qolqwal, just down from the main road, a new gully has formed. One reason are dumps from earlier road works that have narrowed the flood path. An additional cause for gullying is that stone bunds collapsed in the upper part of the gully catchment, just under the ridge, due to intense warfare. There, TDF had established an earthen antitank wall, where the Ethiopian and Eritrean armies and their tanks were blocked for a day or so. A lot of artillery was shot back and forth. Further down (lower photo), at a weak point in the landscape given the presence of vertic soil material [16, 55], the existing gully was expanded and in 2021 the floods bypassed two large check dams. Upper photo in October 2023, lower photo in May 2023.

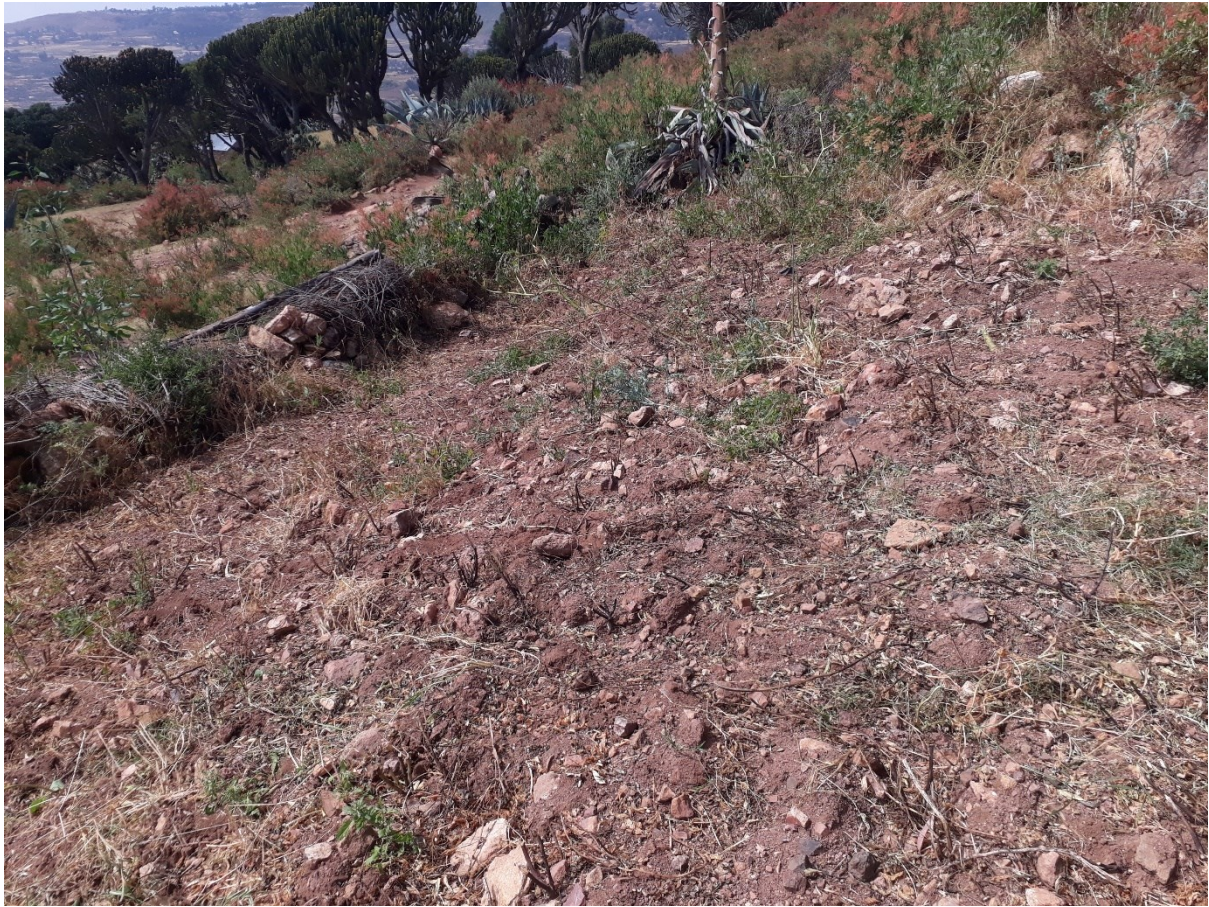
Figure 19. A lynchet slope in Addi Qolqwal, previously under grass [43], was turned into farmland during the war period. Some rills may be discerned. Photo in October 2023.
