Photographic record of land degradation and resilience in Dogu'a Tembien after the shock of the Tigray war (northern Ethiopia)

Executive summary

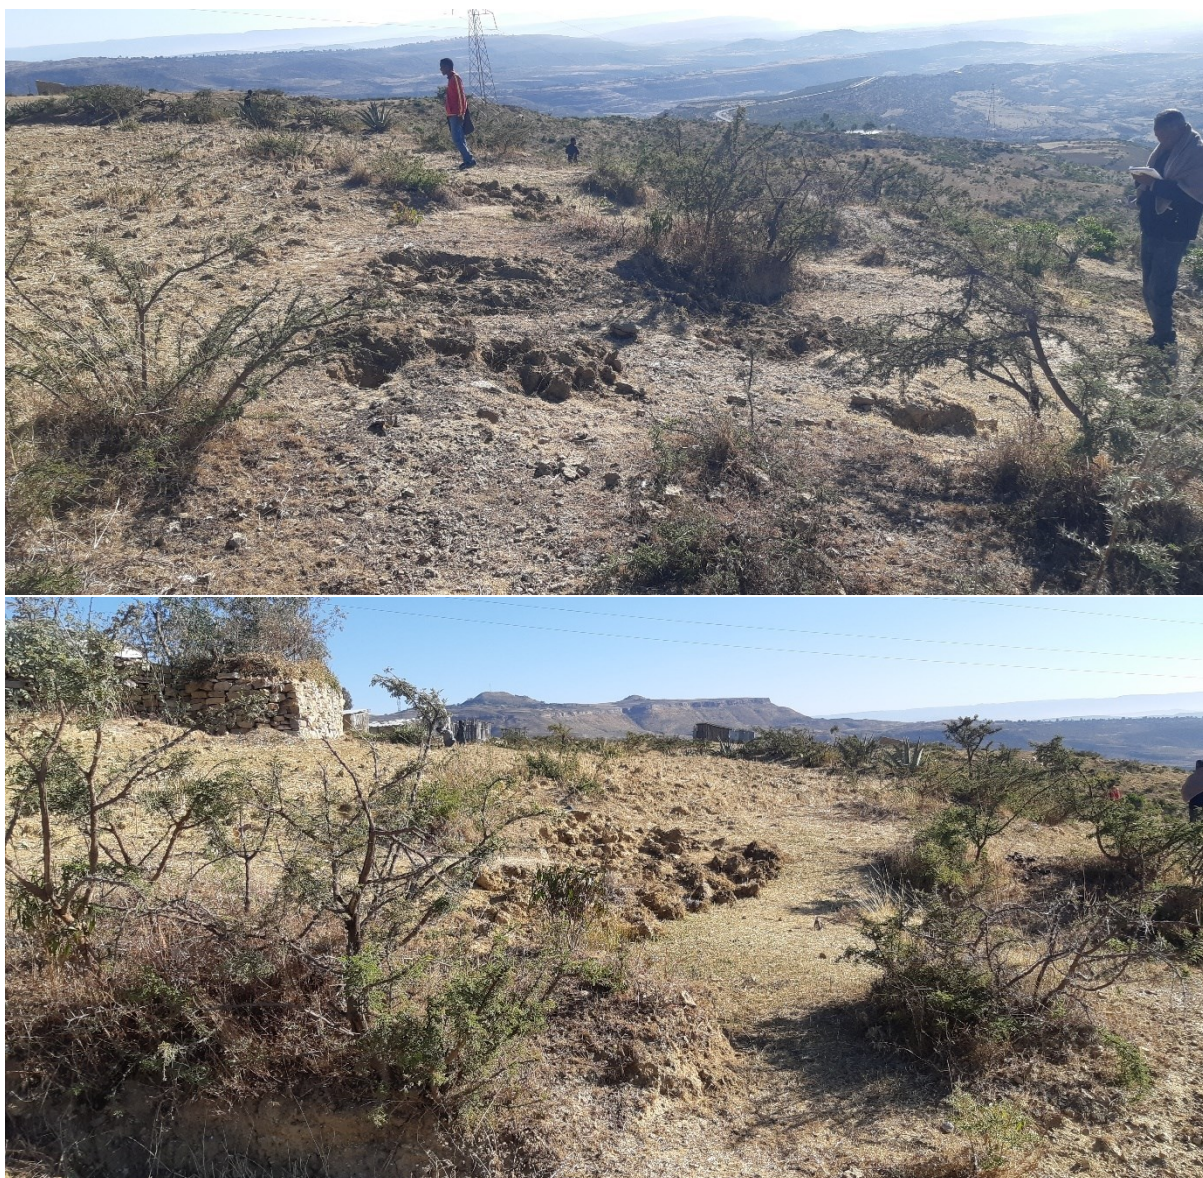
Figure 20. At Afedena, communal rangeland has been quietly privatized by adjacent farmers; they tilled the soil gradually by hoe to evade the notice by other villagers (January 2023). Later on, during plowing, they integrated the targeted areas into their cropland and uprooted the shrubs that stood in the way. Facing hardship, and in the near absence of authorities, several farmers have expanded their farmlands in such a way at the expense of adjacent communal lands.

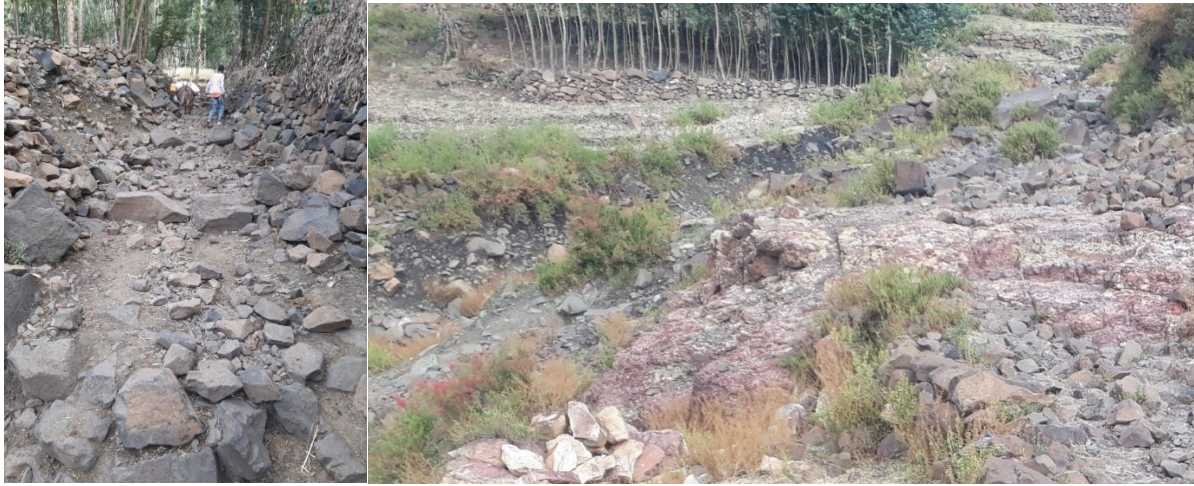
Figure 21. Effects of peri-urban drainage in the Gra Arho village: at left, many of the rocks that had been brought there in the few years before the war to pave a footpath have been dug out to strengthen the fences of the homesteads. This resulted in a narrow, incised footpath that channels rapid runoff. To the right, downslope from the village, the enhanced drainage from Gra Arho led to strong increase in gully erosion. Until 2000, there were no homesteads at all in this area. Photos in October 2023.

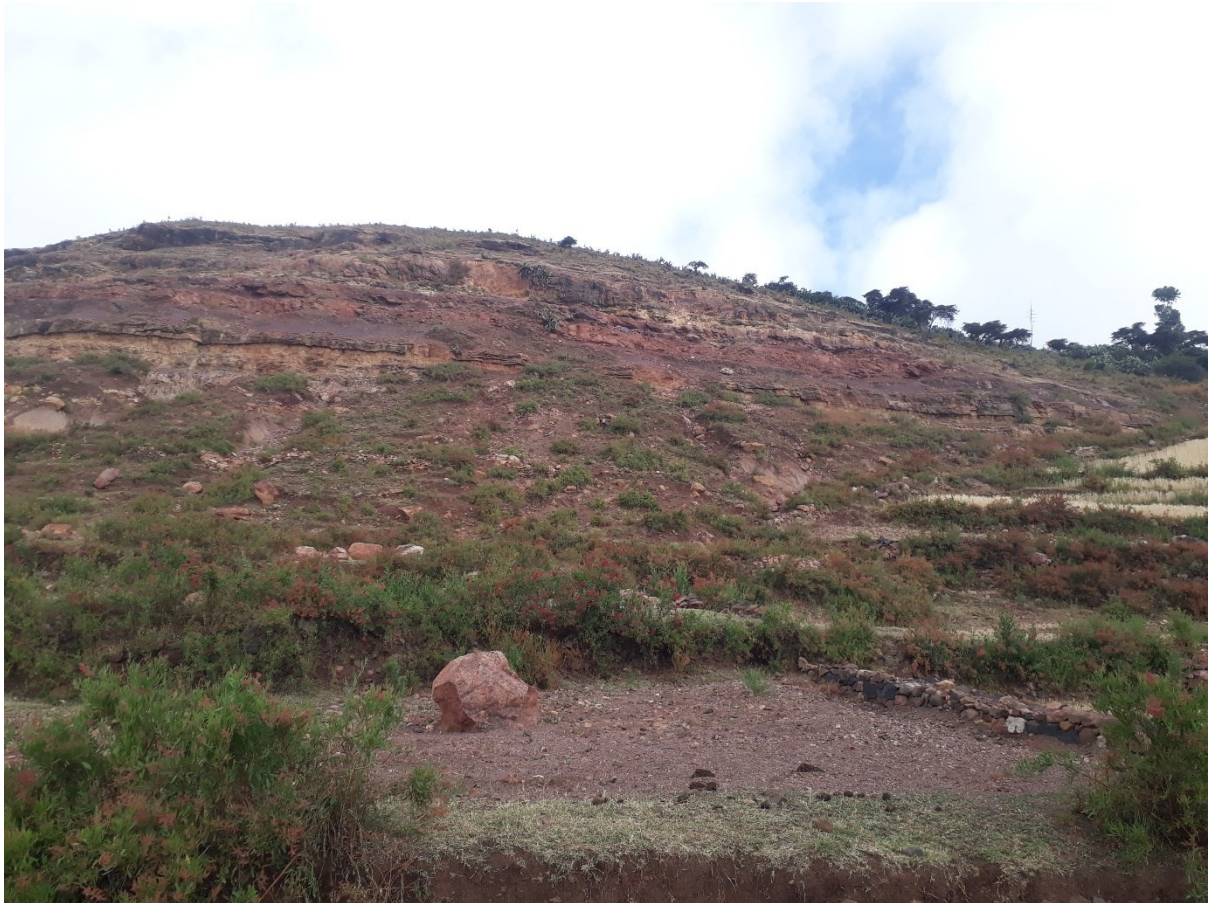
Figure 22. At Golab, the runoff and sediment that originate on this hillslope flood farmlands – see gravel deposits on the terraced farmland (foreground), and a stone barrage at right that the farmer made to keep the flood and its deposits out of the rest of his cropland. We investigated this hillslope in 1999-2001, when the land cover conditions were fairly the same [27]. In the following years, vegetation had regrown a little, and the slanted footpath that comes from the right was a bit better managed. Human interventions brought the landscape back to a situation unseen in the last 20 years. Grazing pressure on the slope has increased again (photo in October 2023), and, especially, a new settlement was established on the top of this structural flat after 2016, where people try to evacuate the runoff water rapidly. That runoff is then directed towards the footpath.

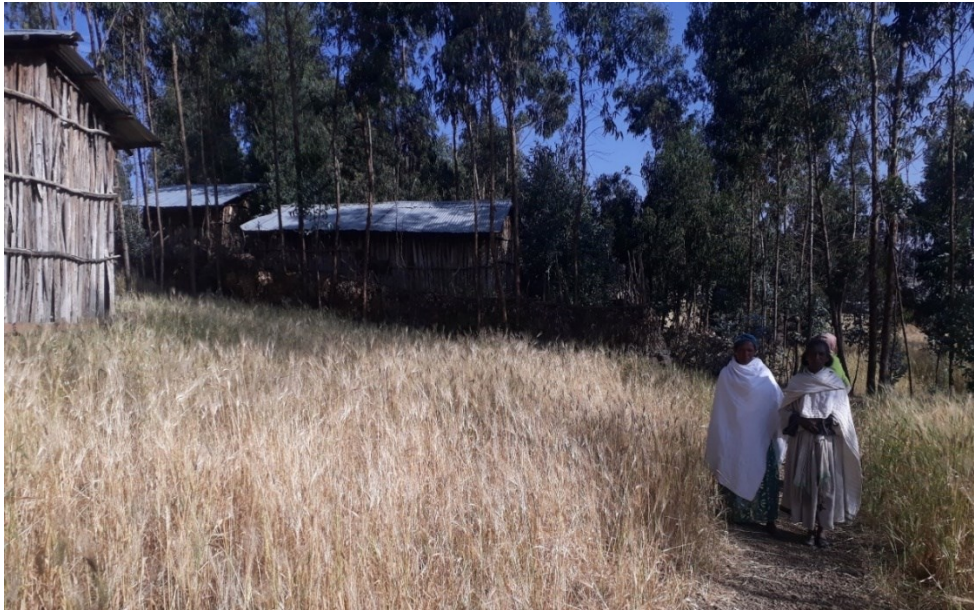
Figure 23. At the edge of Hagere Selam, in Maltmasha (which belongs to the adjacent village of Dingilet), a new settlement has come into existence, where the farmers have used their farmland to establish houses; the most recently established homesteads were constructed during the lawless period. Photo in October 2023.

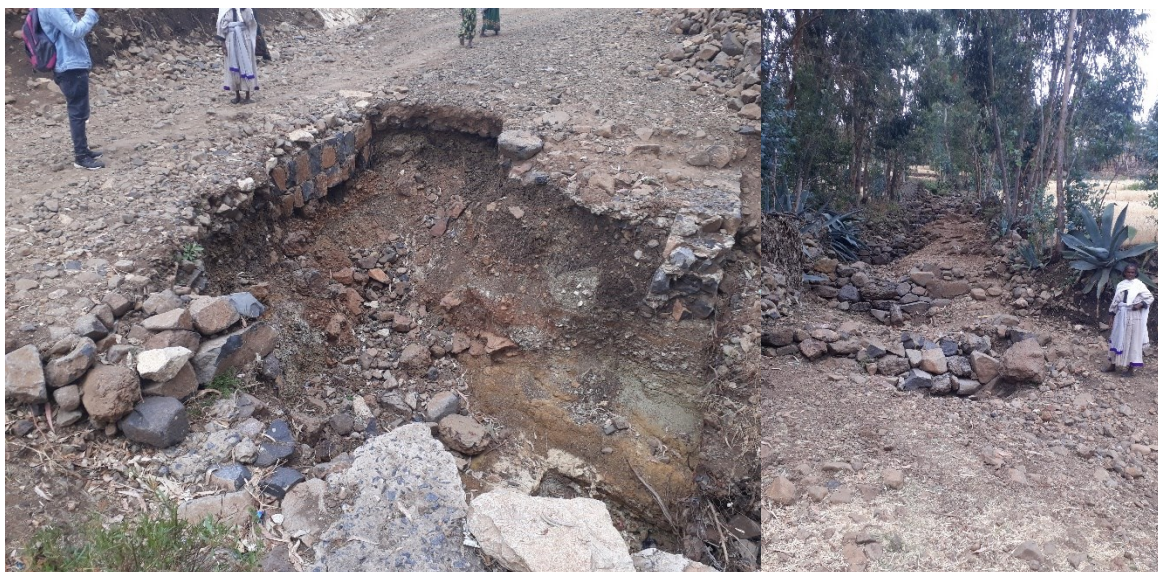
Figure 24. Downslope from Maltmasha, the road from Dingilet to Hagere Selam is affected by gully incision (left), which originated in 2021. The footpath that runs in the thalweg on the upper side serves as a waterway during storms [50]; it is equipped with steps and check dams at regular intervals, which were not destroyed, while the floods have simply cascaded over it (right). The increased storm runoff comes in response to the establishment of the new settlement at Maltmasha. The conflict of interest is that from a management point of view the footpaths should not concentrate the runoff, yet in the village and immediately downslope, dwellers and farmers just want the footpath to concentrate the runoff and evacuate storm water as fast as possible with gullying as a consequence in downstream areas. Such situations are already difficult to manage in peace times, but during the war the community was less organized and the remaining regional and village authorities did not at all focus on spatial planning. Photos in October 2023.

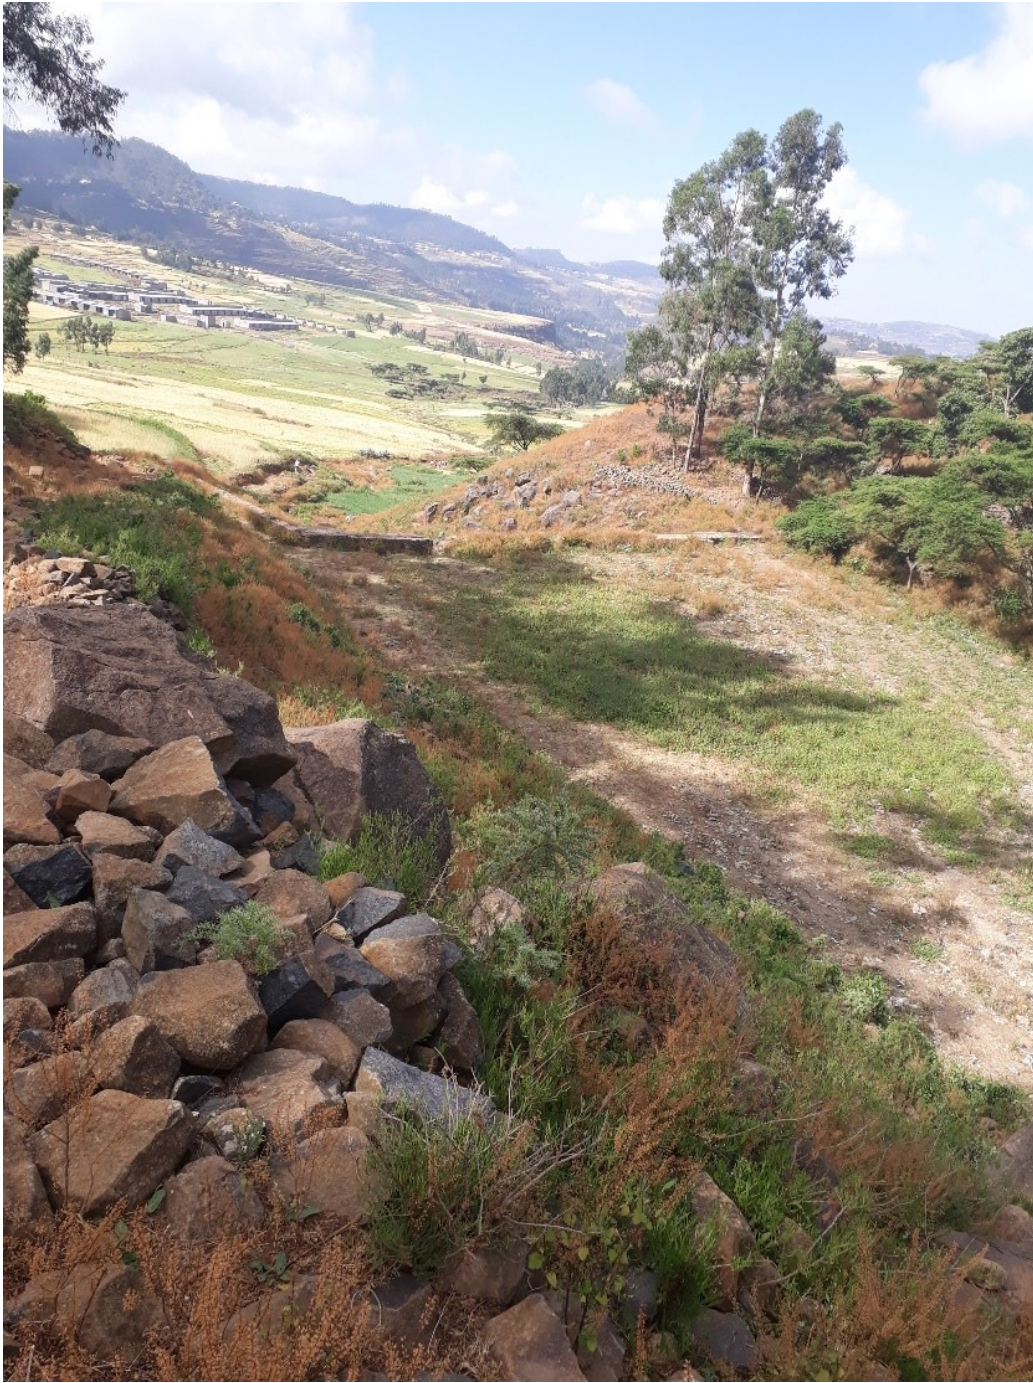
Figure 25. In a gorge at the southern side of Hagere Selam a large flood buffer dam had been constructed that got rapidly filled with coarse sediment [42], which reduced peak flows and enhanced infiltration. In the downstream area, around 1999, very active gullying occurred (Figure 26). After construction of the dam, soil conservation works and abandonment of free grazing, the gully downstream has become a linear oasis; in October 2023, there were quite some locations in the previous gully channel with ponding water. There is good grass growth, and also good discharge in the river downstream.

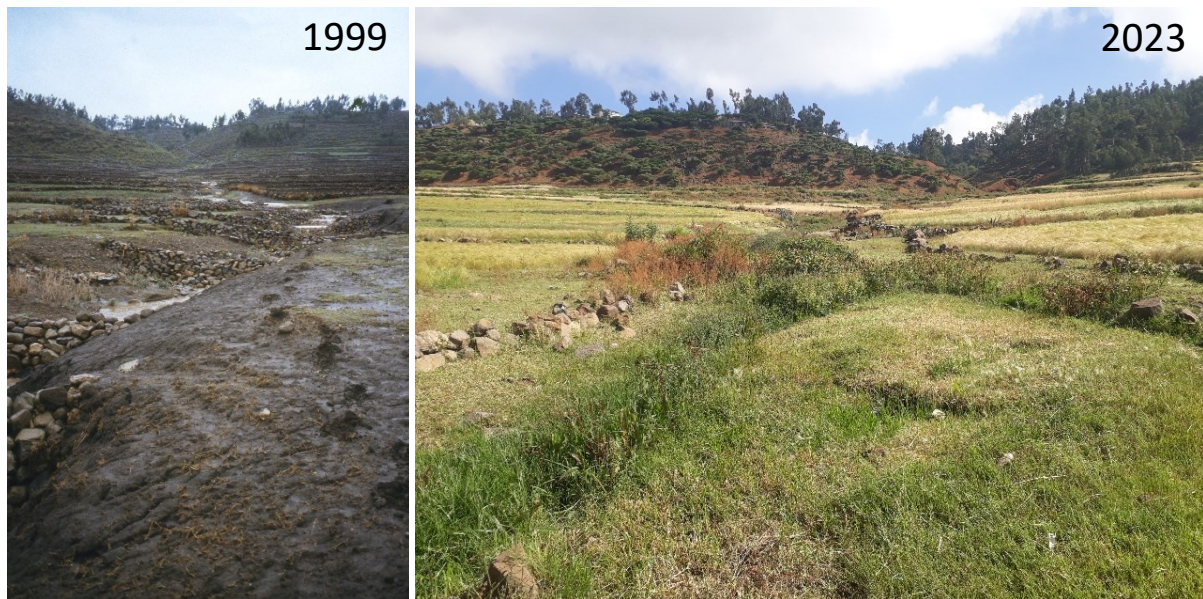
Figure 26. The Addi Selam gully that drains the southern part of Hagere Selam, (at left, July 1999) at the start of conservation works [21] and (at right, October 2023) after full implementation of conservation that withstood the effects of urban expansion and Tigray war. Note the strong vegetation growth in the gully and on the hillslopes at the back. The town extends on top of these hills. The dark green color of the grassy vegetation is related to the slow percolation of nutrient-rich water from the town.

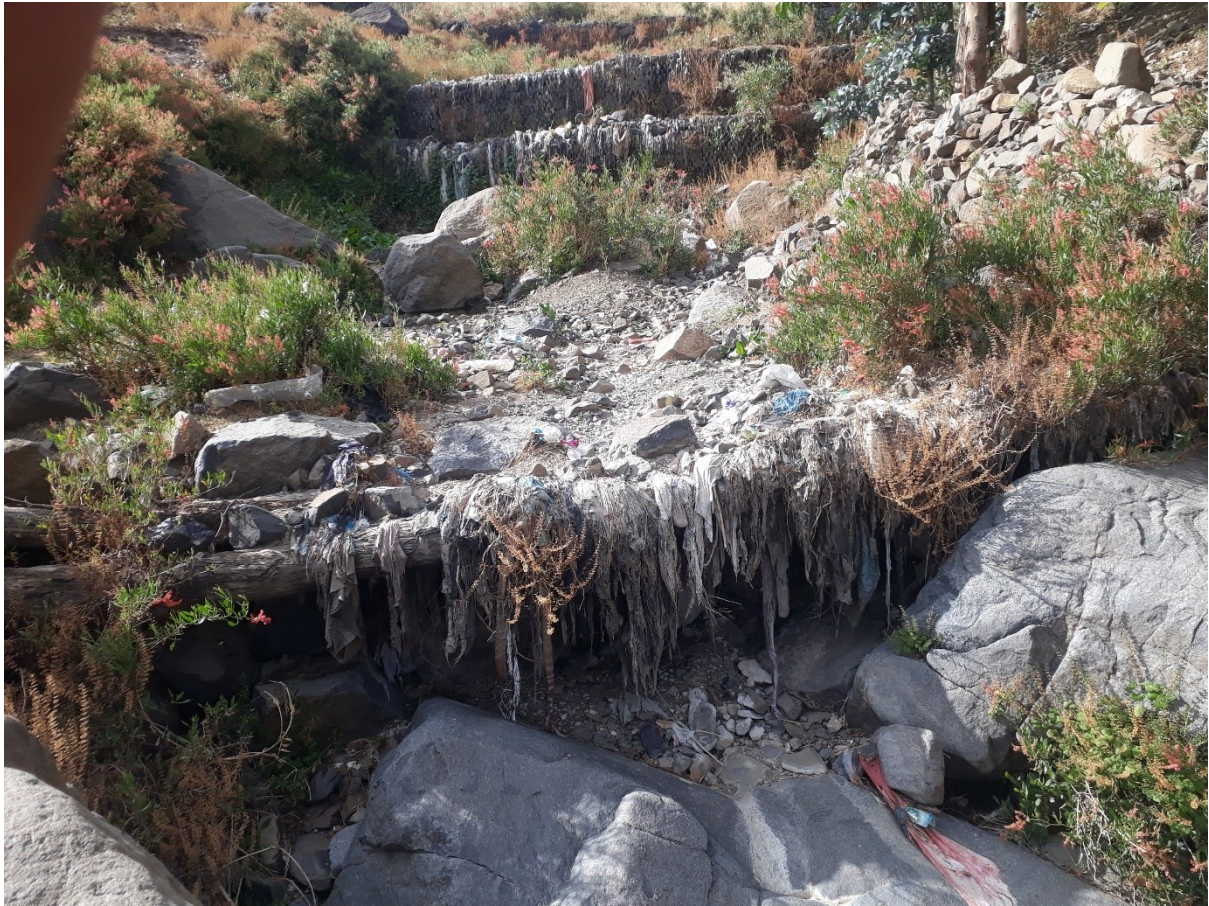
Figure 27. In the Harena torrent, that drains Hagere Selam to the east, the log dams (constructed in 2011) [25] have some of their woods rotten away, but the clusters of large rocks behind them are standing strong, which leads to storm runoff that is better spread over time. The technique in itself has proven its cost effectiveness, but this is also related to the fact that the gully upstream from those check dams has been fully treated with gabion check dams. And more upstream, a large gravel dam buffers floods. There has been a maintenance campaign in places where it started to collapse – that was before the war. Inside and along the gully the vegetation is regrowing. The amount of garbage in the deposits is unprecedented and related to absence of waste collection in Hagere Selam during war and blockade.

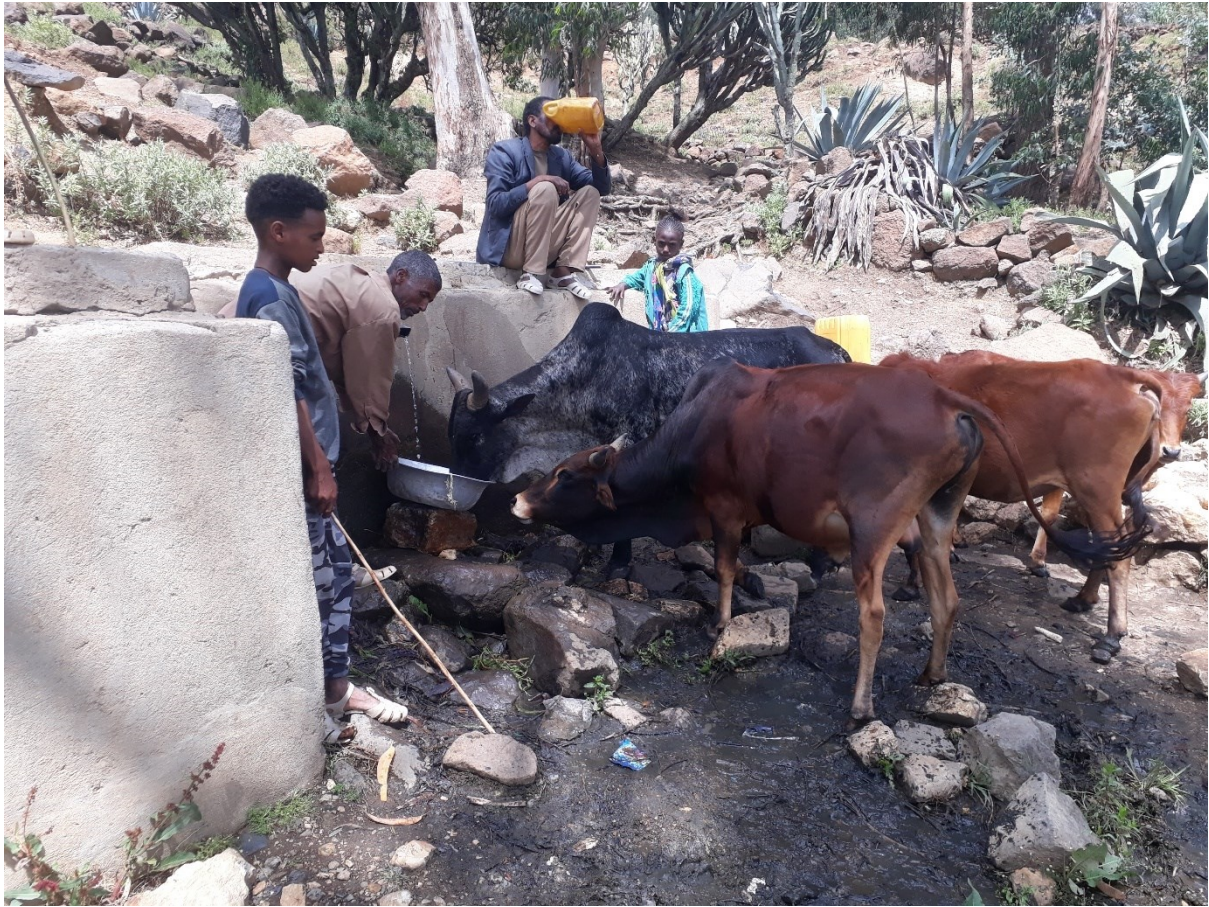
Figure 28. A dysfunctional spring development in May Toqem in November 2023. There had been several spring developments there, and the Selam Watsani project [59] built the latest chamber and taps in 2012. The taps are not working anymore, the cattle trough below it is not operational either; the water is taken directly from the overflow of the storage tank and people use it there both for livestock and domestic consumption. Already before the war it was common to see such dysfunctional or abandoned spring development projects. Additional impacts by the war and the lawless period are diverse and shown below.

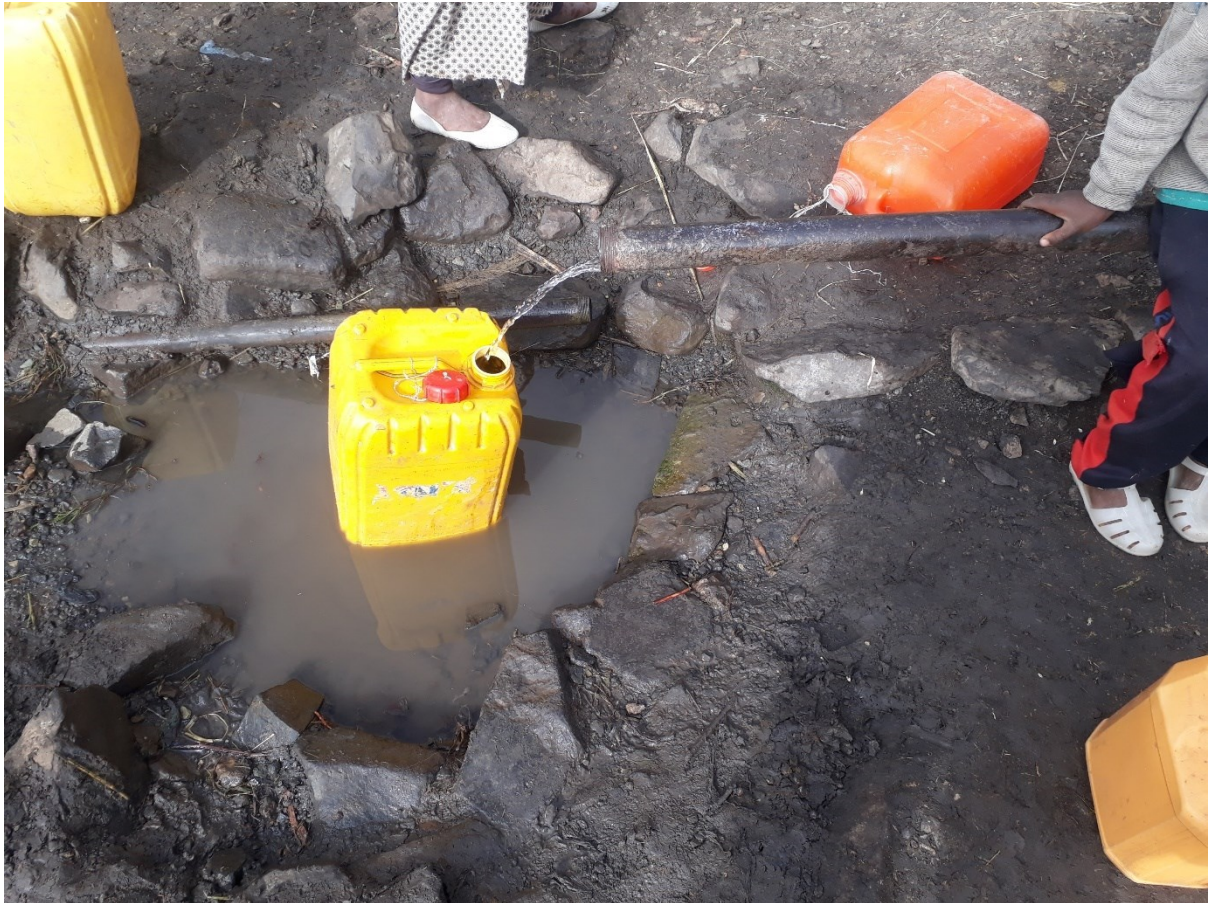
Figure 29. A spring development project, installed by the May Zegzeg project [26], which transfers the spring water from Gra Arho down to the larger Harena village; it was disrupted during the war period. The project had been poorly conceived because it redirected the water from a natural spring in the Gra Arho hamlet to the large Harena village down, leaving the upland people bereft of their spring. During the war, there was lawlessness, and some people of Gra Arho broke the pipe, so their hamlet now again has access to water. Photo in October 2023.

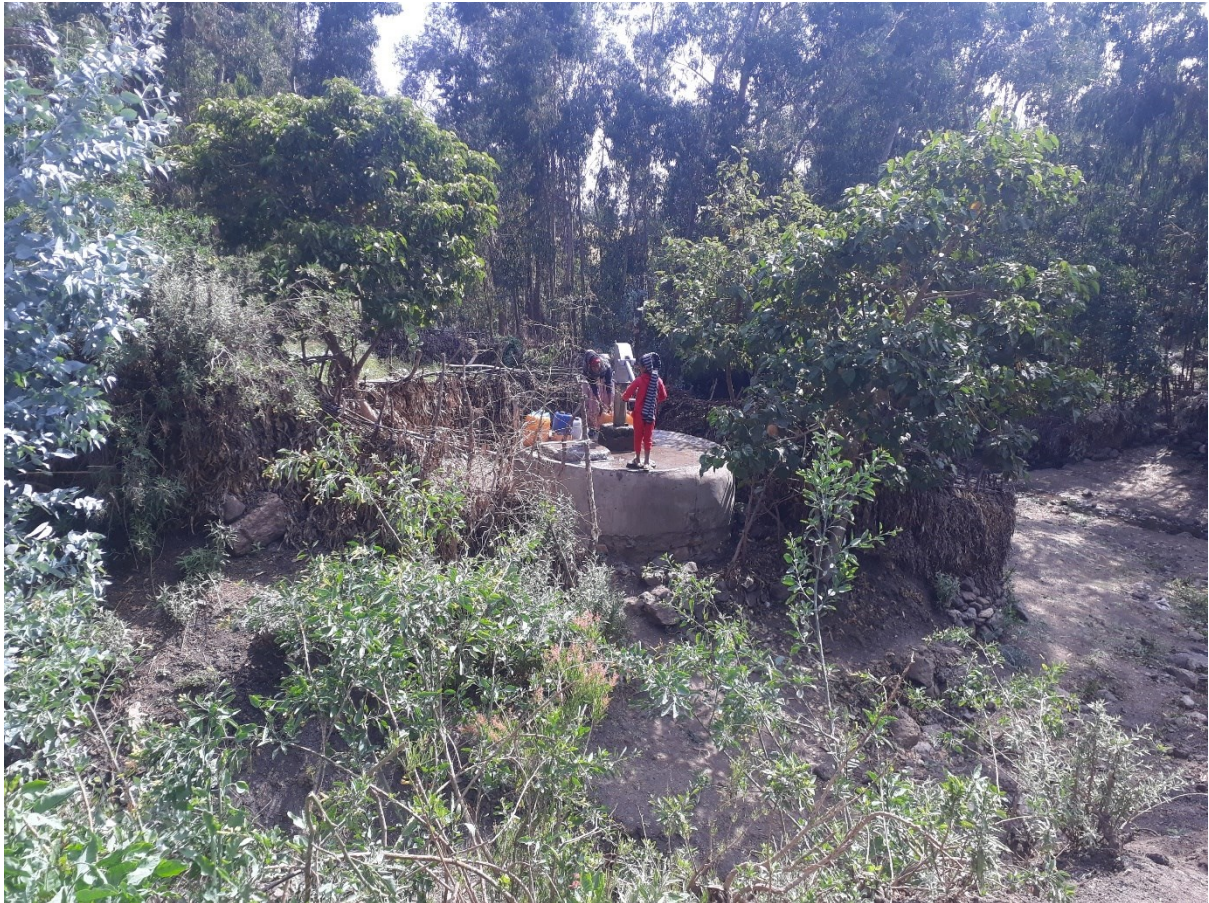
Figure 30. In October 2023, the hand pump at Rubadera in Dingilet is working. It had not interrupted during or after the war. In this village, there are five hand pumps that are operational and that remained operational throughout the war. The water committees in this village are active in protecting the hand pumps and are also repairing them when needed. Before the war, there had been so many problems with hand pumps in general that necessitated repeated visits by experts of the Bureau of Water Resources. Now, the community was on its own, and the handpumps have been functioning for three years.

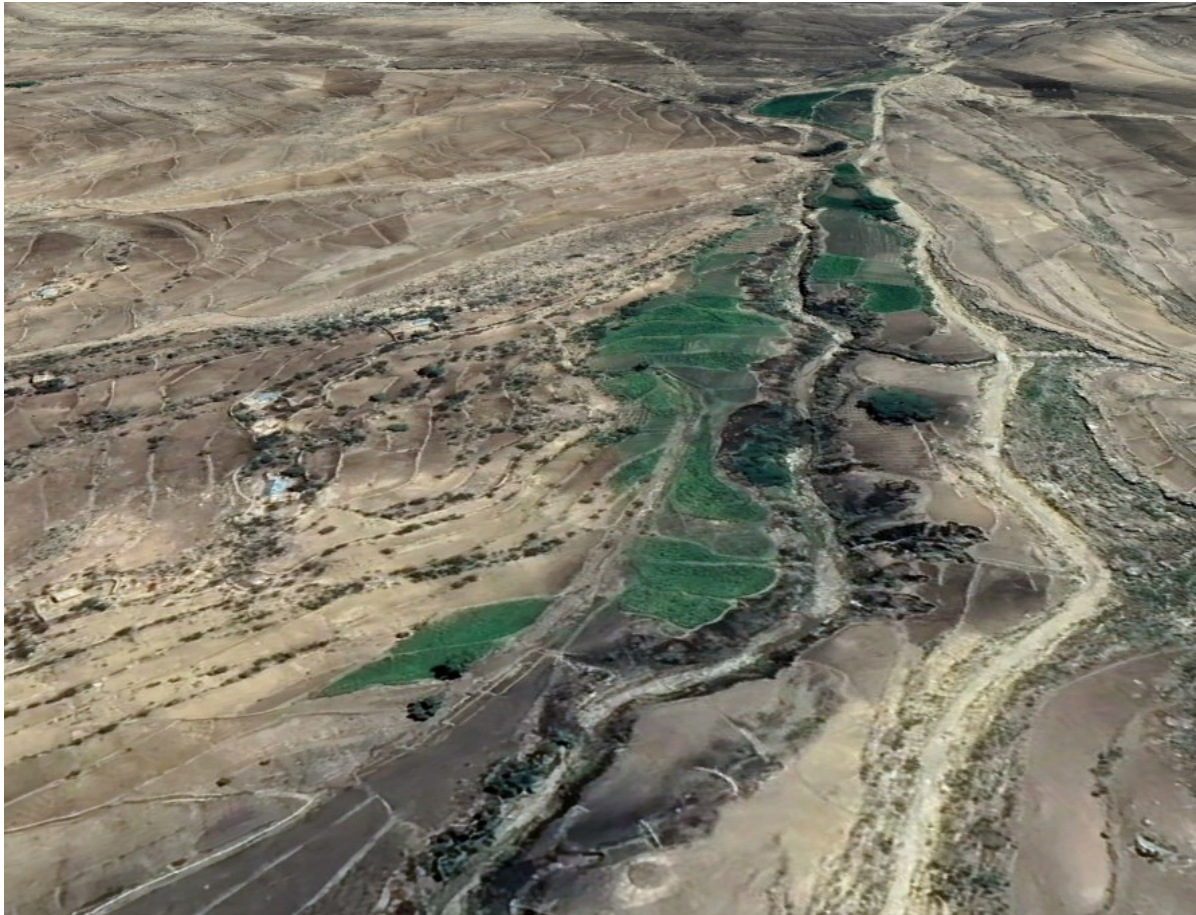
Figure 31. Bird's eye view of the Wunana valley bottom gully area [42], looking upstream (Google Earth, April 2023). Here, no successful rehabilitation had been implemented earlier on; the farmers transformed their adjacent farmlands into irrigated gardens, using water from the Abune Ayzgi spring. They started irrigating in 2018, but the irrigation activities really took off during the war; some 11 ha are now producing two harvests a year. With war and blockade, many irrigation perimeters were expanded. Wherever (seasonal) springs are available, small-scale irrigation has appeared, using gravity, treadle or motor pumps to irrigate land in valley bottoms or private gardens. All these farmer-led irrigation activities [73-76] and expansions were done without any intervention of agricultural experts. Spring discharge was good during the war period, due to sufficient rainfall; yet, interviewed farmers mention two reasons for the expansion of irrigation during the war period: (1) absence of off-farm job opportunities, so the next best option was considered to work on one's own land during the slack season, and (2) increased demand for local vegetables in the towns, as no vegetables could be imported from elsewhere in the country during the war.

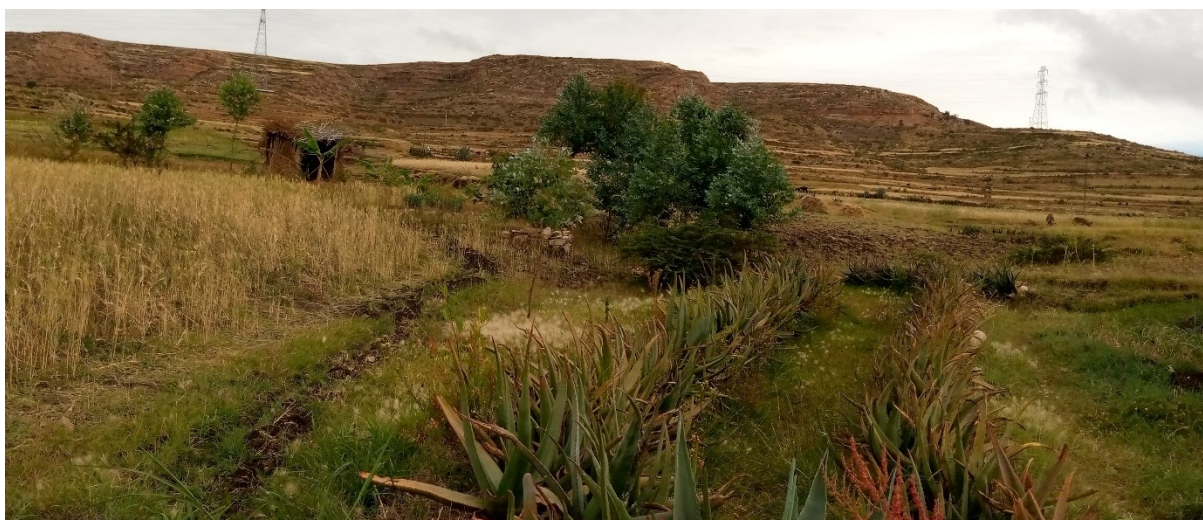
Figure 32. The previous May Bi'ati gully where subsurface dams were installed in 2011 [56] has become a linear oasis, as observed in November 2023. The works led to a near-total fill of the gully (in the middle of the photo) and a raised water table; in the war period, ten farmers have done the effort to irrigate the rehabilitated gully bottom and adjacent lands.

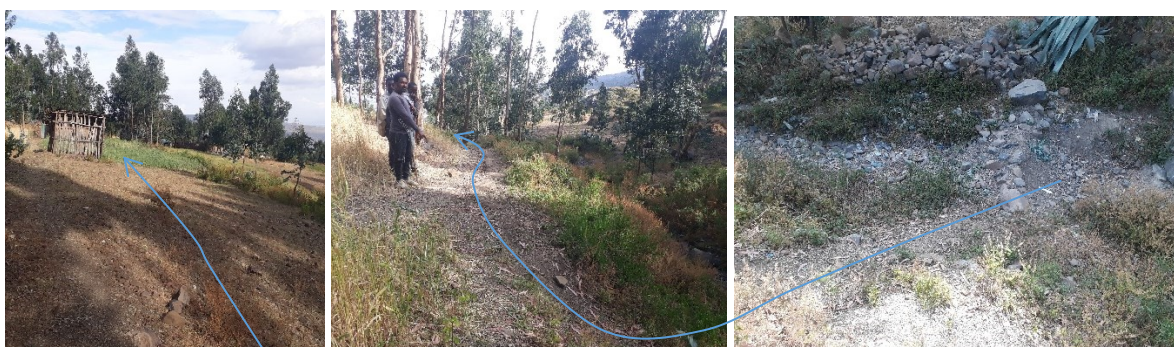
Figure 33. At Gra Arho, an innovative farmer used a treadle pump to take water from an ephemeral river (that runs for one or two months after the end of the rainy season – right photo) through a makeshift irrigation canal (central photo) to a plot they irrigated for growing garlic (left photo). At the end of the rainy season, in September, there were no irrigation activities in their main irrigated lands down in the valley, so they could bring their treadle pump to the uplands for supplementary irrigation. As the river has fallen dry (photos in October 2023), the farmer will irrigate one more time, bringing water from the Gra Arho spring (Figure 29) by his donkey.

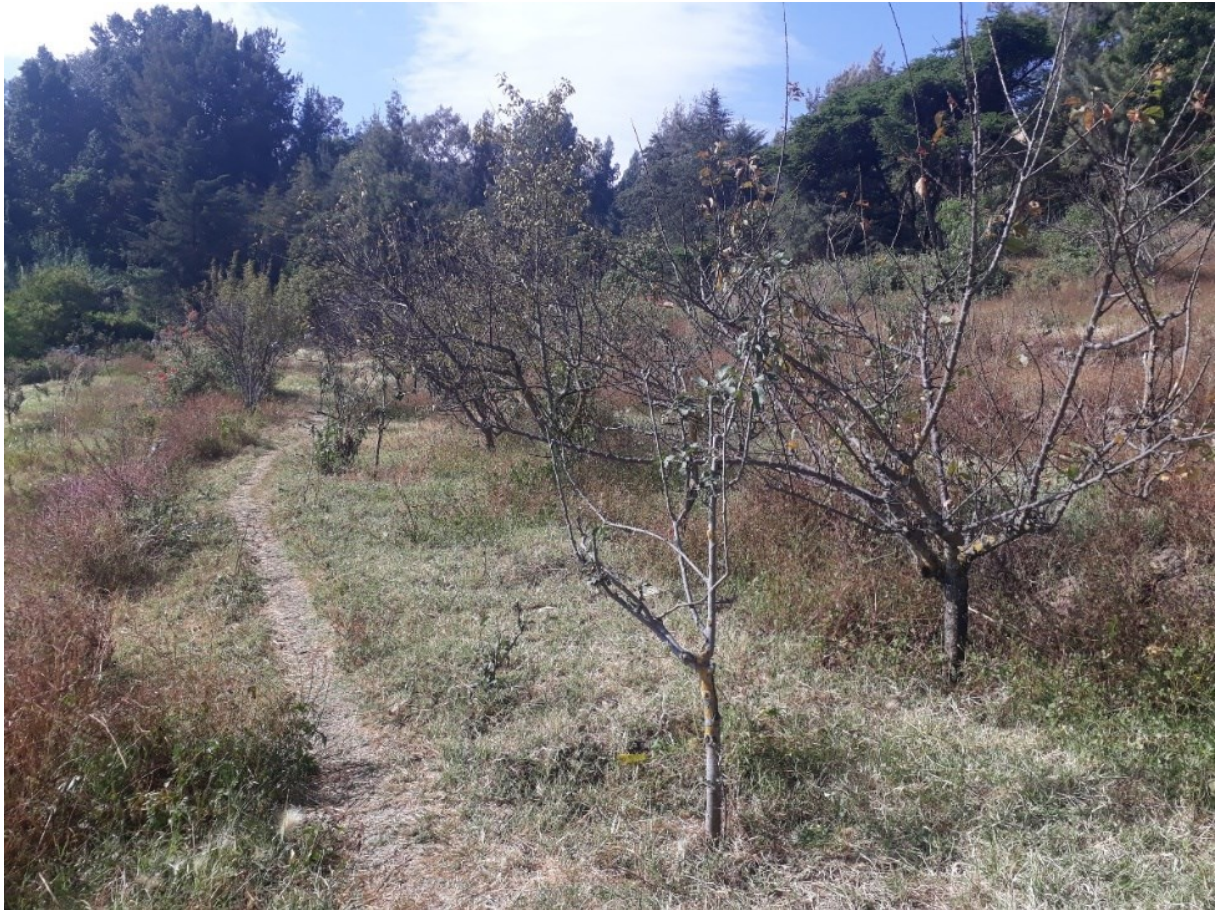
Figure 34. Throughout the war and blockade, the May Zahla apple tree nursery [51] has remained well fenced and guarded by the people of Dingilet. Grasses on the nursery site were harvested and sold by bidding, as an income so that guarding could continue. There has been no harrowing around the apple trees, no pruning, and the trees were watered only once in three years. Hundreds of apple trees were growing in October 2023, generally with small leaves. A few apple trees perished in the upper area where it is driest. May Zahla is a naturally moist place, so that apple trees could survive. Also, the rootstock reproduction site was in good shape, so trees could be harvested after the nursery restarts, and sold again to the farmers. There was no evidence of wood harvesting or grazing in the nursery. It was well protected, though not managed, as there were no salaries. People know the benefit of this nursery for their income and for their village. With committed coordination and manual labour, the nursery can be restarted rapidly.

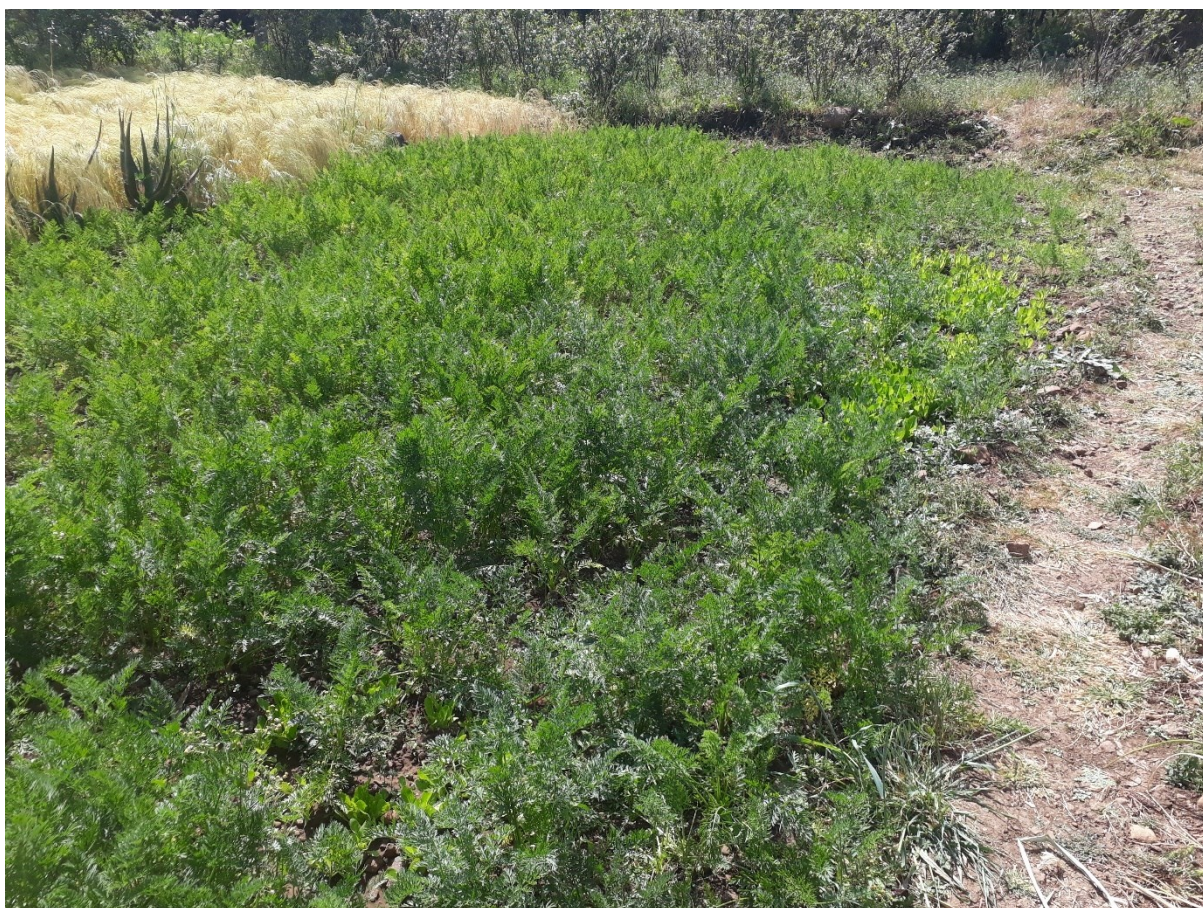
Figure 35. In the village of Dingilet, irrigated vegetable production has continued at many homesteads throughout the war period (November 2023).

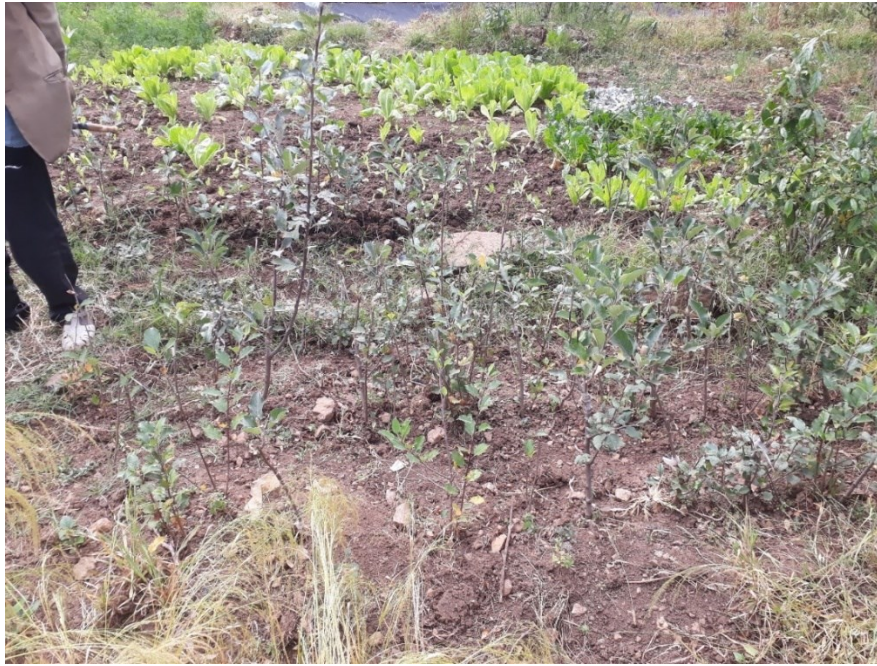
Figure 36. Several farmers in Dingilet have an apple tree production site in their garden, which is part of a project jointly with the nursery. The nursery activities had stopped but the young trees have continued growing in their garden. People from as far as Aksum now come straight to Dingilet to purchase young, grafted apple trees. One reason is that the highly subsidized import of seedlings from Chench (South Ethiopia) was disrupted by the war, and apple trees can only be purchased locally, at market conditions. Photo in October 2023.

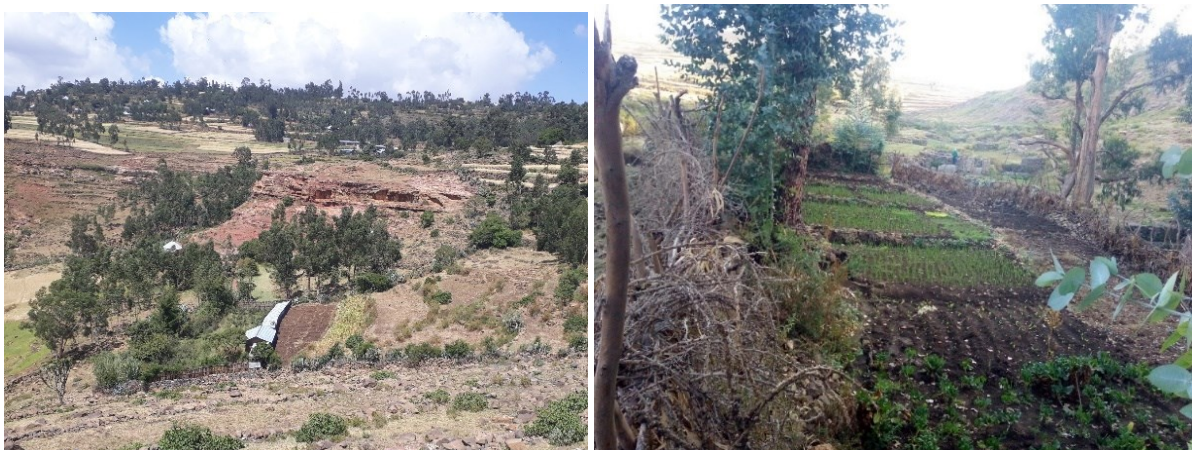
Figure 37. In May Sa'iri, the Shafa Hambar spring (located at the upper right of the left photo) is channeled to many homesteads by a 600 m long cemented canal. Among several irrigated gardens, there is a larger private cooperative vegetable garden (at left, October 2023) in which three relatives grow garlic, tomato, Swiss chard and green pepper (at right, February 2024). By habit, the farmers expect the government to provide seeds for irrigated vegetables. During the war period, some farmers were producing garlic seed which they sold to other farmers at the price of 180 ETB for a “cup” of standardized dimension (i.e. the lid of a jerrycan, 0.055 L). Farmers often multiply carrot seeds themselves. Tomato, chard and green pepper seeds are bought at approx. 70 birr per cup. The cooperative garden continued its activities throughout the war period, because it was deemed a safe place, away from roads.

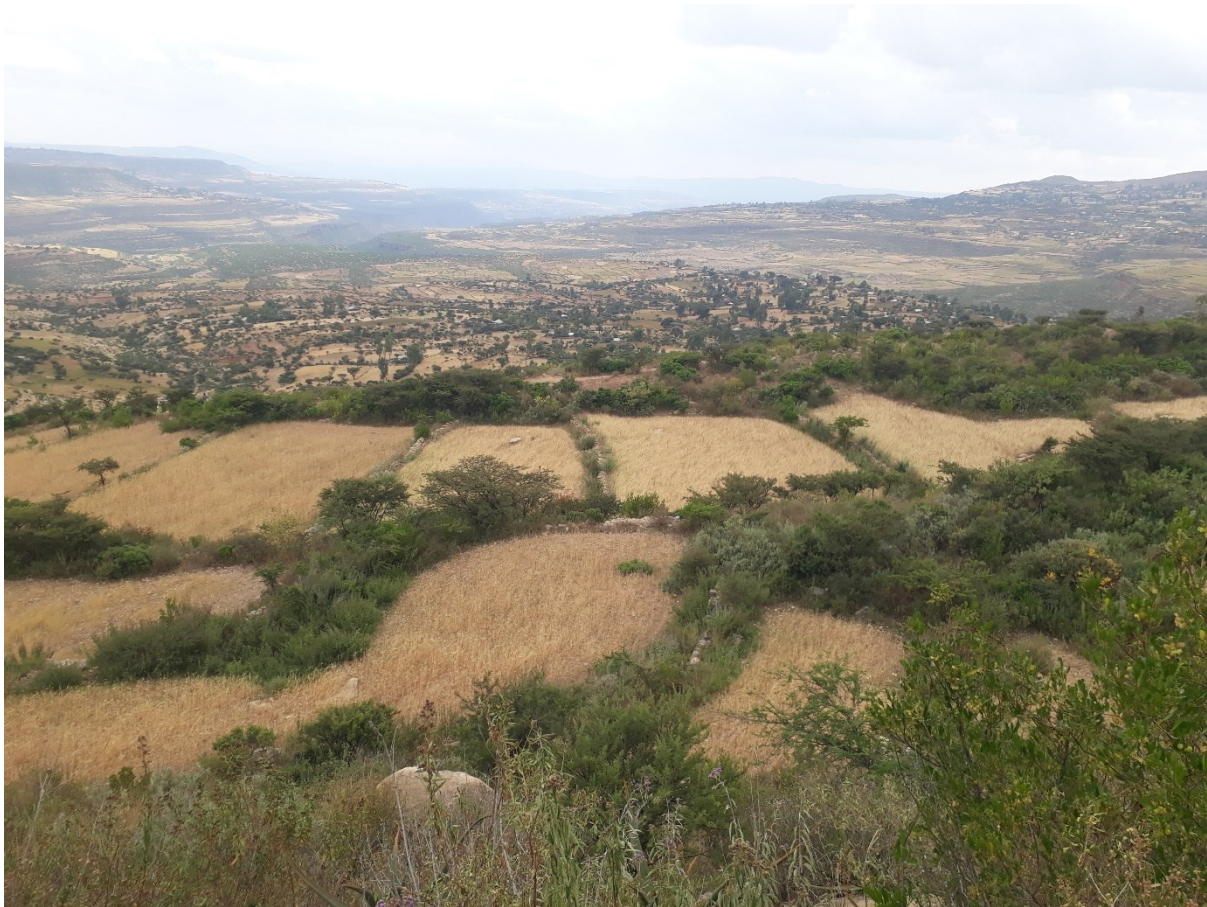
Figure 38. Landscape on limestone at Igri Mallow in October 2023. Stone bunds were established along the contour some 20 years ago and are intact; patches with shallow soils are communal land part of the Igri Mallow enclosure [39, 40], where no wood harvesting occurred during the war. At the centre of the photo, the village of Hech'i with traditional agroforestry on farm boundaries [77]. According to the local farmers, “you have to grow trees on your own farmland boundaries if you wish to cope with the shortage of firewood”.
