Proceedings of 7th Transport Research Arena TRA 2018, April 16-19, 2018, Vienna, Austria

Road safety issues of EU funded bicycle network projects in Hungary

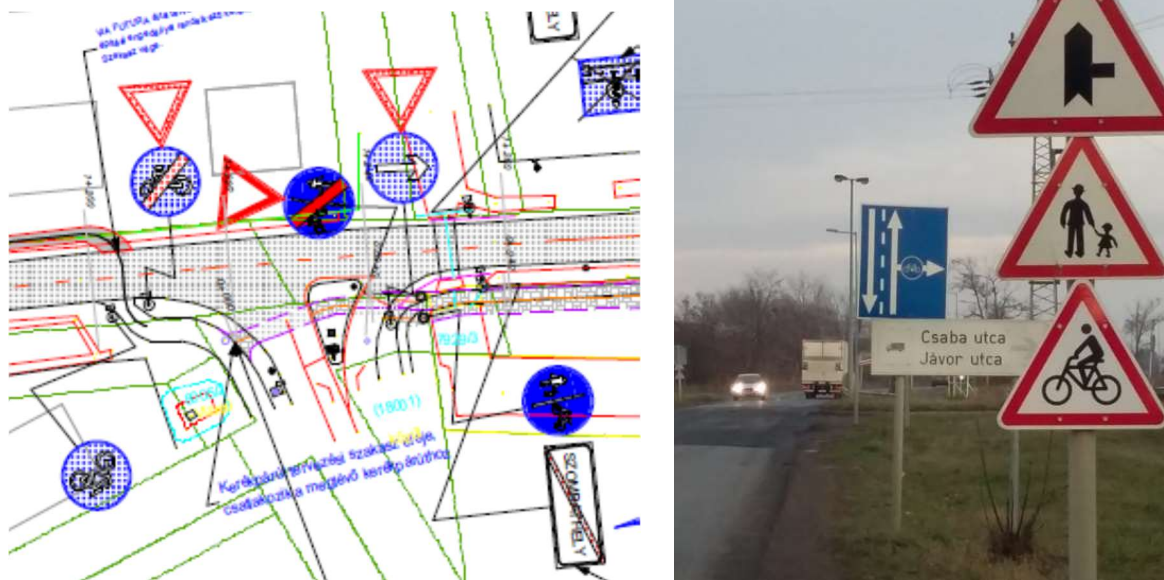
In the recent years, the most common bicycle infrastructure type in audited designs has been a two-way bicycle path on one side of the road, mostly shared with pedestrians (Figure 1). From a safety point of view it has turned out to be an undesirable solution since it creates conflicts between the two most sustainable transport modes. In some cases, this type of design lacks crossing facilities and requires unnecessary bypasses from cyclists. This two-way on one side bicycle path should not be applied in densely populated residential areas, however they are more suitable outside built up areas.

Fig. 1: Two-way bicycle path changing road side unfalely

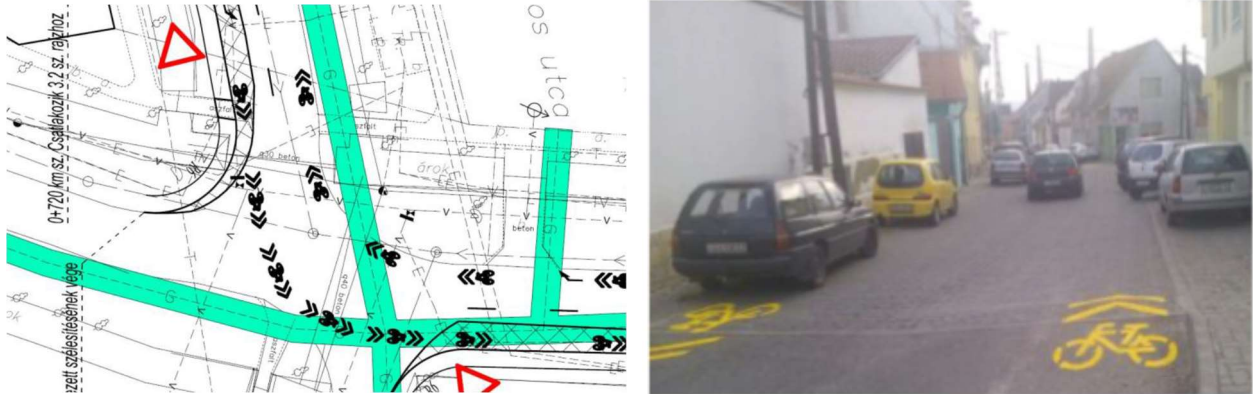
Bicycle chevron markings are applied too frequently and often unnecessarily, even in residential streets with very low traffic volumes (Figure 2). One of the reasons behind this is that these are low-cost measures which can be applied on longer sections, hence receive financial support from EU-funded programs.

Fig.2: Bicycle chevron markings

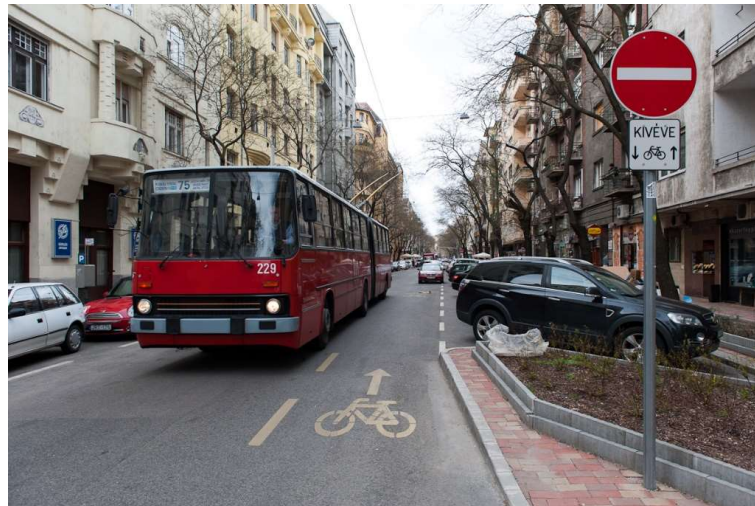
In the city of Budapest numerous one-way streets are open for contra-flow bicycle traffic. Despite the fact they create a much more direct link for cyclist in a one-way street area, they appear to be barely applied by the road authority of the city. In a recent road safety analysis these infrastructure type has turned out to be safe, there were barely no bicycle accidents found in one-way streets with contra-flow bicycle traffic in Budapest (figure 4).

Fig. 4: One-way streets with contra-flow bicycle traffic in Budapest (Source: Centre for Budapest Transport)

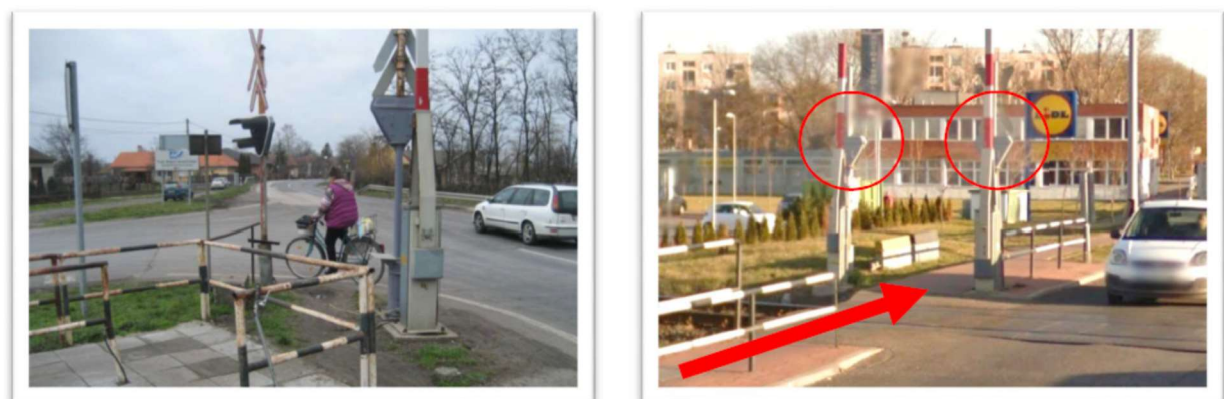
Railway crossings are crucial points in the rail and road network. Cyclist traffic at existing urban railway crossings were also the focus of road safety inspections in the last years. While motorist traffic was controlled by flashing lights and barriers in most of the cases, cyclist infrastructure and control varied over a wide range. One of the typical problems was by-passing the labyrinth fence (figure 5). Another was waiting between the tracks and the barrier. A third problem is shown on figure 4, where cyclists ride in the opposite direction on a one-way bicycle path. Control devices are provided only for cyclists riding in the correct direction and so violators (both cyclists and pedestrians) cannot see the flashing red signal. Based on the experiences with separated bicycle paths, separated barriers are recommended at railway crossings.

Fig. 5. Cyclist is by passing the labyrinth fence (a), cyclist usually ride in the opposite direction (b)

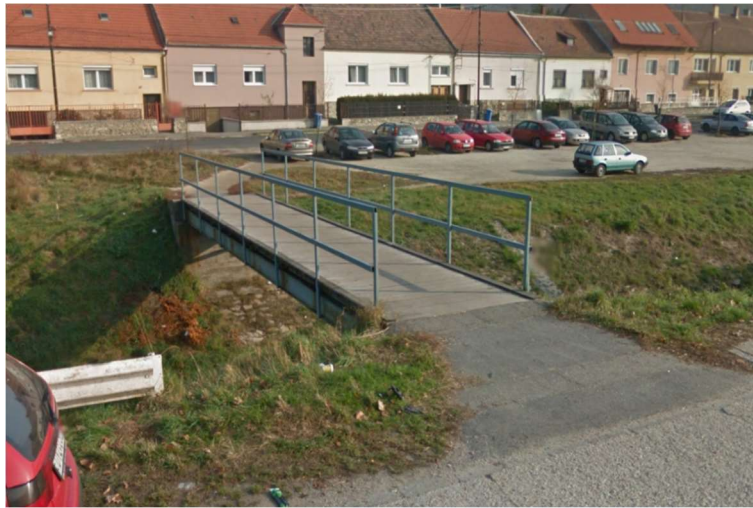
Cyclists' centre of gravity is higher than pedestrians', this is the reason why railings at bicycle bridges supposed to be higher than the ones at solely pedestrian bridges. This aspect was neglected in several projects inserting bicycle network elements into the existing pedestrian network (figure 6)

Fig. 6: Low railing on an existing pedestrian bridge to be assigned as a bicycle/pedestrian bridge

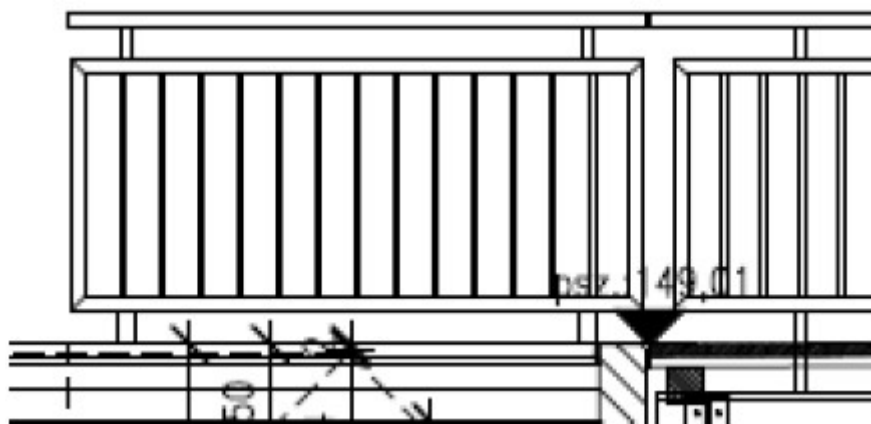
Cyclists' speed level is significantly higher than pedestrians' speed, therefore the geometry of the fence and the shape of the fence's elements have an influence on the outcome of a cyclist crash. Rounded shapes suit well the design theory of forgiving roads, while rectangle shaped and peaked elements carry higher risk (figure 7).

Fig. 7: Rectangle and peaked fence elements of a planned bicycle/pedestrian bridge in Hungary
