Extreme hazards in mountain communities: selected examples and applied risk management

Courmayeur Climate Hub - Project funded
by the European Union NextGenerationEU
under the National Recovery and
Resilience Plan Mission 1 Component 3 -
CUP I74H22000050005

Managing Extreme Hazard Events in Mountain Regions:

A booklet for Politicians and Decision Makers

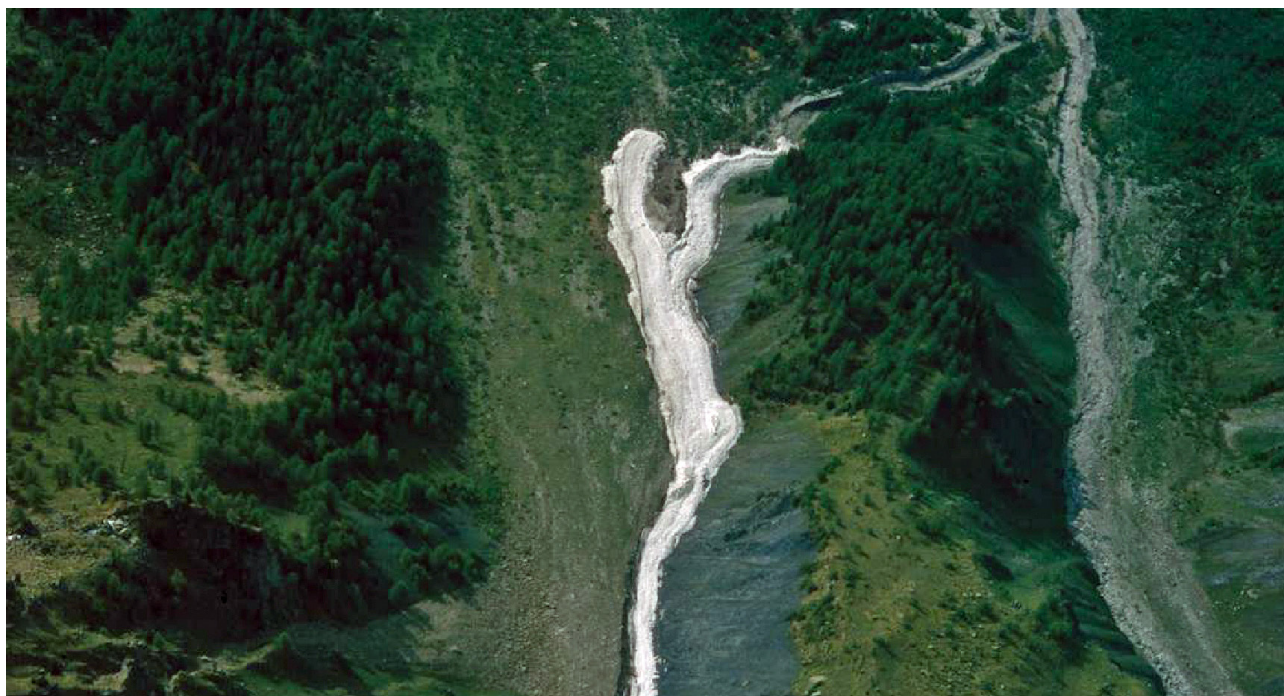
Aerial image of the Ice Avalanche from the Whymper Serac on the 1st of June 1998

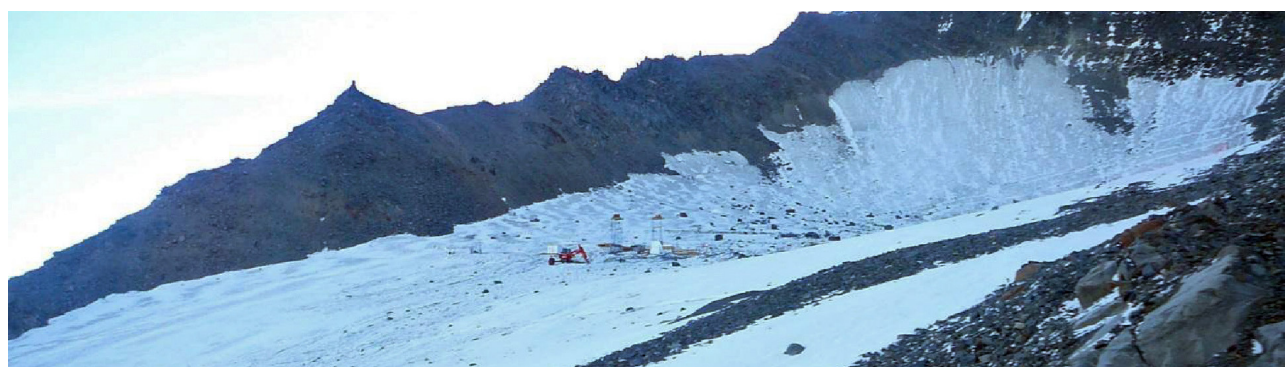
Credit Olivier Gagliardini (IGE) – 2010 pumping of the cavity

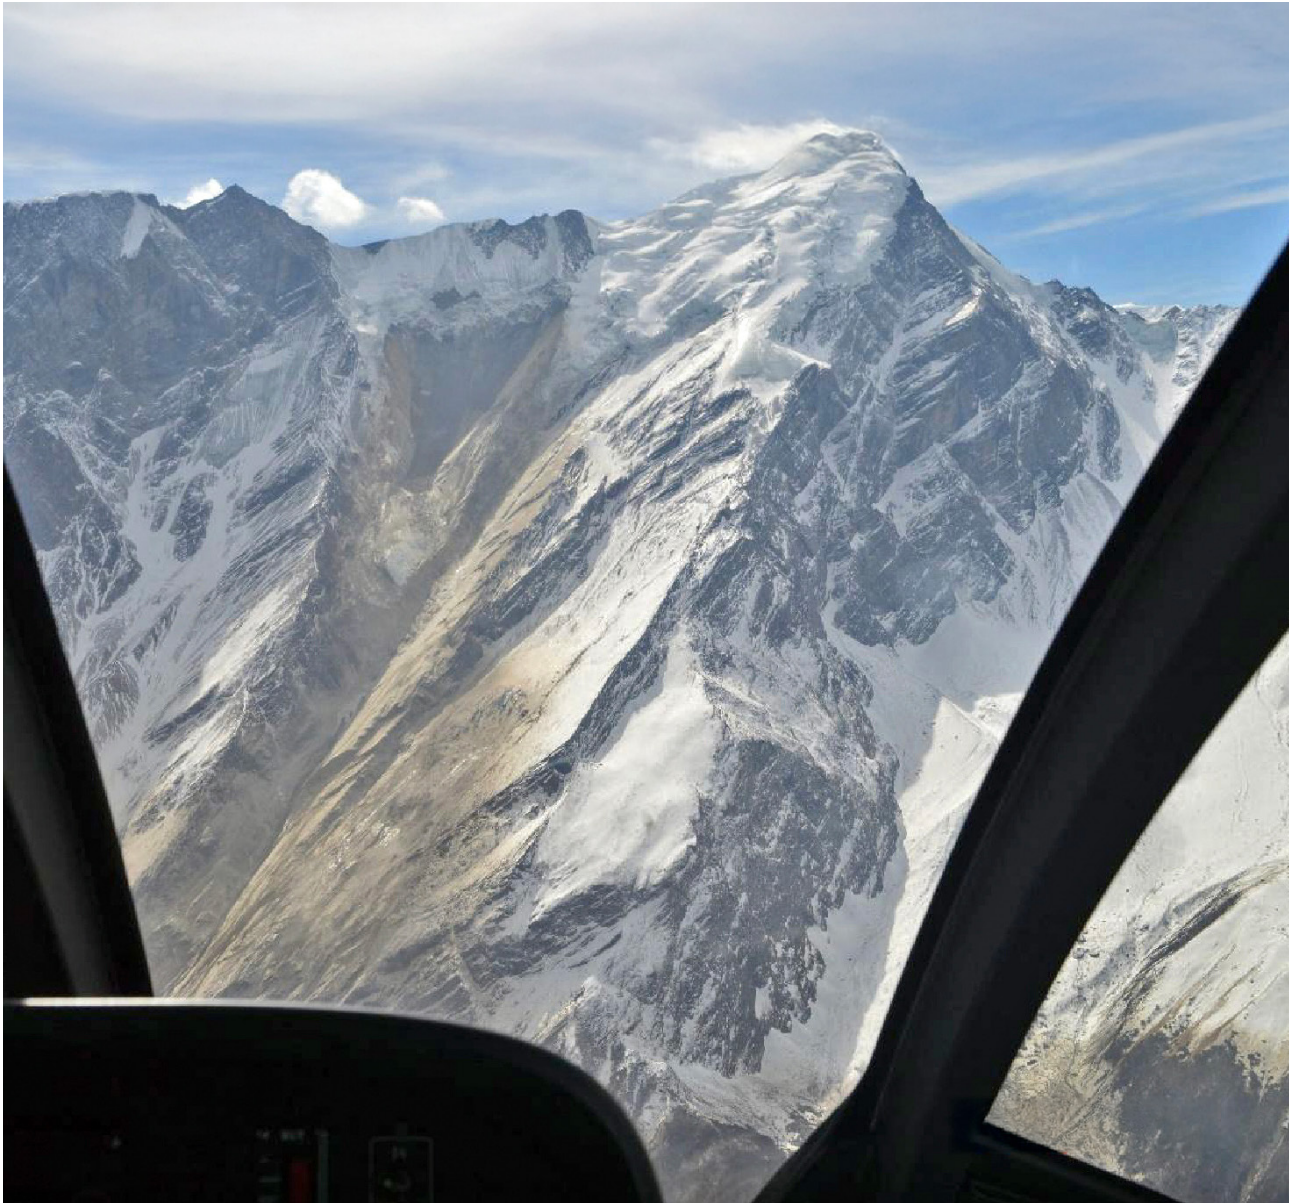
Release Zone of the 7th February 2021 Chamoli Rock Ice Avalanche

About 27 million cubic meters of rock and ice detached from the Rontigad peak on 7 Feb 2021 and initiated as a rock ice avalanche, which later transitioned into a debris flow and a flash flood. It destroyed 2 hydropower projects, killed about 200 people, and caused severe damage to the environment. The impact of this event was observed up to 150 km from the initiation. The huge entrainment and water saturation exacerbated this event during flow.

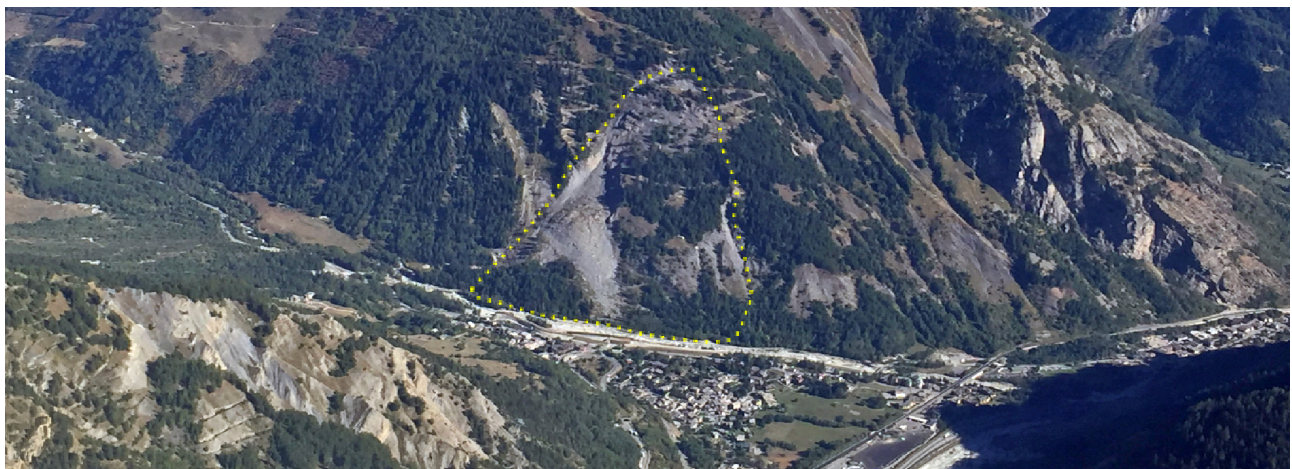
Aerial photo taken from helicopter at about 3700 m a.s.l. on Oct 1st, 2016, showing the 400.000 m³ collapsed sector (2014). The dashed line marks the unstable active slope of the landslide (photo: D. Bertolo).

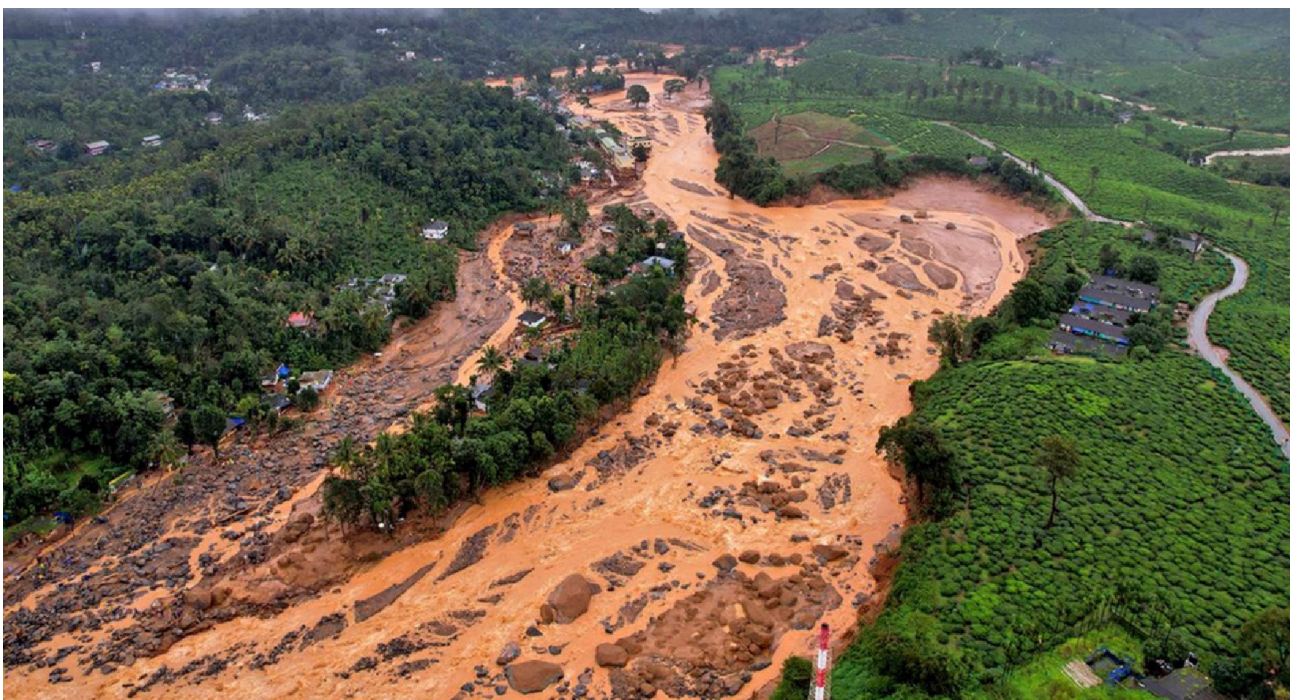
Wayanad Debris flow (The Hindu 2024)
