MAELSTROM

MARine Litter SusTainable RemOval and Management

D5.4

Final Report on operation of the surface and water column removal technology in the Porto region

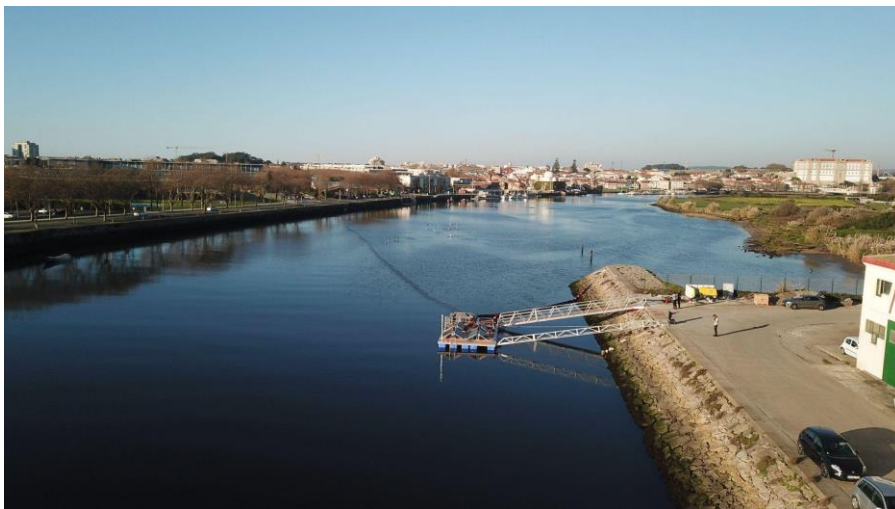
Figure 4.4 - Bubble Barrier Vila do Conde after deployment of bubble hose. Source: TGBB.

The 230 m long Bubble Barrier hose-assembly was deployed according to the plan at the intended location in the Ave River Estuary (Figure 4.4 below), but not without significant effort. The weather was continuously challenging with constant rain and strong winds. Also, due to the time delays, the optimal tidal timeframe couldn't be met anymore and the tidal changes were bigger than initially planned for. This meant that some of the spud poles that were brought from the Netherlands ended up being too short for certain tidal conditions. The changes in planning, equipment, contractor, and the bad weather conditions led to a significant overspending of time and budget.

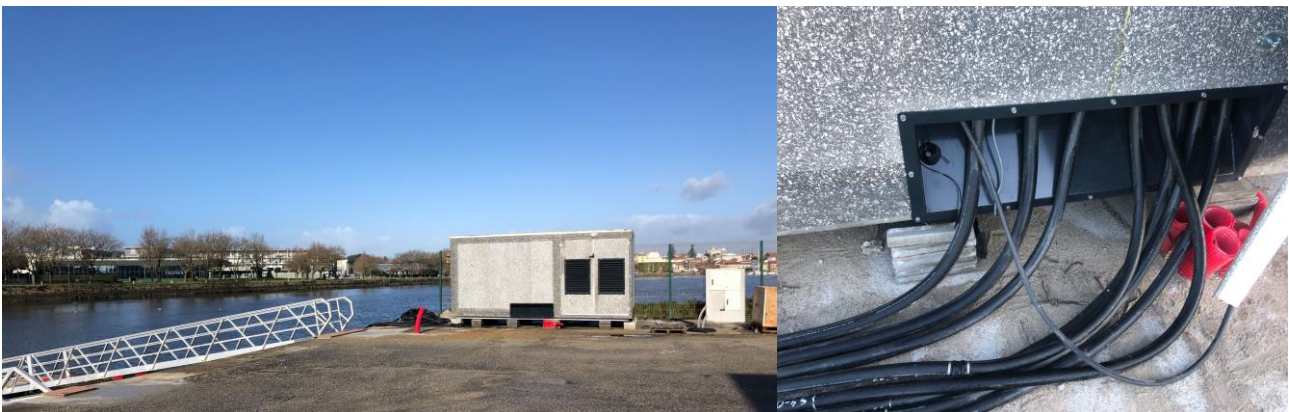
Figure 4.5 - Images from 15/12/2023, when the containerized compressor was placed at the right location and integrated into the Bubble Barrier. Source: TGBB.

Despite the delays, the final result of this process was successful, resulting in a functional compressor housing with a working compressor and filter system. However, due to the complexity, new approach, new suppliers and waiting time, the equipment arrived several weeks later than expected. On December 15th 2023, the Bubble Barrier was connected to the compressor, the technical parts were integrated and the system started working in its planned configuration (see Figure 4.5 below). In total, the full container set up and connection to the system required more work and had higher costs than foreseen.

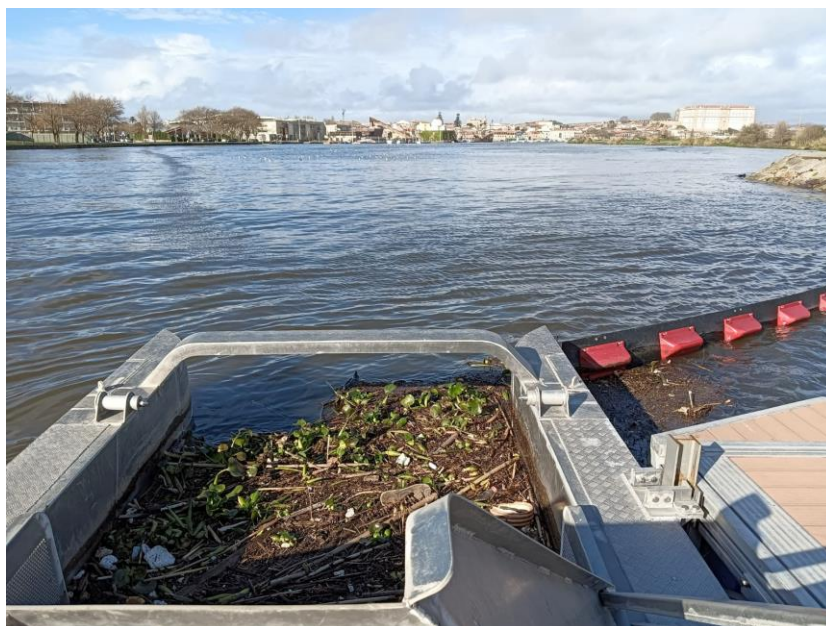
Figure 4.6 - Catchment System view from floating platform. Bubble curtain can be seen along the river in the top left corner of the picture. Source: TGBB.

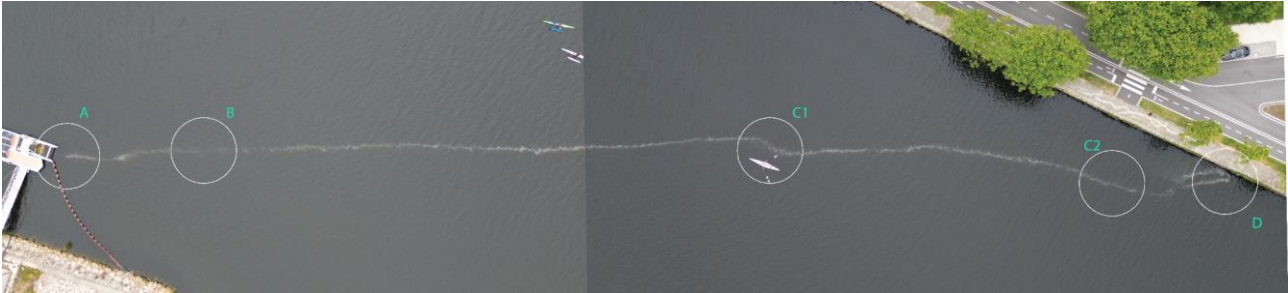
Figure 4.8 - Technical assessment of the Bubble Barrier in Vila do Conde after the optimization. Indicated are points of interest: (A) section at the Catchment System (B) weaker part of the Bubble Barrier (C1,2) curves (D) exposed extremity. Important note: As photos are only a snapshot, one should be cautious to draw conclusions based on a single photo.

Several observations were made during the technical assessment. The extremity of the bubble hoses would occasionally be exposed during the low tides. (Figures 4.8 and 4.9). This resulted in both a waste of air volume, causing a gap in another part of the same section, and the hose material potentially wearing out due to UV radiation. The section was adjusted, which seems to have solved the issue, and the gap was closed.

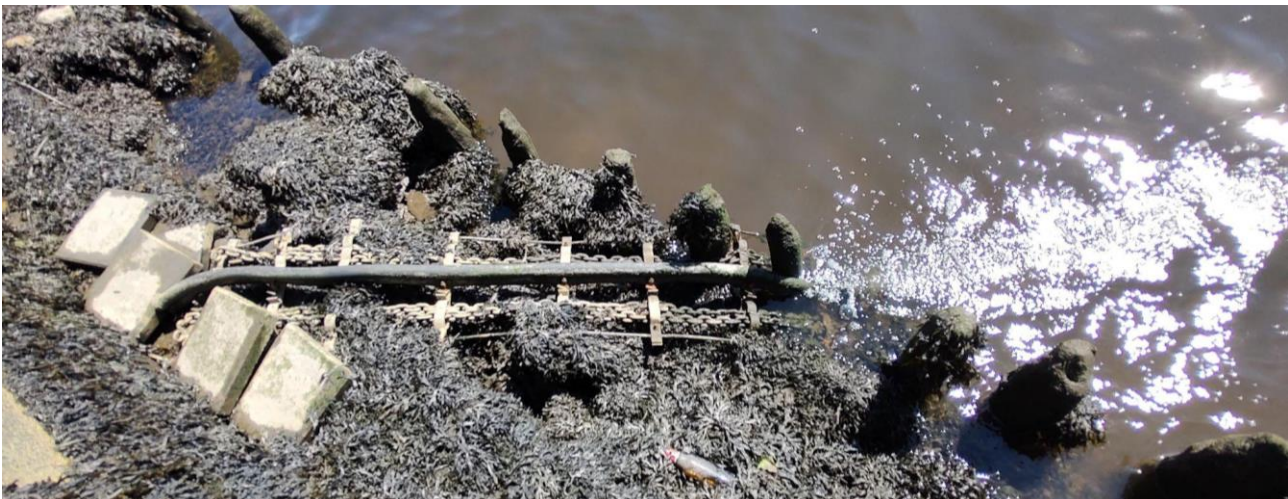
Figure 4.9 - At the northwest extremity of the Bubble Barrier, the bubble hoses would occasionally be exposed during low tide. The situation has been mitigated by shortening and repositioning.

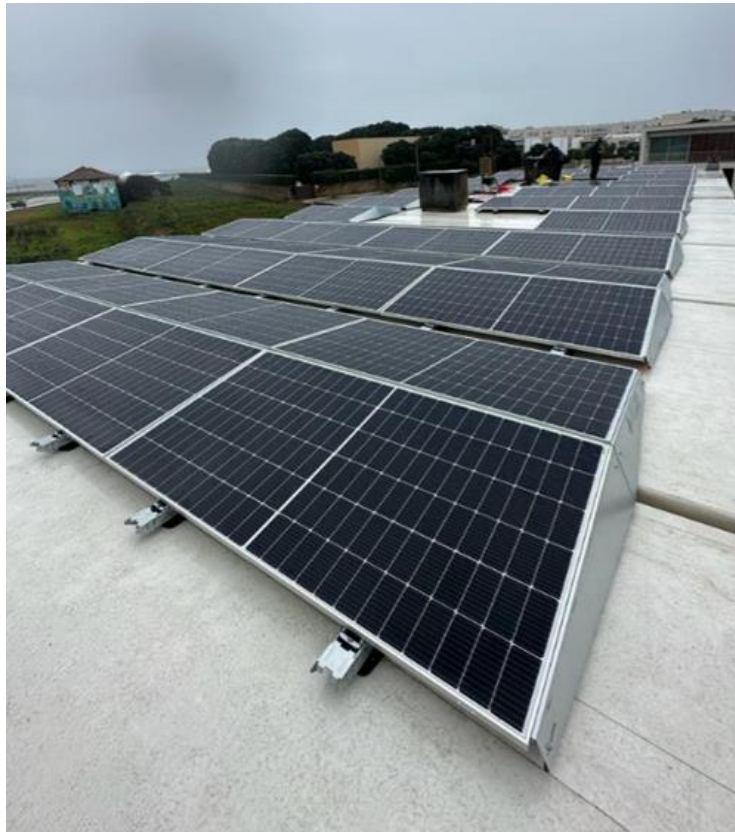
Figure 5.1 - Solar panels installed on the rooftop of the CMIA building.

The installation of the solar panels in Vila do Conde involved several stages. Similarly to the Bubble Barrier, the installation of the solar panels was planned for 2021. However, due to delays in receiving the permits, the installation of the solar panels was also delayed to the end of 2023. The installation of the solar panels on the Environmental Monitoring and Interpretation Centre (CMIA) building rooftop took place in November 2023. In total, 66 solar panels were installed (36.3 kWp), connected to the CMIA building and the electricity grid with a 30 KW inverter. Electricity generation started being recorded in December 2023 and was accessible via an online platform to visualise real-time and past electricity generation of the system. Figure 5.1 shows an image of the solar panels installed on the rooftop of the CMIA building. The panels were installed with an East-West orientation and an inclination angle of 8.6° , maximising the rooftop's potential to generate the most electricity possible. A weather station was also installed on the rooftop of the CMIA building as part of the project. A Bettair weather monitoring system was installed in March 2024 to monitor temperature, humidity, and wind conditions. This allowed the comparison of calculated solar electricity generation data from the solar panels with real time weather patterns.

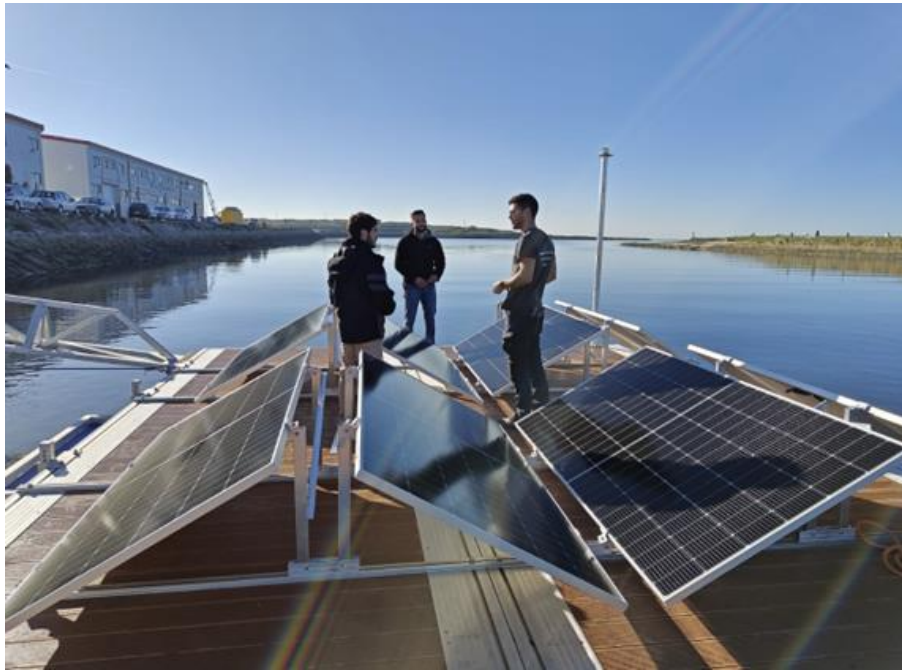
Figure 5.2 - Floating solar panels installed on the floating dock on the Ave River estuary.

In the case of the floating solar panels, 8 panels (4.4 kWp) were installed on the floating dock close to the catchment system, also with an East-West orientation. The inclination angle was higher in this case to ensure the panels fit on the dock with a safe distance for people to walk on the dock and conduct maintenance. Due to delays in the installation of the dock and the Bubble Barrier, the final installation could only be completed in January 2024. The floating solar panels started generating electricity in February 2024. Figure 5.2 shows an image of the solar panels installed in Vila do Conde.

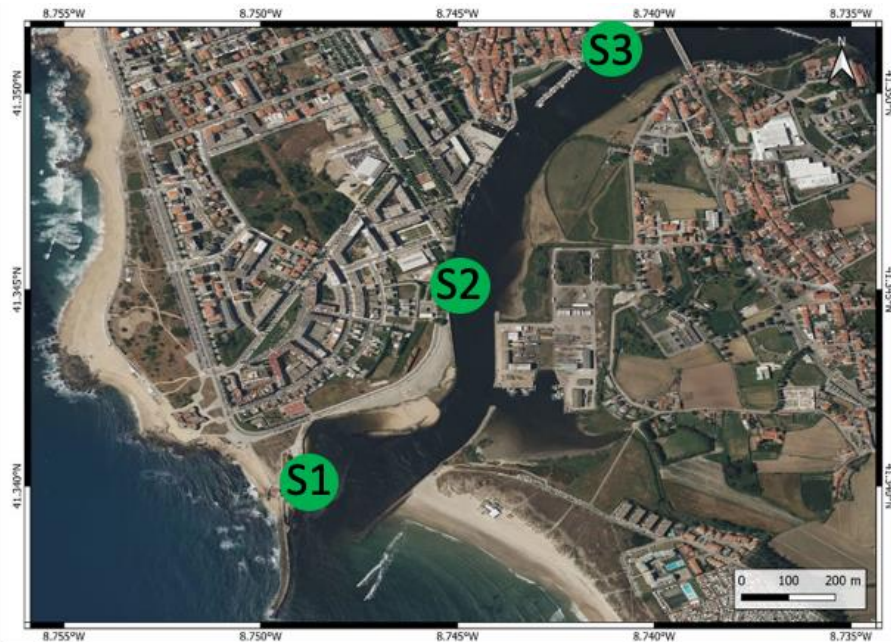
Figure 6.1 - Map of the three observation points (S1 – S3) for FML record in the Ave River estuary. Reference system WGS84.

The evaluation of FML was conducted following European guidelines (Hanke et al., 2013, 2023) through visual observations, which examined the diversity and relative abundance of litter in the area. Monitoring campaigns were carried out monthly from June 2021 to December 2024. FML was observed using binoculars (Olympus 8-16x40 Zoom DPS I), during the ebb tide, at three different locations in the estuary: downstream, midstream, and upstream (S1: 41.340117°N, 8.748913°W; S2: 41.345022°N, 8.745227°W; S3: 41.351156°N, 8.741285°W) (Figure 6.1). The three observation points were located at the same plane, all of them at the margin of the estuary and with an averaged vertical distance to the water surface around 2 m (mean sea level), such that the viewing angle was similar and the results for the three locations can be compared. Although some FML objects could be masked by ripples produced by wind, or small waves produced by boats passing by, it is deemed unlikely to impact results as observational campaigns were performed during calm days with high visibility.

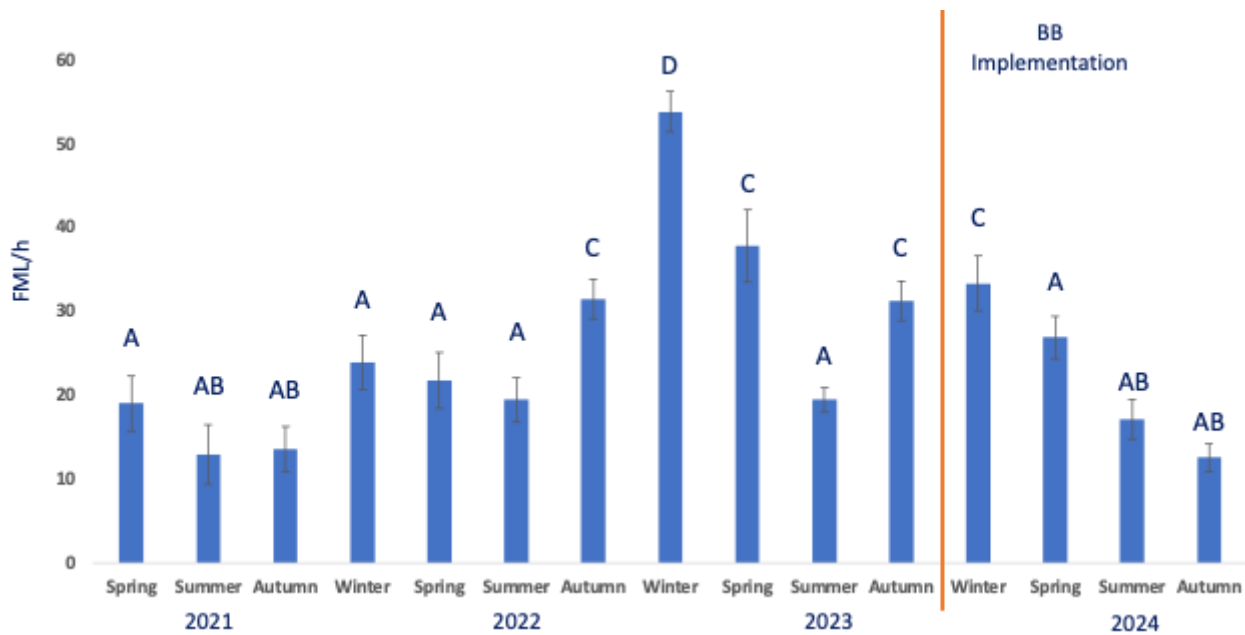
Figure 6.2 - Seasonal mean of the three FML observation sites (S1-S3) (\pm standard errors) in items per hour recorded monthly between 2021 and 2024, before and after the Bubble Barrier (BB) installation. Bars with different letters are significantly different between them ($p < 0.05$).

Significant differences ($p < 0.05$; ANOVA) were observed between seasons, sites, and their interaction (seasons*sites). The data indicated higher values of FML were recorded during Winter, Spring and Autumn, while lower values were observed in Summer (Figure 6.2). These patterns underscore the influence of both temporal (seasonal) and spatial (site-specific) factors on the measured variables. River discharge also related with the weather conditions can also explain part of the variation observed since the highest FML rates occurred during the highest river discharges (Figure 6.3). Most of the FML campaigns were carried out during low or average Ave River discharges, except for winter 2022 and autumn and winter 2023. Particularly the campaign of winter 2022 was performed after a long period with low river discharge and at the onset of a (very) high river discharge. Usually, after a long period of low river discharge, litter tends to accumulate on its river banks, and when the river discharge and water level start to rise, part of this litter is transported to the sea. This can explain the high FML items per hour observed in this season. This hypothesis can also explain the behaviour during autumn 2023, but in this season the FML presents less quantity because the river flow was also lower than during winter 2022. In winter 2024 high river discharges were also observed. However the values did not reach the winter 2022 measurements because the river discharge had been elevated already for months, washing away all the litter on the margins.

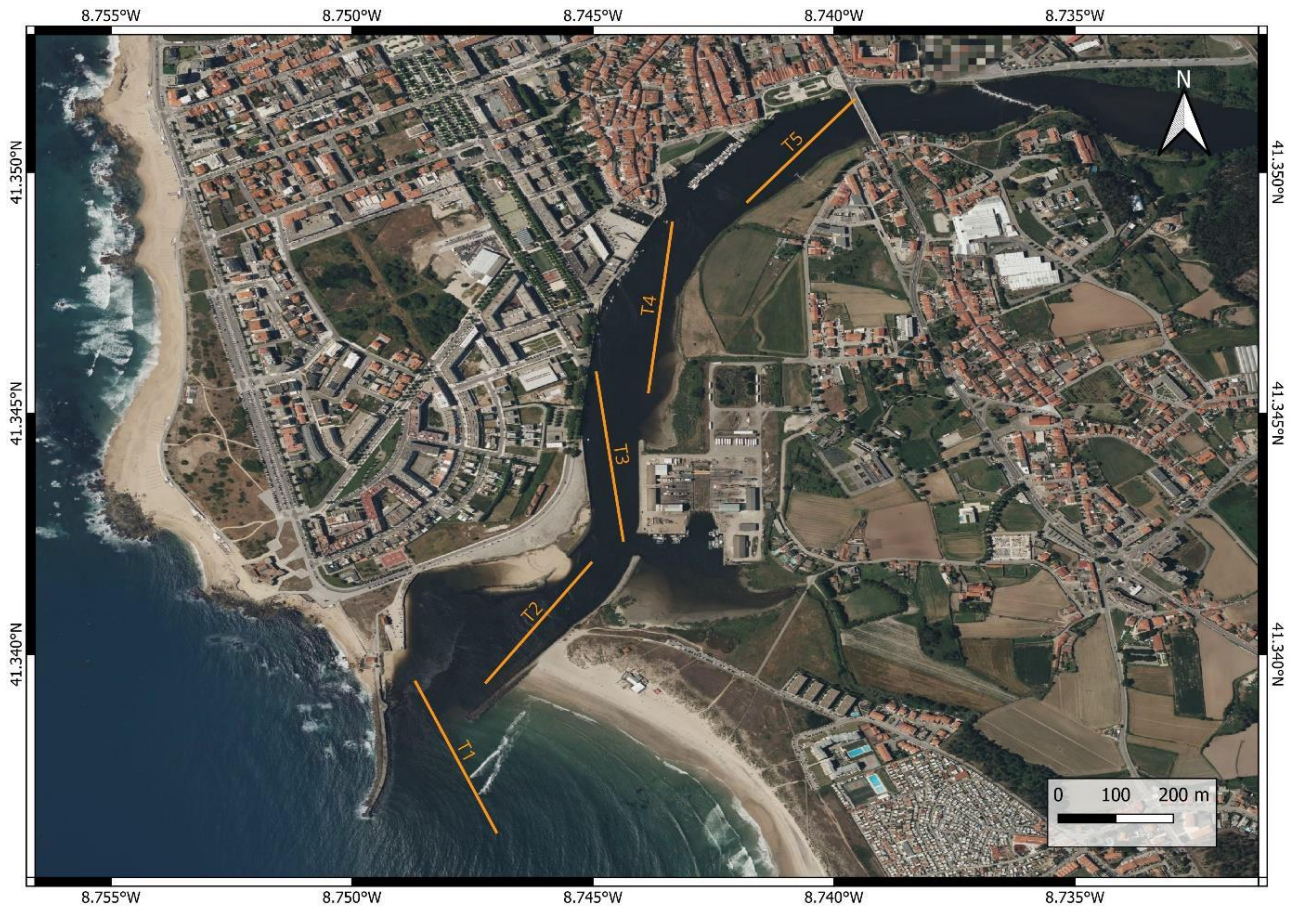
Figure 6.6 - Map of the five selected transects (T1 – T5) for MP in the Ave River estuary. Reference system WGS84.

MP particles in the water column were evaluated following standardized protocols (Gago et al., 2018). Samples for MP were collected under low tide conditions using a manta net with 200 µm mesh size. To quantify the filtered water volume, a flowmeter (Hydro-Bios 438115) was attached to the manta net. The planktonic trawls were performed seasonally (2021-2024) along five different transects, three downstream (T1 - T3) and two upstream (T4 and T5) the technology (Figure 6.6).

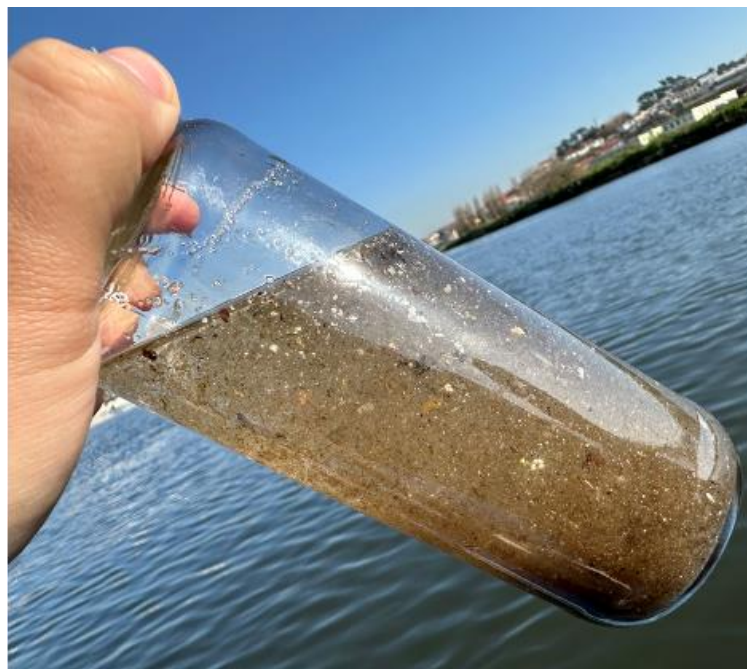
Figure 6.10 - MP sample collected in the bubble curtain with the manta net.

After the installation of the Bubble Barrier, an additional MP collection transect was conducted seasonally over the bubble curtain, following the same methodology and with the same manta net described above. The average concentration of MP in the bubble curtain area was estimated to be 81 MP/m³, which is substantially higher than in other transects, demonstrating that this technology effectively concentrates MP at the surface of the air bubble curtain (Figures 6.9 and 6.10).

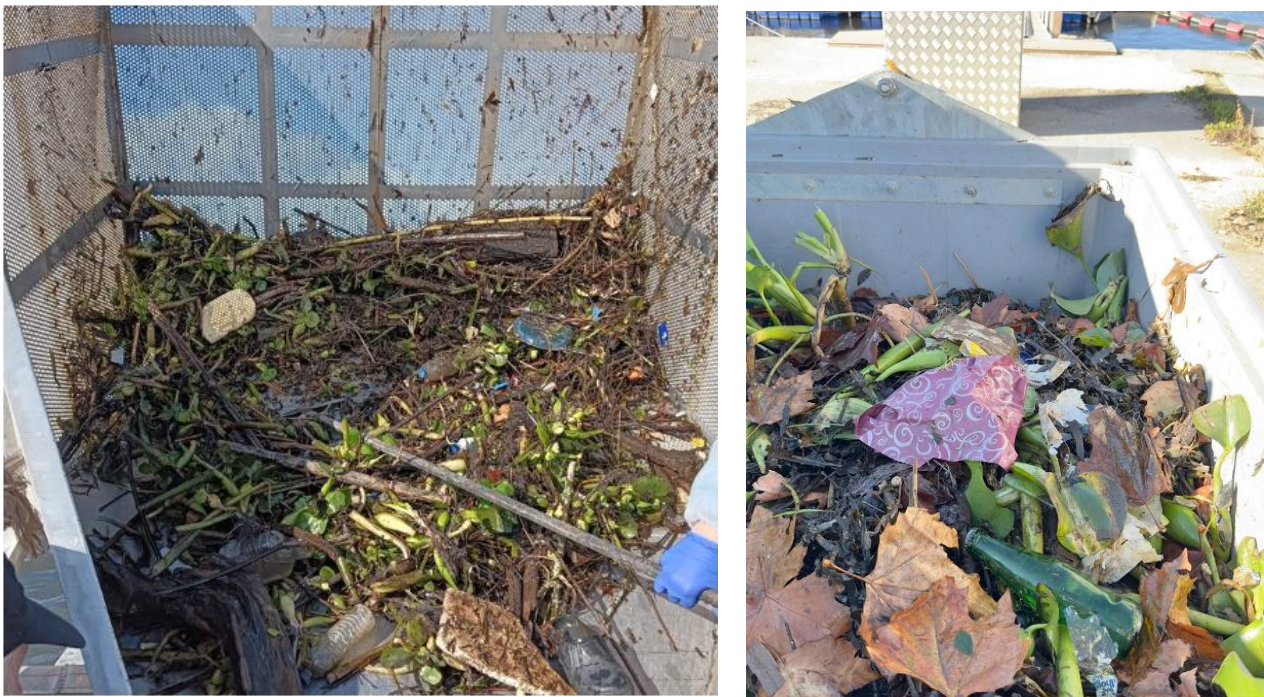
Figure 6.14 - Emptying the catchment system and collected litter for classification.

The detailed assessment of the litter collected by the Bubble Barrier focused on the macrolitter fraction, i.e. all litter > 2.5 cm, following European guidelines for marine litter monitoring (Hanke et al., 2013, 2023). This process involved emptying the catchment system (Figure 6.14), and then separating the organic fraction from the litter and weighing, and categorizing each litter item. This work contributed to and it was developed in the scope of an ERASMUS+ Thesis (Alcalde, 2024).

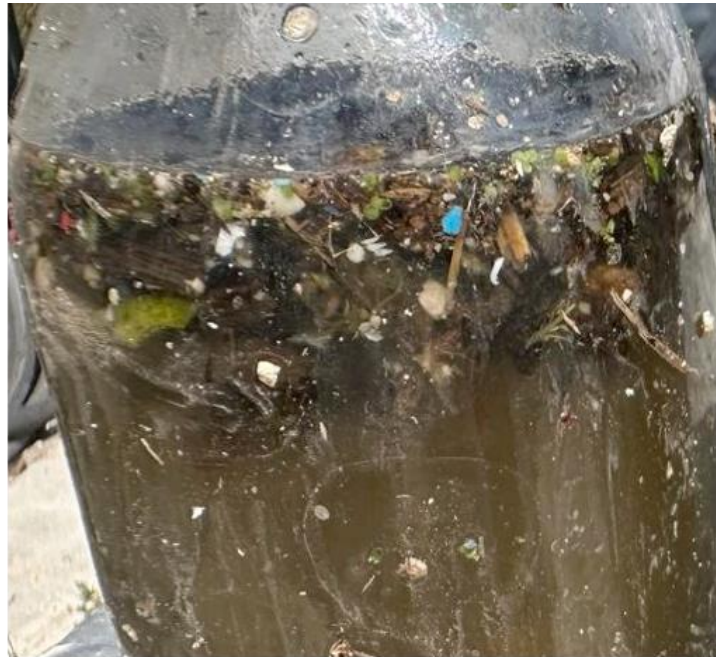
Figure 6.15 - Micro- and mesoplastics collected in the catchment system.

While the Bubble Barrier's ability to capture a significant fraction of organic debris might initially seem like a disadvantage, it is important to note the impact of this organic fraction in the water quality of the estuary. As mentioned above, interceded vegetation often entangles microplastics, enabling the Bubble Barrier to capture them. This would otherwise be impossible due to the system's technical specifications, which do not encompass capturing MP. Previous studies show that certain invasive species, like *E. crassipes*, can retain up to 77% of surface plastics (Schreyers et al., 2024). This phenomenon was observed in the Bubble Barrier, since micro- and meso plastics were collected in the catchment system (Figure 6.15).
