Ceramic Tile Misapplication in Institutional Buildings: Safety, Durability, and Aesthetic Implications

This study employed a qualitative case-study methodology, focusing on two selected buildings within the University of Benin campus: The Bursary Office (a high-traffic administrative facility) and The Faculty of Environmental Sciences (an academic facility with extensive student and staff use). These buildings were selected due to their high public usage and representative nature of institutional architecture in Nigerian universities.

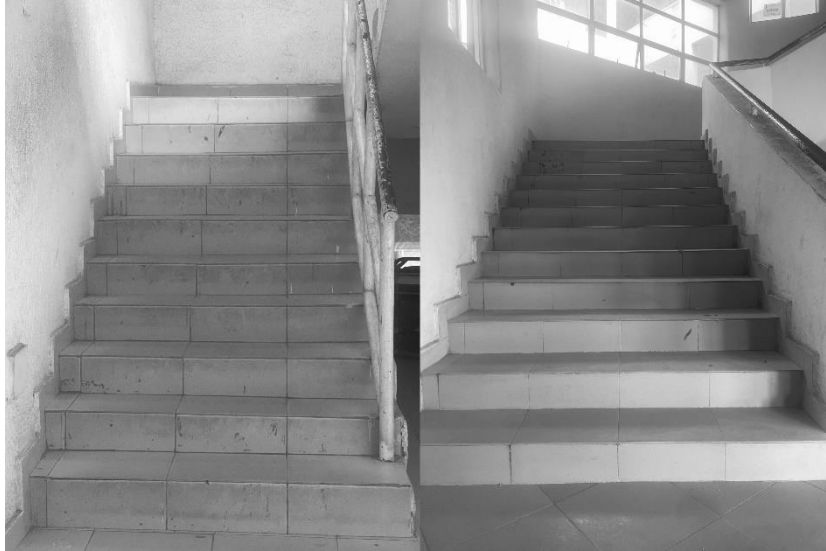
One of the most evident misuses observed was the installation of glossy, smooth-surfaced tiles in staircases and corridors of the Faculty of Environmental Sciences (Figure 1). These tiles, though visually appealing, become dangerously slippery when wet, leading to multiple near-accident reports among students and staff. The lack of slip-resistant finishes violates established safety standards, and it reflects a broader neglect of functional suitability in material choice. Similar trends have been reported by Adebayo and Ajayi (2020), who warn that accidents in tiled environments are often preventable through proper specification.

Figure 1: Slippery glossy tiles installed on staircases, Faculty of Environmental Sciences and the Bursary Office Building (Photo-montage and modified by K.J. Eweka 2025)

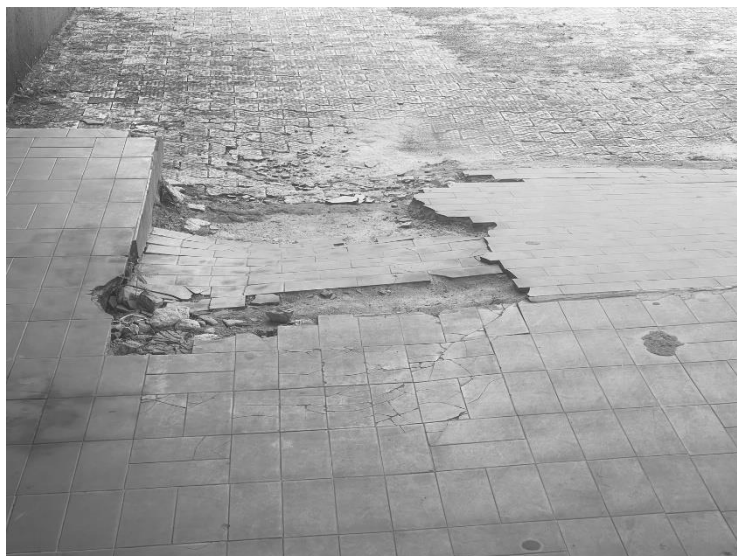
At the Bursary Office, extensive cracking and detachment of floor tiles were observed, particularly in high-traffic waiting areas (Figure 2). This was linked to poor substrate

Figure 2: Detached and cracked floor tiles at the UNIBEN Bursary Office Building (Photographed and modified by K.J. Eweka 2025)

preparation and the use of a low-quality adhesive. Some areas also showed hollow sounds when tapped, indicating voids beneath the tiles. Studies have directly linked such failures in the humid Nigerian climate to inadequate curing of screeds and the use of incorrect adhesive formulations (Oluwole and Adekoya, 2023). Durability problems compromise not only aesthetics but also institutional resources, as constant repairs inflate maintenance costs. Ogunbiyi and Lawal (2020) attribute such failures to poor quality control in procurement and lack of professional oversight during installation.

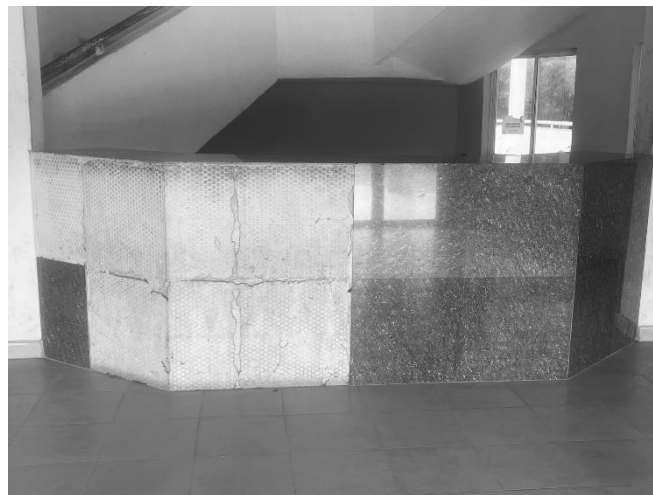
The study also identified visual inconsistencies where different tile patterns and colours were arbitrarily combined. In the Faculty building, brightly coloured wall tiles clashed with subdued floor finishes, creating an atmosphere of visual discord (Figure 3). This undermines architectural coherence and detracts from the professional image of the institution. Adeyemi (2018) argues that aesthetics are central to the cultural role of architecture, and poor material harmony diminishes a building's ability to convey institutional identity. This visual chaos has been shown to negatively impact user perception and satisfaction in institutional settings, as noted in studies on Nigerian public architecture (Nwosu, 2022).

Figure 3: Poorly matched wall and floor tiles in the faculty's lobby (Photographed and modified by K.J. Eweka 2025)
