GIS-based slope-stability zonation for soil-slide hazard assessment in Kottayam, Kerala, India

Government College Kottayam, Nattakom P O 686 013, Kottayam, Kerala, India

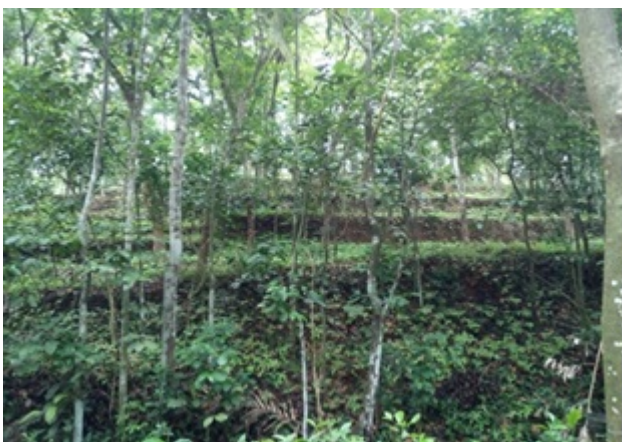
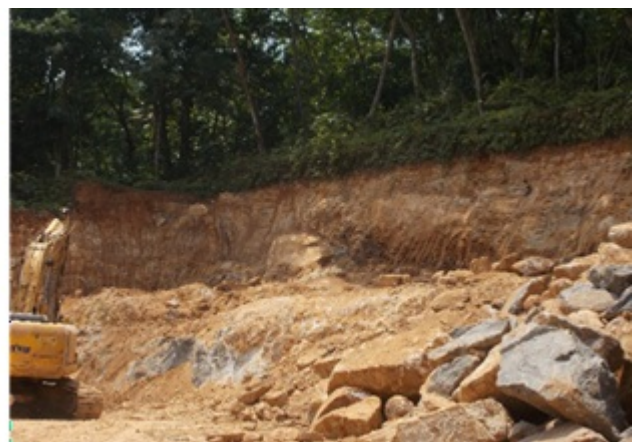
Fig. 7. (a) Contour terracing without a proper drainage system, and (b) development activities that could destabilise the slopes.
