**METHODS AND TECHNOLOGIES OF  
THE RESTORATION OF THE HISTORICAL  
BUILDINGS AND MONUMENTS  
(Example : Bab Sharqi – Citadel of Damascus )**

**Dr.Eng .Mouaffak Doughman**

*Faculty of architecture –Damascus University*

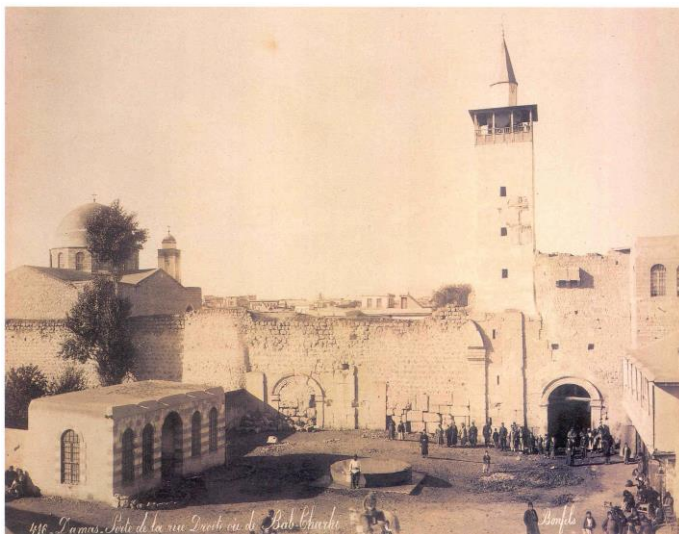
( fig . 1 ) Bab Sharqi – Eastern Elevation before restoration works –1880

The Gate consists of triple passageway , each has an arch ( 27.48 m long and 4.18 m wide ). The central passageway was for the wheeled traffic along the Straight Street, and its height is 10.91 m from the level of the floor tiles to the top point of its inside arch , and its width 4.18 m from the eastern and western sides. Its top boundary is a decorated lintel , above which there is an arch . It is supported by two pillars at both sides. The outer two passageway correspond with arcades (5.98 m high and 3.36 m wide. Above these arches are lintels too which are supported by two side pillars , this structure belongs to the qualities of the Oriental architecture in the Roman era. The distinguishing feature of the eastern elevation of the gate is its four pillars that have bases ( 1.38 m wide , and 0.43 m projection from the front ), the bases are similar to those of the wall of Jupiter Temple of Damascus , which were constructed in the same period of that era. Parts of the arch molding that were above the gate have been found during the excavation near the gate. On the western side, the lintel that joined the arcades of the Straight Street at the Gate is supported by two Doric pillars – each of them is 6.22 m high , and 0.43 m projection from the western front. There are two inner square towers on both sides of the central passageway . From these towers people could climb to the top of the gate for watch and defense . The northern tower was later used as a base for the minaret of the mosque.

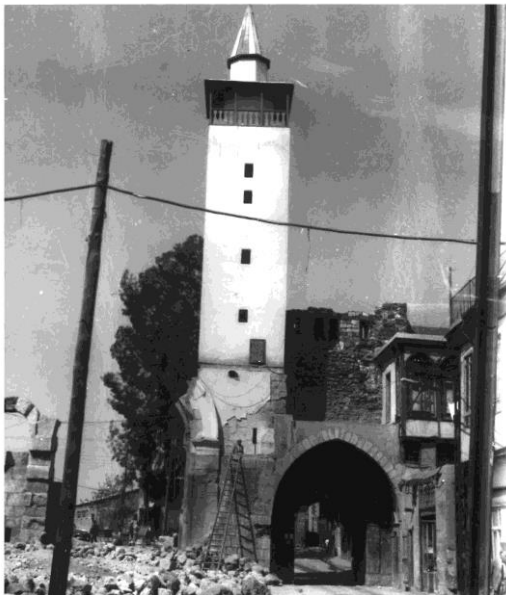
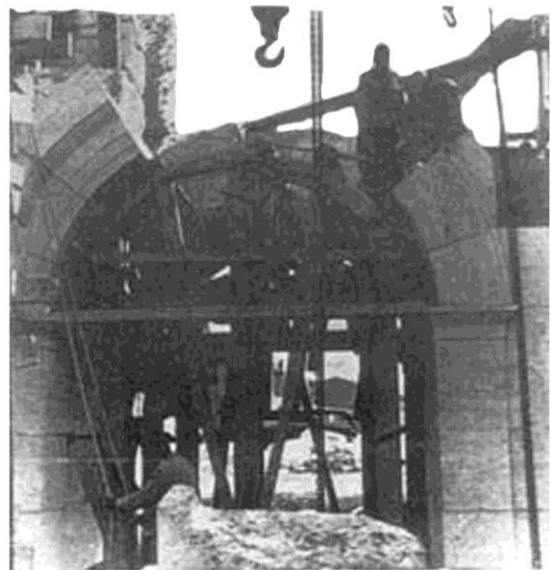
( fig . 2 , 3 ) Bab Sharqi – during restoration works

The Project : The works really started by unclosing all the elements of this building early 1961. All houses and constructions that covered the southern parts and the middle parts have been wiped out. Excavations started to detect all these parts and their remnants. It has been found that are parts of the gate are lost , and its stones were used to restore and rebuild other constructions as they used to do in Damascus.

The strategy of works concentrated on preparing the studies, in which a group of archeologists and engineers participated, on the method of restoration and rebuilding that must be applied , and on whether the lost parts should be returned and renewed or the gate should be left as it is after uncovering it. Finally an agreement has been reached : to adopt the method of rebuilding the lost parts in accordance with the suggested visualization of the original shape , and of using the lime stones of the specifications that are similar to the old stone.

The project has been completed within two years ( 1961-1963 ). After this the gate has witnessed other simple restoration works .see ( fig 2,3,4,5 )

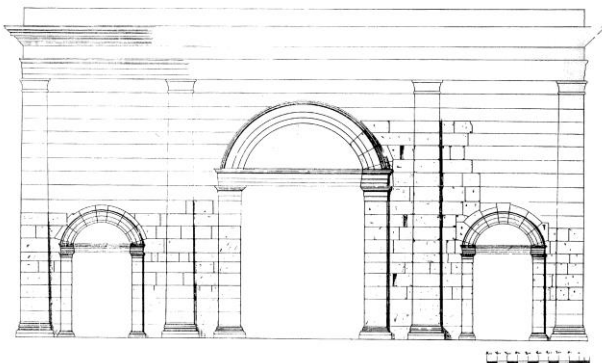
( fig . 4 ) Bab Sharqi restoration Drwing

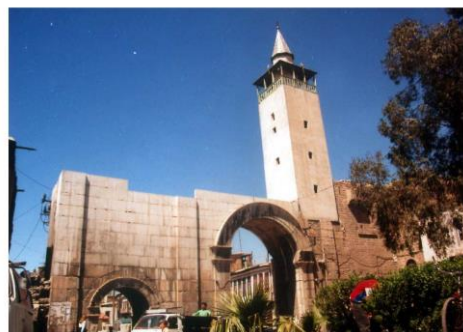
( fig .5 ) Bab Sharqi – photo from East elevation

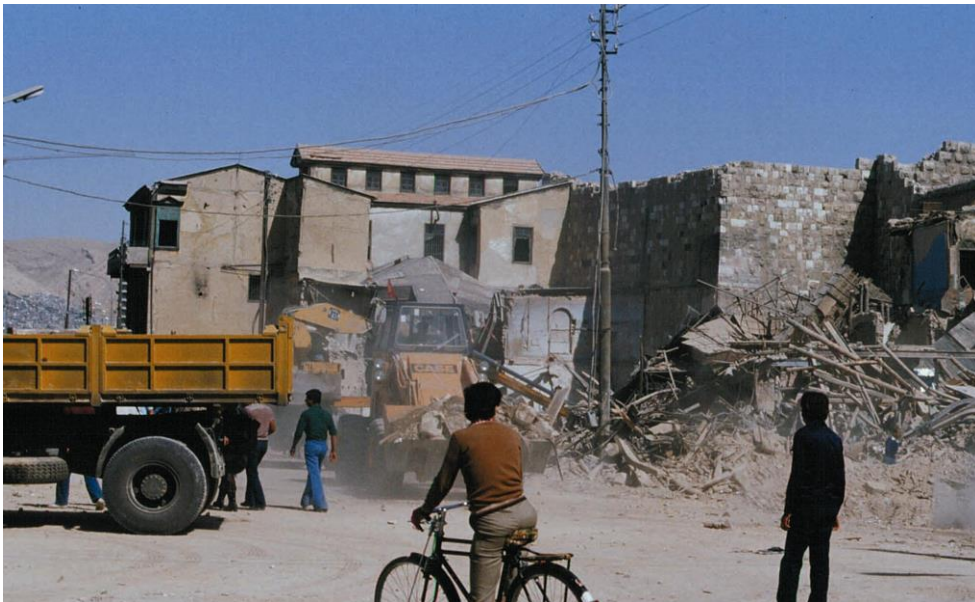
( **fig .8** ) Citadel of Damascus – photo when uncoverd for the restoration works-1980

Losing its military role, the citadel began to deteriorate. When Ibrahim Pasha occupied Damascus, it surrendered without any resistance in 1831. Destruction overwhelmed everywhere. After the French colonization, the citadel was converted to a prison and remained so until it was evacuated early 1985 when the bazaars or markets to the west , east and north around it were demolished as per the general designing drawing of Damascus city ( Echoshar ) .see ( **fig 8** )

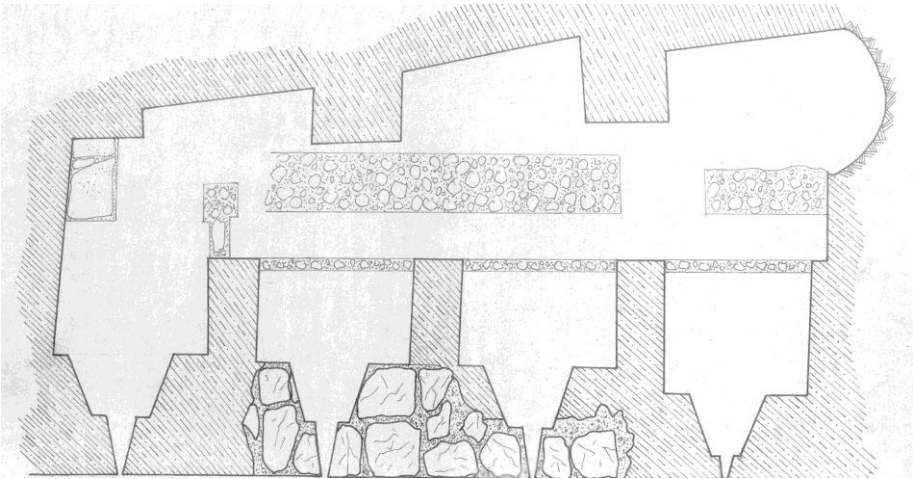
( fig . 9 ) Citadel of Damascus – Plan of the wall during the rastoration

This project is considered one of the most important projects in the citadel. It was executed by the Military Construction Execution Establishment in 1985,see ( **fig 9,10,11,12,13** )

The General Directorate of Antiquities and Museums provided a complete study of the works of restoration and reconstruction in the citadel . A clear policy was followed in this project , which included : on the one hand , reconstructing the western tower in accordance with a perception that had been taken from the actualities of the completed Ayyubid towers in the citadel , and the execution works had to be done by an establishment that owned the equipment and expertise to execute such works. Thus, the project was to reconstruct the south-western tower and restore the southern side of the citadel in addition to some restoration works in some northern towers and the inner and outer bodies. In order that the works be conveniently completed, a special strategy was formulated which was concentrated on the following :

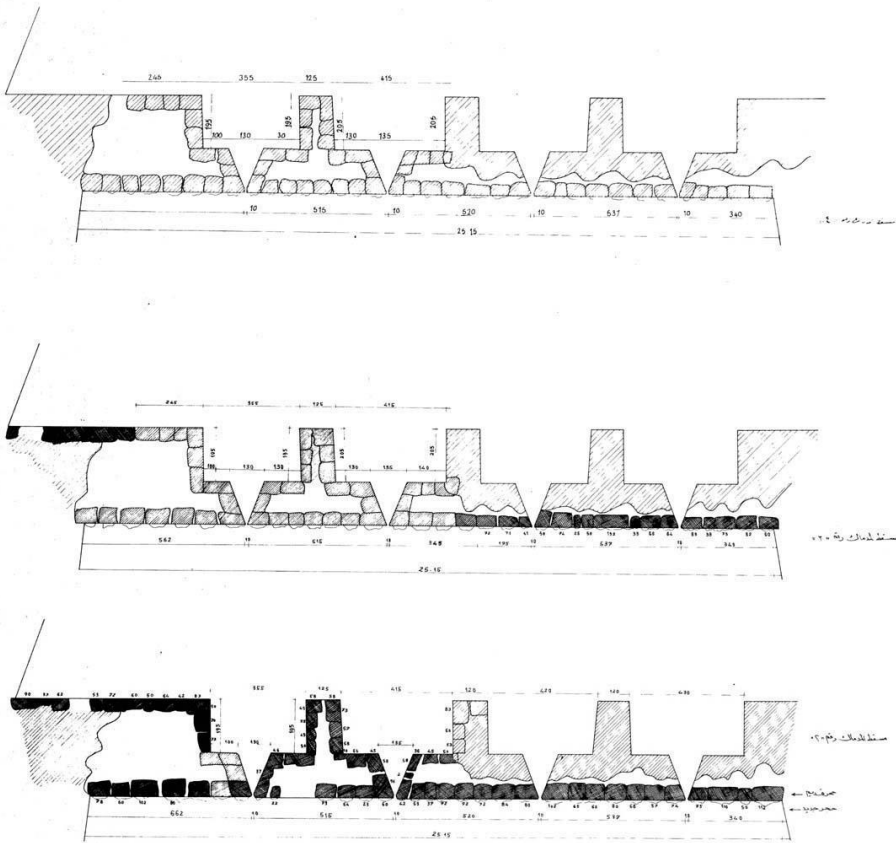
( fig .10 ) Citadel of Damascus – Plan of the wall befor and after the rastoration

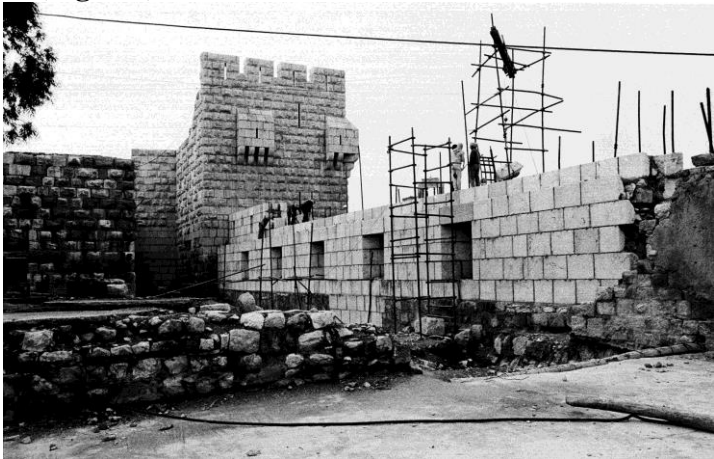
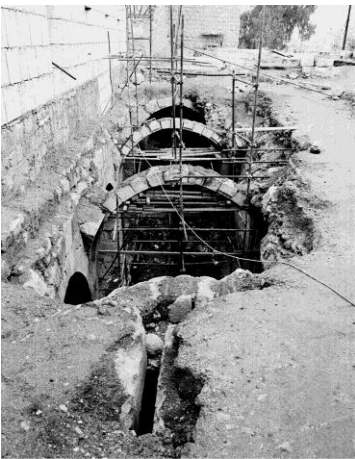
( fig .11, 12 ) Citadel of Damascus photo to the western wall during the restoration

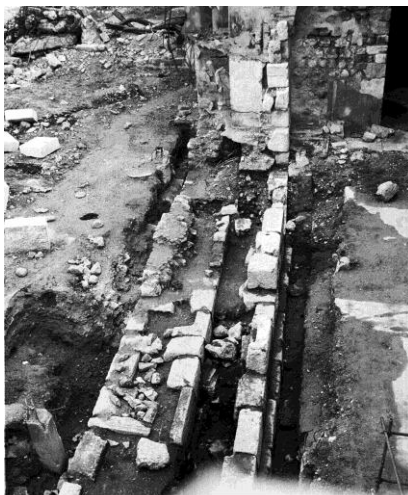
( fig . 13 ) Citadel of Damascus photo to the western wall before the restoration
