THORNTONS RECYCLING BALBRIGGAN

Industrial Emissions Licence Reg. No P1014-01

ANNUAL ENVIRONMENTAL REPORT 2018

SUBMITTED March 2019

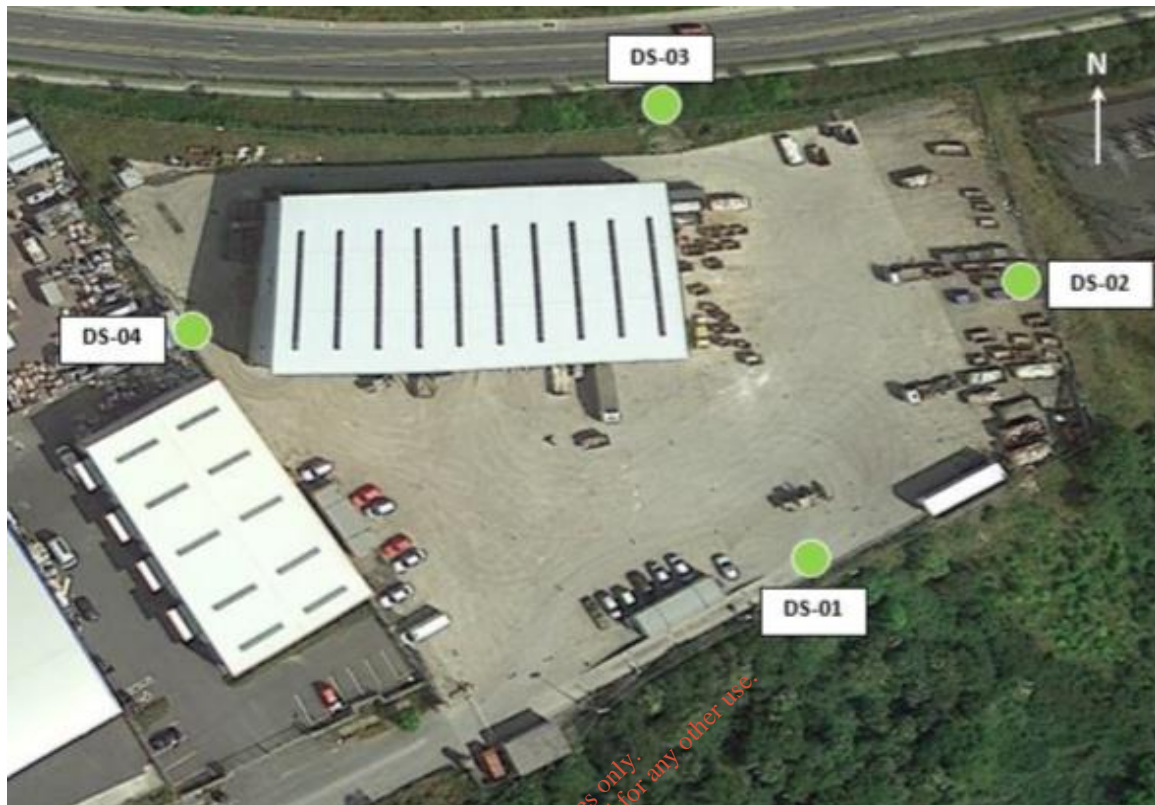
Figure 2 - Dust Monitoring Locations

Annual Dust Monitoring was carried out at four locations DS-01, DS-02, DS-03 and DS-04. Thorntons Recycling are required by Schedule D to monitor dust four times a year, results are displayed in Table 3 and Figure 3. Monitoring locations are shown in Figure 2 below.

Thorntons Recycling Balbriggan is located in a predominately industrial area. A nearby busy road forms the northern boundary of the facility. Monitoring point DS-03 is located on this boundary and as a result receive significant input from passing traffic and vehicles. DS-04 is located on the western boundary and is in close proximity to neighbouring manufacturing facilities.

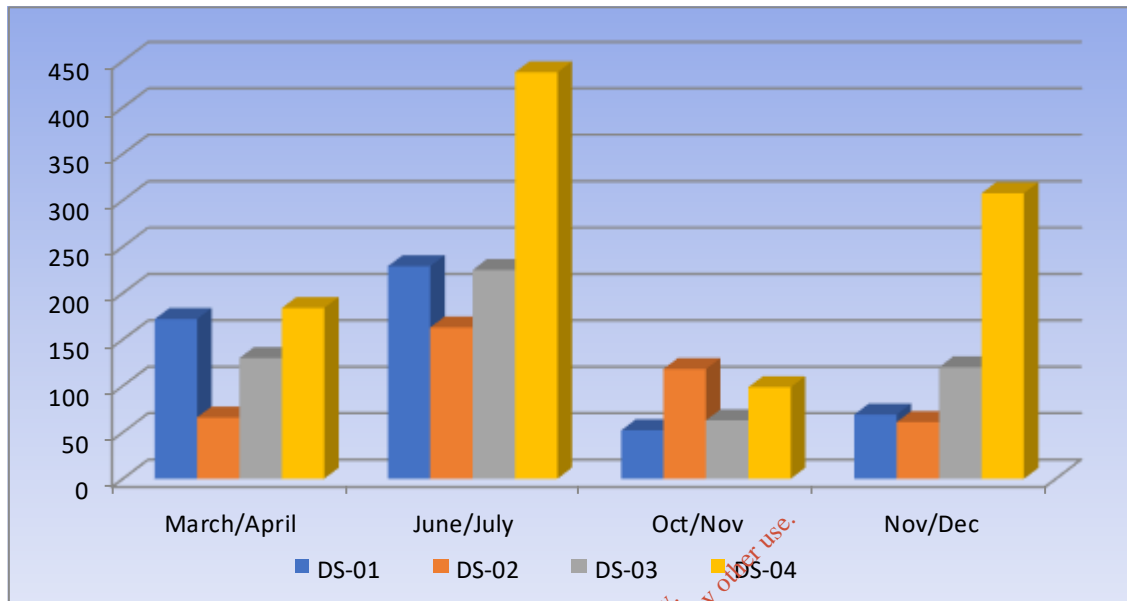
Figure 3 - Dust Monitoring Results 2018

The emission limit value for dust deposition is 350mg/m²/day. During 2018 one (DS-04) of the dust emission levels exceeded the emission limits (Table 2). After inspecting the area around DS-04, it was noted that there was a significant amount of fine wood dust on the ground near the monitoring location. This dust was not attributed to the operations of the facility, but to the operations of a neighbouring manufacturing facility. Figure 3 shows the trends in dust deposition during the year.

Thorntons Recycling will continue to monitor dust on a regular basis. Thorntons Recycling staff use fire hoses to wet down yard surfaces at the facility during dry periods. Thorntons Recycling uses a sweeper lorry to sweep the yard area to reduce the likelihood of debris accumulating.

Thorntons recognises the importance of maintaining dust levels below the emission limit level of 350mg/m²/day and are fully committed to maintaining compliant emissions from the facility in 2019.

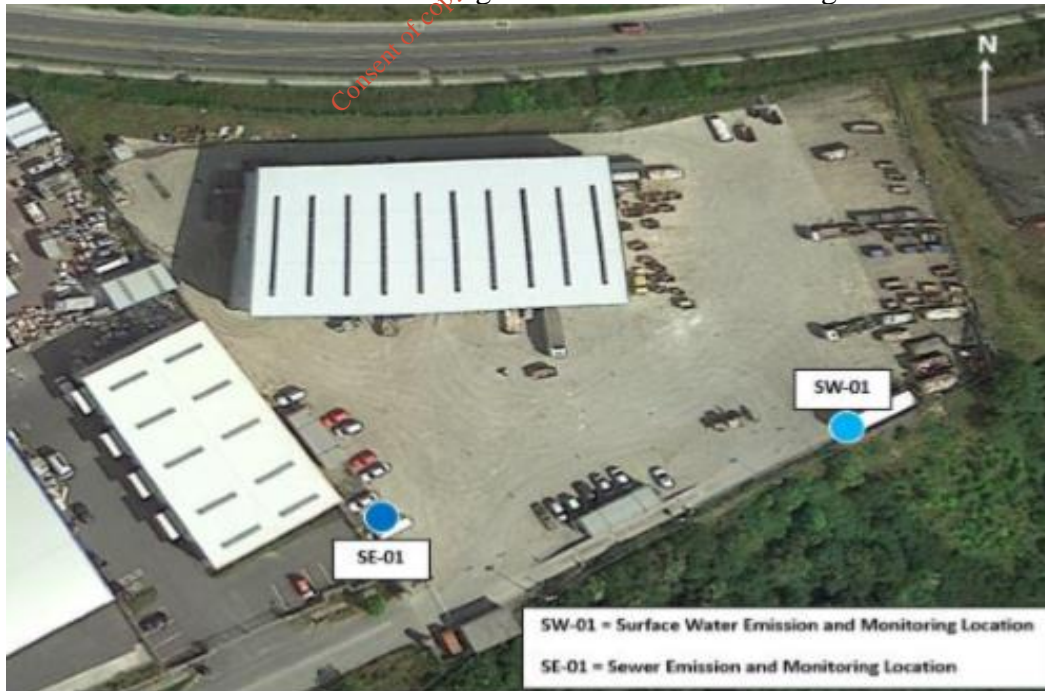
Figure 4 - Water Monitoring Locations

Monitoring is carried out by Thorntons Recycling as per Schedule C of Industrial Emissions Licence P1014-01. Monitoring locations are shown in Figure 4 below.

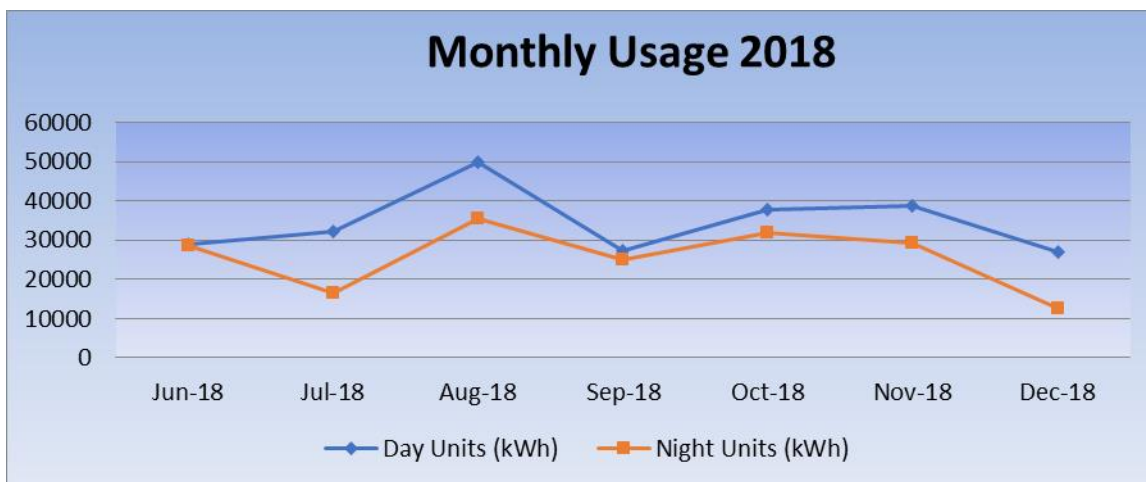
Figure 5 - Day and Night Electricity consumption 2018

421,618KW of electricity was consumed between June and the December of 2018. Thorntons Recycling took over this facility on June 1st, 2018. Therefore, energy data is only available from June 1st, 2018. Thorntons Recycling track all energy consumption at their facilities on an Internal Energy Management System.

Figure 5 illustrates the monthly daily and nightly usage of electricity on site during 2018.

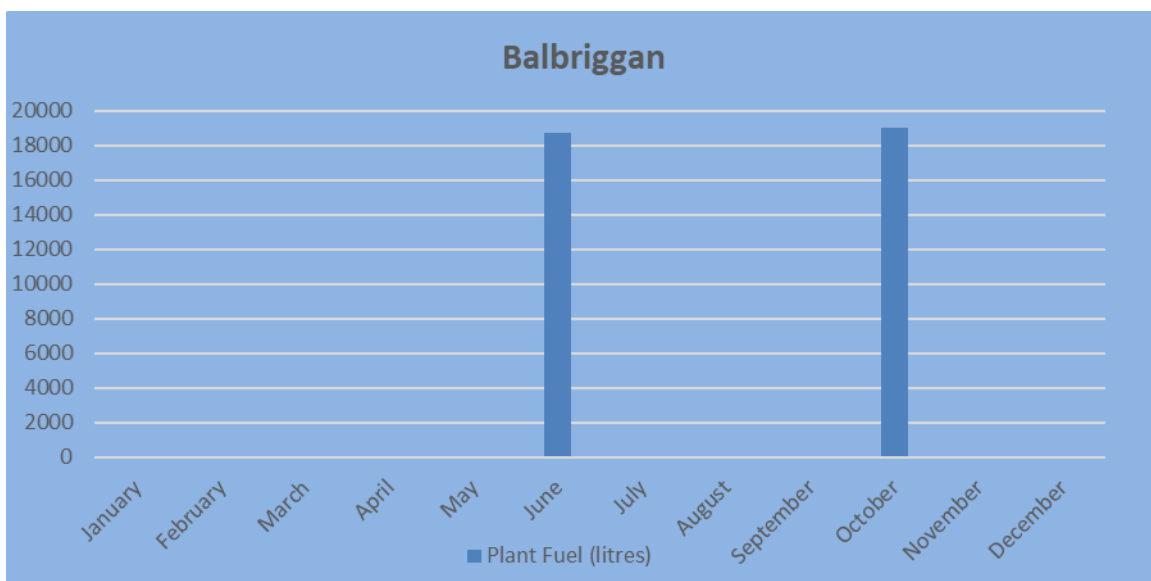
Figure 6 - Plant Fuel Consumption 2018

The main type of fuel used at Thorntons Recycling, Balbriggan is machinery diesel. The breakdown of fuel consumed is detailed in Figure 6 below. In 2018 a total of 37,696 litres of plant diesel was consumed. Plant diesel data is only available from June 1st, 2018.

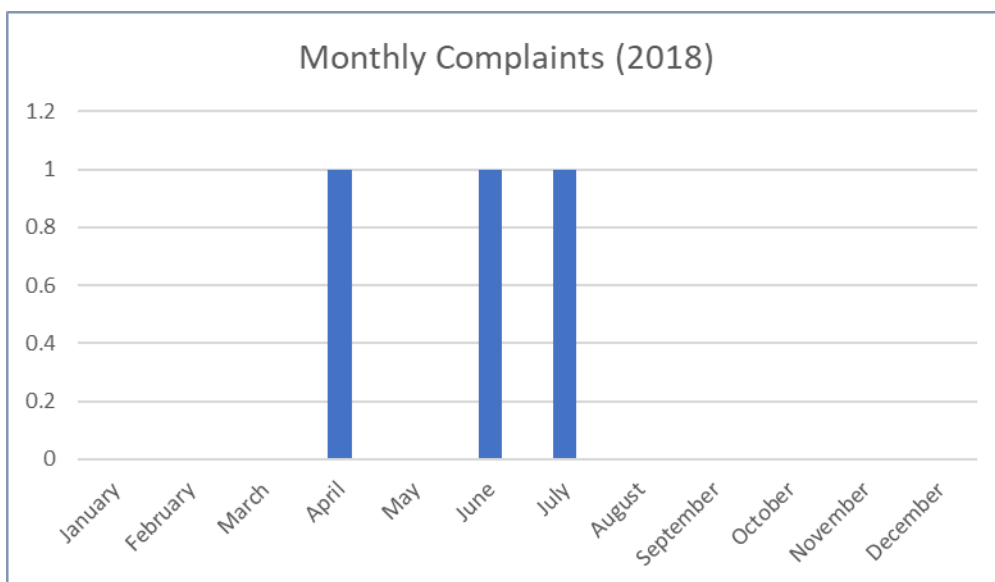
Figure 8 - Break down of all complaints 2018

Complaints are reported either directly to the EPA or to Thorntons Recycling, Balbriggan during 2018. Figure 8 shows the breakdown of complaints by the month in 2018. There was a total of 3 complaints received during 2018 which was a reduction of 37.5% on the previous year.

Analysis of the complaints during 2018 shows that 3 complaints were received (all in relation to odour) from one individual.
