Accessing the Compliance Standards of Selected Projects of Thabang Rural Municipality, Nepal

Design/Methodology/Approach: The compliance status of RCC and masonry building and the motorable road was checked by field observation with help of a checklist and their result are shown through bar graphs. For water supply projects water demand compliance was checked by field observation and water tariff calculation was done based on the possible yearly expenses of water supply management along with effective analysis of Detail Project Reports, Design, and Drawings.

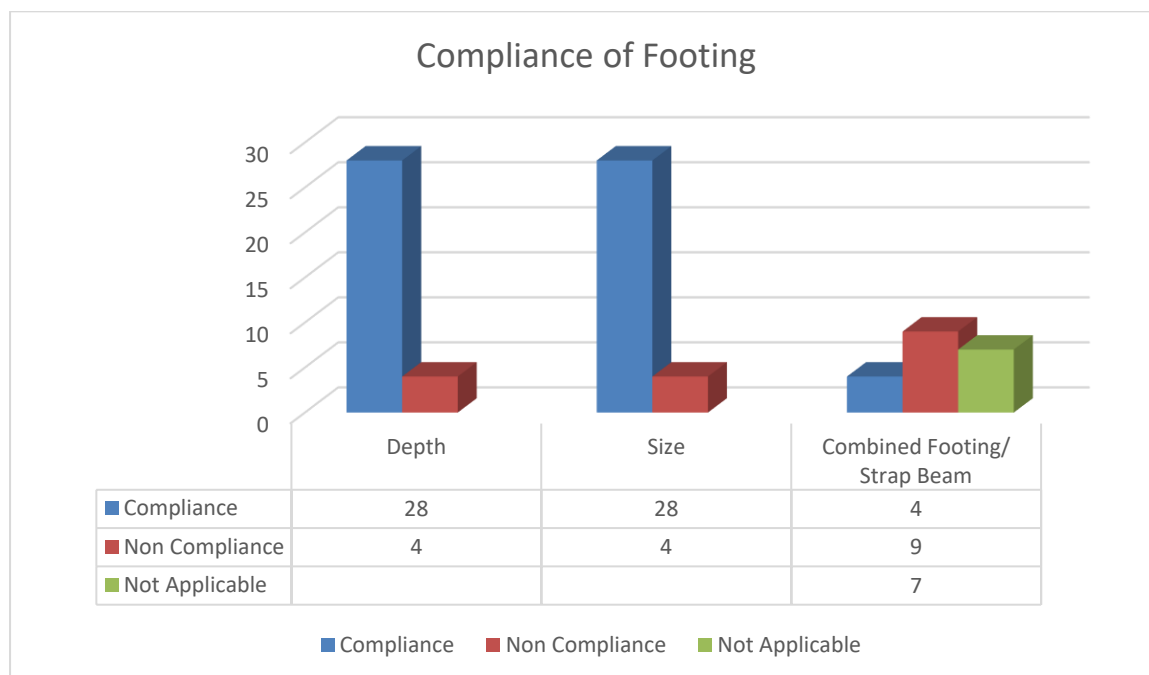
Fig. 1: Compliance of Footing

A study at Thabang Rural Municipality shows compliance of footing by analyzing the depth of footing, Size of footing, and Combined footing/Strap beam parameters. It is seen that out of 32, 28 buildings comply, and 4 buildings are noncompliant with depth and size criteria which indicates most of the buildings are constructed following NBC code criteria for the foundation. A combined footing or Strap beam is provided when footing has to be placed at the boundary. The above bar chart shows in 7 buildings combined footing is not applicable, 9 buildings are constructed at the boundary without providing combined footing and 4 buildings are constructed at edged providing combined footing/Strap beam. Local people of Thabang Rural Municipality say that in past there was the concept of building houses attaching to the neighboring house for safety.

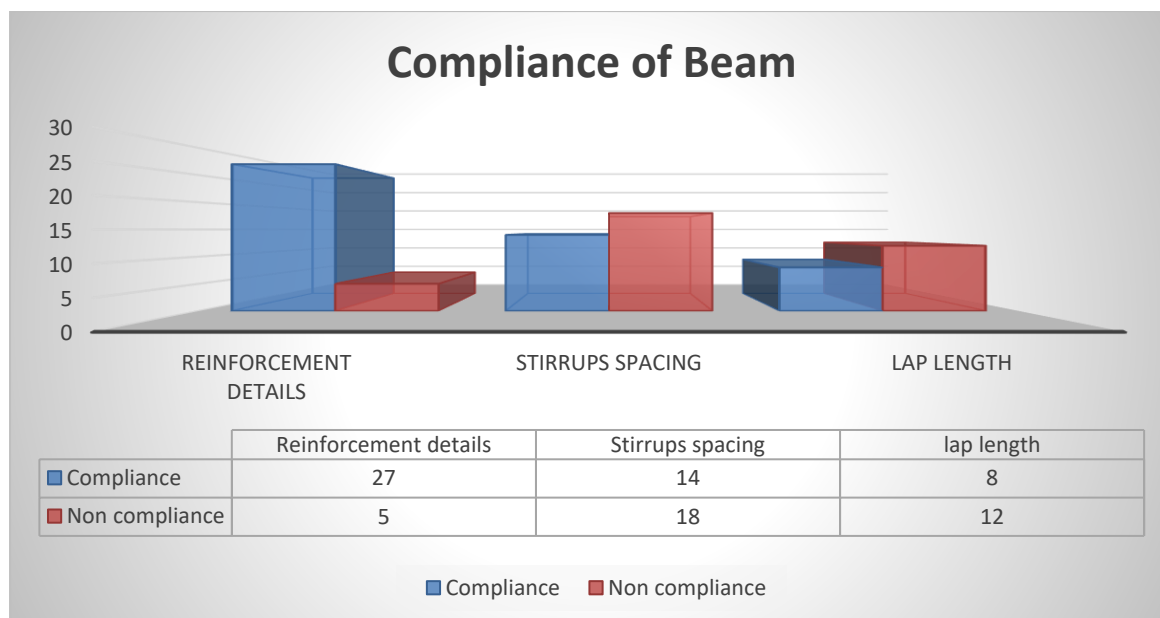
Fig. 2: Compliance of Beam

A study at Thabang Rural Municipality shows compliance of beam by analyzing the depth of reinforcement details, Stirrups spacing, and lap length parameters. It is seen that out of 32 samples, 27 buildings compliance and 5 building non-compliance with reinforcement details, 14 building compliance, 18 building non-compliance in stirrups spacing criteria. Lap length criteria were only checked in RCC buildings and it shows 8 building compliance, 12 building non-compliance in lap length criteria which indicates most of the buildings are constructed following NBC code criteria for reinforcement details specification. But in the case of spacing of stirrups field observation shows that 6" or more than 6" spacing was provided through the entire length of the beam.

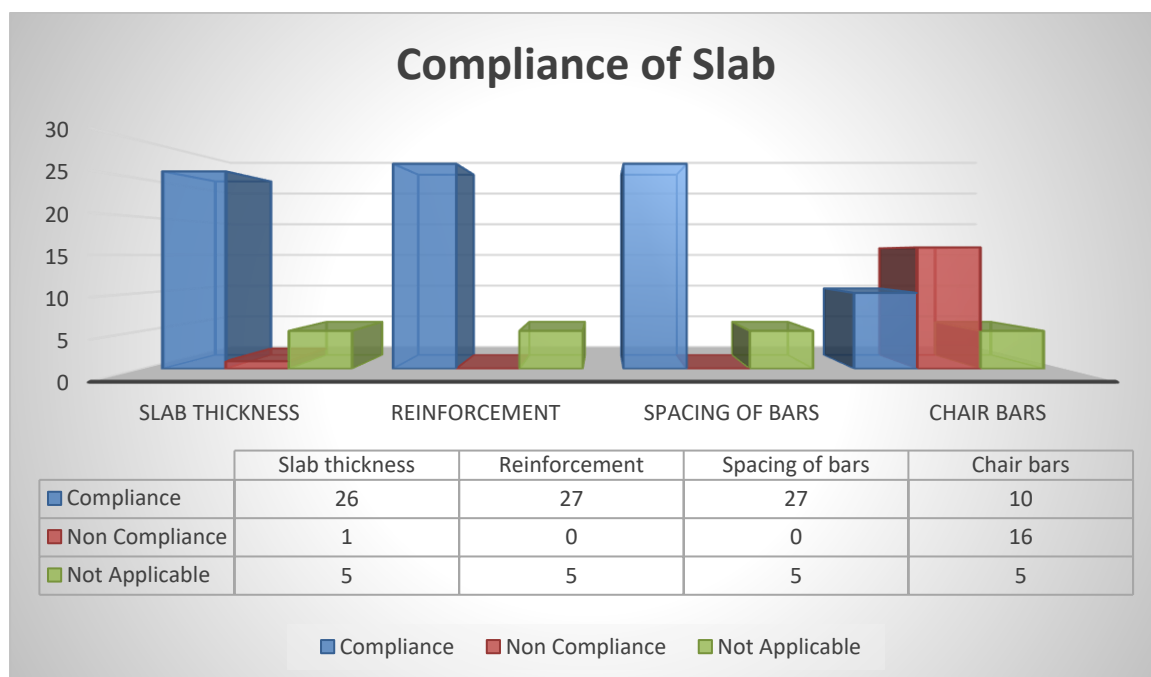
Fig. 3: Compliance of Slab

Compliance of slab of 32 buildings of Thabang Rural Municipality was studied by observing slab thickness, reinforcement bars, spacing of bars, and chair bars criteria. The above bar chart shows among 20 RCC buildings all comply with slab thickness specification but in masonry out of 12 buildings, 6 buildings comply, 1 noncompliance, and 5 buildings have the flexible roof of either CGI sheet or slate stone. Similarly, all buildings with RCC slab compliance diameter of reinforcement bar and spacing of bars in the slab. Chairs bars are only provided in 10 buildings and in 16 buildings there were no chair bars. This study shows that almost all RCC buildings with concrete slabs are fulfilling their minimum criteria like slab thickness, spacing of reinforcement. It is also seen that chair bars placing has not taken more importance in the slab as only 10 buildings have concreted slab by placing chair bars.

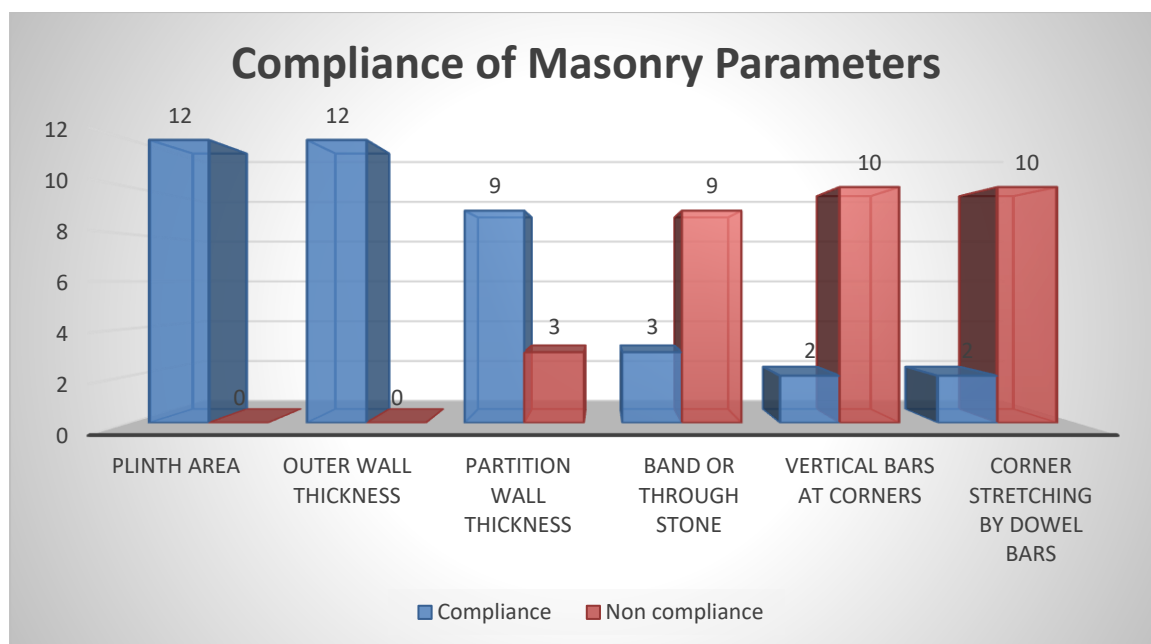
Fig. 4: Compliance of Masonry Parameters

Compliance of masonry building was checked by analyzing plinth area, outer wall thickness partition wall thickness, band or through stone, vertical bars at corners, corner stretching by dowel bars along with other above parameters. The above parameters show that out of 12 buildings all compliance in plinth area, outer wall thickness. Similarly, 9 buildings comply, 3 buildings are noncompliant in partition wall thickness. Band stone and corner stretching by dowel bars are very essential in masonry as it provides a box effect, strengthen the corners, and also avoid the propagation of the crack. But this criterion was only fulfilled by 2 buildings out of 12 buildings. This observation proves that most of the masonry buildings were built avoiding the NBC-2012, specification.
