Evaluation of rock slope stability for a touristic coastal area near Kusadasi, Aydin (Turkey)

Abstract The study area, which will be open to tourism in Kusadasi (Aydin), has steep and high cliffs on the Aegean coast in Turkey. Flysch is the main lithological unit and consists of alternating sandstone–claystone–marl sequences. Some sliding and rockfall problems have occurred in the area in the past, so potential geological hazards need to be investigated to ensure the safety of tourists. The aim of this study is to mitigate geological hazards by recommending engineering solutions, which will ensure the continuation of the nature-friendly appearance of the slopes. To accomplish these tasks, a geological survey was performed. It involved gathering information on rock discontinuities by means of scan-line surveys and collection of rock samples. Furthermore, in situ and laboratory tests were also carried out. The data collected from the field and laboratory test results were used to perform slope stability and rockfall (2-D and 3-D) analyses for different slope conditions along 43 profiles. Based on the analyses, rockfall was found to be the main slope instability problem in the study

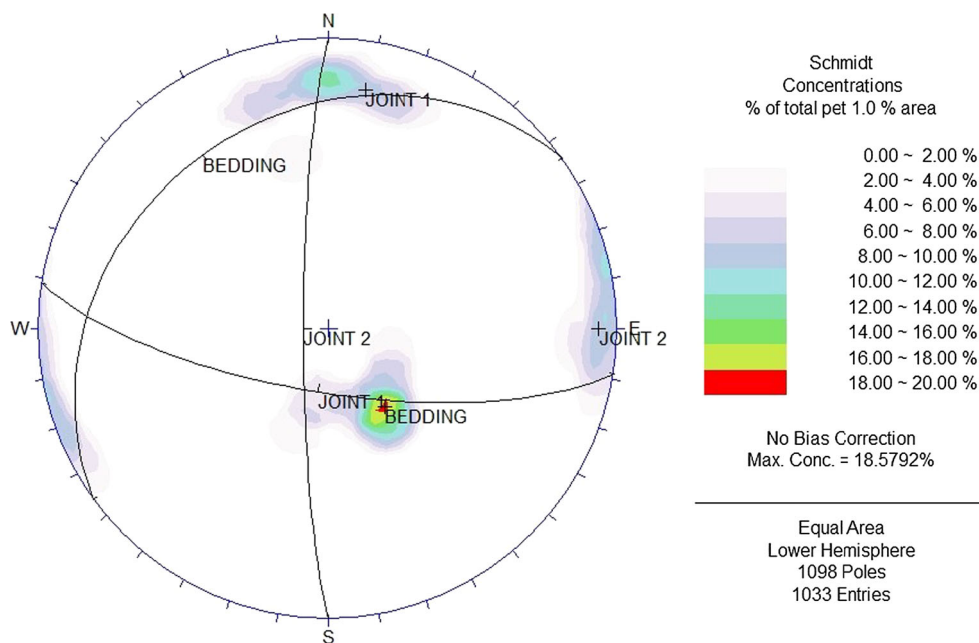
Fig. 4 Stereographic projection of the major discontinuity sets in the study area

The rocks in the study area are generally gray, light brown, thin to thick bedded and moderately weathered. They consist of an alternation of sandstone–claystone–marl. The most common discontinuity is the bedding plane. Additionally, joints have developed, mainly in two different orientations (Fig. 4). The changes observed in the major discontinuity sets are related to the deformation of the layers.

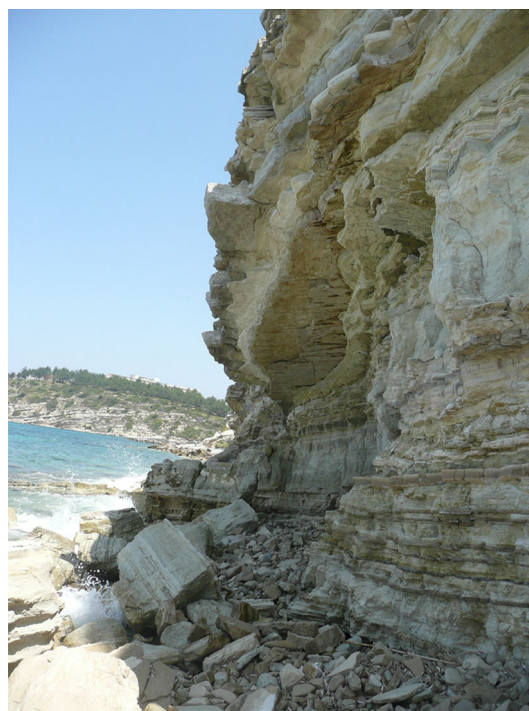
Fig. 6 Photograph showing fallen rocks at the coast

The thickness of the layers (beds) ranges from 1 to 50 cm. The layers are continuous and their surfaces are generally rough. The kinematic analyses carried out according to Wyllie and Mah (2004) reveal that except in the second, fourth, and fifth locations, no failure is expected in the study area. In the second location (Fig. 5), sliding-type (plane failure) movements and erosion could be seen, while in the fourth and fifth locations wedge failure is expected. Because the dimension of the blocks causing the wedge failure is very small, the failure is expected to be manifest in rockfall mode (Fig. 6). A typical

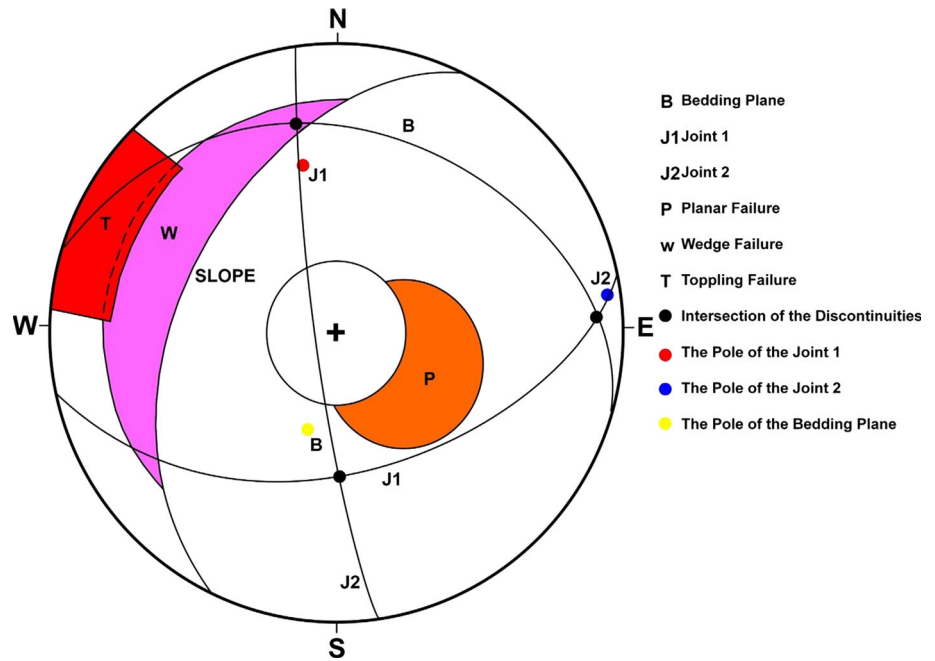
Fig. 7 A typical kinematic analysis for the 4th profile

kinematic analysis for the 4th location is presented in Fig. 7. Groundwater is not encountered in the area. Oxidation marks on the joint surfaces can be seen occasionally in the field. The average Schmidt rebound value of the unit is found to be 42.

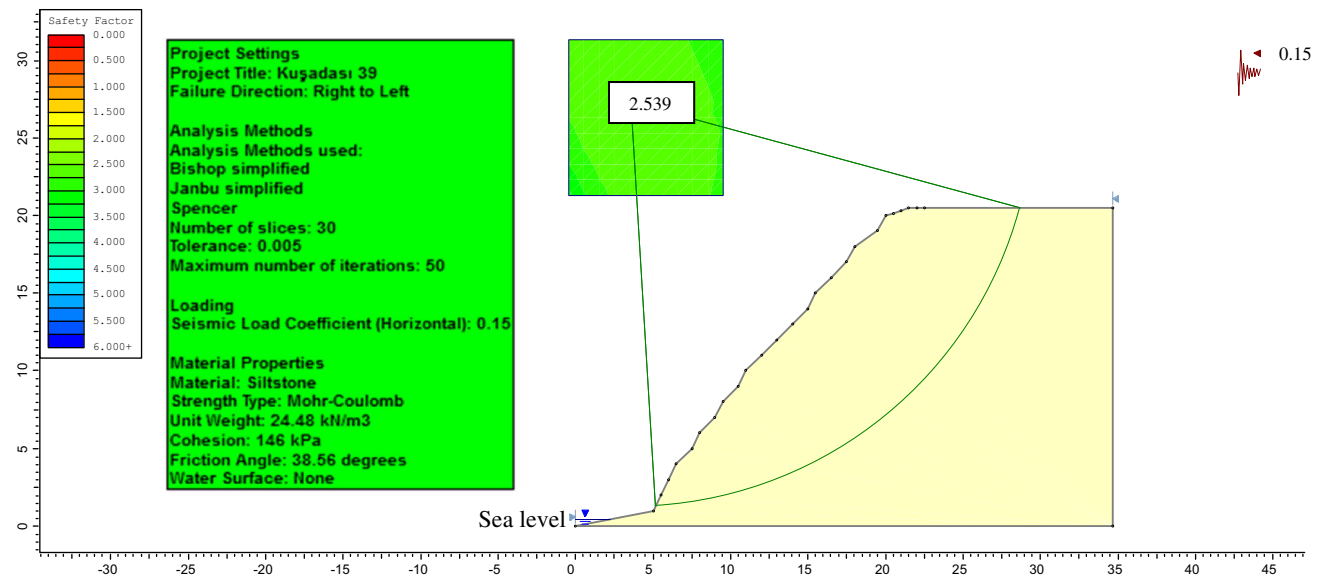
Fig. 9 The result of limit equilibrium analysis for the 39th profile of the original slope

example of limit equilibrium analysis for the 39th profile of the original slope is given in Fig. 9. The factors of safety (Abramson et al. 2002; Duncan et al. 2014) values for all

slope types are much higher than 1.5 for all three slope conditions, and circular mass failures are therefore not expected in the cliffs of the study area.

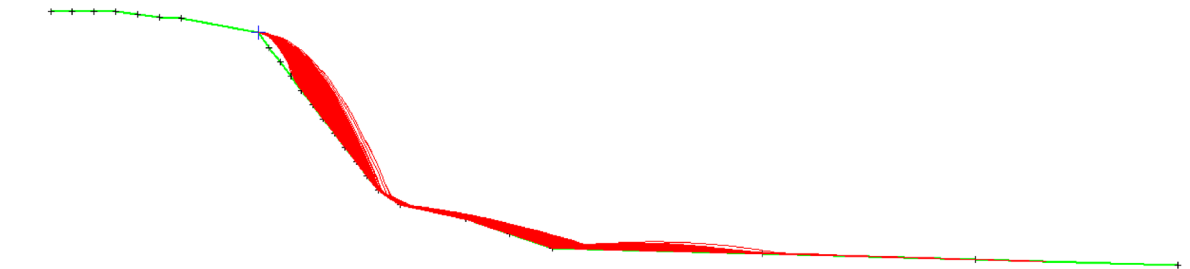
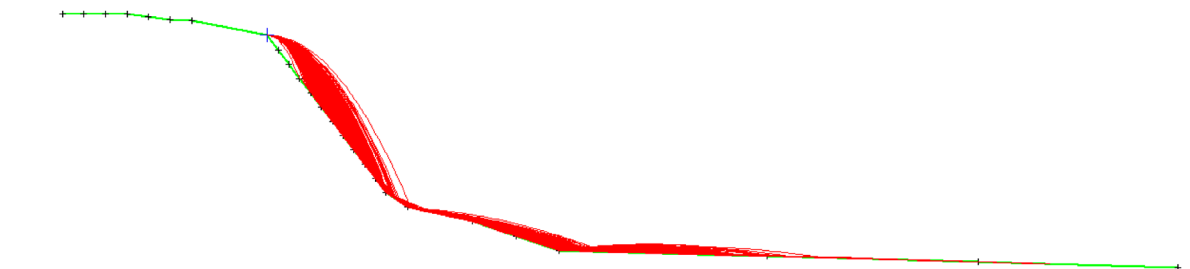
Bounce Height Envelope

Horizontal Location of Rock End-points

Fig. 11 A typical 2-D rockfall analysis for the original slope of the 13th profile

inclined slope and benched slope. When the rocks were made to fall from the original slope, some of them went as far as the sea. This also applies to the inclined, and inclined with one-bench slopes. When the rockfall end points were considered for all slope conditions (Fig. 12), it became clear that the rockfall blocks act in falling mode and stop at a shorter distance in the original slope conditions. For the original slope, these blocks describe a falling mode style. On the other hand, rolling and bouncing movements are dominant in the other two slope conditions (inclined and benched slopes) and the end points imply a larger run-out. These slopes may therefore pose a danger for people near

the coast. Based on this, the profile of the existing slope must be preferred over the inclined and benched slopes. The maximum bouncing height is 5.75 m at the middle of profile 33 and the bouncing height significantly decreases near the coast. Therefore, a protective wall made of natural local stones should be considered at this site.

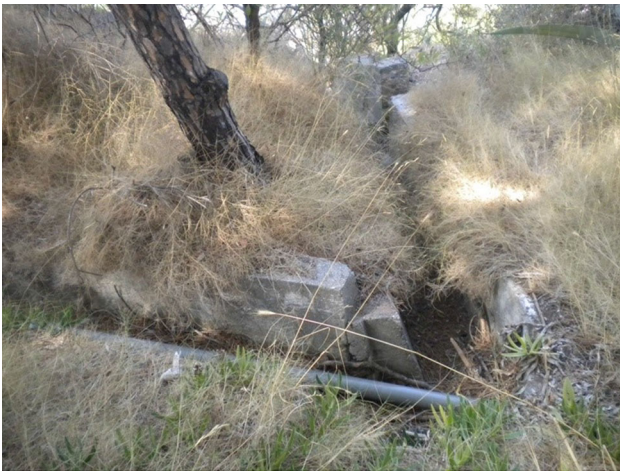
Fig. 14 Improper installation of the old surface drainage line

In the study area, there is a surface drainage line on the upper part of the cliffs but some deficiencies were observed in the surface drainage lines at some locations. Additionally, the drainage line turns with a right angle (Fig. 14) in the north of the study area (near profile 1 in Fig. 8) which renders it unsuitable for draining water. For these two reasons, new drain lines (top width = 50 cm, base width = 30, depth = 40 cm) must be built (Fig. 15) and the former ones should be removed. In this way, the drainage lines, which must always be kept clear, will prevent the flow of rainwater into the cliffs.

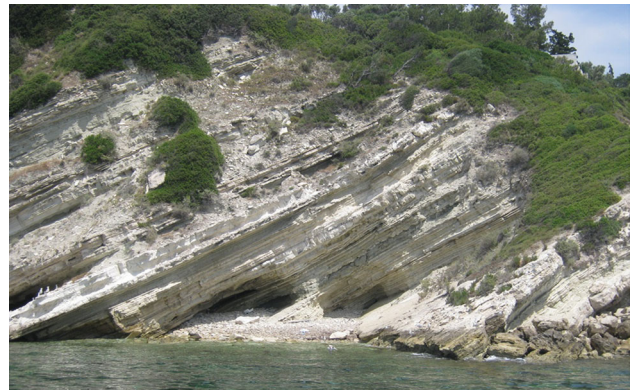
Fig. 16 The rock units carved by wave action

The rock units consisting of alternating sandstone–claystone–marl between profile 13 and 23 in Fig. 8 have been carved by wave action (Fig. 16). Small-scale collapses have occurred in the areas that have large caverns. Because these

caverns are potentially dangerous, they must be filled fully (Fig. 15) and as early as possible with natural stones.
