# Protection of Floating Roof Petroleum Storage Tanks against Lightning Strokes

F. M. Mohamed, A. Y. Abdelaziz

The case study will examine the application of the above recommendations for the El Hamra Terminal New Storage Tank Project (El Hamra Port Terminal, North Coast, WEPCO Company, Egypt).

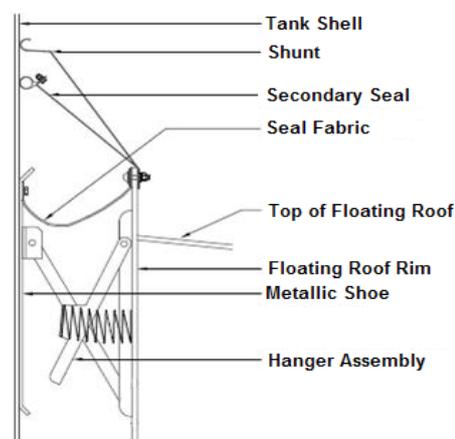
Fig. 1 Cutaway of FRT Shell-Roof Seal Interface space [1]

PETROLEUM products such as crude oil, gasoline, diesel fuel, etc., are commonly stored in Floating Roof Tanks to allow any trapped gas within the crude oil to escape, as this stabilizes the crude oil. Floating roof tank is a type of tank used for the storage of large amounts of petroleum products such as crude oil. FRT has an open top which is equipped with a steel roof which moves up and down according to the level of the stored petroleum product in the tank. The floating roof edge is rounded with a rim seal that has a function of preventing the flammable vapor of stored product from escaping outside the tank and mixing with air, which helps to prevent fires from occurring. The tank seal is made of flexible insulating material of different designs. The construction details of the interface space between the shell and the roof of the floating roof tank is shown in Fig. 1, the primary and secondary seals are customized around the roof-shell interface to fit the tank and prevent air gap occurrence. Also, the double seal material provides safe operation and long life time for the tank.

During the repeated process of filling and drainage the tank with the petroleum products the seal material can become damaged, and then the tank inner shell may be subjected to corrosion and accumulation of petroleum residue which electrically isolates the roof shunts from the tank shell and from any connection to earth [1].

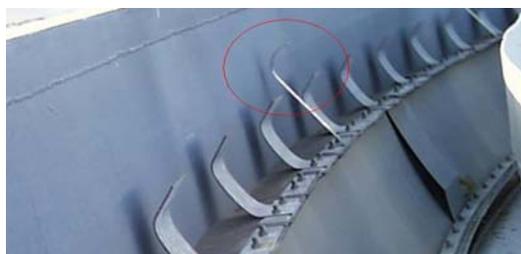
Fig. 2 Shunt not making contact with Out-of-Round Tank Shell [1]

- 1) Dissipation array system (DAS) located above the telecom tower.
- 2) Spline pole system (SPS) located above lighting tower.
- 3) The shell is bonded to the tank through (shunt straps), and there was damage in some of these shunt straps; consequently, it is not connected to the tank shell as per Fig. 2.
- 4) The existing shunts are not electrically connected to the tank shell because of the heavy crude oil components, such as wax, tar, and paraffin, etc., that cover the inner wall of the tank, and thus breaking the electrical connection between the tank shell and shunts.

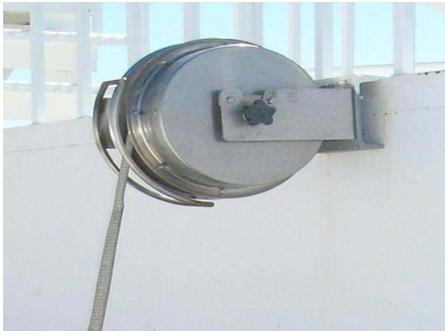
Fig. 3 LEC Retractable Grounding Assembly (RGA) on Floating Roof Tank [1]

- 3) It is also common practice to install bypass conductors between the roof and the tank spaced at intervals no more than 30 m around the circumference of the floating roof. For the new floating roof tank that shall be under our case study, it has a length of at least 49 m because the dimension of the tank (90 m diameter and 18 m in height). The installation of the bypass conductors is easy, inexpensive, and can be installed on both new and existing tanks. The bypass conductors shall have an impedance that is less than that of presented by shunts, so it shall attract the intermediate and long-duration component of the lightning-stroke current to pass through it rather than the shunts. However, the bypass conductor end-to-end voltage may be so high as to cause a dielectric breakdown of the insulating surrounding air. This lead the tank owners to use a retractable conductor wound on a spring-tensioned reel (RGA), instead of the standard conductor. Lightning Eliminators & Consultants (LEC) [1], has developed a roof-shell bonding mechanism (RGA) which is better than the conventional type of bypass conductor. RGA is complete with a spring to retract the conductors on the wheel. The length of the bypass conductor is always keeping the minimum length regarding the location of the floating roof at the top or the bottom of the tank. Also, a typical retractable grounding assembly (RGA) of floating roof tank is shown in Fig. 3. Due to the large diameter of the floating roof tanks (FRT's), and order to increase the electrical connection between the roof and the shell of the FRT, it is recommended to install multiple RGA's on the floating roof tank. The RGA should be installed at intervals no more than 30 m around the circumference of the floating roof [1]: so, in our case, the recommended number of RGA's shall be not less than 10 m, as the tank diameter is 90 m, and the circumference is about 285 m. Although RGA is better than conventional cables, it provides optimal solution for the tank protection against lightning

- 4) Installation of the retractable bypass conductor (RGA's), in addition to the existing shunt straps system, can be installed to existing and new tanks in the future.
- 5) Checking that all the tanks in the zone of the tank fire are connected to the earthing network, as per the applicable code.
- 6) Installation of an Early Streamer Emission (ESE) air terminal system on the tank shell according to the tank diameter.
- 7) Performing lightning risk assessment analysis for the new floating roof tanks that shall be installed in areas subjected to frequent lightning activity.

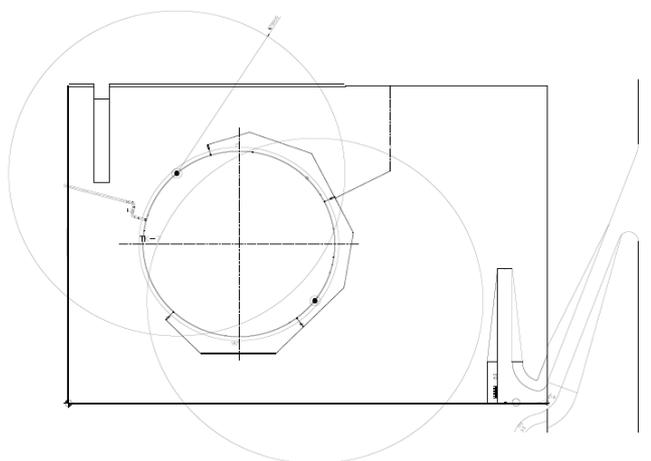
Fig. 5 Snapshot from EL Hamra Terminal New Storage Tank (7) Lightning Layout

- 1) Installation of two diagonally opposite Early Streamer Emission (ESE) air terminal systems on the tank shell, as shown in Fig. 5.
- 2) The required level of protection is level 1 and the radius of protection of each (ESE) shall be not less than 79 m, because the tank diameter is 90 m.

- 3) Install two 5 m high hot dip galvanized steel poles to carry out each (ESE) system
- 4) Install two down conductors made of tinned copper with a minimum size of 50 mm<sup>2</sup> to connect the ESE terminal to the earthing system.
- 5) Install two Lightning strokes counters with an Enclosure IP55 and numerical reading facility.
