# An *In Situ* HVEM Study of Dislocation Generation at Al/SiC Interfaces in Metal Matrix Composites

MARY VOGELSANG, R. J. ARSENAULT, and R. M. FISHER

Annealed aluminum/silicon carbide (Al/SiC) composites exhibit a relatively high density of dislocations, which are frequently decorated with fine precipitates, in the Al matrix. This high dislocation density is the major reason for the unexpected strength of these composite materials. The large difference (10:1) between the coefficients of thermal expansion (CTE) of Al and SiC results in sufficient stress to generate dislocations at the Al/SiC interface during cooling. In this *in situ* investigation, we observed this dislocation generation process during cooling from annealing temperatures using a High Voltage Electron Microscope (HVEM) equipped with a double tilt heating stage. Two types of bulk annealed composites were examined: one with SiC of discontinuous whisker morphology and one of platelet morphology. In addition, control samples with zero volume percent were examined. Both types of composites showed the generation of dislocations at the Al/SiC interface resulting in densities of at least  $10^{13} \text{ m}^{-2}$ . One sa

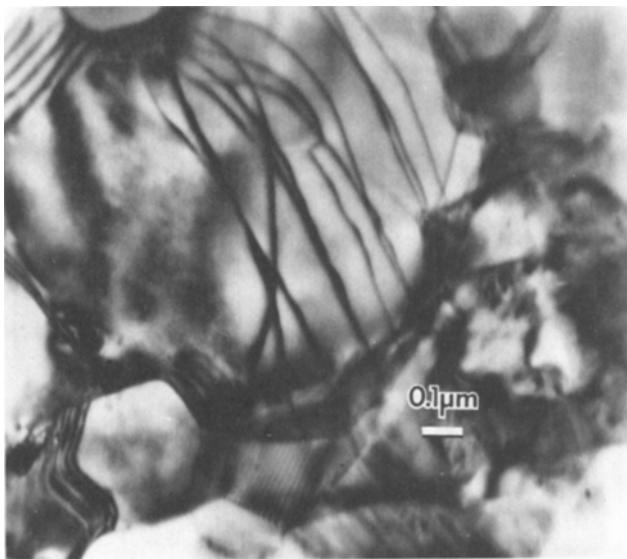
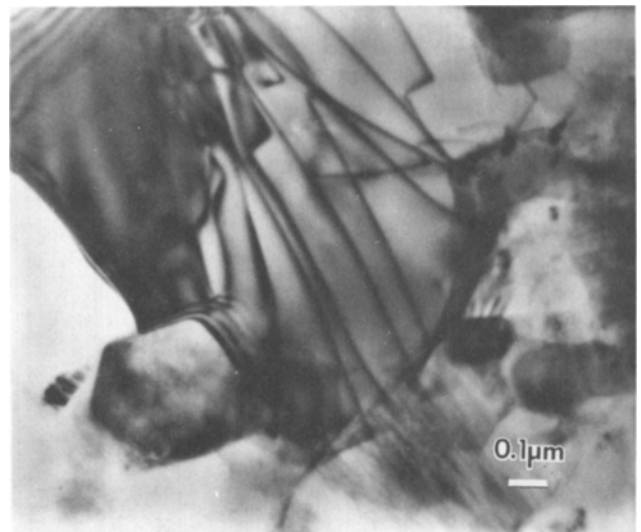
Fig. 4—(a) A foil cut transverse to the whisker axis (5 vol pct SiC). At the beginning of the thermal cycle, 370 K, the dislocations tended to bow away from the two hexagonal SiC whiskers. (b) The dislocations straighten on further heating to 570 K (same area as Fig. 4(a)). (c) Further rearrangement of the dislocations occurred on heating to the annealing temperature of 800 K in the microscope. The dislocations straightened and moved to more equally spaced positions (same area as Figs. 4(a) and 4(b)). (d) During cooling to 570 K the dislocations again began to bow away from the SiC whiskers (same area as Figs. 4(a-c)). (e) On cooling to 360 K, the curvature of the dislocations became pronounced, indicating the operation of a thermal stress; however, the generation of new dislocations did not occur (same area as Figs. 4(a-d)).

The 5 vol pct whisker sample, sectioned transverse to the whiskers so that the hexagonal whiskers are viewed end-on in the microscope, had a small subgrain size, 2.0  $\mu\text{m}$ , and a high dislocation density,  $4 \times 10^{13} \text{ m}^{-2}$ , in the subgrains (Figure 4(a)). In this case, on heating the dislocations did not disappear but straightened from an initially bowed configuration and became more regularly spaced: a polygonized configuration. These dislocations did not disappear at high temperatures (Figures 4(b) and 4(c)). On cooling, the dislocations again bowed away from the Al/SiC interface but the density of dislocations did not increase; if anything, the number slightly decreased (Figures 4(d) and 4(e)). Several of the subgrains appeared to change shape during the thermal cycle; however, their boundaries did not move past the surrounding SiC whiskers.
