“Locomotive Fire-box Stays.”

By FRANCIS WILLIAM WEBB, Vice-President Inst. C.E.

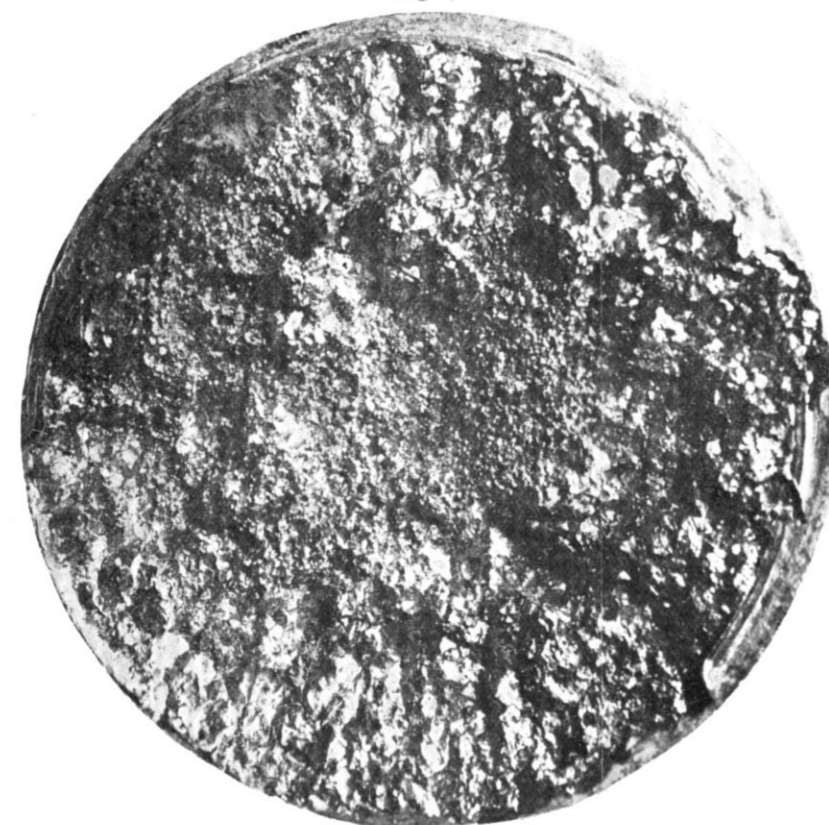
Fig. 9.

COPPER-ALUMINIUM STAY, BROKEN HEAD

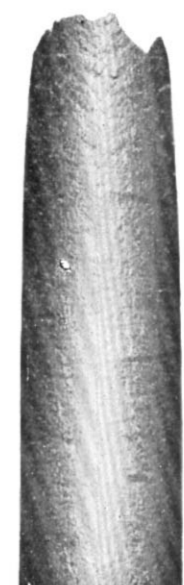
Fig. 20.

TEST "S" AT 400° F.

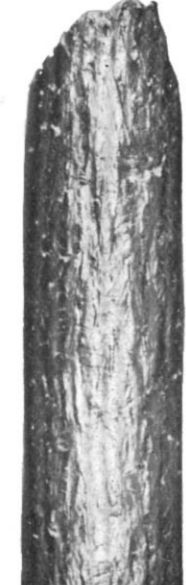
Fig. 21.

TEST "L" AT 400° F.

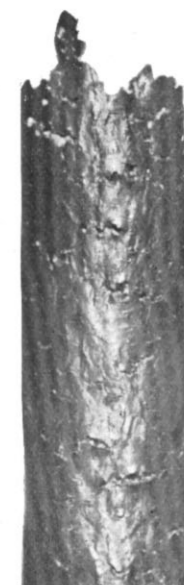
Fig. 23.

TEST "L" AT 500° F.

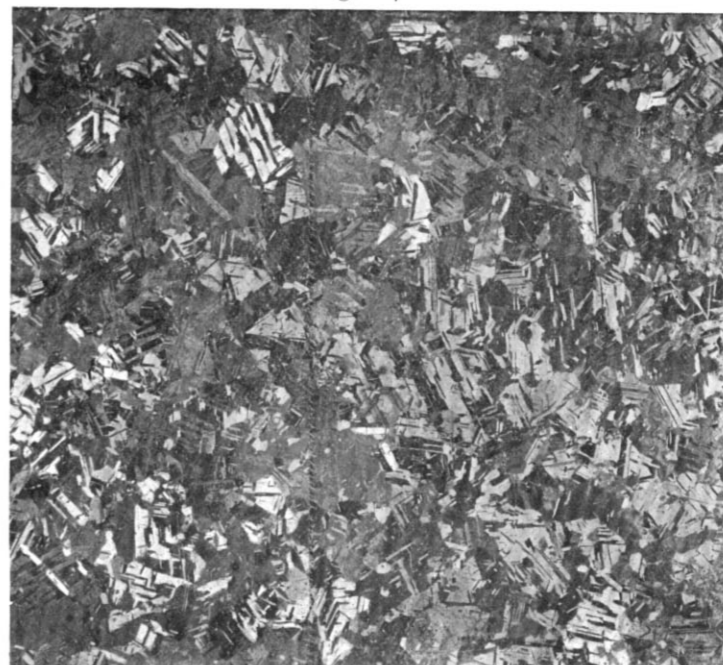
Fig. 14.

14, which are magnified four diameters. It was also observed that the crystals were either large (Fig. 14) or small (Fig. 12), or large and small mixed (Fig. 13), but not of intermediate size. In view of this heterogeneous structure, the three test-pieces of the copper-aluminium alloy for each temperature consisted of one piece of all large crystals, marked "L"; one piece of all small crystals, marked "S"; and one piece, as nearly like Fig. 13 as possible, marked "M." Separate chemical analyses of large-crystal and small-crystal test-pieces showed them to contain the same percentage of aluminium (7·13 per cent.).

COPPER-ALUMINIUM ROD. LARGE CRYSTALS.

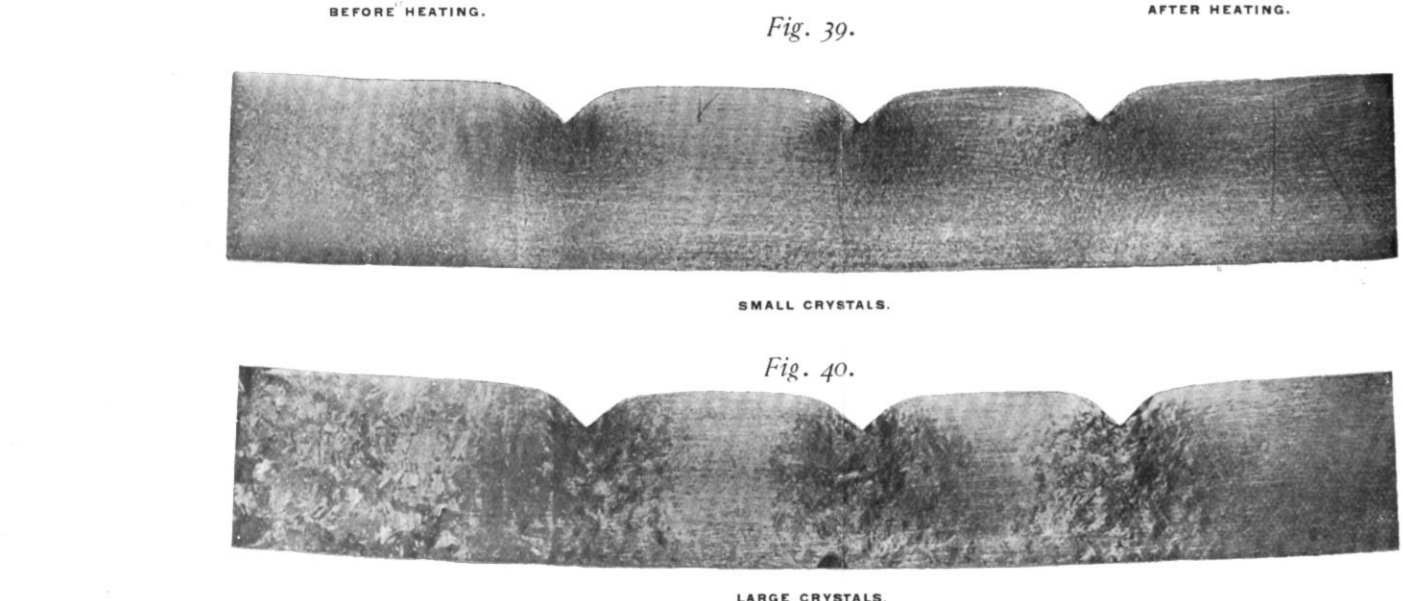
Figs. 39 and 40, Plate 5, show the hardness test-pieces of copper-aluminium alloy. It will be observed that the effect of the pressure has been to force the crystals out at the side of the test-piece, this being very marked in Fig. 40.

MAGNIFICATION.
FIGS. 25, 26, 39 AND 40,
4 DIAMETERS.
FIGS. 27-37, 41 AND 42,
2 DIAMETERS.

COPPER-ALUMINIUM ALLOY, ROLLED ROD. INDENTATION TEST PIECES.

Riveting Copper and Copper Alloys, etc., in Copper Plates.—On examining the leaky stays of the copper-zinc alloy, which during their life had been drilled and drifted, it was not possible to say whether the cracks at the bases of the threads were caused by the original riveting or by the subsequent drifting. With a view to ascertain the effect due to riveting alone, stays of each kind of metal, Nos. 1, 3, 4 and 5, were prepared in the ordinary way and were riveted into a piece of copper fire-box plate. They were then cut from the plate with the copper surrounding the threads, sectioned longitudinally, polished and etched (*Figs. 27-30, Plate 5*). It will be observed that the copper stay is the

only one of the four that has made a really good joint; each of the others distinctly shows imperfect contact between the threads of the stay and the plate. In fact, when the specimens were cut in two, the copper plate fell away from three specimens (Figs. 28-30), but remained fast in the other (Fig. 27). The riveting did not produce any marked change in the structure of the alloys.

These tests show that, except in the copper stay, the effect of riveting has been to expand the hole in the copper plate at the base, and also to damage the plate under the riveted head. Seeing, however, that the above results had not been obtained in actual practice, further specimens of Nos. 1, 2, 3, 4 and 5 were prepared, screwed into position in a fire-box, and riveted up in both plates: all done exactly in accordance with the Author's usual practice. They were cut out, with the copper or steel plate surrounding the threads, and were sectioned longitudinally, polished and etched (Figs. 31-35, Plate 5). The results undoubtedly point in the same direction as the preliminary tests, although the copper stay in Fig. 31 is not nearly as good a fit as that in Fig. 27: it is certainly, however, the best result of this series. Fig. 36 shows a bad joint made by using a stay with defective threads. Fig. 37 shows a joint made by the copper-zinc alloy in the steel plate.

Fig. 41 is a section of a copper stay—selected at random—cut from a fire-box after 7 years' service; and although the head is much wasted, the joint is very good. Fig. 42 is a steel stay from the same fire-box after 12 years' service; the threads are almost corroded away, and their holding power must have been practically nil, the space between the threads being filled with corroded metal and boiler-scale, which were responsible for the joint. Fig. 43 is a copper stay from another boiler, cut from both plates after 8 years' service; although the joint is not as good as that shown in Fig. 41, it is satisfactory.
