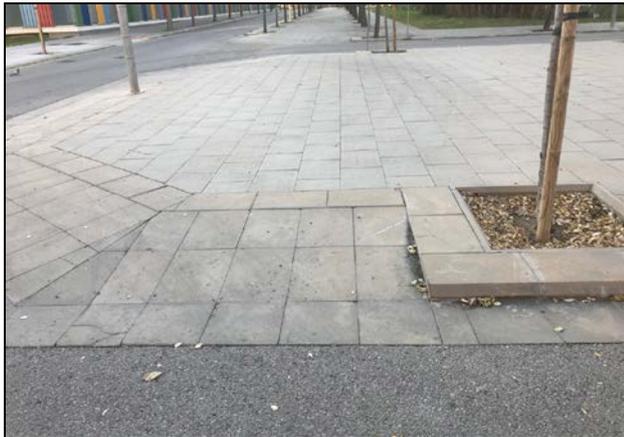
Figure 5. Curb ramp scenario.

4.1.1 Curb ramp: As a first test case study, we have selected a single pavement structure that contains two elements of interest from the accessibility point of view, a curb ramp and a step (Figure 5). The structure is located in an area with good GNSS constellation visibility.

The curb ramp model was generated with the two smartphones: the iPhone 4S (iP4S) and the iPhone 7 (iP7). In order to adjust the scale, the measures of a square tile belonging to the rig were used. In this test, we checked the horizontal, and the vertical dimensions of the curb ramp as well as the dimensions and angles of some inclined elements. In Figure 7, one of the generated point cloud together with the elements of interest are presented.

To conclude this section, just to note that curb ramp technical characteristics are in compliance with the Catalan and Spanish regulations (Table 1), so the element can be tagged as adequate.

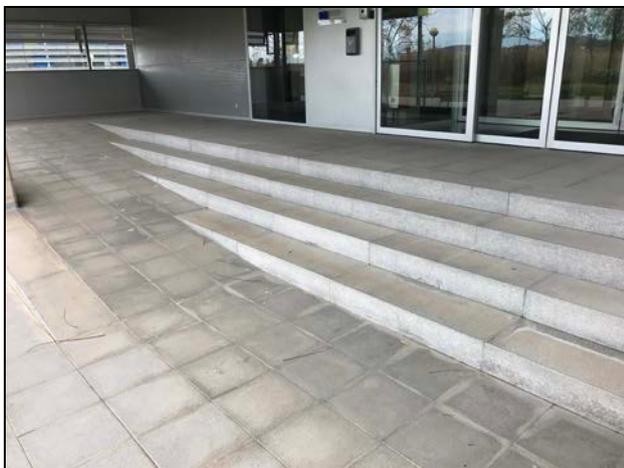
Figure 6. Stairs and ramp scenario.

4.1.2 Stairs and ramp: As a second test case study, we have selected a structure with four stairs and a long ramp (Figure 6). The structure is located in an area with poor GNSS constellation visibility.

The stairs and ramp models were generated with just one smartphone: the iPhone 7 (iP7). In order to adjust the scale, the measures of a square tile belonging to the ramp were used. In this test, we checked the horizontal and vertical dimensions of the steps as well as the slope of the ramp. In Figure 8, one of the generated point clouds together with the elements of interest are presented.

For the stairs and ramp case, the step height is slightly higher than the ones specified in the Catalan and Spanish regulations. The ramp slope is in compliance with the Catalan regulation but it is slightly higher than the Spanish upper limit. In addition, the usable pass width is not in compliance with the Catalan regulation. For this case, both ramp and stair could be tagged as moderate in terms of accessibility according to the Catalan and Spanish regulations.

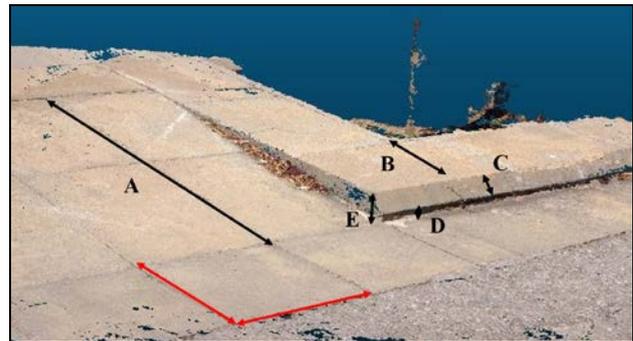
Figure 7. Curb ramp scenario. 3D reconstructed point cloud along with reference targets. The measurements used to compute the point cloud are represented in red, while the reference measurements used to check the relative accuracy of the point cloud are represented in black.

First test intends to analyse the impact of using a pre-calibrated camera or to calibrate it during the adjustment. This test was done with full set of images acquired using iP7 camera. In Table 2 and Table 3, the results of this test are presented. It can be seen that there is no impact either on the computed measures or on the calibration values. It can also be seen that the results completely fulfil the accessibility map requirements, since all the errors in distances are below 1 cm.

Manual meas. (cm)	iP7 pre meas. (cm)	iP7 pre diff. (cm)	iP7 self meas. (cm)	iP7 self diff. (cm)
Horizontal measurements					
A	120	120.36	0.36	120.36	0.36
B	35	34.75	0.25	34.75	0.25
Vertical measurements					
C	7	6.84	0.16	6.84	0.16
D	2	1.87	0.13	1.87	0.13
E	7	6.92	0.08	6.92	0.08

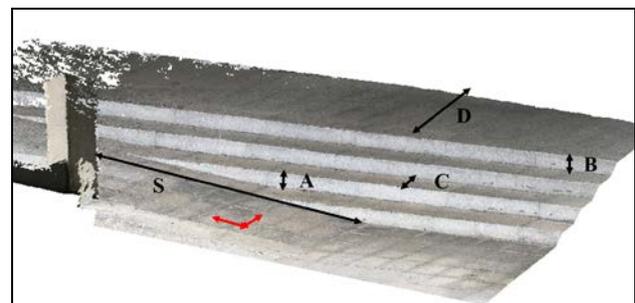
Figure 8. Stairs and ramp scenario. 3D reconstructed point cloud along with reference targets. The measurements used to compute the point cloud are represented in red, while the reference measurements used to check the relative accuracy of the point cloud are represented in black.

Again, first test of this scenario intends to analyse the impact of using a pre-calibrated camera or calibration during the adjustment. This test was done with full set of images from iP7. In Table 8, the results of this test are presented. It can be seen that there is no impact on the computed measures. It can also be seen that the results completely fulfil the accessibility map requirements, since all the errors in distances are below 1cm.

Manual meas. (cm)	iP7 pre meas. (cm)	iP7 pre diff. (cm)	iP7 self meas. (cm)	iP7 self diff. (cm)
Horizontal measurements					
A	160	159.99	-0.01	160.18	0.18
B	36.5	36.62	0.12	36.43	-0.07
Vertical measurements					
C	18	17.10	0.90	17.20	-0.80
D	17.5	16.66	0.83	16.75	-0.75
