## Remote analysis of an open-pit slope failure: Las Cruces case study, Spain

# Remote analysis of an open-pit slope failure: Las Cruces case study, Spain

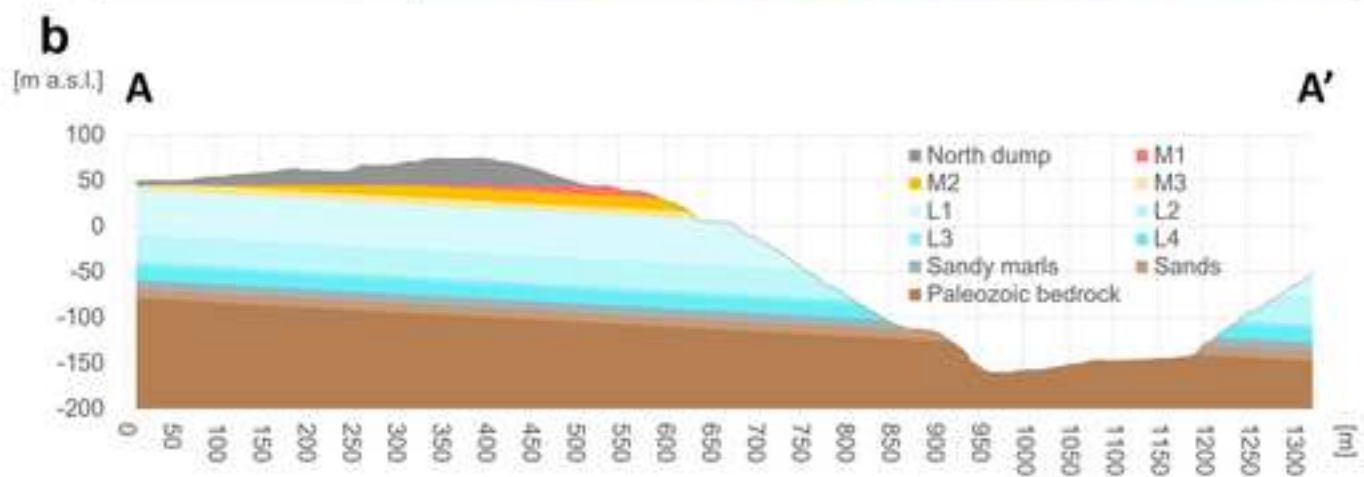
6  
7 **Fig. 2** Pre-failure scenario. **a** Orthoimage (Instituto Geográfico Nacional 2019) and layout of Las Cruces  
8 open-pit mine (adapted from First Quantum Minerals Ltd. 2015). Black line: cross-section profile trace.  
9 White box: photogrammetry processing spatial extent. White dashed box: 3D geo-mechanical modeling  
10 spatial extent. **b** Cross-section of the north slope and lithostratigraphic sequence (adapted from Montero et  
11 al. 2009, Cooper et al. 2011 and First Quantum Minerals Ltd. 2015)

On the other hand, a pre-failure orthoimage (Figs. 2a and 3a) and a set of ten quasi-vertical single-frame aerial images (1 m resolution) covering the study area, both of them corresponding to February 2016, were downloaded from Instituto Geográfico Nacional (2019) as well. Finally, a pre-failure DEM (Figs. 5 and 6), corresponding to February 2016, was obtained by processing those ten single-frame aerial images also using the software Agisoft Photoscan Pro. Again, no camera positions were available so the GCPs used for referencing the post-failure DEM were also placed on the model, including an additional in-pit GCP placed on the bottom of the pit to ensure a reliable photogrammetric processing result in the vertical direction.

The simplified 3D stability analysis was performed as follows. For the geometry of the study area, we used the pre-failure DEM considering a box of size 1,860 m x 2,200 m centering the open pit (white dashed box in Fig. 2). For the materials, a unique homogeneous material was considered, corresponding to the Blue Marls. Averaged material properties (unit weight  $\gamma = 15$  kNm<sup>-3</sup>,  $\Phi = 20^\circ$ ,  $c = 250$  kPa,) were adopted. For the boundary conditions, displacements were fixed in the bottom plane, located ~300 m below the surface. Perpendicular displacements were also fixed in the side planes and a pore-water pressure value of 0 kPa was prescribed on the surface (saturated condition). For the applied external load, only gravity force was contemplated. The 3D finite element mesh, composed by 227,202 nodes and 149,325 quadratic tetrahedral elements (10 nodes per element), and the adopted hydrostatic pore pressure contours are depicted in Fig. 8. The performed 3D stability analysis is shown in Fig. 9.

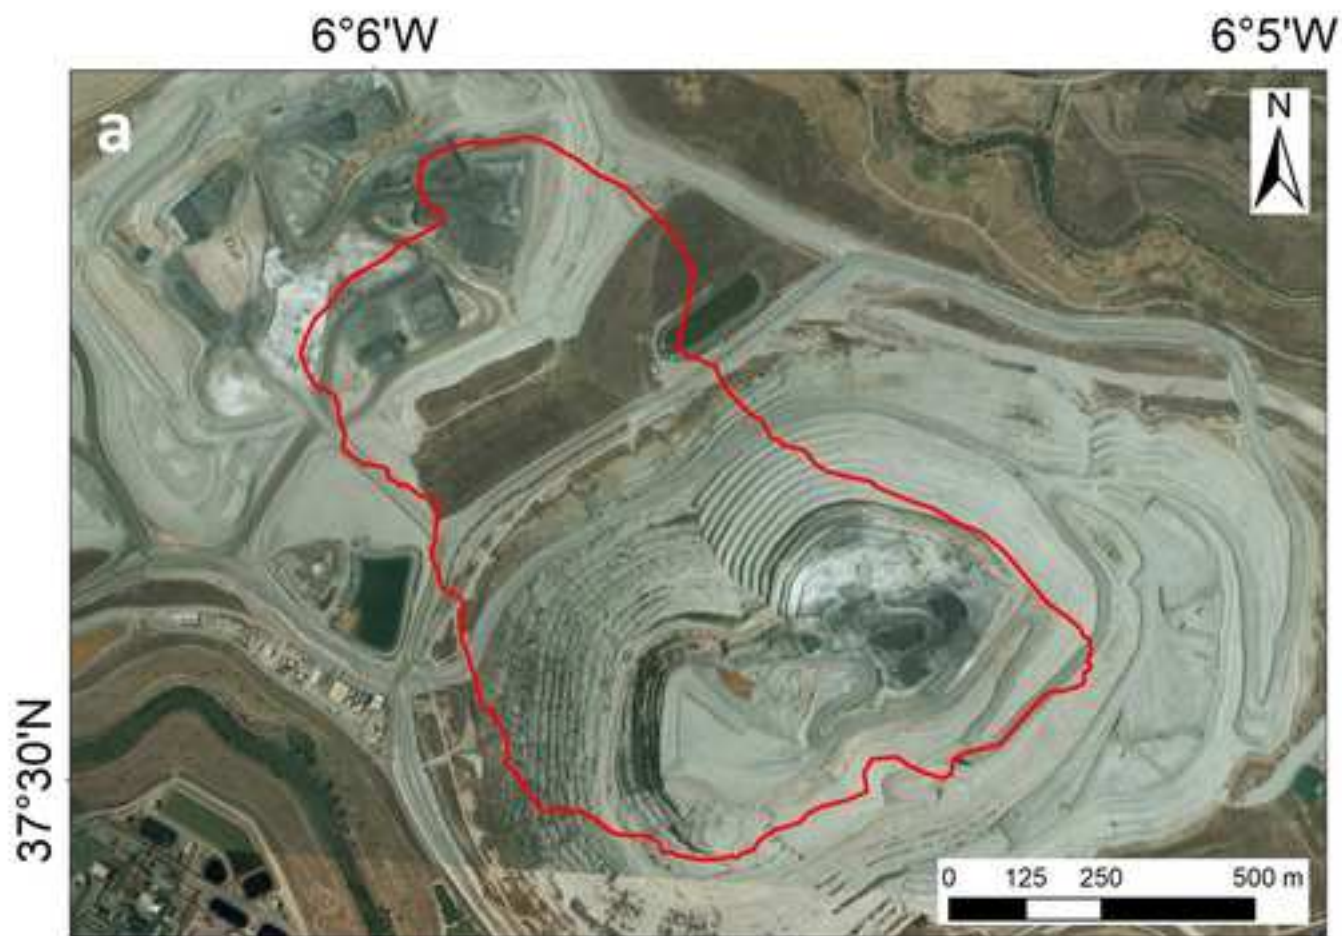
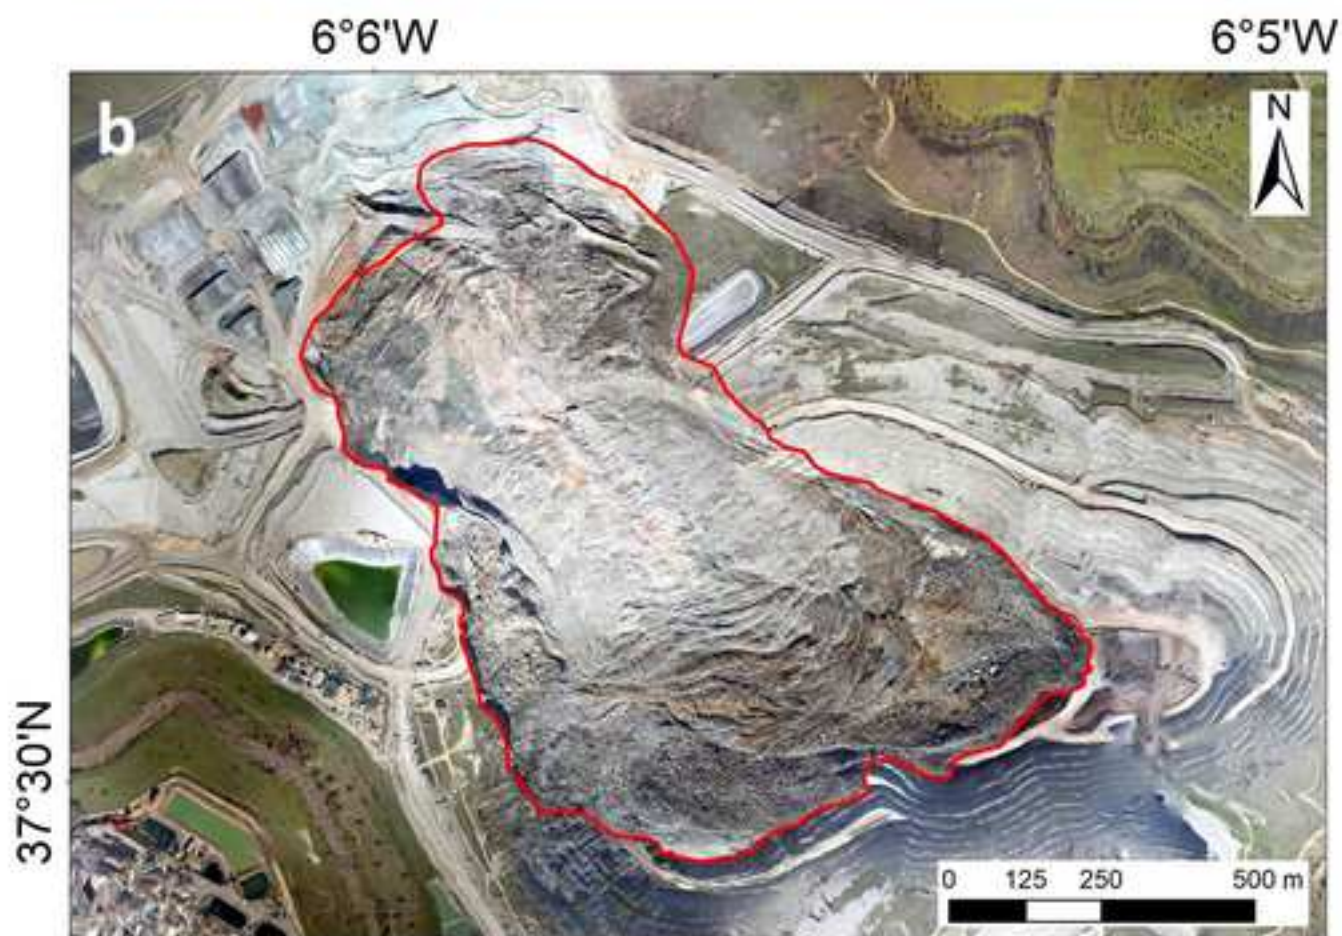
12  
13 **Fig. 3** Orthoimages of the failure area. **a** Pre-  
14 failure orthoimage (Instituto Geográfico Nacional  
15 2019) from February 2016. **b** Post-failure  
16 orthoimage from January 2019

Immediately after the failure, the available literature was collected, as well as data on orthoimages, topography, geology, hydrogeology and geotechnical properties of the materials involved. Fig. 3 shows two orthoimages of the study area before and after the failure.

A post-failure orthoimage (Fig. 3b), corresponding to January 2019, was obtained through the application of SfM techniques. A set of 204 photos (resolution of 3,840 x 2,160 pixels) was processed using the software Agisoft Photoscan Pro (Agisoft LLC 2018). The photos were taken on 25 January 2019 (i.e. 2 days after the failure) from a private helicopter with a conventional digital camera for visual inspection purposes. As no camera positions were available for the images, five GCPs were extracted from a 2013 Aerial Laser Scanning (ALS) point cloud and placed on the model. The 2013 ALS point cloud was directly downloaded from Instituto Geográfico Nacional (2019). Due to the presence of the moving mass, no GCPs could be placed inside the pit. GCPs in areas not affected by the mining operation were selected for referencing only. Additionally, a post-failure DEM (Fig. 4), corresponding to January 2019, was also obtained by processing these 204 photos.

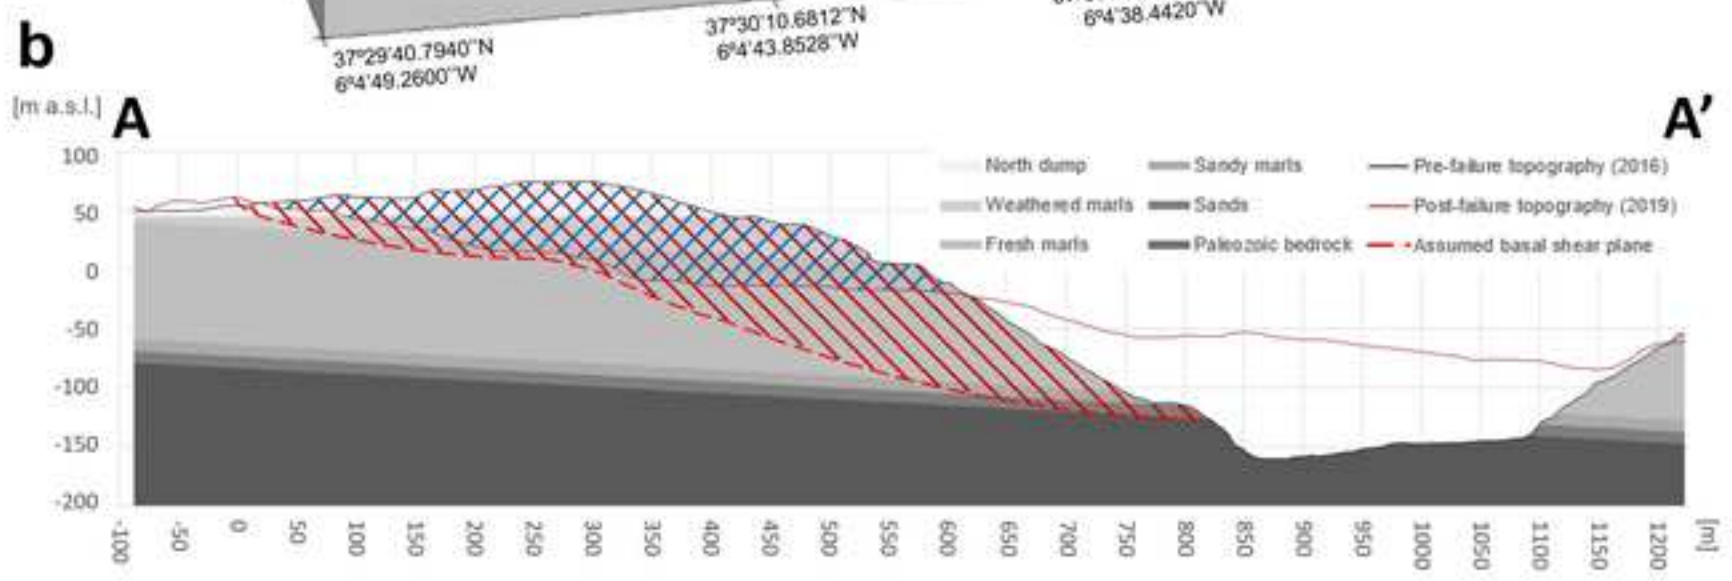
17  
18 **Fig. 4** Post-failure scenario. **a** Detail of the slope failure and main geomorphic features. White line: cross-  
19 section profile trace. **b** Cross-section of the north slope and main lithostratigraphic units. Blue line fill  
20 pattern: initial moving mass volume estimate. Red line fill pattern: refined moving mass volume estimate

The external boundaries of the slope failure (Figs. 3 and 4) were defined by photointerpretation using the pre- and post-failure orthoimages. The source area for the initial estimation of the moving mass volume was obtained by selecting the negative elevation change values (red to yellow area in Fig. 4a and blue line fill pattern in Fig. 4b). The elevation change was calculated as the difference between the post- and pre-failure DEMs, and the initial volume estimate was calculated as the mean elevation difference within the source area multiplied by its surface area. Then, the geometry of the basal shear plane (red dashed line in Fig. 4b) was deduced by comparing the two DEMs and taking into account the lithological profile of the open pit. The initial estimation of the overall volume of the instability was further refined by considering this basal shear plane profile. In order to do this, a smooth theoretical 3D shear surface was derived from both the basal shear plane profile and the external boundary of the failure using Inverse Distance Weighting interpolation. The source area for the refined volume estimate was delimited by selecting the pixels where the difference between the theoretical 3D shear surface and the pre-failure DEM was negative (red line fill pattern in Fig. 4b). The refined volume estimate was calculated as the mean of this differential value within the recomputed source area multiplied by its surface area.

46 The post-failure orthoimage (Fig. 3b) was used to conduct, along with the pre- and post-failure DEMs, a  
47 detailed geomorphic analysis of the landslide (Fig. 4). We classify the slope failure as a complex movement  
48 (Varnes 1978) with a well-defined exposed shear plane clearly present in the post-failure DEM (Fig. 4a),  
49 which suggests a primary failure initiated somewhere near the north dump barrier berm triggering  
50 subsequent failures towards the dump. The entire moving mass consists of two distinct parts: (i) an upper  
51 part with the typical features of a rotational landslide such as head scarp, secondary scarps and sagged  
52 crown; and (ii) a mudflow-earthflow lower part, with debris on the frontal section. The external boundaries  
53 of the slope failure (red lines in Figs. 3 and 4a) were used to determine the landslide surface area (785,000  
54 m<sup>2</sup>). Then, the obtained pre- and post-failure DEMs were used to estimate failure volumes. The post-failure

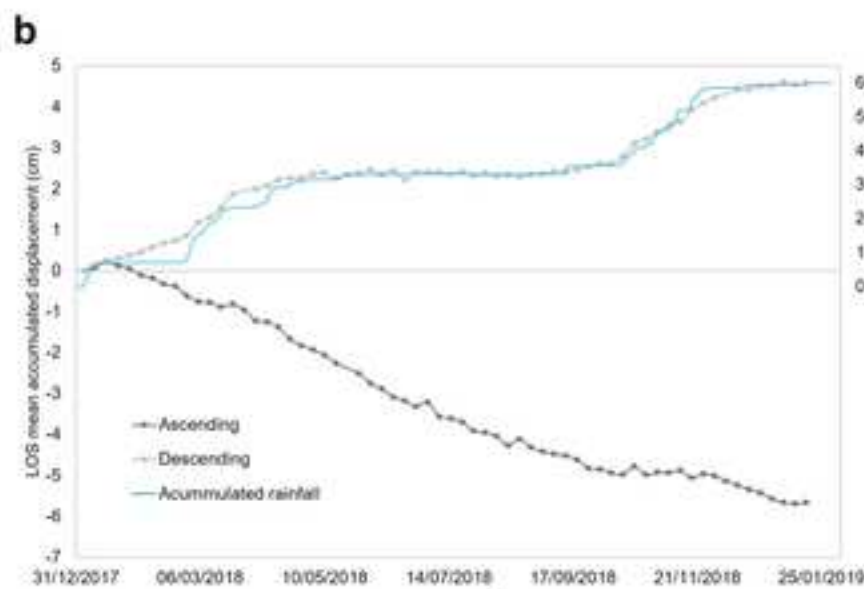
24  
25 **Fig. 6** Mean LOS displacement time series for the year prior to the failure (from January 2018 to January  
26 2019). **a** Mapped areas. **b** Accumulated displacements over the north slope. **c** Mean velocities over the  
27 mapped areas. Accumulated displacements over the **d** processing plant, **e** south dump, **f** north dump 1 and  
28 **g** north dump 2

Area	LOS mean velocity (cm/year)	
	Ascending	Descending
Processing plant	-0.1	0
North slope	-6.2	3.7
South dump	-8.3	-5.9
North dump 1	-7.1	-4.5
North dump 2	-5.6	-4.1

46 coefficient 99%), coinciding with two rainfall episodes from early January to late April 2018 and from early  
47 September to late December 2018 (Agencia Estatal de Meteorología 2019). On the contrary, the  
48 acceleration event revealed by the ascending results in the north slope, slightly delayed with respect to the  
49 last acceleration event observed in descending geometry, show a slightly worse correlation with rainfall  
50 (Pearson coefficient 90%). To conclude, in the south and north dumps, the results show an even lower  
51 correlation with rainfall (Pearson coefficient between 64 and 83%).

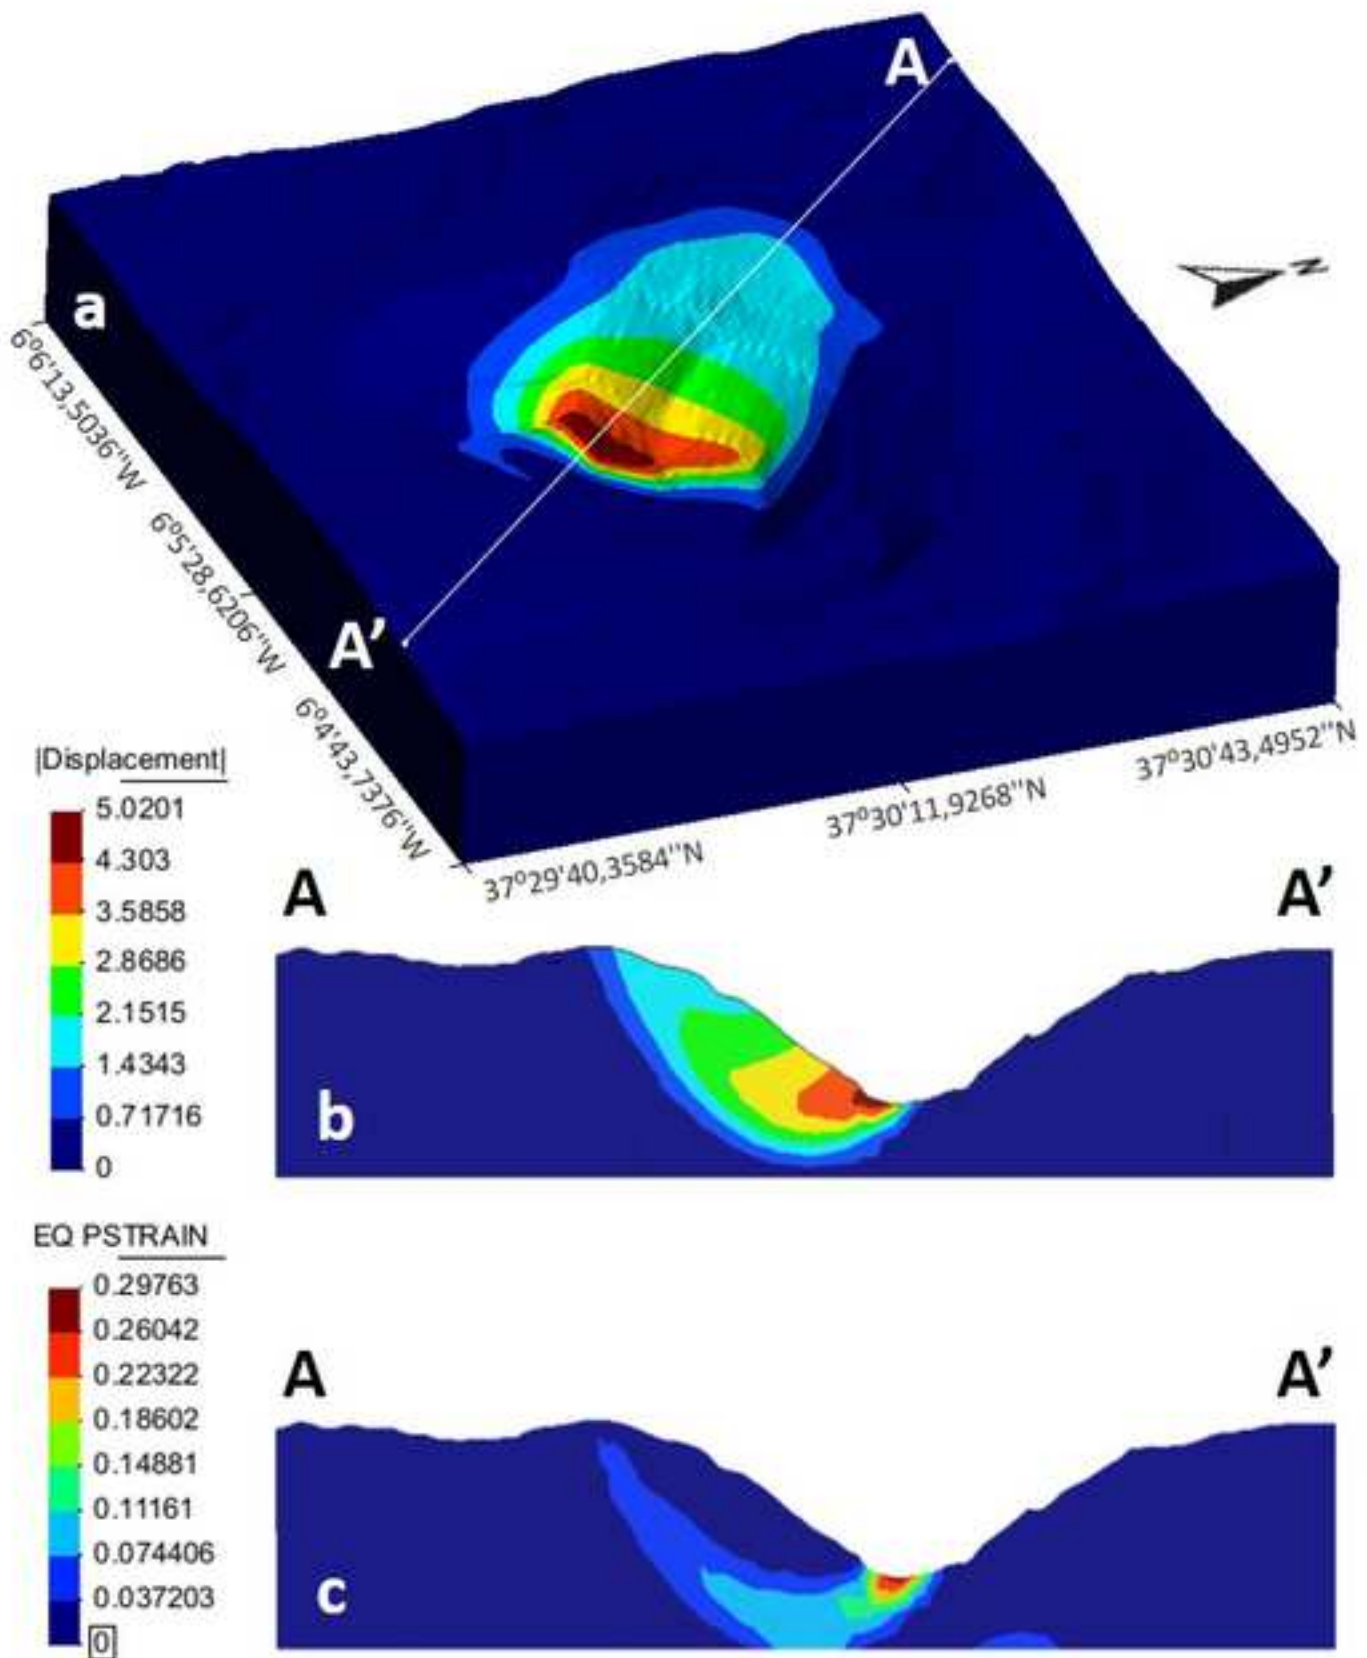
38  
39 **Fig. 9** 3D stability analysis: failure mechanism for the computed Safety Factor  $SF = 1.20$ . **a** Displacement  
40 contours (in m) at failure. **b** Cross-section of the displacement contours at failure (in m). **c** Cross-section of  
41 the equivalent plastic strain contours at failure. White line: cross-sections profile trace

The results of the 3D stability analysis are illustrated in Fig. 9. The 3D stability analysis results in a  $SF$  equal to 1.20, which indicates that all the open-pit slopes are stable for that particular configuration. However, the computed critical slope is located in the northwest side of the open pit, i.e. in the north slope. The computed failure source area (light blue polygon in Fig. 9a) is estimated at 314,000 m<sup>2</sup>.

13 would contribute to create a more unstable modeling scenario, has not been considered in the present  
14 analysis. Anyway, the computed failure mechanisms in 3D and 2D are similar (Figs. 9 and 13), although  
15 the displacement contours in the three 2D cases in peak conditions show a slightly different geometry.
