### **Sensors for Monitoring Corrosion of Steel Embedded in Concrete**

This paper presents the use of an innovative low cost sensor for monitoring corrosion of steel members embedded in concrete. Corrosion of steel reinforcing bars or embedded steel in concrete structural components is a major concern for structures such as bridges and parking garages. Moisture and chloride ingress through the cracks is the primary reason for corrosion of such concrete structures. The chloride and moisture levels significantly affect the electrical conductivity of concrete. A low cost sensor for measuring concrete resistivity (or conductivity) was developed by researchers at West Virginia University. This sensor is very durable and can be embedded in concrete members (beams, columns, etc.) at the time of pouring concrete. The electrical resistivity measurement obtained using this sensor can be used to evaluate the potential for corrosion of embedded steel. This paper presents laboratory and field results obtained using the sensor to demonstrate its usefulness. The paper also highlights the simplicity and ease of use of this sensor. In addition, the paper also discusses the use of a commercially av

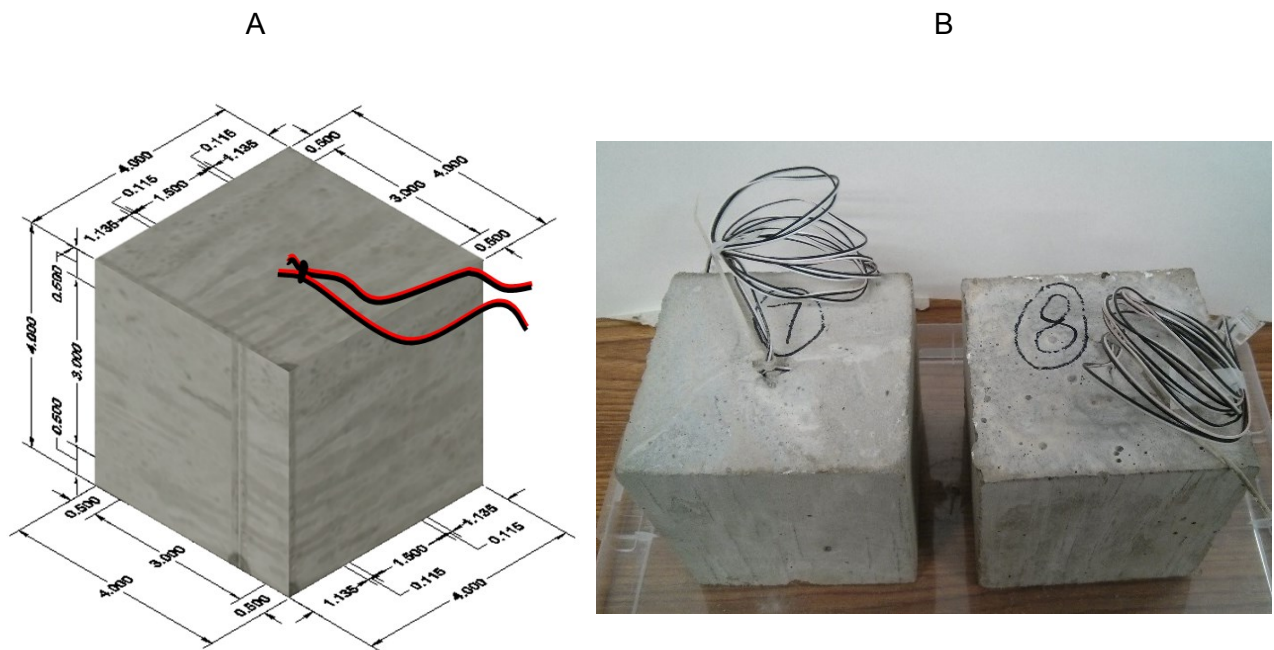
**Figure 2: A) Model of the electrical resistivity sensor (dimensions in inches) and B) actual sensors for laboratory testing**

The electrical resistivity sensor developed in this study comprises of two parallel plain carbon (A36) steel plates embedded within a 4"x4"x4" (101.60x101.60x101.60mm) concrete cube. The steel plates were spaced at 1.50" (38.10mm). The size of the concrete cube ensures concrete cover of 1.135" (28.83mm) is provided on both sides of the steel plate assembly and 0.50" (12.70mm) of concrete cover on the other four sides perpendicular to the plate thickness. The cubes were produced using fast-setting concrete mix with a 28 day strength of 31MPa (4500psi). Aggregates in the mix were measured and found to have sizes between 9mm and 14mm. The steel plates used were 3"x3" (76.20x76.20mm) with 0.115" (2.92mm) thickness. The geometry of the designed sensor is shown in Figure 1: A. The sensor also had electrical wires connecting to the plates for resistance measurements as shown in Figure 1: B. A model of the sensor, and a picture of the sensors produced in the lab is shown in Figure 2 (patent application is in progress).

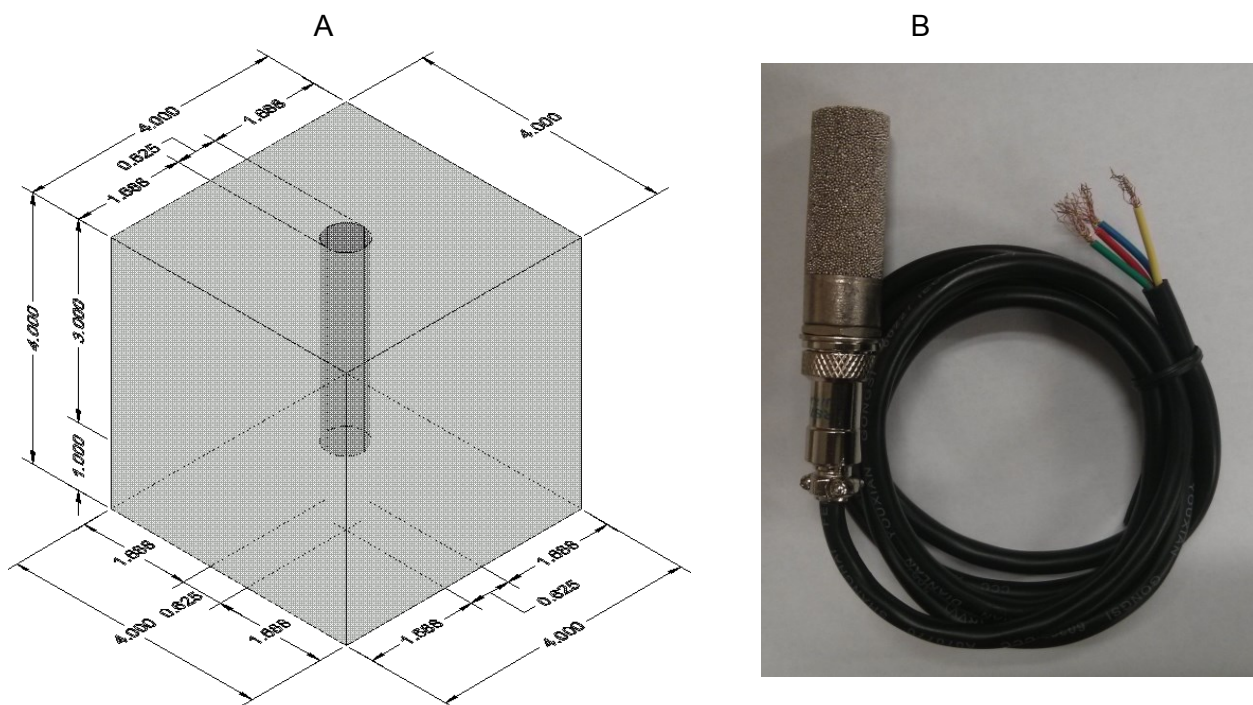
**Figure 3: A) Geometry of cube for temperature/humidity sensor (dimensions in inches) and B) Temperature/Humidity sensor**

The temperature/humidity sensor system was produced by installing commercially available sensor in pre-cured 4"x4"x4" (101.60x101.60x101.60mm) concrete cube with 5/8" (15.875mm) diameter and 3" (76.20mm) deep hole at the top with 1" (25.40mm) concrete cover at the bottom (Figure 3: A). The sensor is shown in Figure 3: B.

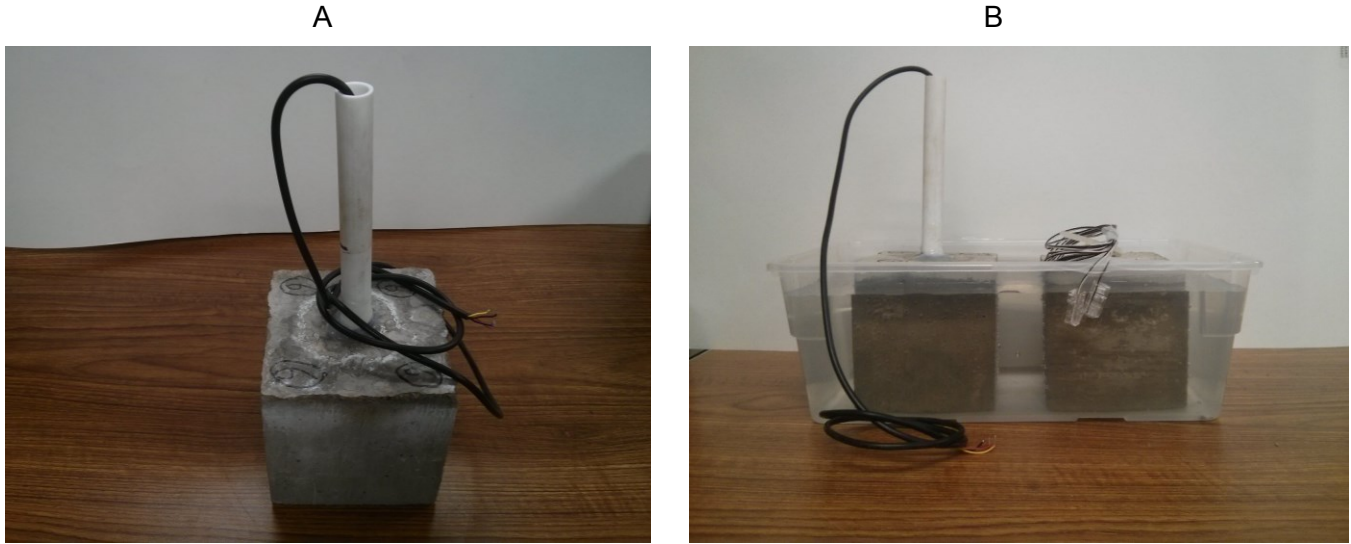
**Figure 4: A) Final temperature/humidity sensor assembly and B) soaked sensors**

The sensor was installed in the cube along with a plastic tube (on the top portion of the hole) to bring the wire out. The area around the wire (inside the plastic tube) was sealed up to prevent water and wet concrete from entering the hole through the opening. This ensures that moisture only gets to the sensor through the concrete pores and prevents the sensors from being damaged by wet concrete when installed in the field during construction or rehabilitation. Figure 4: A shows the completed sensor assembly.

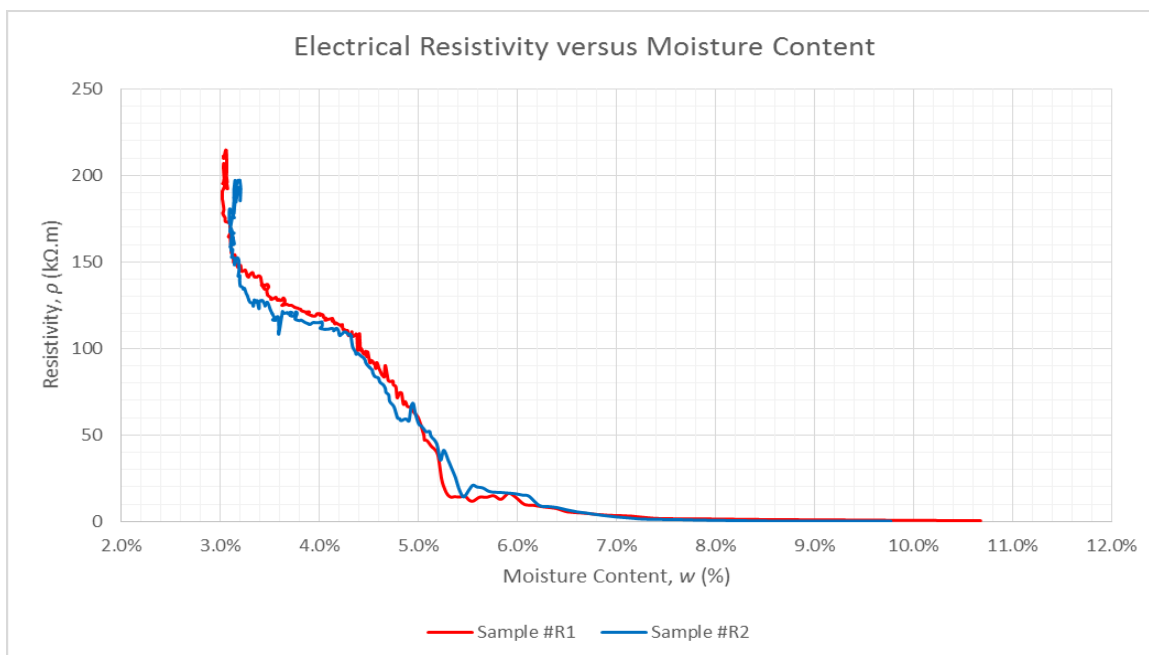
**Figure 5: Variation of concrete electrical resistivity with moisture content**

The variation of electrical resistivity values for the two sensors were observed to be consistent with each other over the course of one year.<sup>7</sup> The variation of concrete electrical resistivity with moisture content is shown in Figure 5.

Figure 5 shows two distinct regions, a low electrical resistivity region with a low slope above 5.5% moisture content and a high electrical resistivity region with a significantly higher slope below 5.5% moisture content. In the latter region, the connectivity between water molecules in the concrete pores is lost, thus leading to a steep electrical resistivity curve.

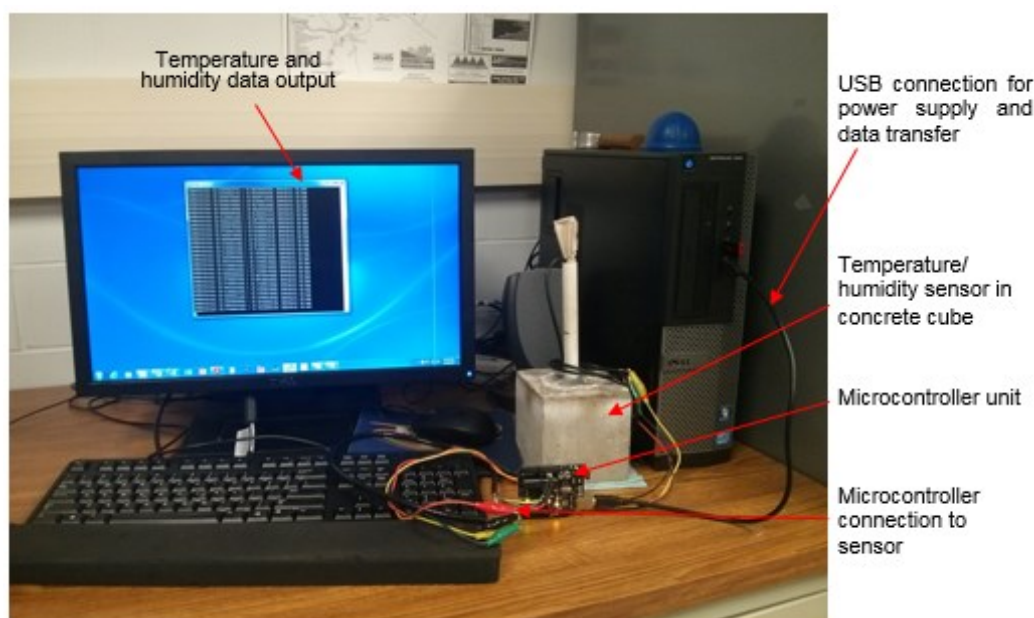
**Figure 6: Data collection set-up for temperature/humidity sensor**

Similar to samples R1 and R2, the sample T-H1 (encasing the temperature/humidity sensor) was also soaked in water for two weeks and then allowed to dry in the laboratory. During the lab drying period, the sensor was monitored for weight, temperature and humidity variations for 368 days. A microcontroller unit was used, along with a computer, for obtaining data from the temperature/humidity sensor (Figure 6).

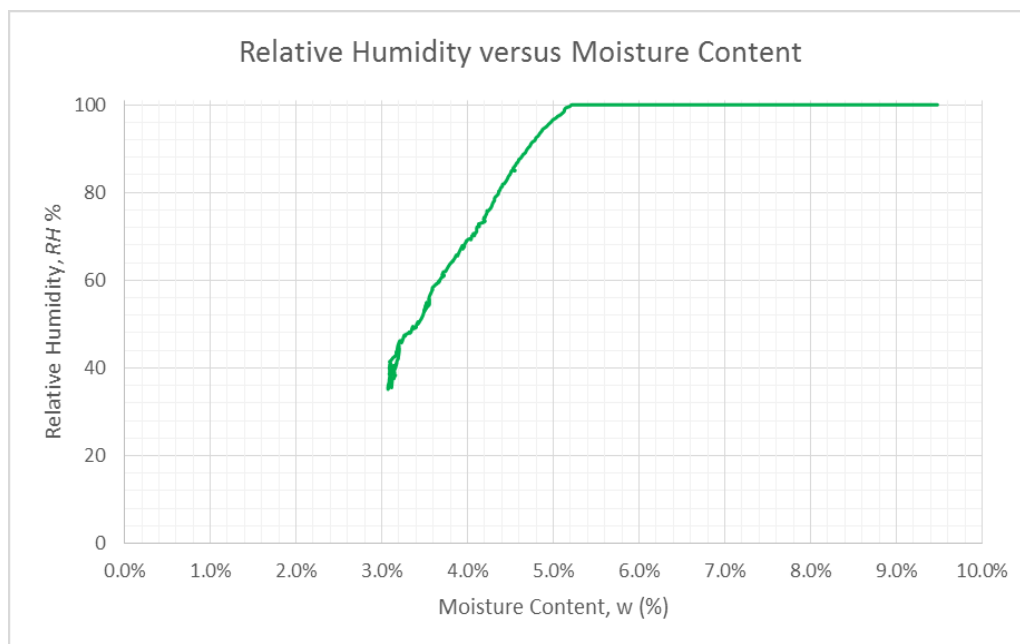
**Figure 7: Variation of relative humidity with moisture content**

The variation of relative humidity within the sample with moisture content is shown in Figure 7. Equation (2) was used for computing moisture content of the cube.

The relative humidity remained constant at 99.99% level when the concrete was saturated till the moisture content dropped below 5.3%, and then decreased gradually at a constant rate to 3.2% moisture content as shown in Figure 7.

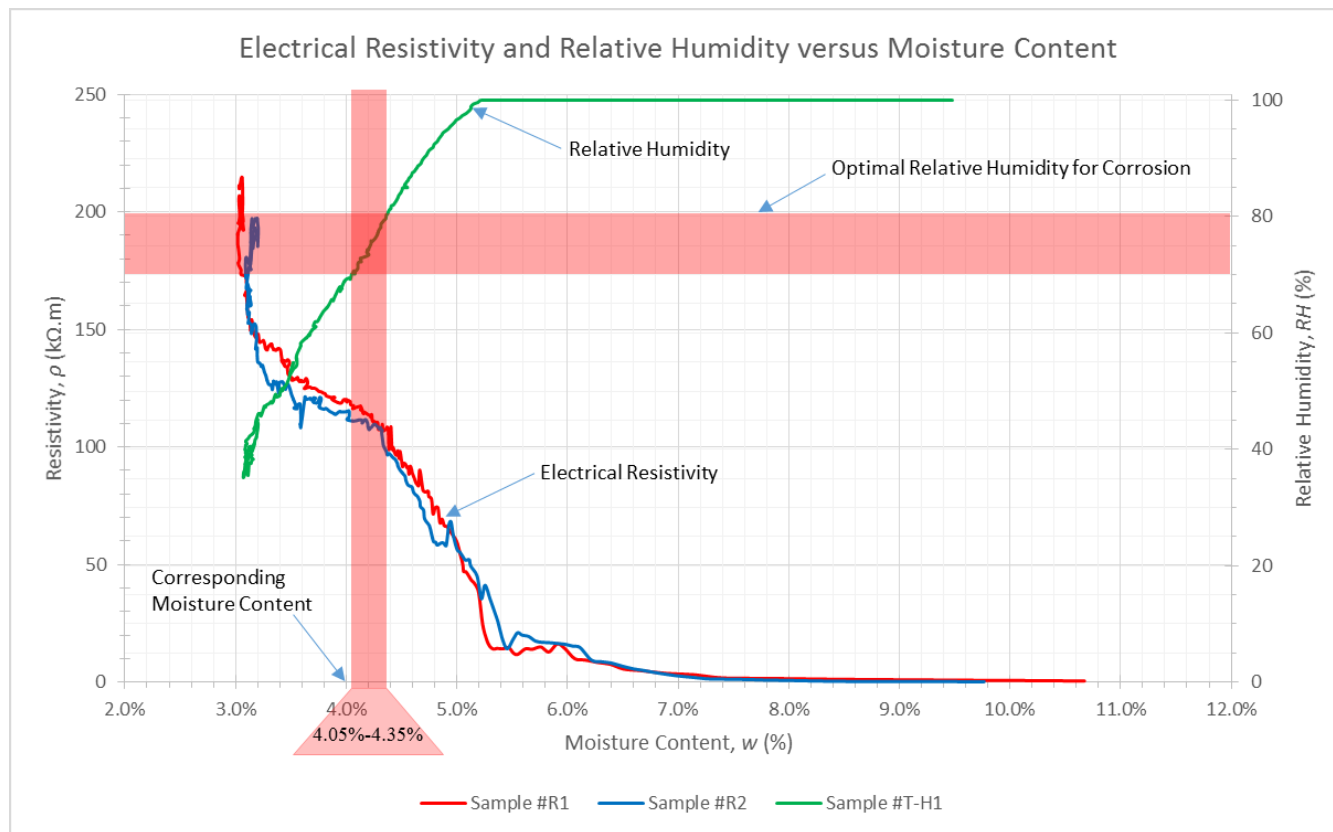
**Figure 8: Calibration curve for corrosion data interpretation**

The likelihood of corrosion is very high when the relative humidity is between 70-80% and the concrete resistivity is below 0.2kΩ.m but minimal for all other conditions. The likelihood of corrosion is much lower when the relative humidity and concrete resistivity values are away from the optimal ranges. The above observations are shown in Figure 8.

Thus, there is a high potential for corrosion of the embedded steel if low resistivity values below  $0.2\text{k}\Omega\cdot\text{m}$  is observed at the time when the relative humidity within the concrete is between 70-80% (moisture content of the concrete is around 4%). Infiltration of chlorides into concrete can significantly lower the electrical resistivity value of concrete and increase the potential for corrosion of the embedded steel.

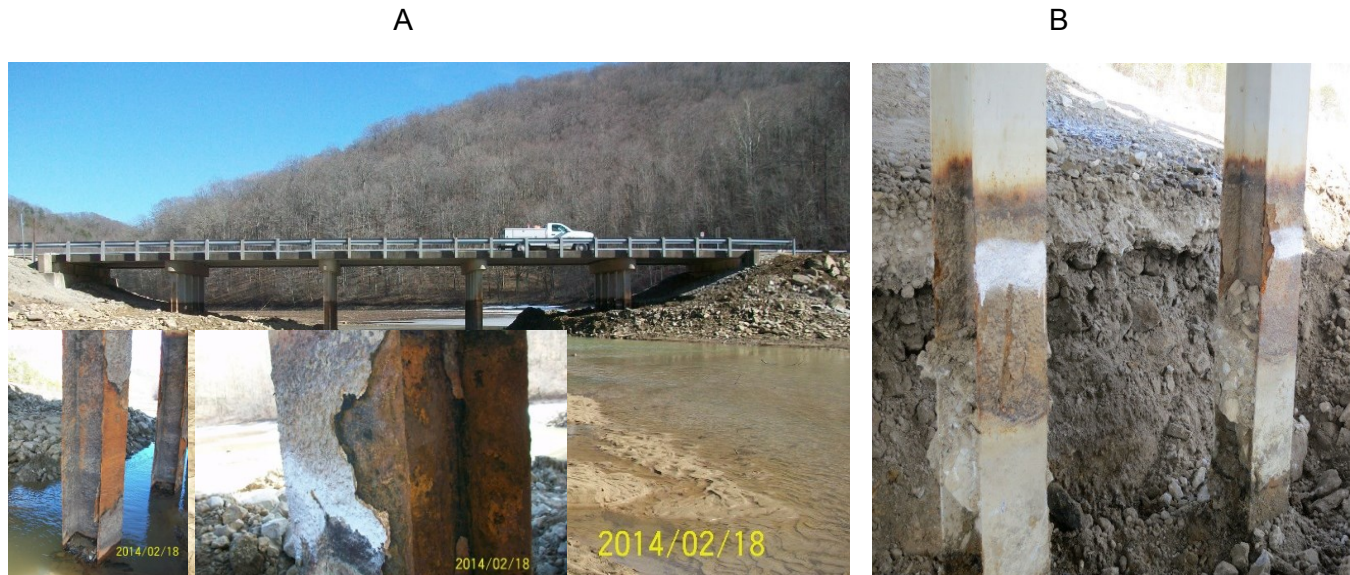
**Figure 9: A) East Lynn Lake Bridge before rehabilitation and B) submerged portion of piles free from corrosion damage**

Figure 9: A shows the bridge prior to the rehabilitation work. The portion of the steel H-piles above the permanent water level got corroded over time due to seasonal rise and fall in the water levels, resulting in section loss of the steel up to 50%. The capacity of the bridge was thus reduced, resulting in load rating of 6 tons (the original rating was around 15 tons), with one lane closure and maximum speed reduced to 10 mph.<sup>14</sup>

The portion of the steel H-piles about 1 foot below the ground surface was sound and free from corrosion (Figure 9: B). This was observed after 3 feet deep trenches were dug around the piles to expose the portion beneath the ground surface. This portion of the piles did not corrode because it was permanently submerged under water and there was no oxygen available to promote corrosion reaction.

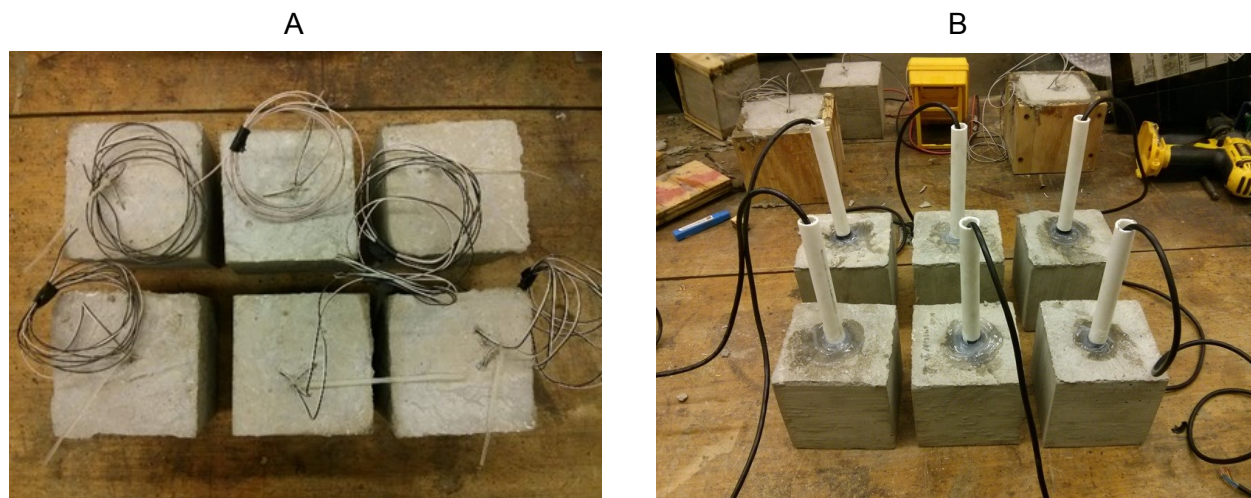
**Figure 10: A) Electrical resistivity sensors and B) temperature/humidity sensors**

Before the FRP shells were installed, six electrical resistivity sensors and six temperature/humidity sensors (Figure 10) were attached to the surface of the steel piles (in the corroded portion) to enable nondestructive monitoring of further corrosion potential after rehabilitation. Two sensors of each type were attached to three steel piles. In addition, two temperature/humidity sensors were placed outside in a location under the bridge to measure the ambient temperature/humidity. The sensors were wired and connected to a central monitoring board, which can house a data acquisition unit if needed. Figure 11: A shows the sensors attached to a steel pile. The rehabilitation of the 20 piles (columns) of the bridge was completed in 3 weeks during March 2014, which brought the bridge back to the original design capacity at 25% of conventional construction cost for the bridge.<sup>14</sup> Figure 11: B shows the bridge after rehabilitation, together with the pile identification labels used for data interpretation.

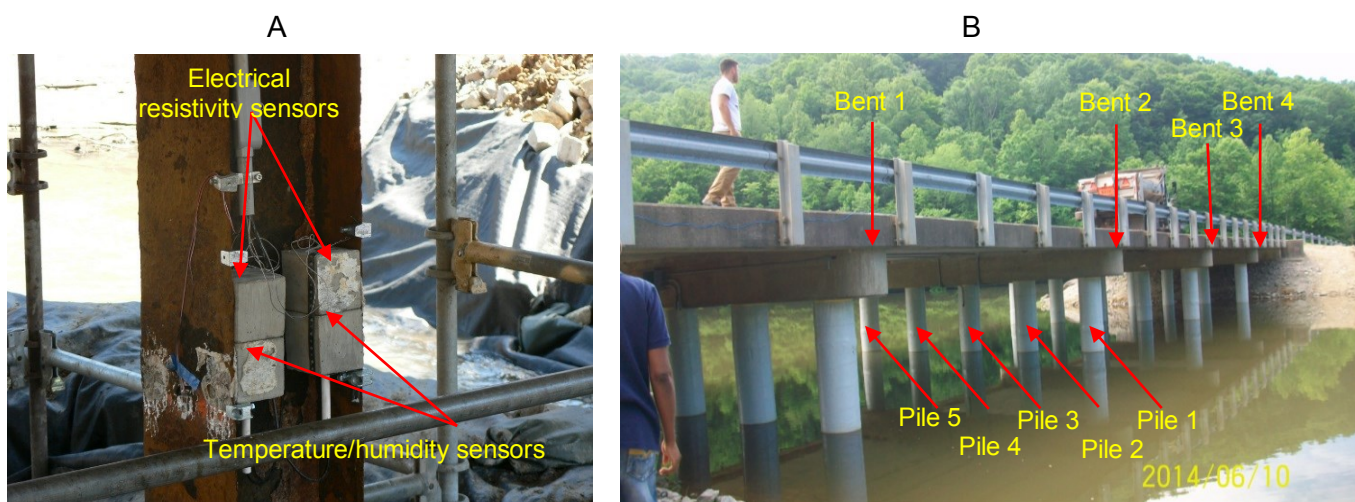
**Figure 11: A) Electrical resistivity and temperature/humidity sensors installed in the field and B) East Lynn Lake Bridge after rehabilitation, showing pile identification labels**

The sensors were installed in three of the piles (Pile 3 in Bent 1, and Piles 3 and 4 in Bent 2). The three piles had two sensors of each type (electrical resistivity, and temperature/humidity), placed in the
