DELIVERABLE REPORT

DETAILED SURVEY OF THE REAL PILOT

e-SAFE

Energy and Seismic Affordable rEnovation solutions

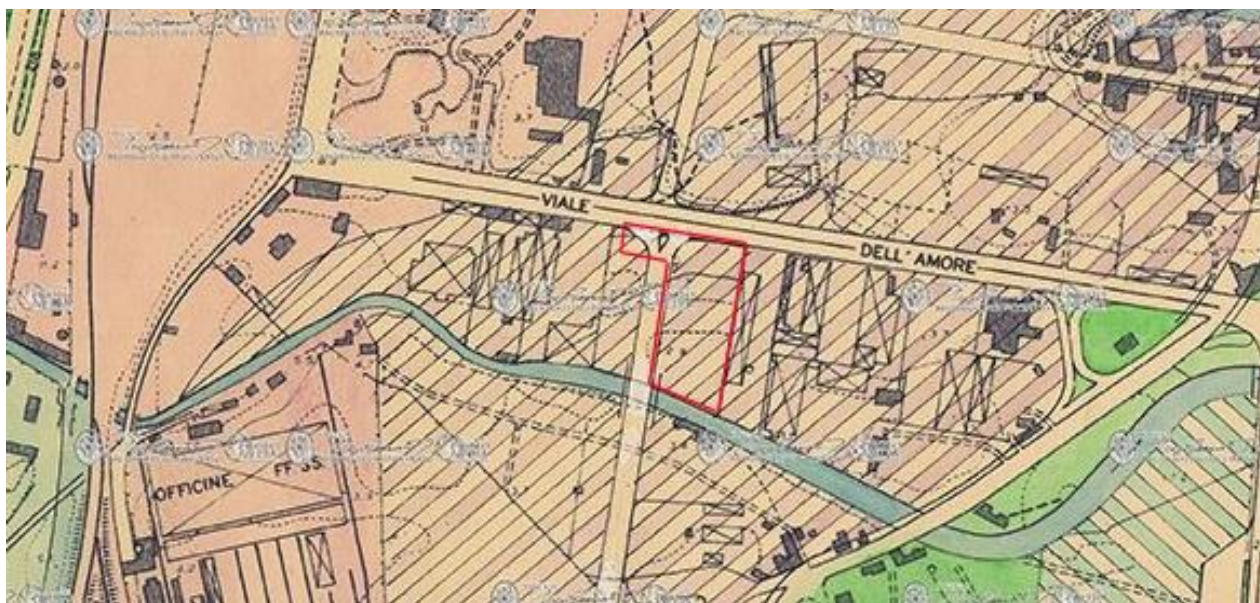
Figure 2: The red perimeter represents the IACP residential settlement in via Acquicella Porto on the 1964 urban development plan drafted by Luigi Piccinato. Namely, the diagonal hatch pattern, that affects most of the area where the pilot building is located, indicates the Industrial area.

The residential settlement in via Acquicella Porto by IACP is anomalous because it was built in a part of Catania with a purely industrial and commercial vocation. This is evident from the analysis of the nearby urban fabric (Figure 1). Furthermore, this vocation is demonstrated by the design intentions at the time, which aimed at the creation of a farmers' market. Indeed, "At first, in 1946, the market was thought to be built in Via Acquicella Porto, with a project by Santi Buscema, head of the UTC [Municipal Technical Office], who studied it with a series of sheds placed close to a torrent" [1, p. 465]. Commercial and industrial sheds indeed still characterize this part of Catania: they enclose and, at the same time, isolate the residential settlement of IACP. The craft and commercial vocation of the area is confirmed and integrated in the 1964 Town Development Plan drafted by Luigi Piccinato, and still in force today (Figure 2).

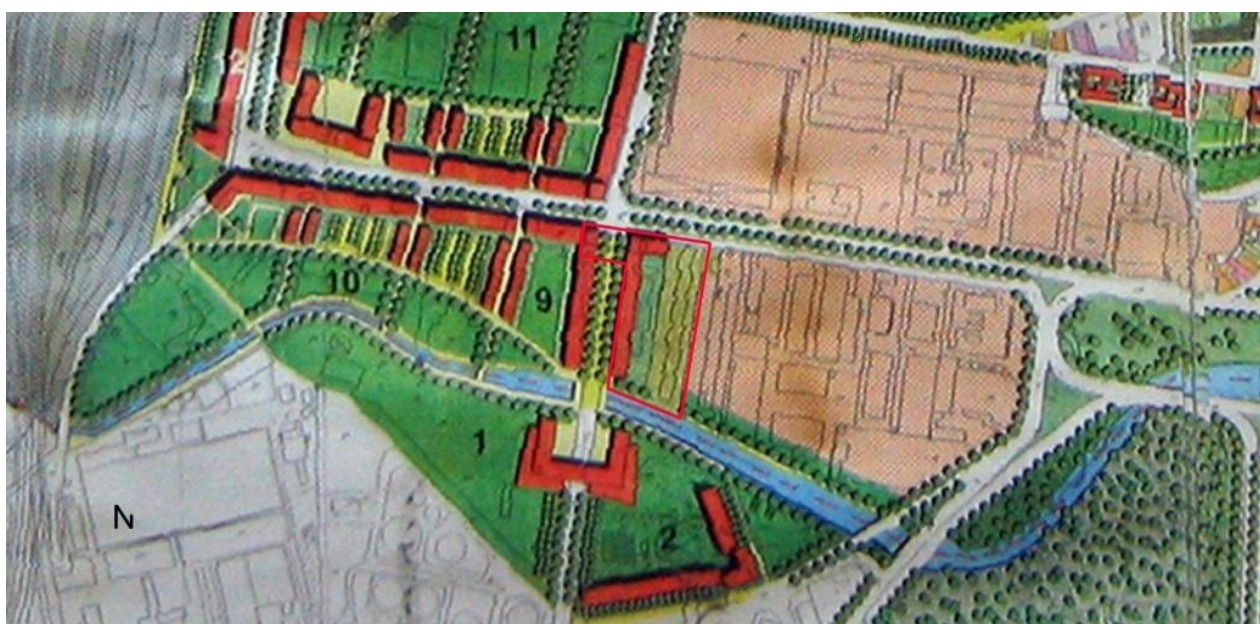
Figure 3: The red perimeter represents IACP residential settlement in via Acquicella Porto in 1996 urban plan proposal drafted by Pier Luigi Cervellati.

However, this vocation seems to have been partly disregarded by the proposals for the urban development plan that followed Piccinato's one. In particular, the design intentions of the 1996 development plan proposal drafted by Pier Luigi Cervellati completely remove the IACP settlement in via Acquicella Porto. Indeed, Cervellati's plan replaces part of the industrial and commercial fabric, including our residential complex, with a monumental and equally unlikely residential urban fabric [2] (Figure 3).

The axis should have ended with a building/door beyond the Acquicella torrent (Figure 3). However, Cervellati's proposal plan maintained part of the neighborhood's industrial sheds, used for commercial and craft activities.

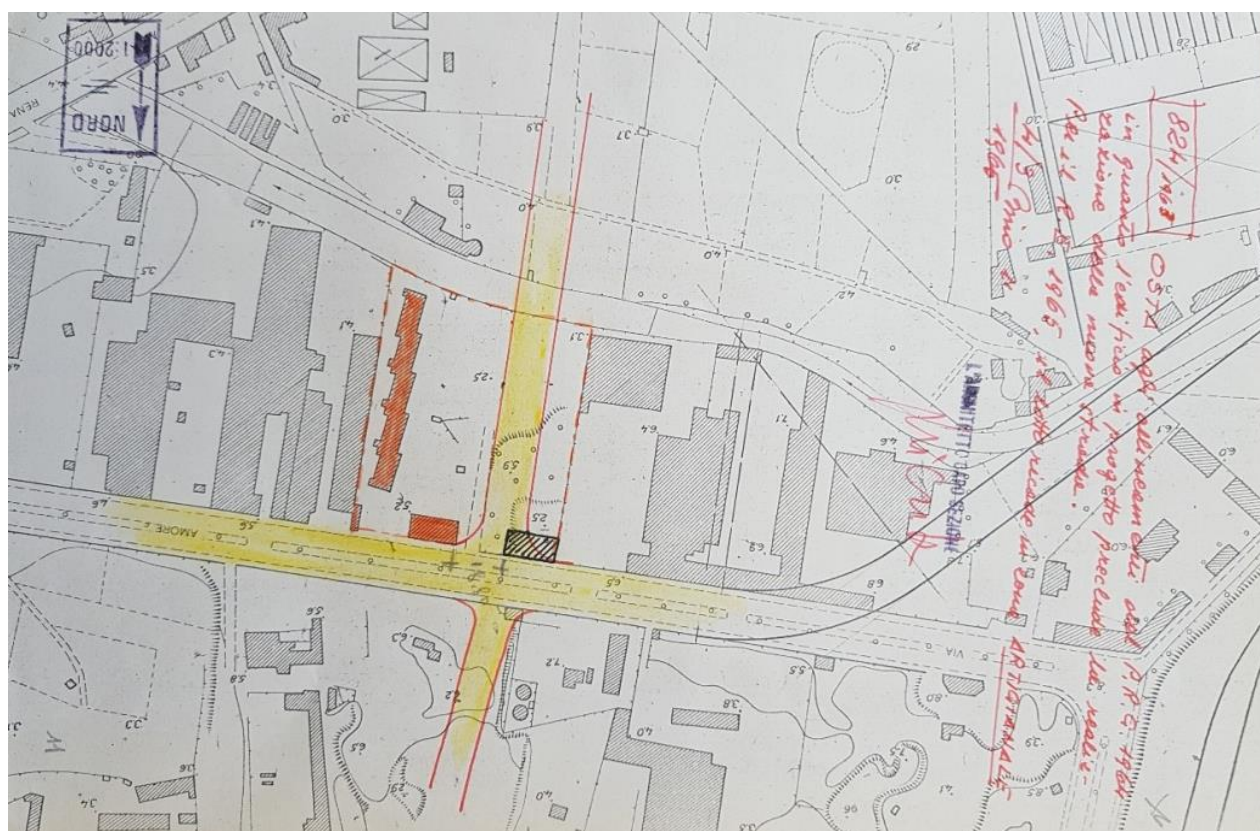
Figure 6: Map with the road planned in the 1964 plan.

The original project, after vision by Technical Office, has been redesigned to respect the distances of the buildings from a road foreseen by the 1964 Town Development Plan that has not yet been realized (Figure 5). It is the same street that in Cervellati's proposal coincided with the axis that was characterized by the continuous fronts of lined-up buildings that ended with a square and the door-building (Figure 3). This version of the project, in consideration of the plan forecasts, has provided for the elimination of two lined-up blocks to leave the area free for the future road (Figure 6).

The planimetric organization of the residential settlement in via Acquicella Porto is characterized by the relationship between the L-shape of the area, the presence of the Acquicella torrent and the building types (tower and linear type). The L-shape, which was originally a trapezoid (Figures 4 and 5), is partly due to the adaptation of the project to the requests of the Building Commission (Figures 6 and 7) concerning the road planned in the 1964 Town Development Plan.

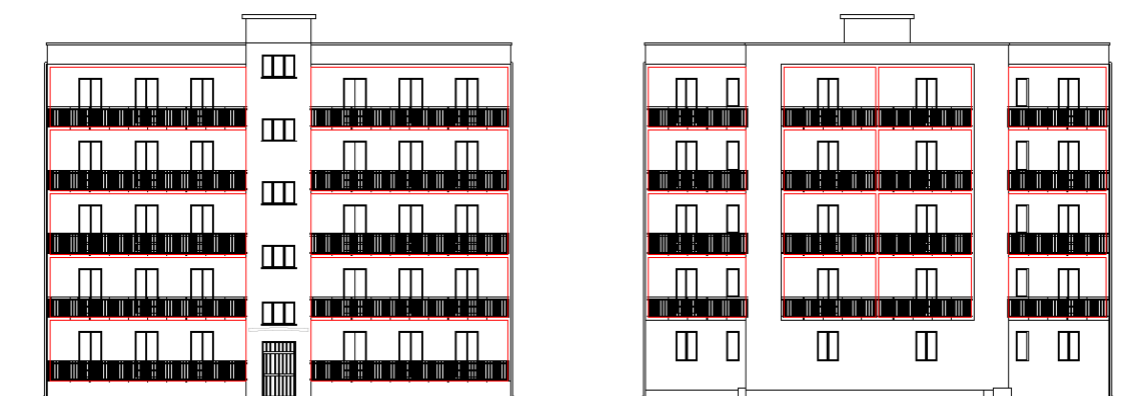
Figure 15: Front on the north (right) and south (left) side. Red line represents loggias.

bedrooms, and two separate ones on the north side serving: the first, a bedroom and the laundry room and the second the other bedroom. All balconies are closed on the short sides to form loggias on the long façades of the building, to the north and to the south (Figure 15). Unlike the original project, the raised floor on the northern front, on via Acquicella Porto, has only some windows and there are no balconies (Figure 15). Moreover, on the short fronts, east and west, the original design of the block did not provide any opening while in the realized building the two short fronts have a column of windows that corresponds to the second opening of one of the bedrooms of the apartments (Figures 11 and 16).

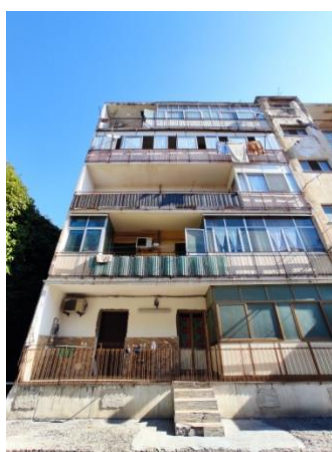
Figure 17a: Detail of southern elevation (left side).

Other transformations operated by the residents, to be considered as attempts to improve the façades and to customize their homes, are: the change of the façade colour (Figures 17a and 17c); the cladding with different shape and type of stone materials (Figure 17a and 17c); the addition of stairs for secondary and independent access to some balcony (Figure 17a); the walling of some openings (Figure 25); the transformation of doors in windows (Figures 18 and 25). Finally, in some cases, the inhabitants replaced the old windows, probably for their bad conditions or also to improve security, with new ones (Figures 18, 25, 28 and 29).

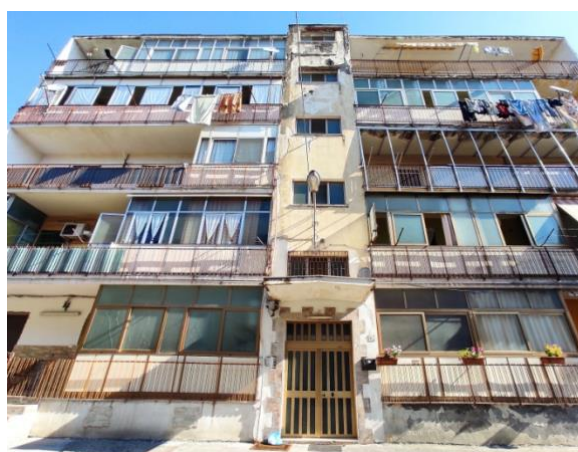
Figure 17b: Southern elevation. Real state (2021).

The photos on the current state of the pilot building (2021) are a plastic representation of the transformations that the inhabitants, over time, have made (Figure 17 and 24). On the outside of the building these transformations are often reversible because they are made by temporary structures such as “verandas” or by the introduction of technological components (e.g. air conditioners, parabolic antennas).

However, some of these transformations have also involved permanent changes in the internal distribution of the apartments. In particular, on the south side, the one overlooked by the living area (kitchen, dining and living room), there are many “verandas” in almost all the apartments (Figures 17 and 18). “Verandas” are usually considered by the inhabitants as extra rooms in the balconies, and this true for most of the “verandas” of the pilot building. In some cases (Figures 19, 20, 21, 22 and 23), these “verandas” are used as kitchens, allowing to have more space inside. All “verandas” have different configuration with the same type of material (aluminium frames). Even their location on the balconies differs from one floor to another.

Other elements affecting the overall image of the building (Figures 17, 18, 24 and 25) are: the external condenser units of the air conditioning systems, some parabolic antennas, the exhaust air extractors, gas system pipelines and electrical and telephone wiring.

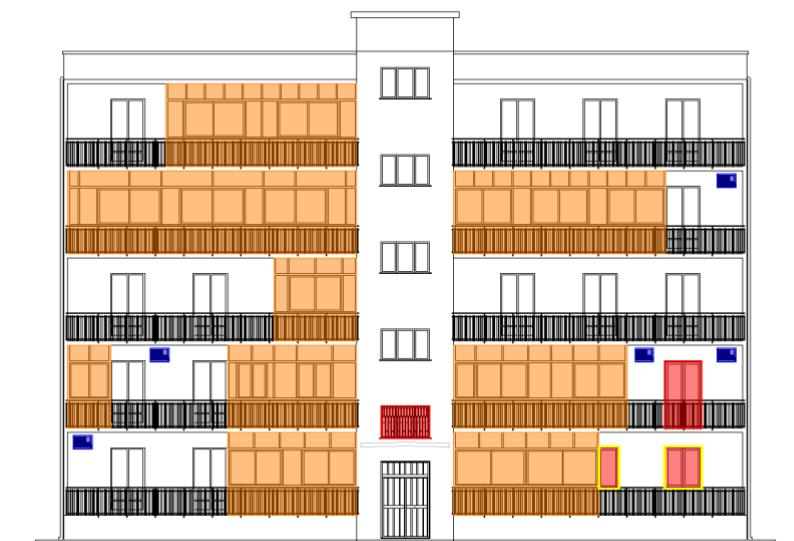
Figure 18: South elevation with the transformations by the residents. The “verandas” are shown in orange. The demolitions of the interior walls are shown in red. The air conditioners are shown in blue.

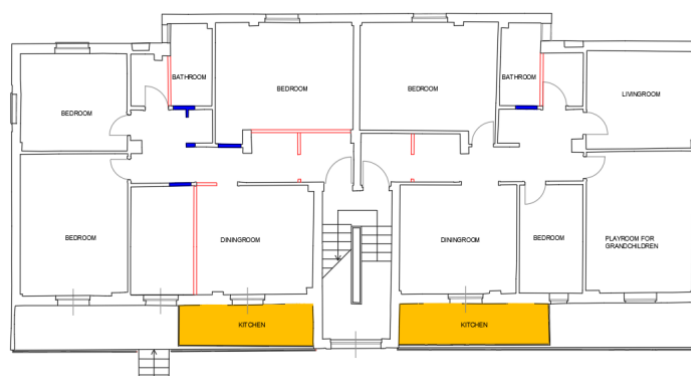
Figure 19: 1st floor transformations by the residents. The “verandas” are shown in orange. The demolitions of the interior walls are shown in red. The construction of walls in blue.

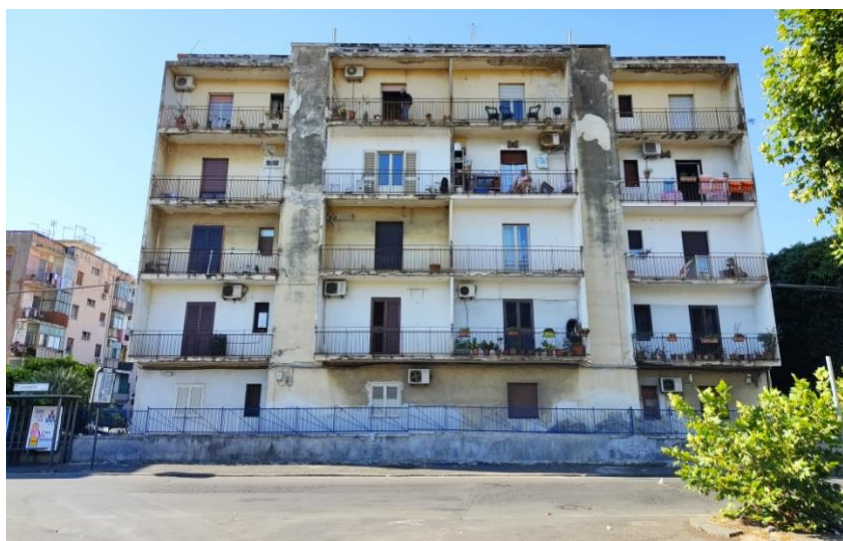
Figure 24: North elevation on via Acquicella Porto.

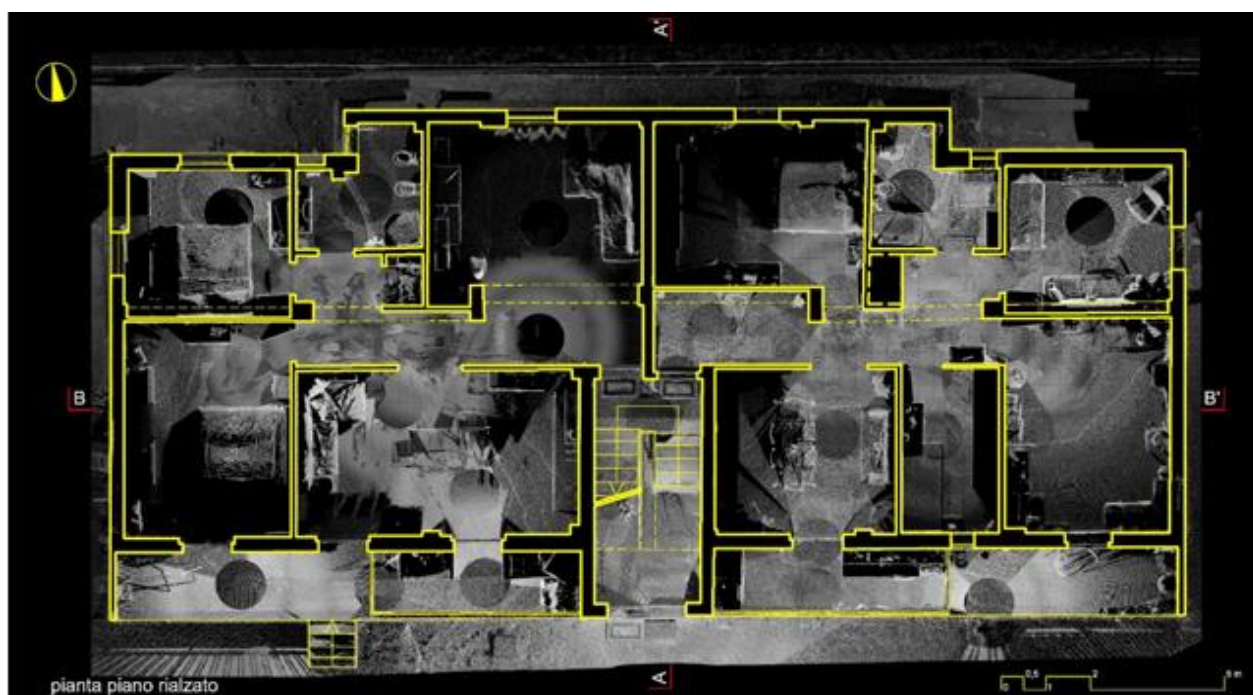
Figure 31: First floor Plan.

Because of several discrepancies between the existing preliminary drawings and the results of this survey, especially in the position and size of certain structural elements, new 2D drawings were produced (plans, elevations, and vertical sections) by using the CloudWorks Autocad application, which enables to visualize and easily manipulate the Cyclone point cloud in a CAD environment.

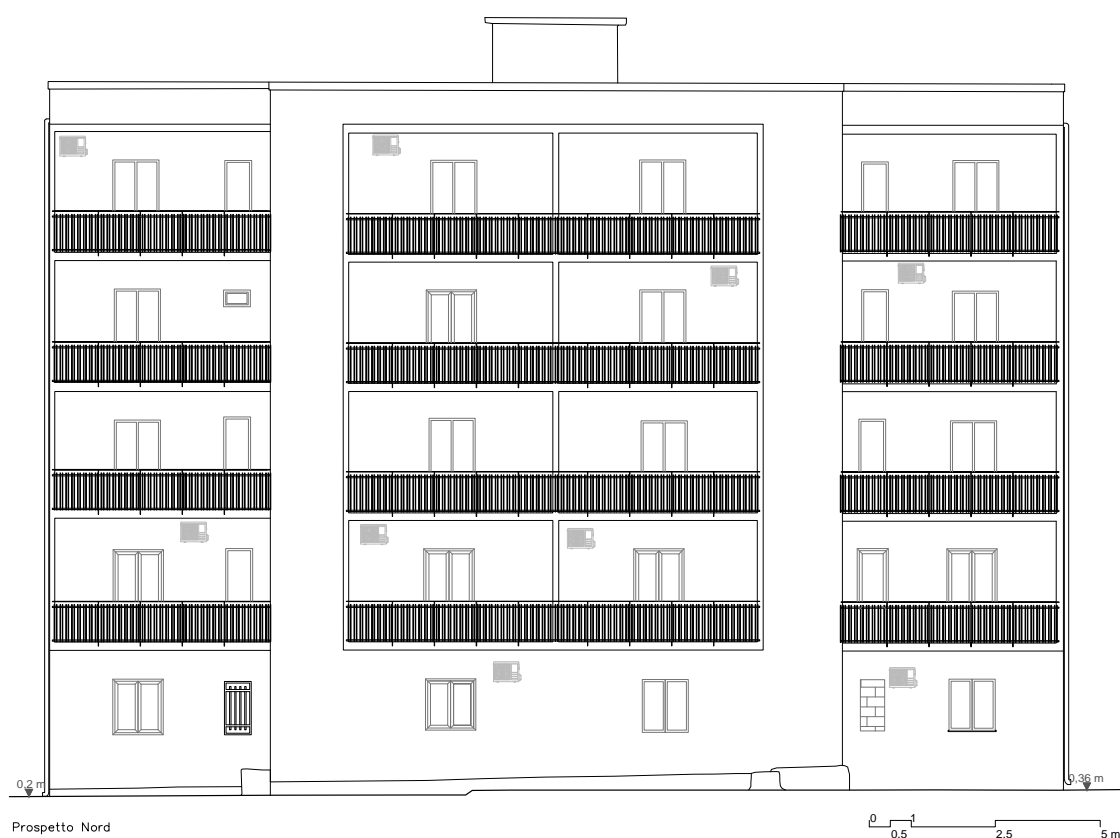
Figure 42: North front (by laser scanner survey).

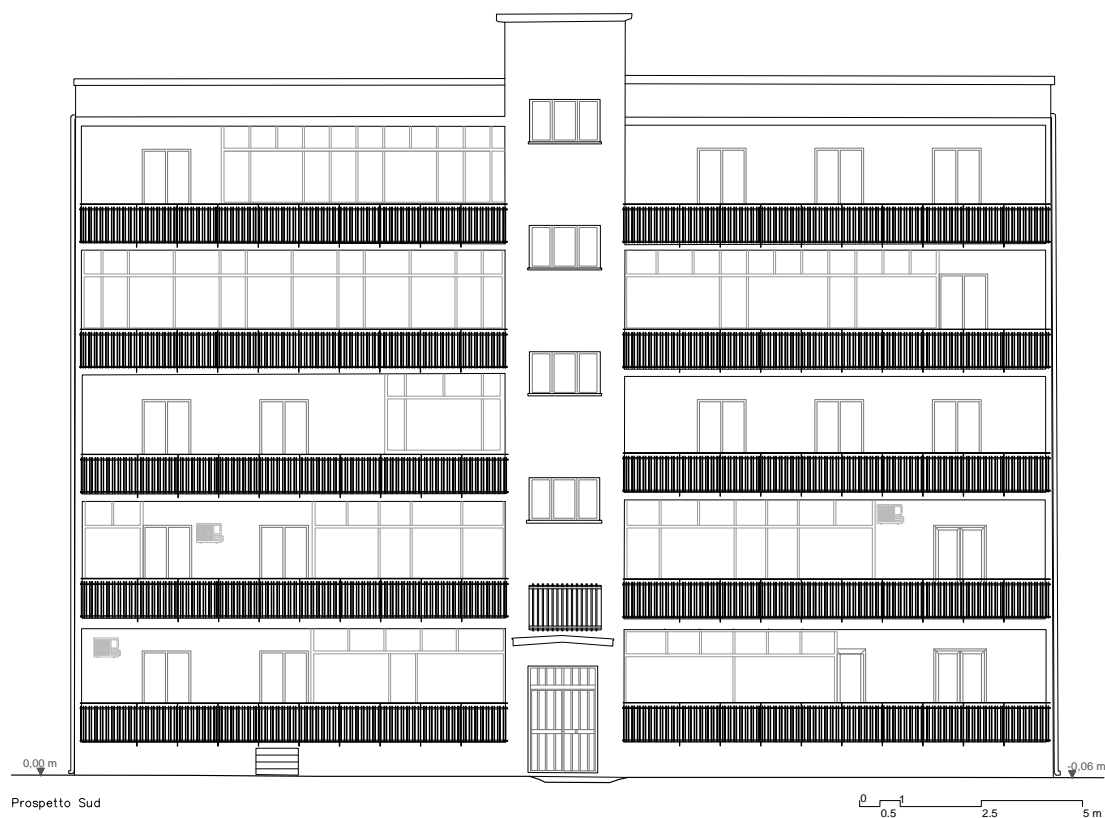
Figure 44: South front (by laser scanner survey).

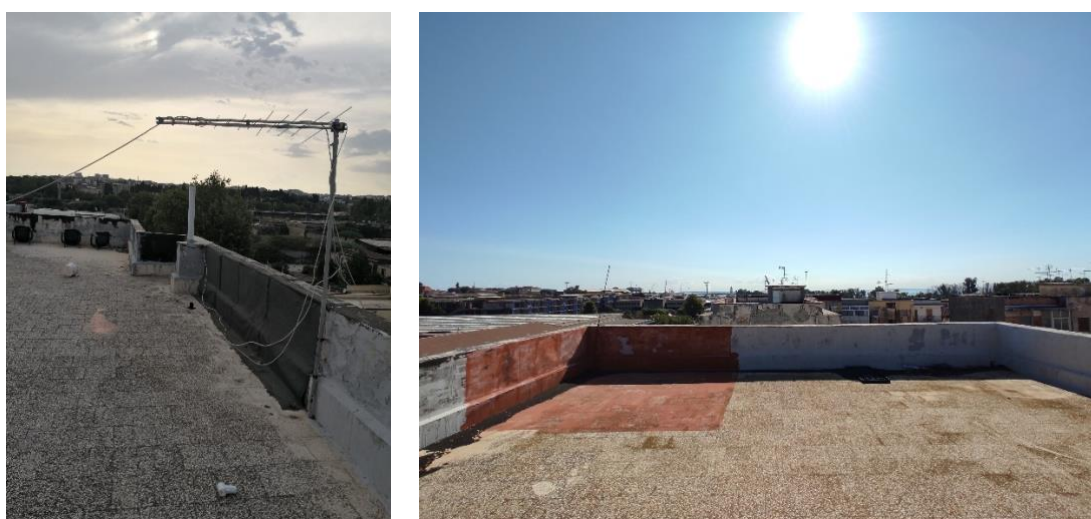
Figure 46: Views of the flat roof.

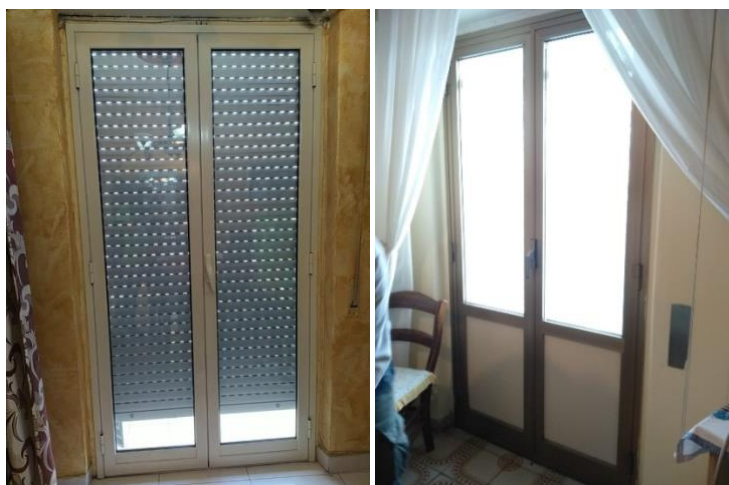
Finally, Table 7 details the number of each fixture typology in every apartment. As it is possible to observe, most of the external fixtures (21 out of 72) are double-glazed door windows with PVC frame and thermal break (Type M, see Figure 48), likely indicating a rather recent replacement of older typologies such as Type J and K (aluminum frame with thermal break, see Figure 48) that are still found in various apartments.

Figure 48: Examples of door window typologies M (on the left) and K (on the right).

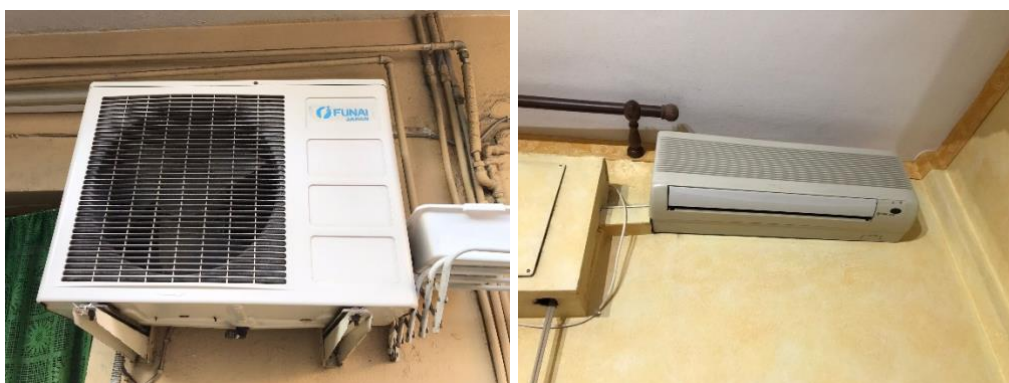
In the current state of the building, no apartment is equipped with a heating and cooling system able to ensure thermal comfort in the entire apartment. Some apartments are equipped with one or two old split units (e.g. one in the kitchen and one in the main bedroom, see Figure 50 for an example) that could be used for air conditioning purposes (see Table 10). These split units can deliver a thermal peak power in the range of 2 kW to 2.7 kW, albeit at the expense of high electricity consumption because of their low Coefficient of performance (COP) estimated in the range of 2.2 to 2.7.

Figure 50: External (on the left) and internal (on the right) views of a split unit in flat 2L.

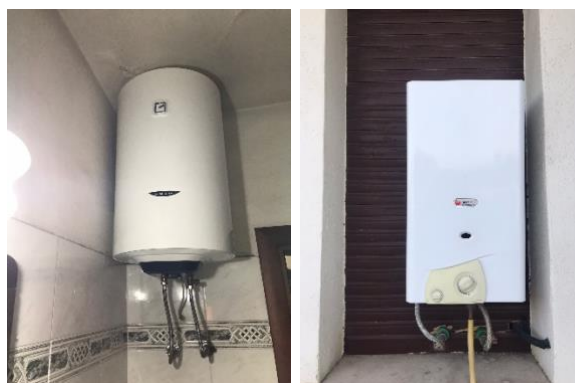
Figure 51: A typical electric boiler (on the left) and gas boiler (on the right) found in the pilot building for DHW production.

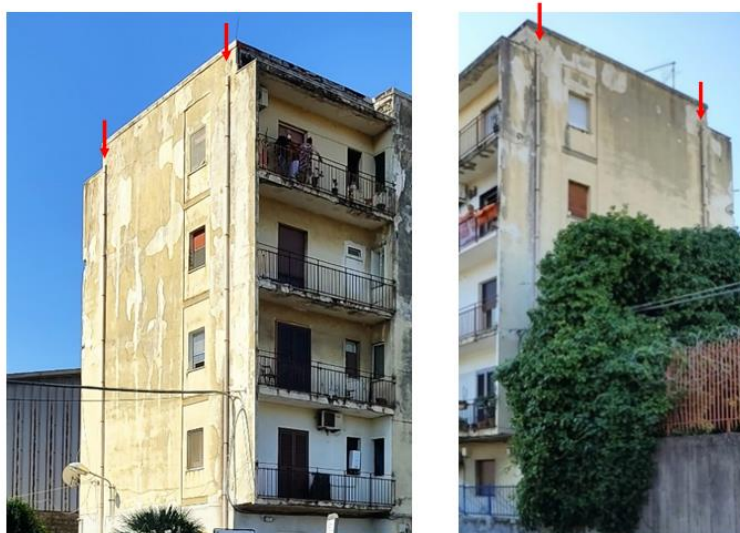
The rainwater drainage system from the flat roof consists of four vertical PVC downpipes that drain the rainwater at ground level. The downpipes are placed on the short fronts (east and west) of the building, as shown in Figure 52.

Figure 52: Downpipes placed on the east (left side) and west (right side) oriented facades of the pilot building

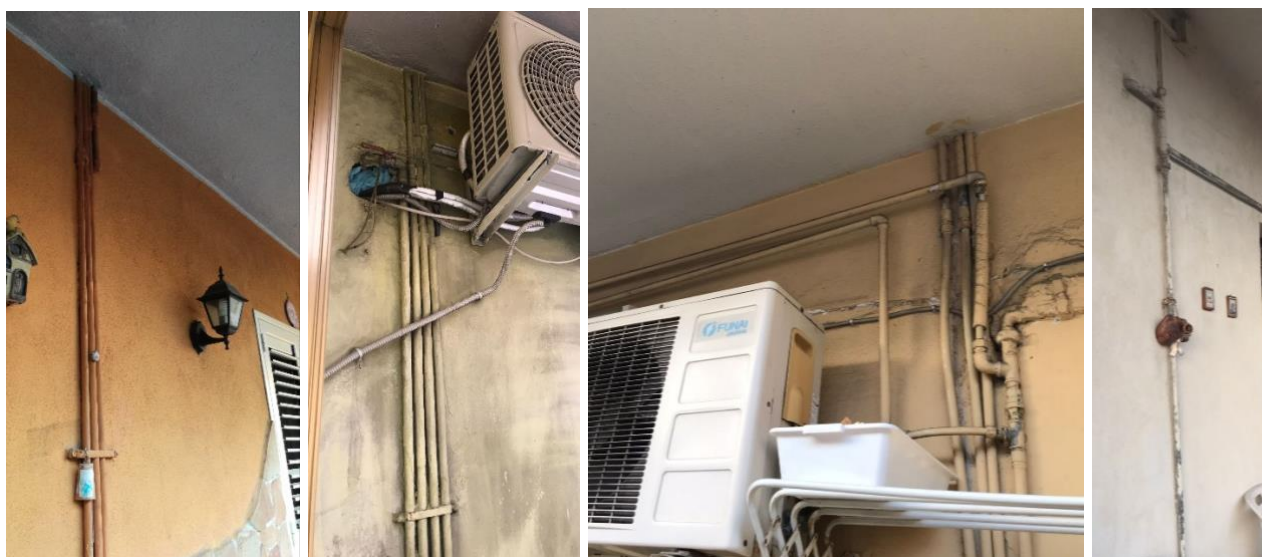
On the other hand, the water supply system consists of external pipes with a diameter of 1 inch. The water pipes are located on the south façade of the building and branch off from the first storey to the top one, as shown in Figure 53. The water meters of all apartments are located at the two lateral fronts of the building (ground floor) and are accessible from the outside (Figure 54).

Figure 53: Water pipes located on the south façade of the building (from left to right: first storey, second storey, second storey, fifth storey)

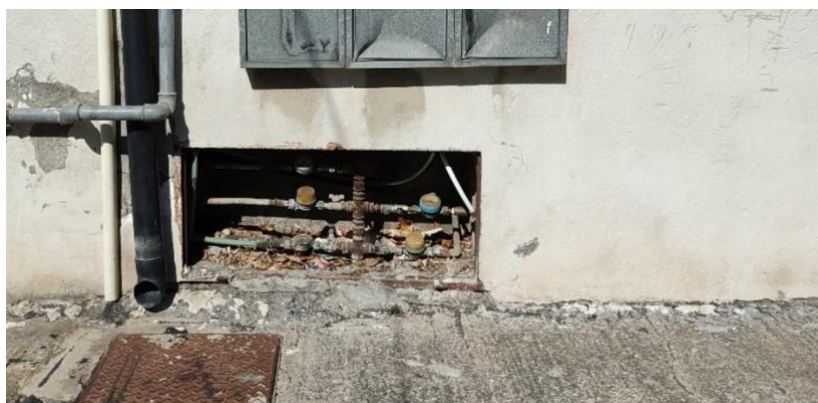
Figure 54: Water meters located at the east front of the building

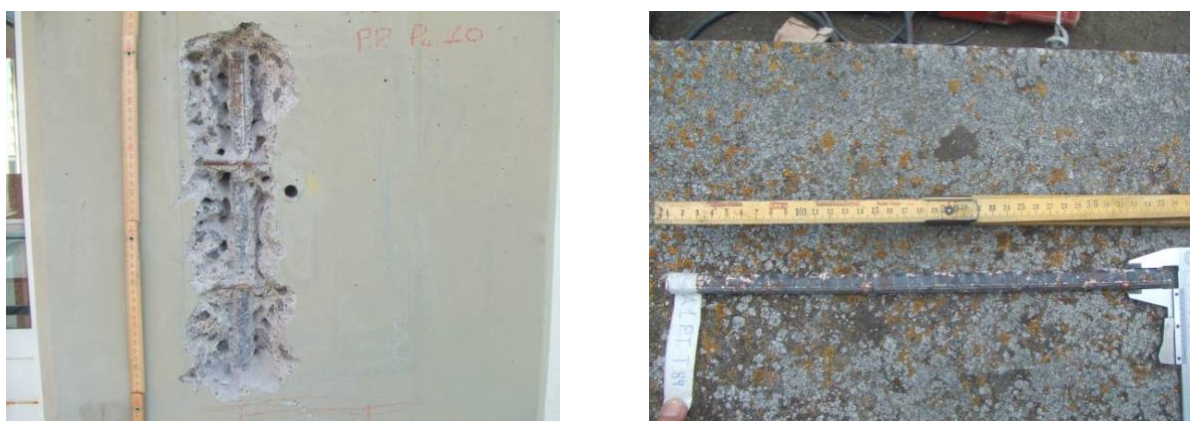
In the preliminary phase, the external layer of concrete and part of the concrete itself (the so-called cover) are removed. The picking of the concrete continues until the bar is reached. The reinforcement bar is thus exposed for a length of about 50 cm. Before removing the sample, the reinforcement bar is first replaced by overlapping and welding a reinforcing bar having at least the same diameter. Subsequently, the bar is removed to be subjected to laboratory tests (Figure 66). Afterwards, restoration operations are conducted to refurbish the concrete layer, usually by means of specific types of mortar for the restoration of concrete (rheoplastic, thixotropic, with controlled shrinkage and fibre-reinforced).

Figure 66: Extraction of steel bars and steel sample.

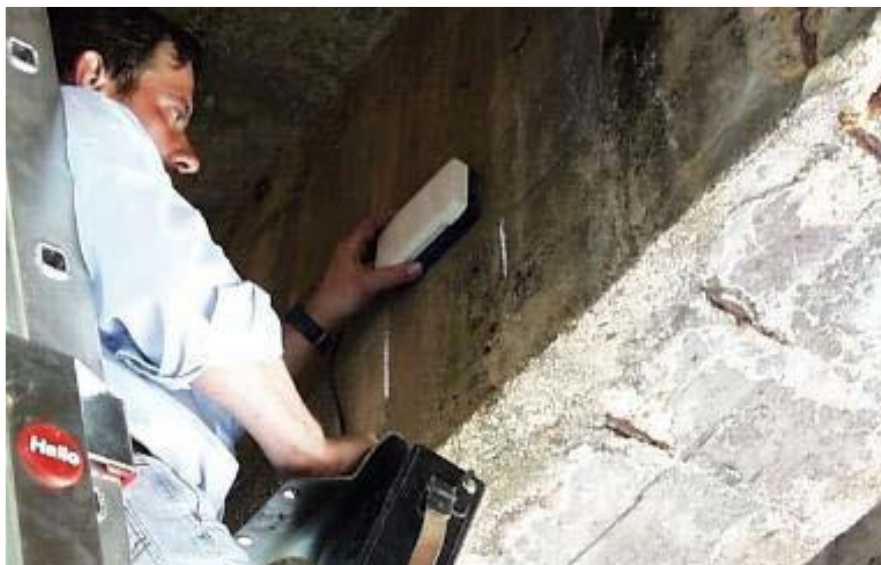
The covermeter tests (Figure 67) aim at the identification of the steel reinforcements embedded in the structural elements (BS 1881:204 [24]). In particular, the main goal of this test is to determine the presence and the diameter of steel bars and the steps within two consecutive bars. To this end, a magnetic detector of ferrous metals is used, whose measurements are based on the damping of a resonant circuit in parallel. An alternating current with a fixed and constant frequency flows through the probe coil creating a magnetic field. The shape of the probe ensures that the magnetic field stretched along the axis of the probe is distributed on the plane; the possible presence of metal objects in the area of influence alters the voltage of the coil. This alteration occurs according to a diameter-coverage ratio of the identified metal object and its value is obtained through the analogic indicator of the instrument.

Figure 67: Covermeter test.

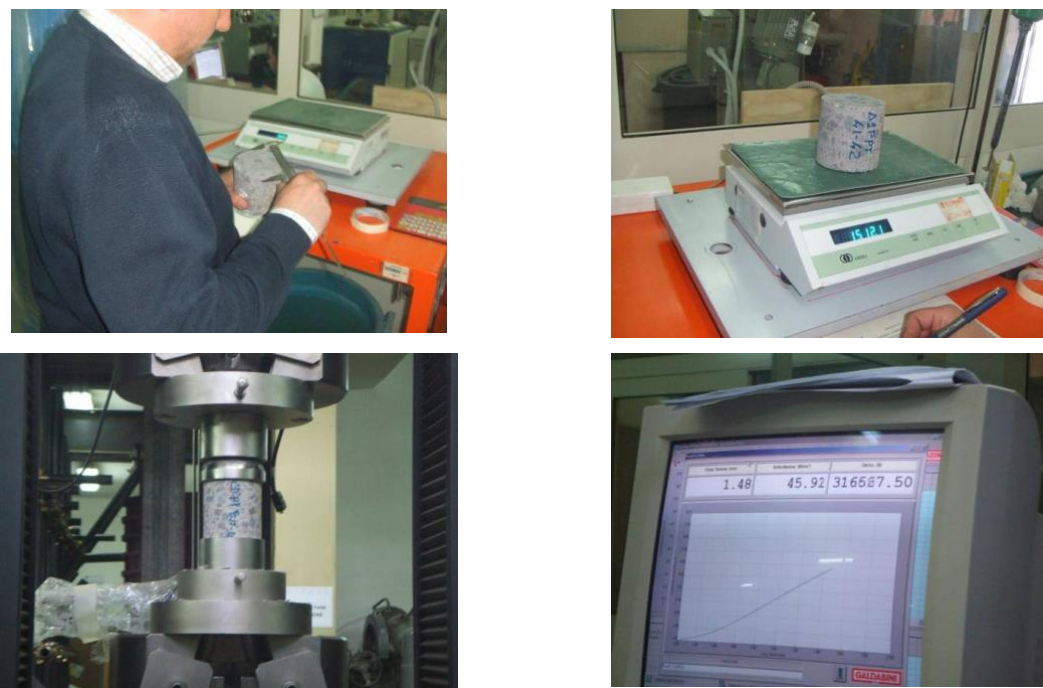
Figure 70 Execution of uniaxial compression test.

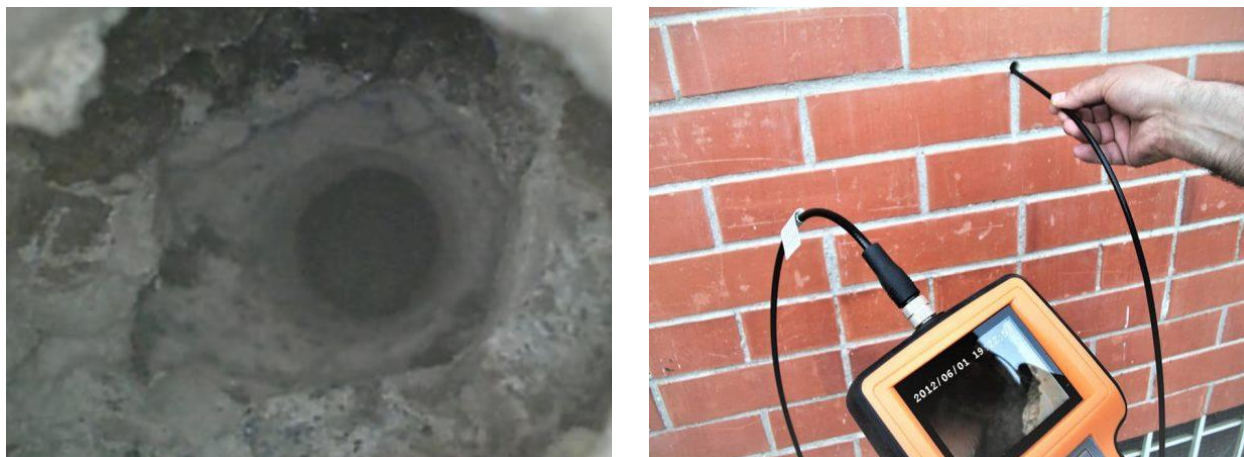
Figure 71: Execution of endoscopic test
